# Development of a hurricane-resistant roof-to-wall connection using high-performance fiber composites

DEVELOPMENT OF A HURRICANE-RESISTANT ROOF-TO-WALL  
CONNECTION USING HIGH-PERFORMANCE FIBER COMPOSITES

A thesis submitted in partial fulfillment of the  
requirements for the degree of

CIVIL ENGINEERING

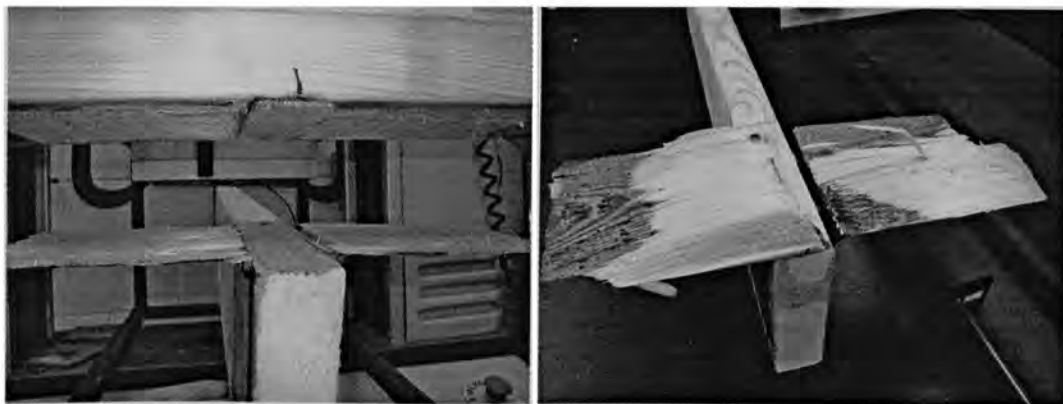
**Figure 3.19 – Failure of Configurations A with GFRP (left) and CFRP (right)**

Configuration A was developed by enlarging the contact area of FRP that was used in Configuration V of Stage I. The top plates were connected to the joist using four 4 in. x 9 in. FRP pieces. Each FRP piece was placed, such that half will be on the top plate and the other half on the joist. The specimens prepared by GFRP and CFRP are shown in Figure 3.18. It was seen that modes of failures were very similar for glass and carbon. In all specimens, the FRP peeled off from the top plate came while detaching wood fibers (Figure 3.19). It was observed that ultimate load for carbon FRP was approximately 20% higher than that of glass FRP. Also, the separation of wood fibers from the top plate was more obvious in CFRP ties.

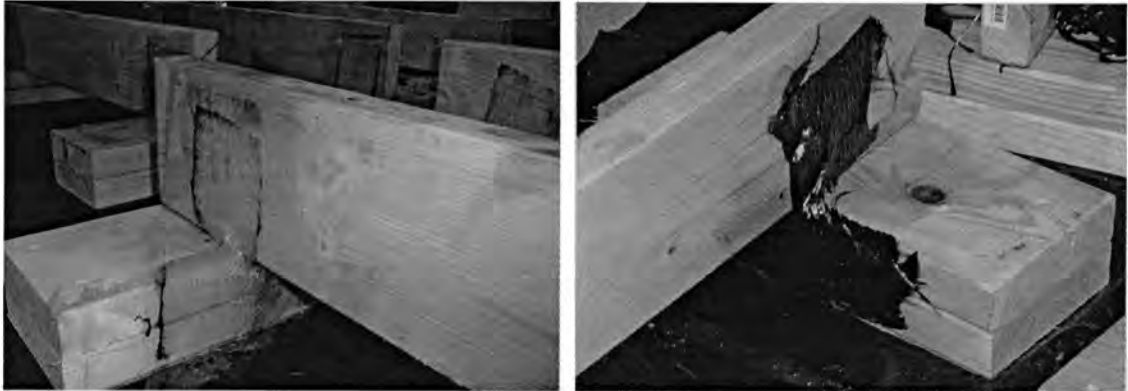
Configuration B was a modified version of Configuration IV of Stage I. The FRP used for each connection was made with one piece instead of two and the load transfer width was increased from 1/2 in. to 1 in. Also, the area bonded to the top plate was increased. The specimens prepared with CFRP and GFRP are shown in Figure 3.20.

**Figure 3.20 – Configuration B with GFRP (left) and CFRP (right) before testing**

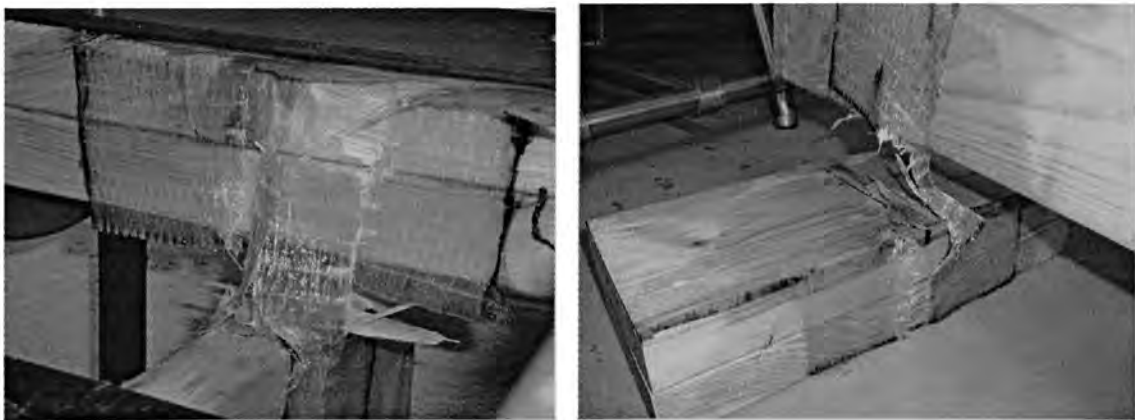
With configuration B, two different modes of failure were observed as shown in Figure 3.21. In Figure 3.21a, it can be seen that the FRP under the load transferring piece peeled off as a block, while in the other specimen the load transferring piece ruptured and a portion of FRP separated from the top plate (Figure 3.21b).

**Figure 3.21 – Two modes of failure observed in Configuration B**

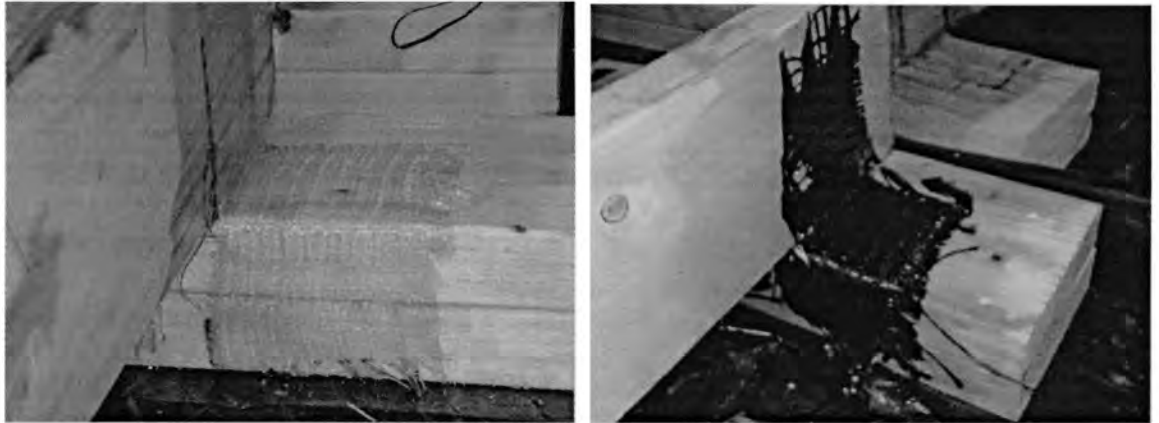
Connections C was made using bidirectional glass or carbon FRP to improve the mode of failure that was observed in Configurations III of Stage I. The L shaped FRP was placed on each side at the end of the joist, as shown in Figure 3.22.

**Figure 3.22 – Configuration C with GFRP (left) and CFRP (right) before testing**

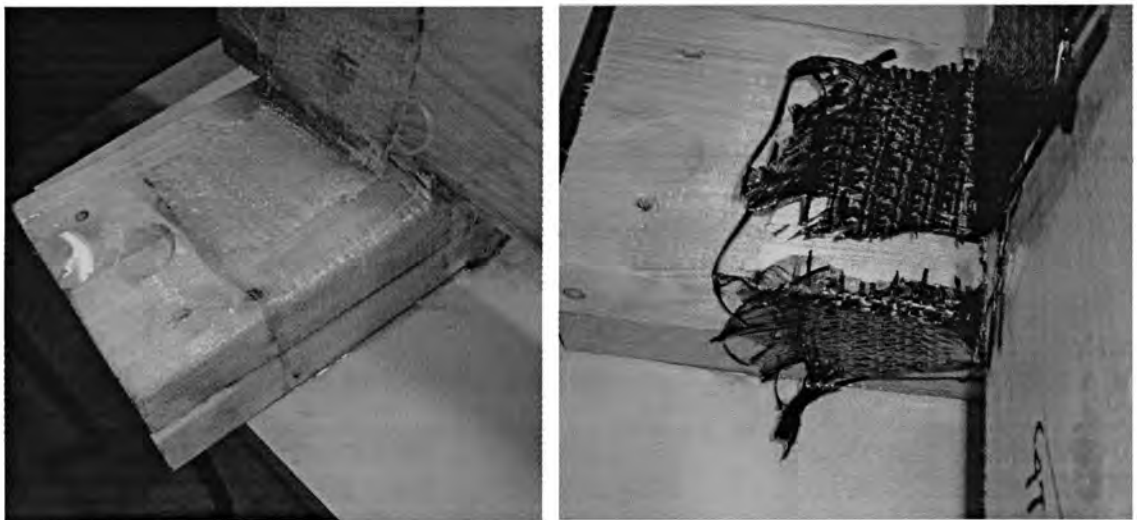
The mode of failure was very similar in specimens prepared with GFRP and CFRP. The connection failed as the FRP ruptured along the bent line on the top plate, and subsequently peeled off (Figure 3.23).

**Figure 3.23 – Failure of Configurations C with GFRP (left) and CFRP (right)**

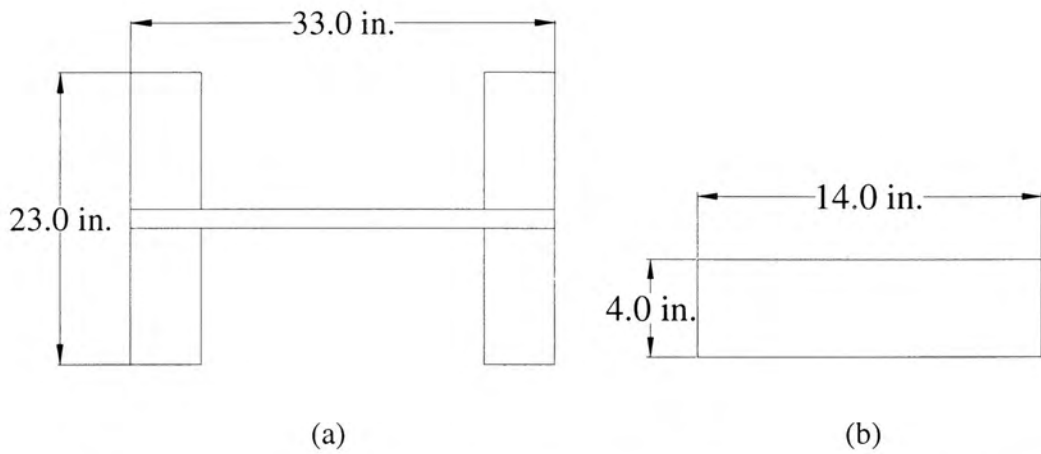
In the previous stage, it was seen that failure of Configuration A with GFRP occurred with peeling of FRP from the top plate. In order to overcome this problem, specimens having a larger FRP-wood connection area on the top plate were prepared. For this set of experiments, the top plates of specimens were increased to 23 in. and the length of one FRP tie was increased to 14 in. The portion of FRP which is placed on the joist remained the same at 4.5 in., while the portion on the top plate was increased to 9.5

in. The schematics of the new specimen and the FRP tie are shown in the Figure 3.25.

**Figure 3.25 – (a) Top view of test specimen to accommodate longer ties, (b) Longer FRP tie**

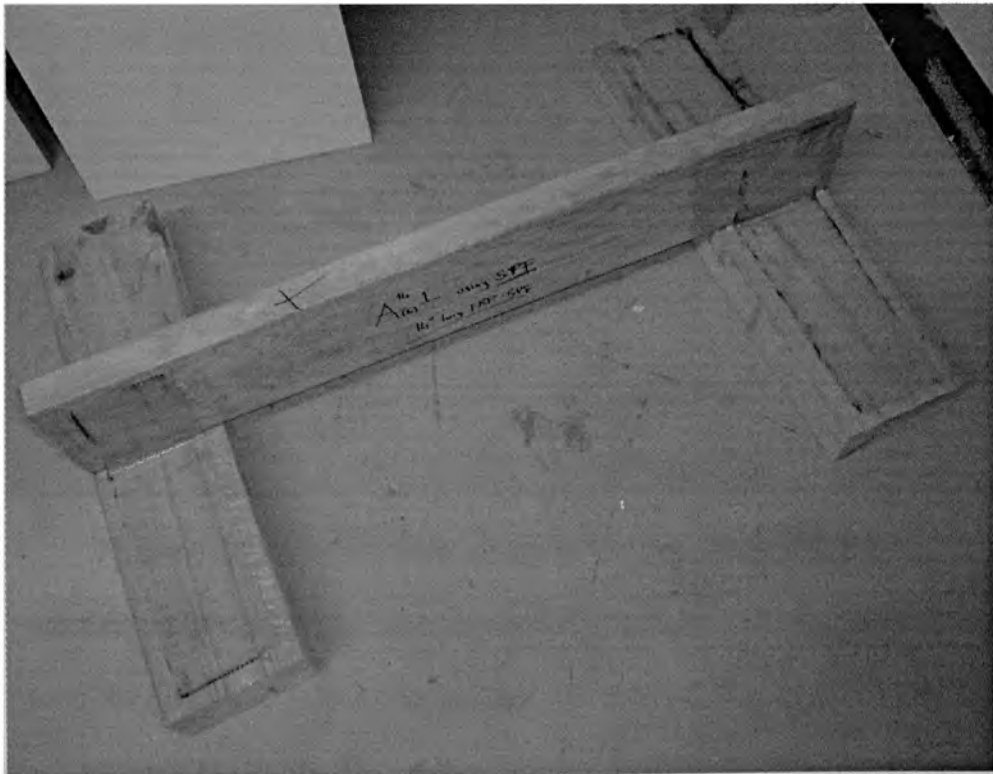
**Figure 3.26 – Specimen with longer FRP ties**

Figure 3.26 shows one of the specimens before testing.

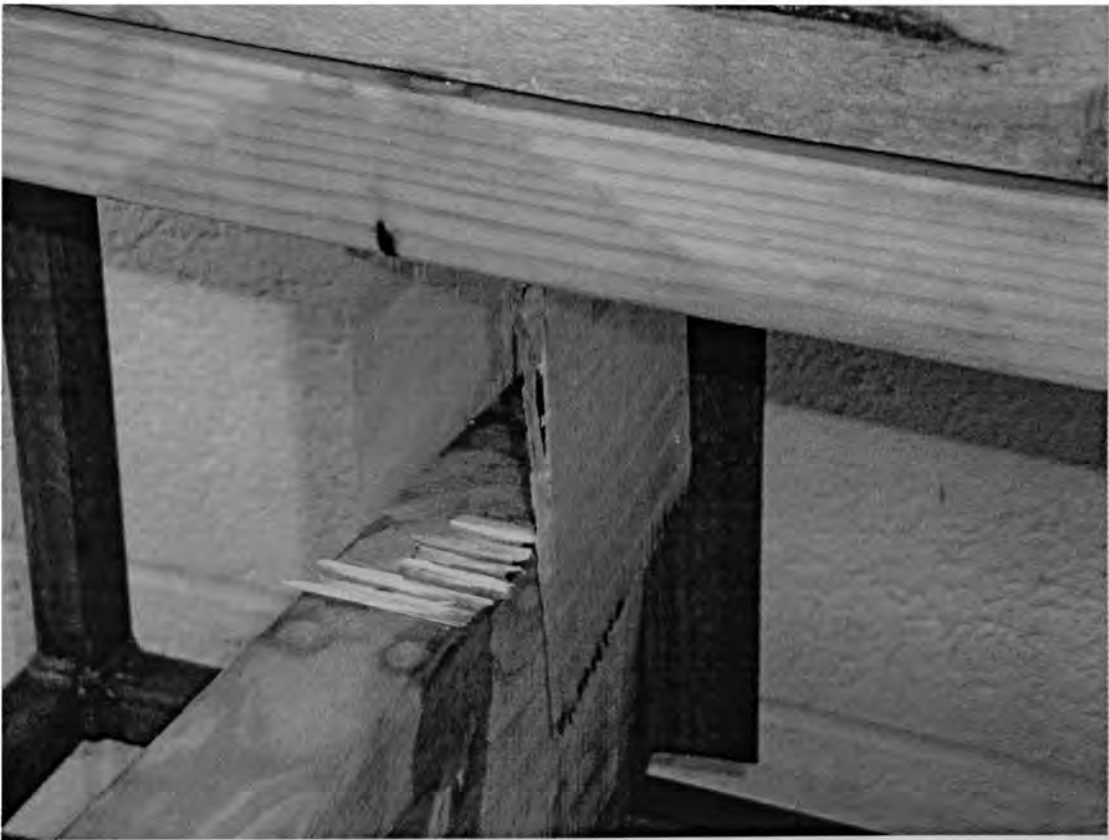
Three tests were conducted with each SPF and SYP. The mode of failure changed from peeling off of FRP on the top plate to bond failure of FRP placed on the joist in shear (Figure 3.27). However, there was almost no increase in the ultimate load as compared to the specimens with shorter FRP ties. Also, it was seen that the results obtained from specimens with SPF wood were higher and more consistent than those with SYP wood.

**Figure 3.27 – Shear failure of specimen with longer FRP ties**

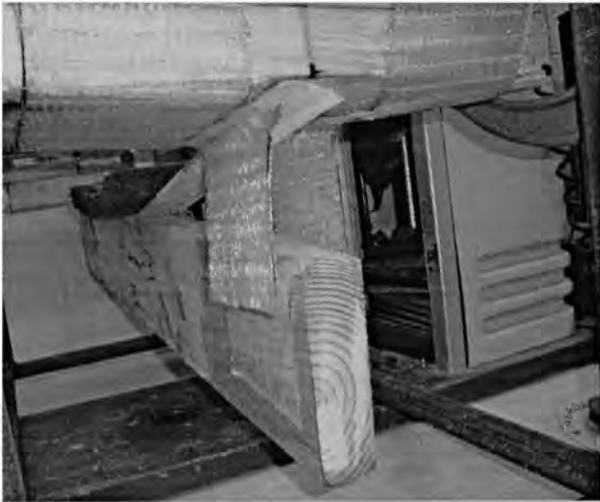
the portion of the tie on the top plate. It was noted that the strap worked quite well in terms of changing the mode of failure and holding the FRP tie onto the top plate. However, the increase in the ultimate load was not significant. The mode of failure was identified as bond failure in shear on the plane where FRP is connected to the joist (Figures 3.28 and 3.29). Again, the specimens prepared with SYP wood yielded a lower average ultimate load with a larger scatter, as compared with those with SPF wood.

**Figure 3.28 – Failure of specimen strengthened with straps**

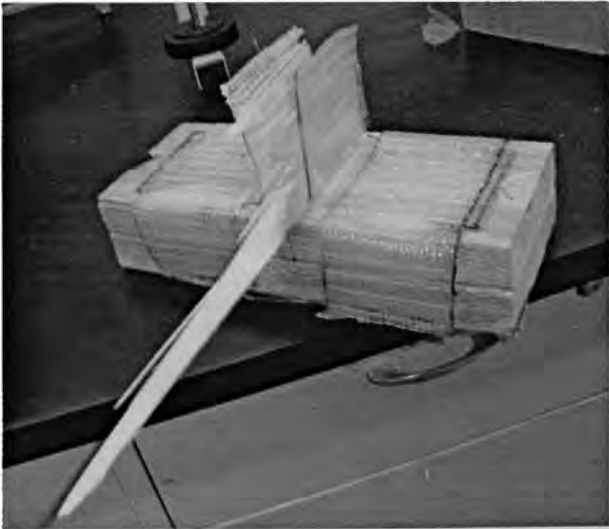
**Figure 3.29 – One of the top plates after testing**

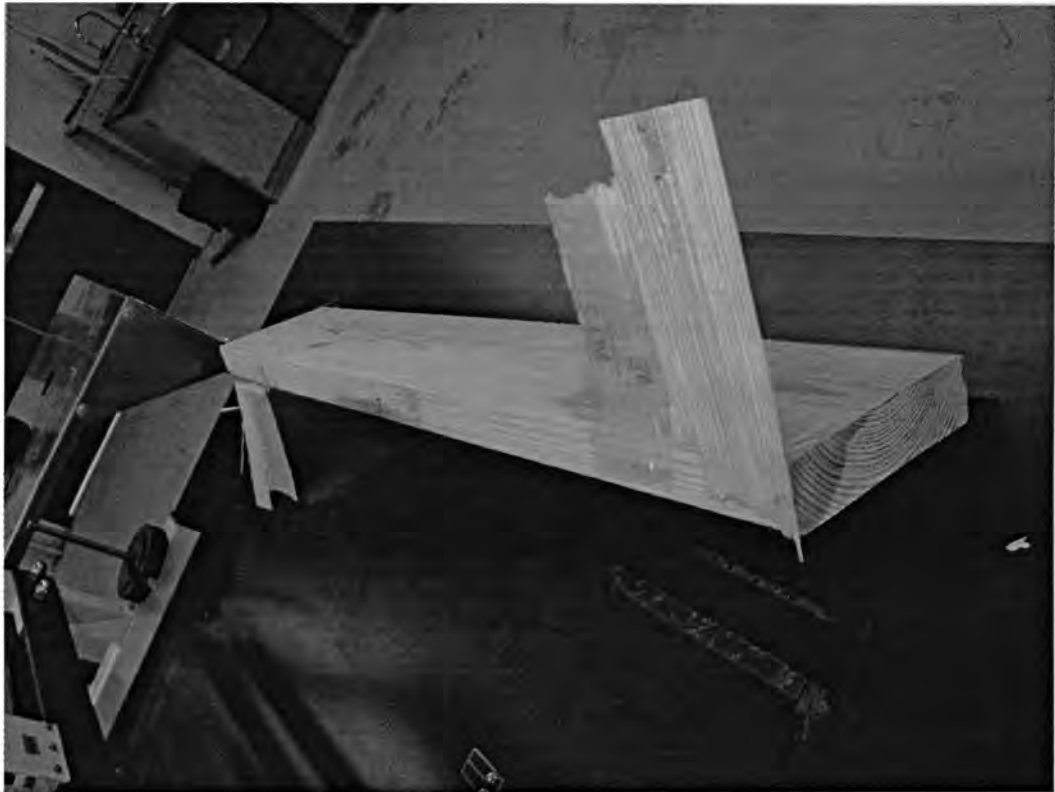
A set of test was conducted to see the trend in the ultimate load, when one FRP tie of Configuration A was used per top plate instead of two. The FRP ties were placed diagonally at two ends of the joist. It was seen that the ultimate failure load decreased by about 25% as compared to the specimens with two ties on each top plate. The mode of failure remained the same as FRP ties peeled off from the top plate (Figure 3.30).

**Figure 3.30 – Joist separating from top plates with FRP ties peeled off**

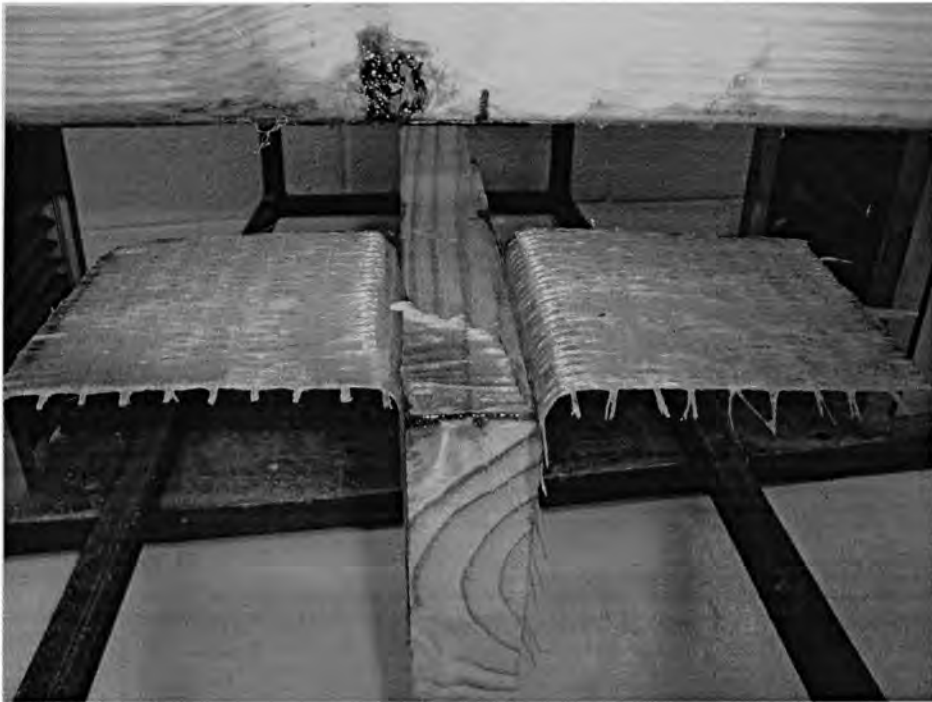
The same set of tests for Configuration A in Stage II was conducted with SYP wood to evaluate the effect of wood type. Even though the mode of failure was the same, the ultimate loads of specimens with SYP wood were notably lower than those with SPF wood. Moreover, the amount of wood fibers peeling off from the top plate was very little for SYP wood (Figure 3.31).

**Figure 3.31 – Failure of specimen with SYP wood**

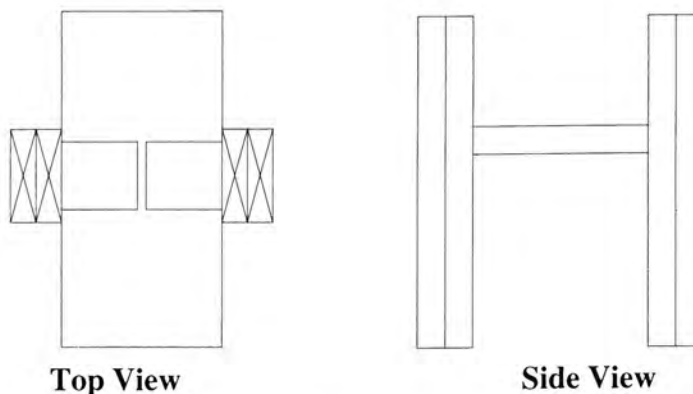
For investigating the performance of Configuration under lateral loads, a test setup was adopted similar to that commonly used by hurricane clip manufacturers. Two ties were placed at the centerline of the nominal 2 in. x 10 in. SYP wood, as shown in Figures 3.32 and 3.33. The load was applied using an inverted U-shaped wood element (Figure 3.34).

**Figure 3.32 – Top and side views of specimen tested for lateral loading**

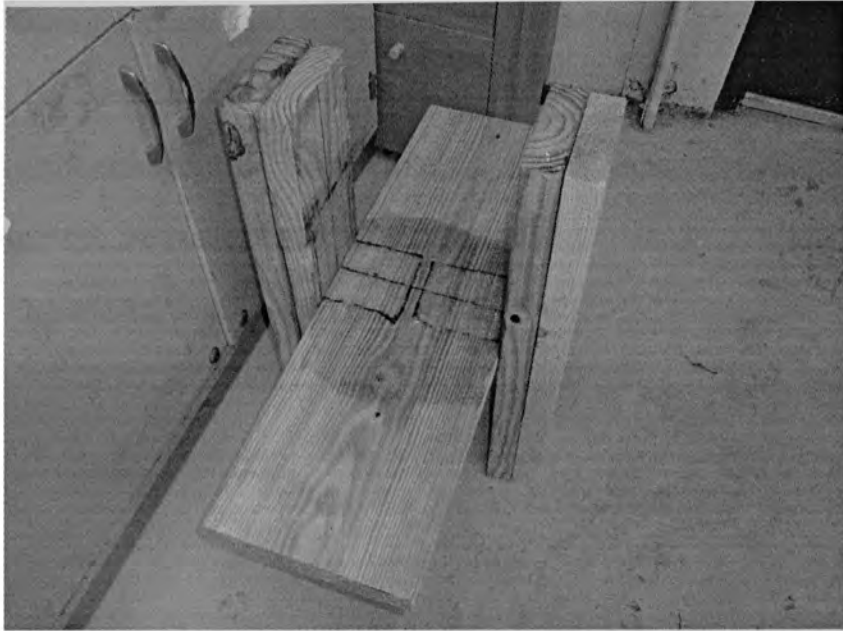
**Figure 3.33 – Specimen used for lateral loading tests**

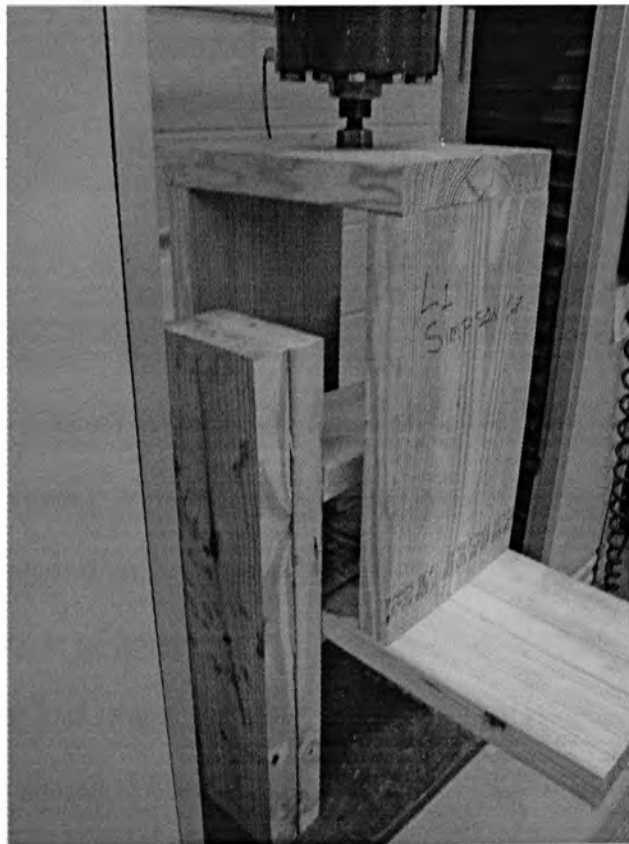
**Figure 3.34 – Application of load in lateral loading test**

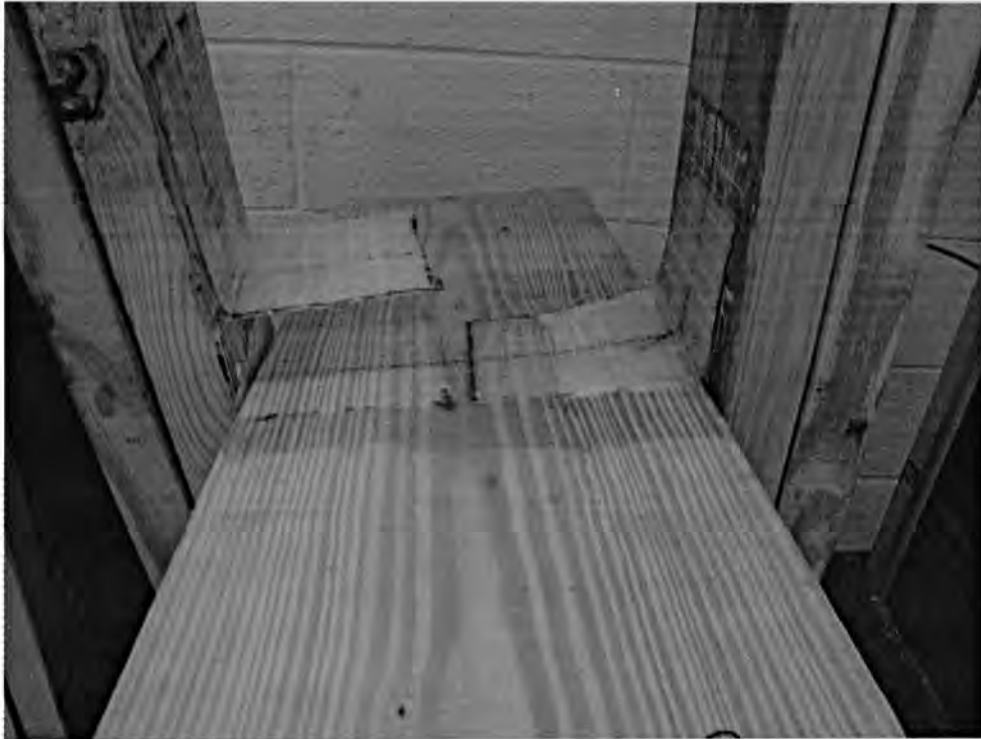
The average ultimate load of the three specimens was 2,290 lbs, yielding a value of 1,145 lbs per connection in the lateral direction. This value is much higher than the lateral capacity of most hurricane clips. Generally speaking, the allowable lateral load for hurricane clips is in the range of 100 to 200 lbs. The typical mode of failure for FRP ties is shown in Figure 3.35, which clearly is peeling off.

**Figure 3.35 – Typical mode of failure under lateral loading**

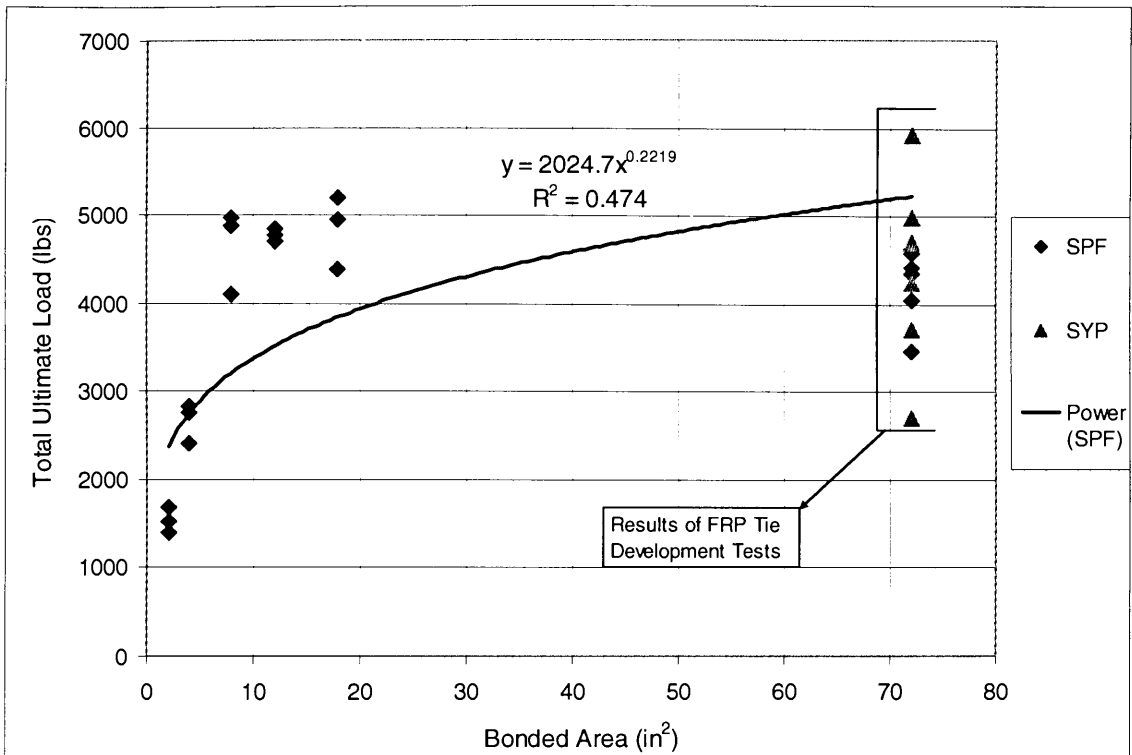
**Figure 3.37 – Total ultimate load versus bonded area**

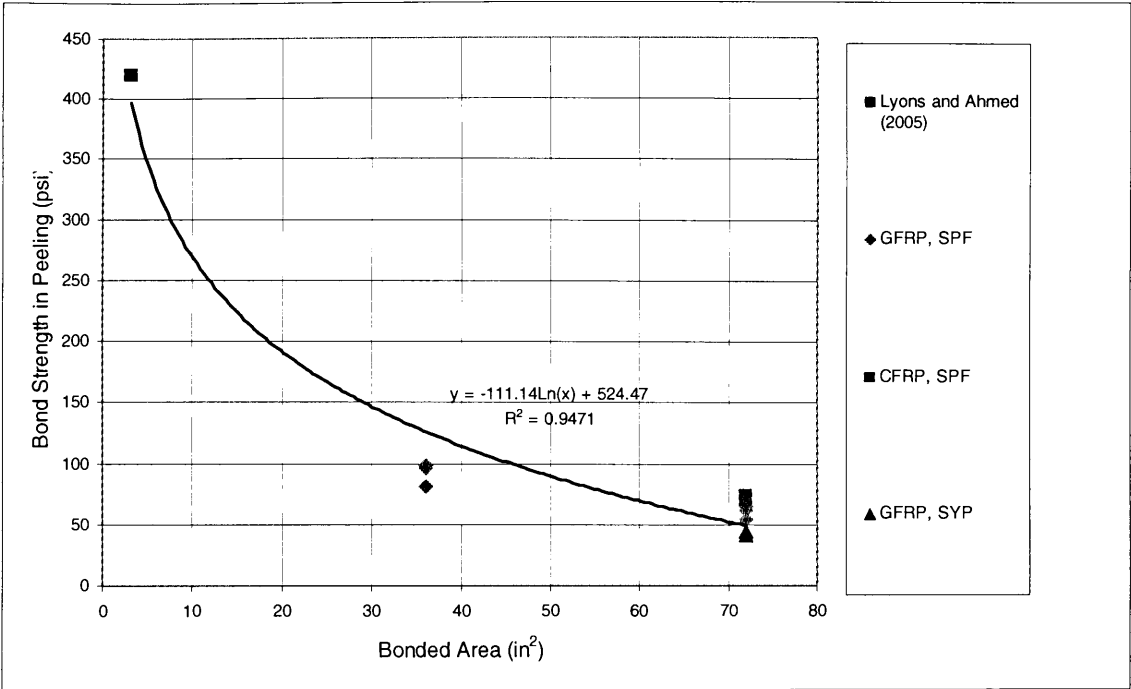
In Figure 3.38, the FRP-wood bond strength in peeling is shown against the total bonded area for the specimens which failed as FRP peeled off from the top plate. It can be seen that, CFRP has a better bonding capability than GFRP. Also, SPF performs better than SYP in terms of bond strength. Moreover, a data point obtained from the study conducted by Lyons and Ahmed (2005) is included in this graph. This point represents the bond strength obtained from dry prepared specimen, which was cured in laboratory conditions and tested using a 2 in. diameter pull-off tester. A natural logarithmic fit was obtained using regression analysis for all data points with an  $R^2$  value of 0.947, as given by

**Figure 3.38 – Bond strength in peeling versus bonded area**

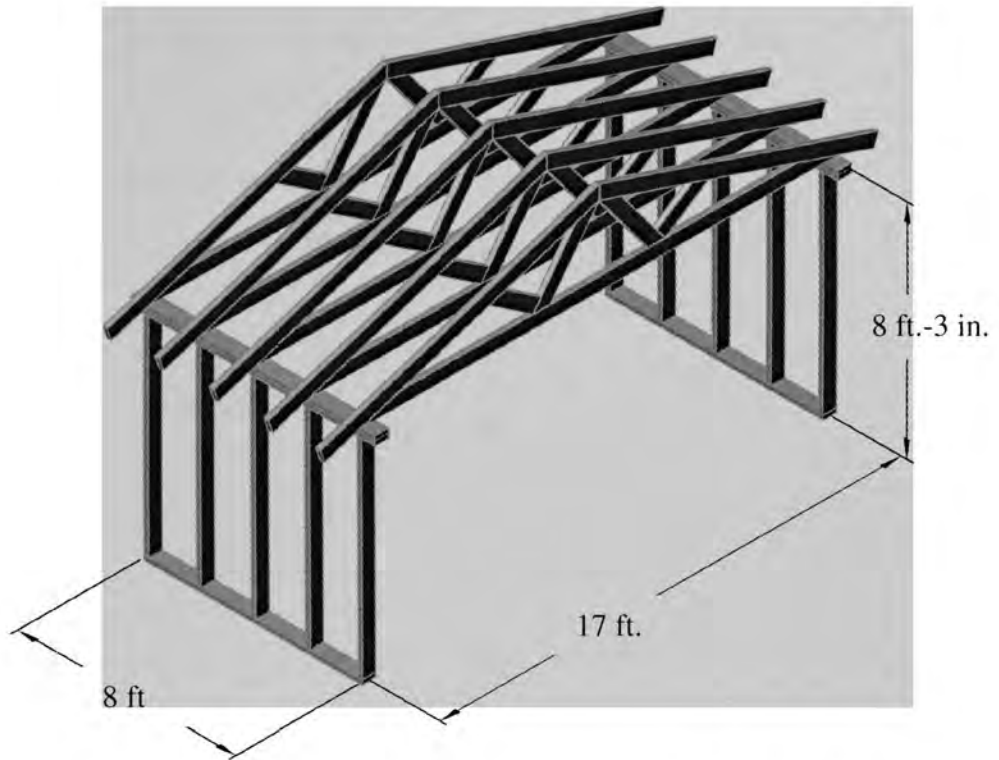
In order to assess the in-situ performance of the FRP tie under uplift forces, a full-scale test was carried out. The specimen was constructed using spruce pine fir (SPF) 2 in. x 6 in. dimensional lumber with a grade of No. 2 or better. The specimen consisted of two 8 ft.-3 in. high, 8 ft. long shear walls, with a center to center spacing of 17 ft. The shear walls were supported by five W type trusses, as shown in Figures 4.1 and 4.2. The shear walls had 9 ft. long double top plates, five vertical studs and a single 8 ft. long bottom plate. The double top plate had a 6 in. overhang at the ends for the placement of FRP tie (Figure 4.1, 4.2 and 4.3). The APA-rated 19/32 in. thick 4 ft. x 8 ft. plywood was used as sheathing on the outer walls and the roof. On the roof, the sheathing was placed such that the 8 ft. sides were parallel to the ridge. On the outer walls, the sheathing was placed such that the 8 ft. sides were parallel to the studs. The sheathing was attached to the roof and the outer walls using #8 size, 2 in. long screws spaced every 6 in.

**Figure 4.1 - The full-scale test specimen without sheathing**

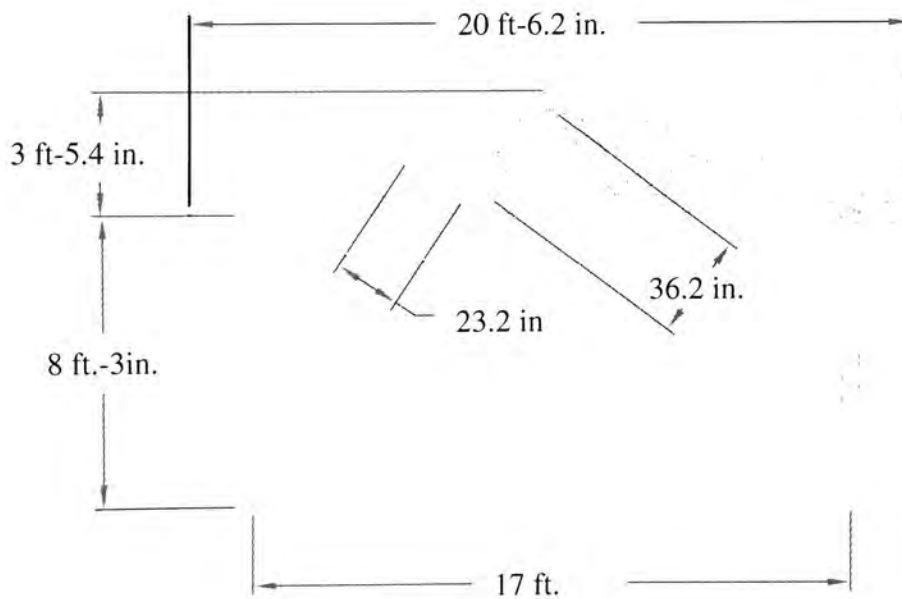
**Figure 4.2 - Front view of test specimen**

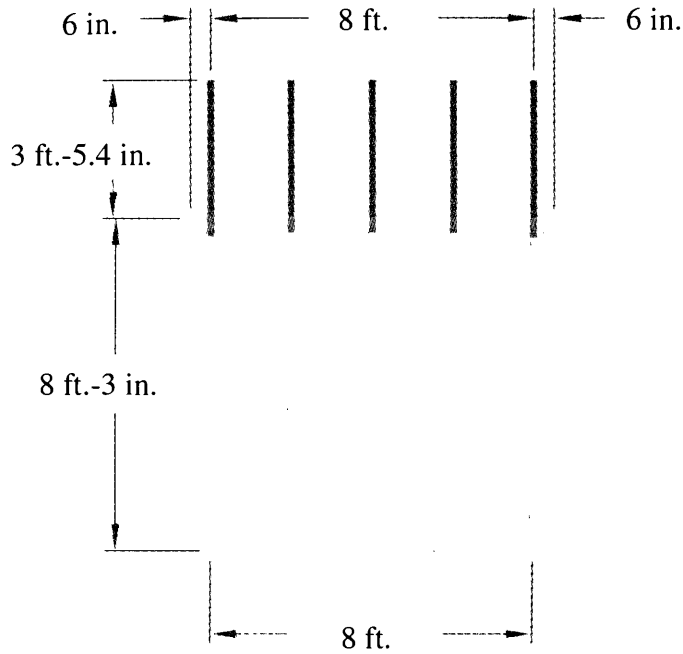
**Figure 4.3 - Side view of test specimen**

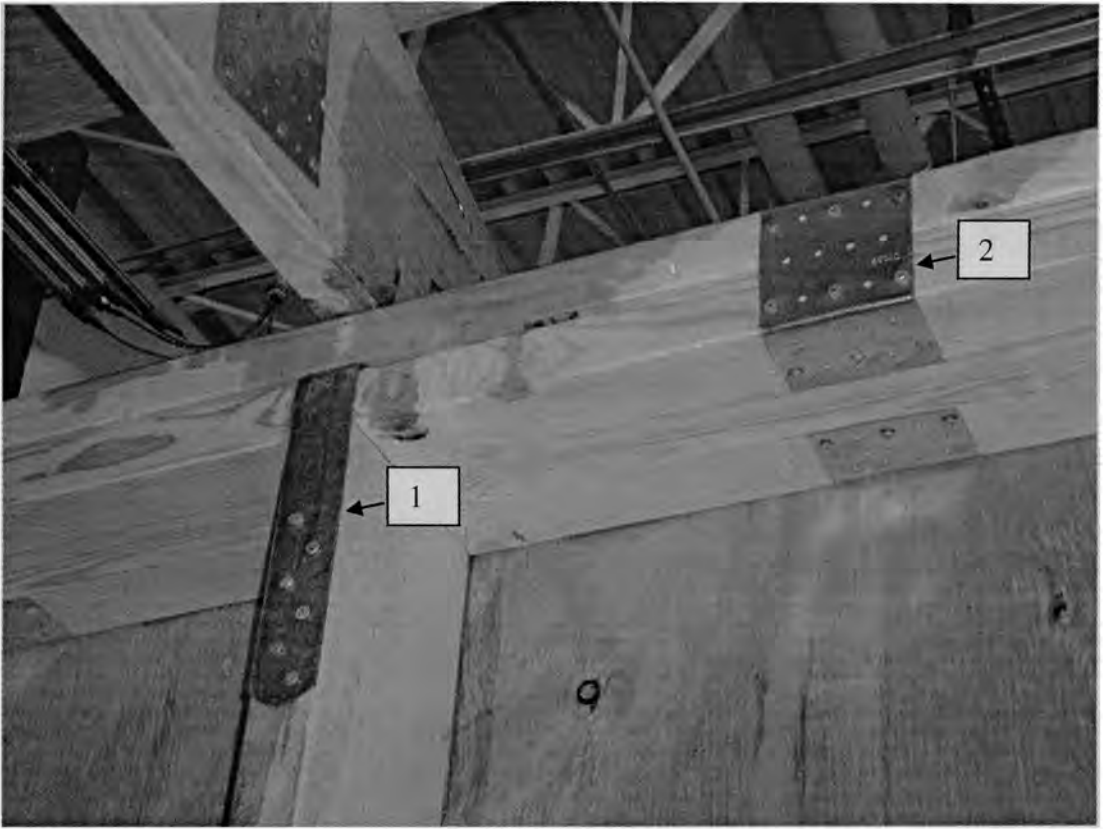
The specimen was constructed by a professional carpenter. Some parts of the structure were intentionally strengthened beyond normal construction practice to ensure failure is limited to the FRP connection. U-shaped straps were used at the top and bottom of shear walls to connect the plates to the studs using twelve 1.5 in. long 10d nails. Also, the possible separation of double top plate was avoided using a U-shaped metal connector holding the top plates together by nine 1.5 in. long 8d nails spaced at 24 in. (Figure 4.4). Moreover, the ridge on the roof was strengthened using V-shaped metal straps to avoid opening up at high loads.

**Figure 4.4 - (1) Strap holding the stud and the lower top plate together; and (2) U-shaped metal plates holding the upper and lower top plates together**

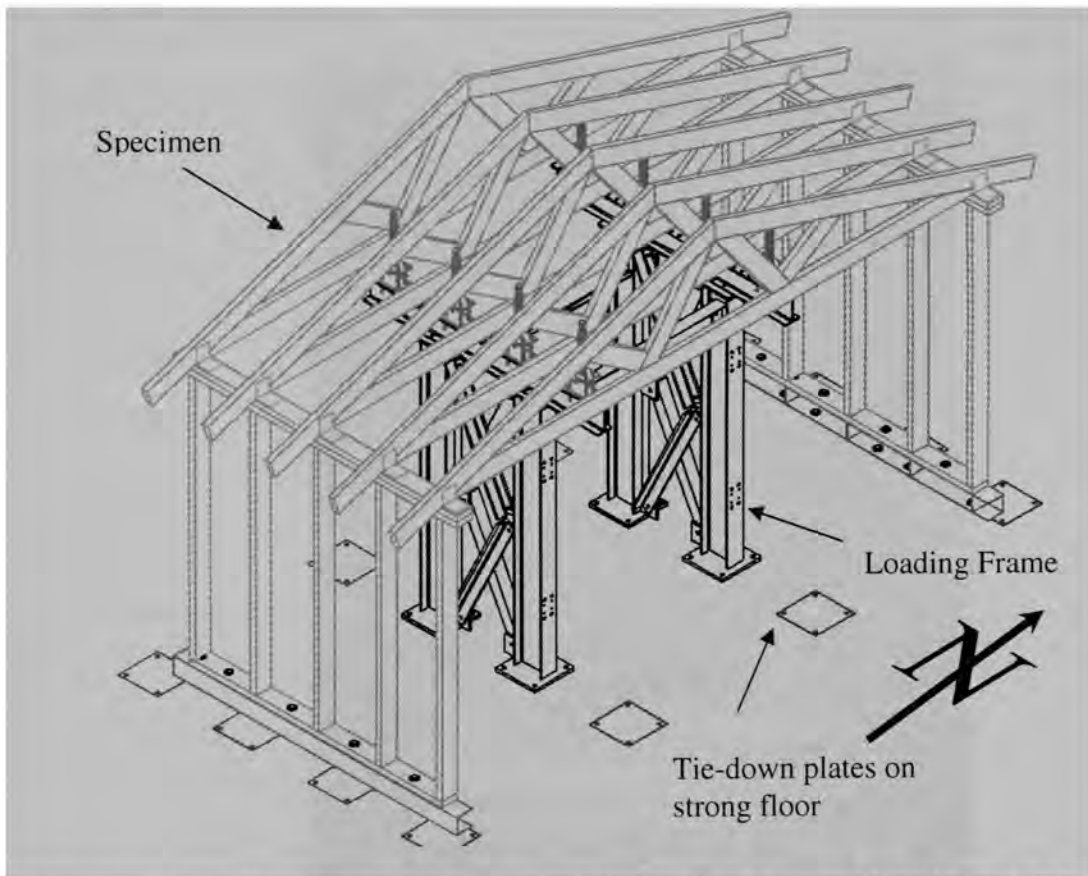
The test specimen was affixed to the strong floor in the laboratory using two steel channel sections under the two shear walls, using bolts on the bottom plate spaced at 24 in. The load was applied onto the roof using 8 hydraulic jacks connected to a single electric pump equipped with a speed control valve. Four of the jacks were applying force to the north part of the roof and four to the south part of the roof. The spacing between the jacks was 2 ft. in east-west direction and 6 ft. in north-south direction (Figure 4.5). A steel loading frame was fabricated to mount the hydraulic jacks. The jacks were first bolted to  $\frac{1}{2}$  in. thick steel plates. Subsequently, the plates were bolted to four 12 in. long  $\frac{3}{4}$  in. diameter threaded rods. The steel plates of the same size as those on the top were

**Figure 4.5 - Full-scale test specimen and the loading frame without sheathing and instrumentation**

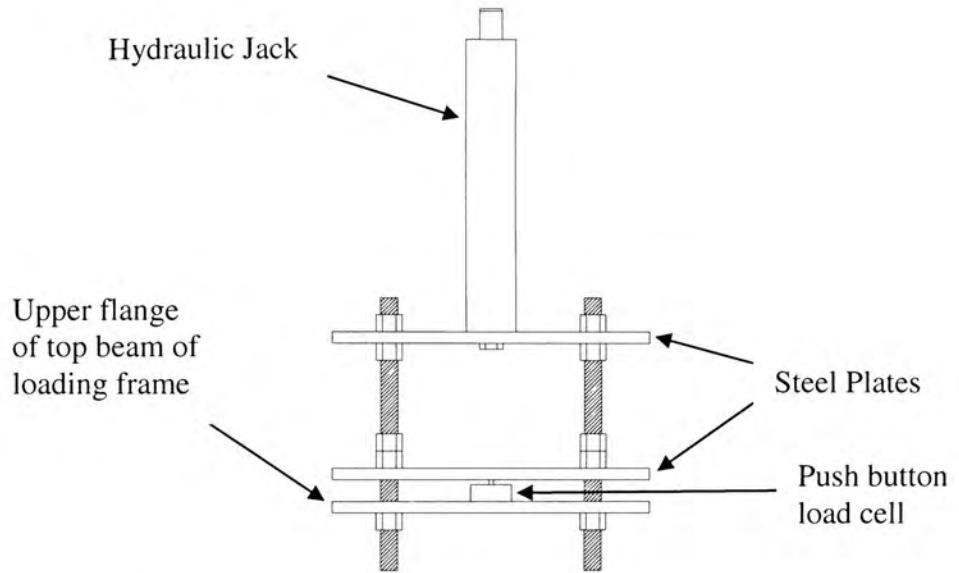
bolted at the bottom. Load cells were placed on the top beam of the loading frame, such that it will be on the same vertical axis with the jack. The jack system was placed on the loading frame through the holes on the top beam, such that the load cells will be sandwiched between the bottom plates and the loading frame (Figure 4.6). In order to distribute the load, 8 ft. long channel members were constructed using four 2 in. x 6 in. dimensional lumbers. Steel angles were screwed to the wooden channel, and the entire section was connected to the clevis eyes placed on top of the jacks using a bolt (Figure 4.7). This connection system allowed the wooden member to rotate freely about the clevis.

**Figure 4.6 - Placement of load cell between the loading frame and steel plate**

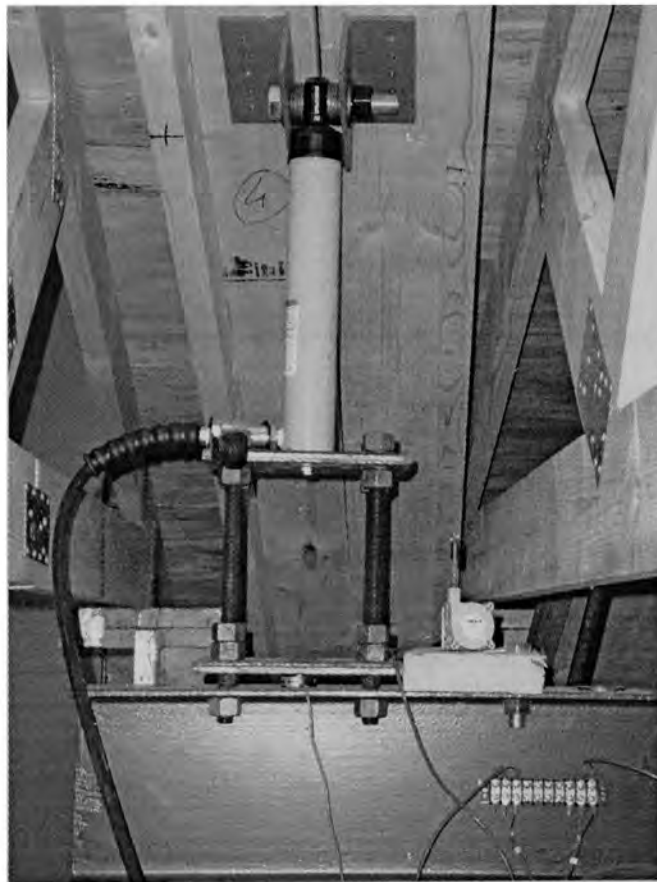
**Figure 4.7 - Jack with the load distribution channel mounted on top**

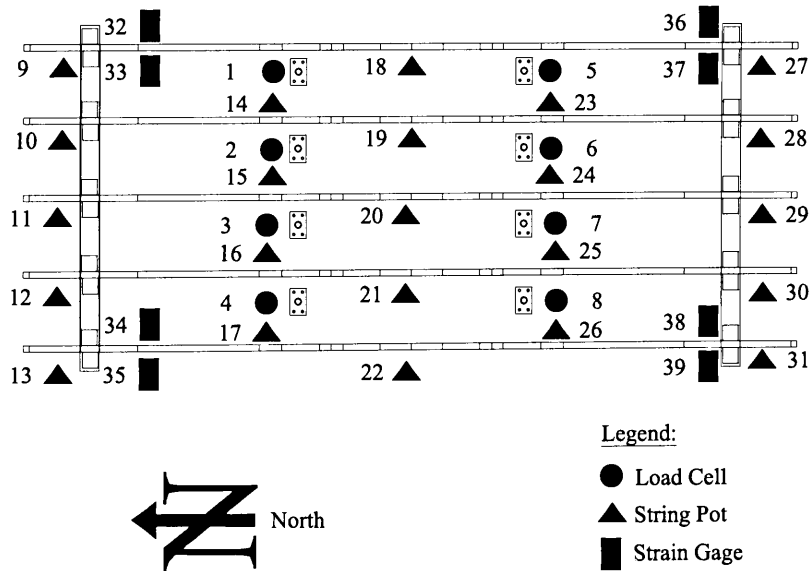
The instrumentation for the full-scale specimen consisted of twenty three string pots, eight strain gages and eight load cells. The numbering and schematic representation of sensors are summarized in Table 4.1 and shown in Figure 4.8. The sensors are numbered starting from the load cells, to string pots and finally to strain gages. The numbering sequence starts from northeast corner and moves in the clockwise direction. A push-button load cell was placed under the vertical axis of each jack to measure applied load. String pots 9-13 and 27-31 were placed on the outer wall, to measure the displacement of each truss at 1.5 in. away from the wall on the outside. String pots 18-22 were connected to the 8 ft. long wooden member assembled on the loading frame to measure the displacements at the center of the bottom chord of the truss. String pots 14-17 and 23-26 were directly connected to the loading frame to measure the displacements at loading points on the axis of rotation of the wooden channel members. Eight 60 mm strain gages were used to measure the strains centered on the vertical legs of the FRP ties. These strain gages were measuring the strains at FRP ties located at four corners of test specimen. Figure 4.9 shows a sketch of the instrumented specimen before testing.

**Figure 4.8 - Schematic representation of sensor locations**

Sensor No.	Sensor Type	Measurement
1, 2, 3, 4	Load cells	Located under the jacks on the north side of the structure to measure the applied load
5, 6, 7, 8	Load cells	Located under the jacks on the south side of the structure to measure the applied load
9, 10, 11, 12, 13	String pots	Connected to the northern outer wall, 4 ft above the ground to measure the displacement of the truss at a distance of 1.5 in. from top plate
14, 15, 16, 17	String pots	Connected to the loading frame to measure the displacements at the loading points on the north side of the test specimen
18, 19, 20, 21, 22	String pots	Connected to the loading frame to measure the displacements at the center of the bottom chord of the trusses
23, 24, 25, 26	String pots	Connected to the loading frame to measure the displacements at the loading points on the south side of the test specimen
27, 28, 29, 30, 31	String pots	Connected to the southern outer wall, 4 ft above the ground to measure the displacement of the truss at a distance of 1.5 in. from top plate

32, 33, 34, 35, 36, 37, 38, 39	Strain gages	Attached to FRP ties at 4 corners of the test specimen to measure the strain on center line of the vertical leg of the tie placed on the joist

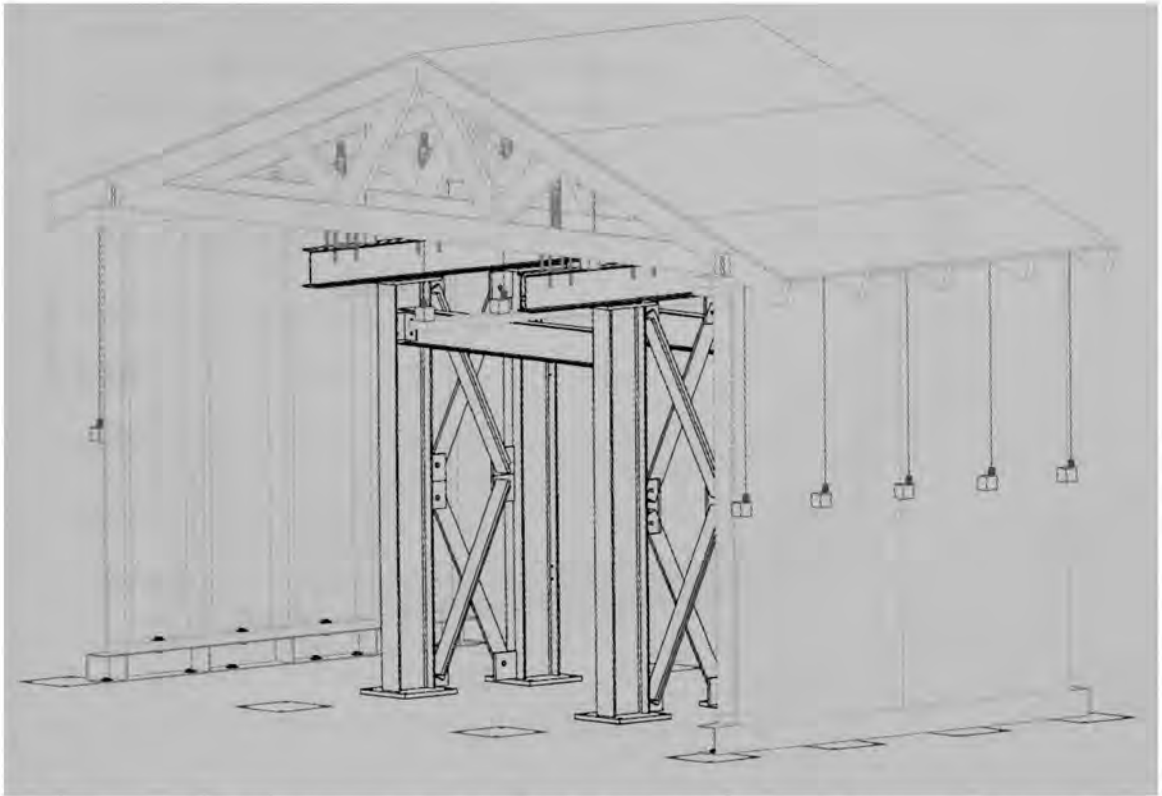
**Figure 4.9- - Schematics of full-scale test specimen with sensors in place**

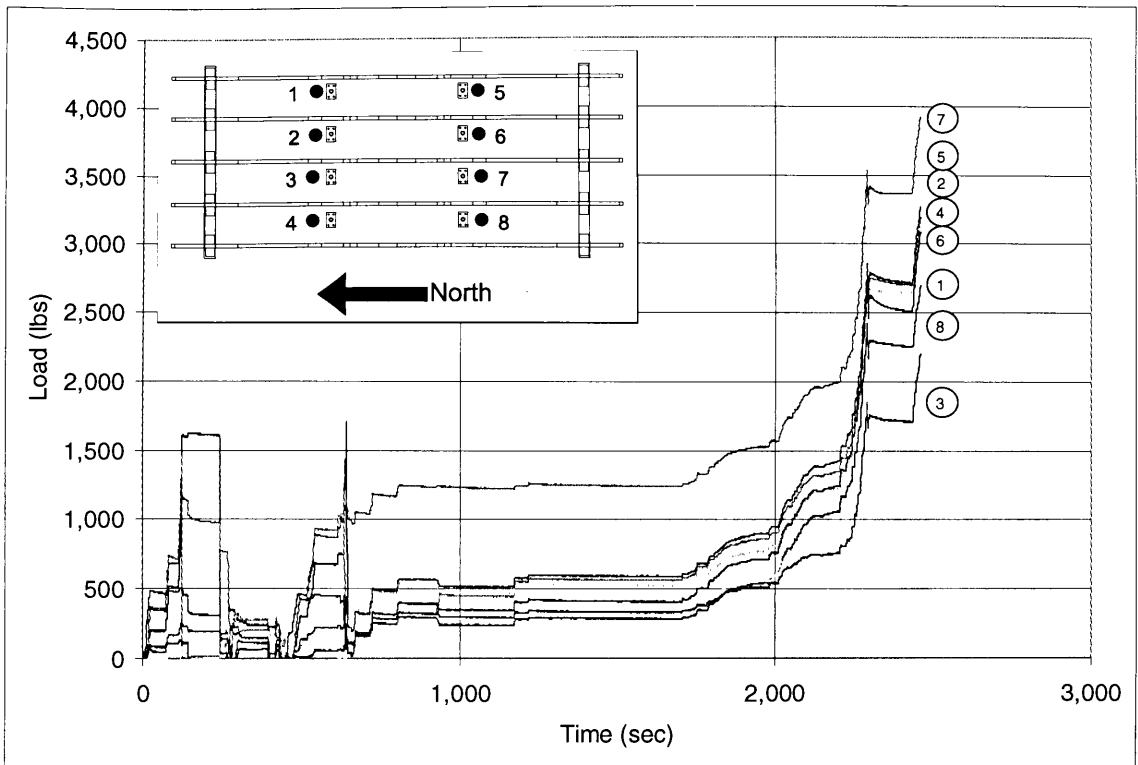
Figure 4.10 - Load applied from each jack

The loading history for the test specimen is shown in Figures 4.10, 4.11 and 4.12. Figure 4.10 represents the load applied from each individual jack. Figure 4.11 shows the load applied on each quadrant of the roof. Figure 4.12 shows the total load applied on the specimen. Figure 4.13 compares the loads applied from each jack at the time of failure. As seen from Figures 4.10 and 4.11, the loads applied from each jack were not exactly the same. This may be attributed to the manifold locations, hose lengths, and bends that might change the ease of flow in the system.

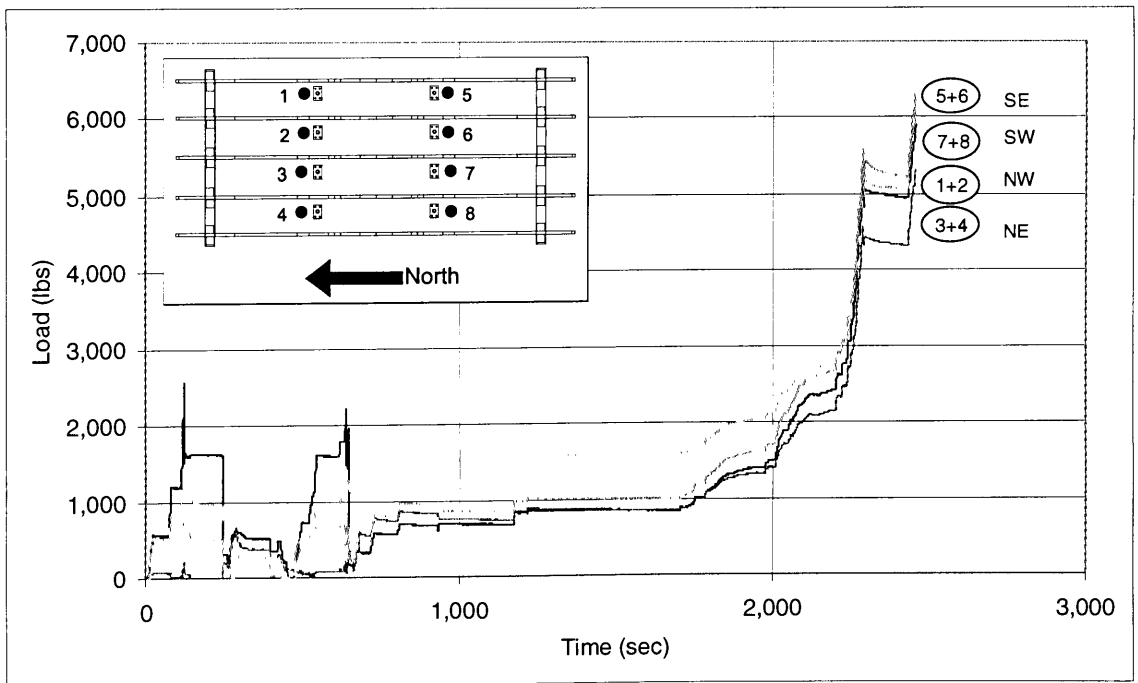
Figure 4.11 - Load applied to each quadrant of the roof
