# Development of a hurricane-resistant roof-to-wall connection using high-performance fiber composites

DEVELOPMENT OF A HURRICANE-RESISTANT ROOF-TO-WALL  
CONNECTION USING HIGH-PERFORMANCE FIBER COMPOSITES

A thesis submitted in partial fulfillment of the  
requirements for the degree of

CIVIL ENGINEERING

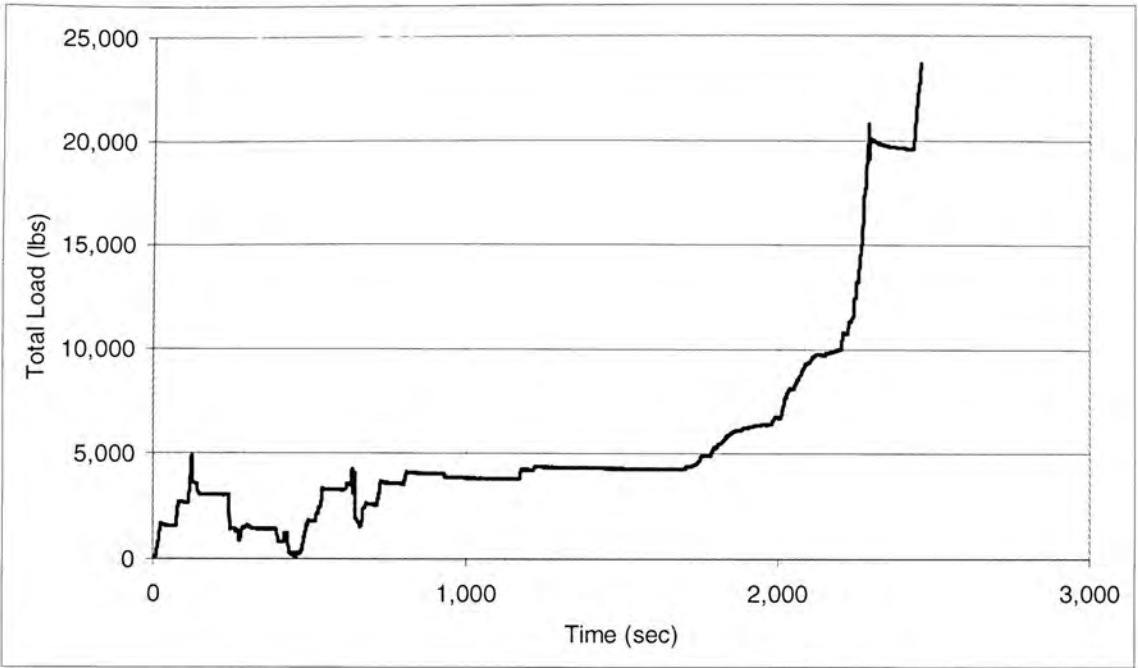
**Figure 4.12 - Total load applied on the specimen**

The loading history for the test specimen is shown in Figures 4.10, 4.11 and 4.12. Figure 4.10 represents the load applied from each individual jack. Figure 4.11 shows the load applied on each quadrant of the roof. Figure 4.12 shows the total load applied on the specimen. Figure 4.13 compares the loads applied from each jack at the time of failure. As seen from Figures 4.10 and 4.11, the loads applied from each jack were not exactly the same. This may be attributed to the manifold locations, hose lengths, and bends that might change the ease of flow in the system.

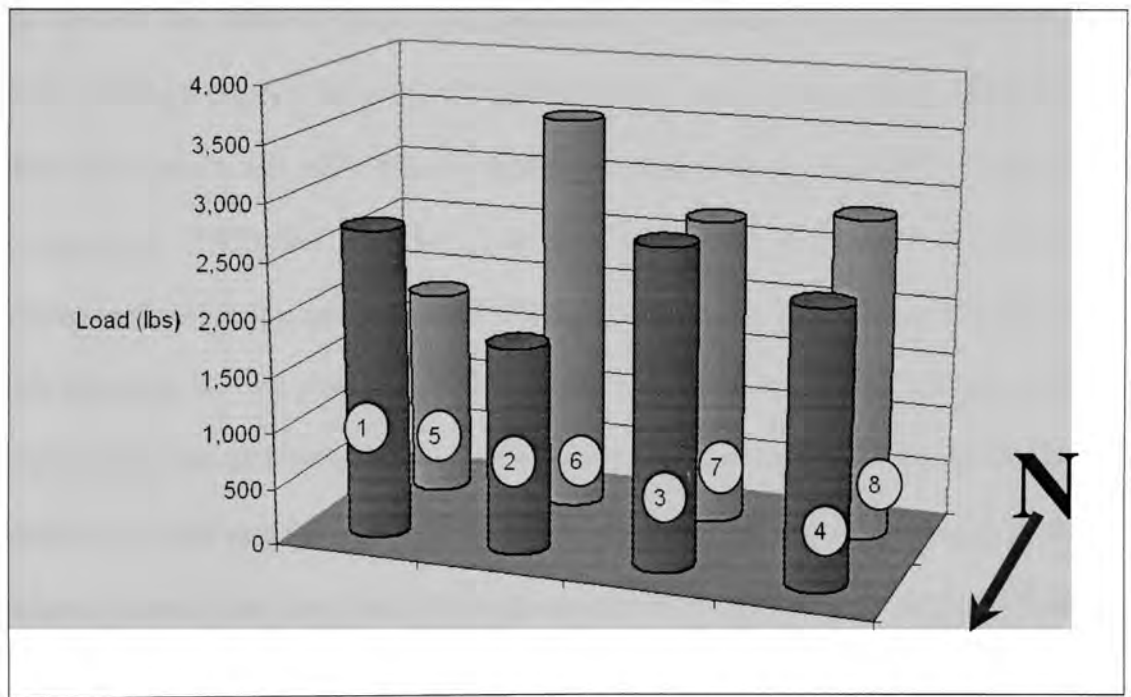
**Figure 4.13 - The loads applied at each cylinder at initial failure load**

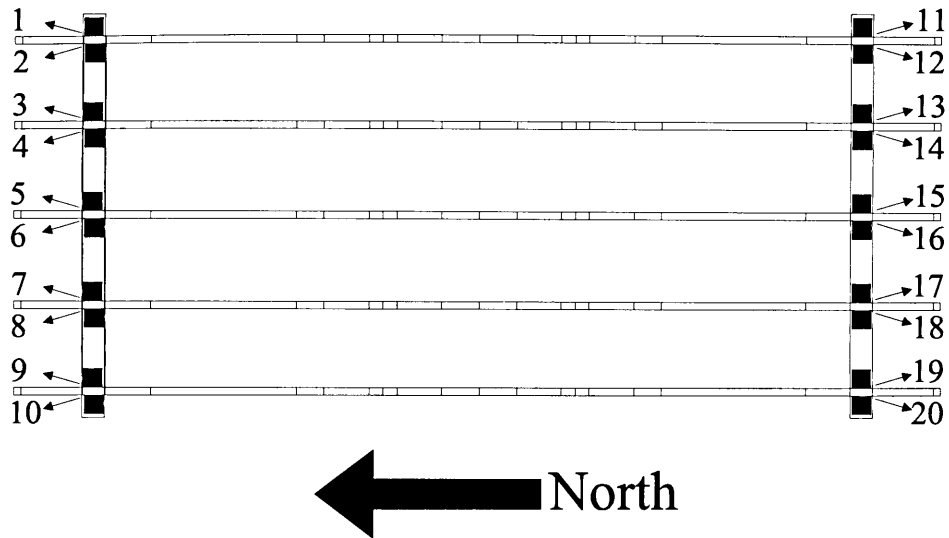
**Figure 4.14 - The numbering of FRP ties**

For explanatory purposes, the FRP ties are numbered as shown in Figure 4.14.

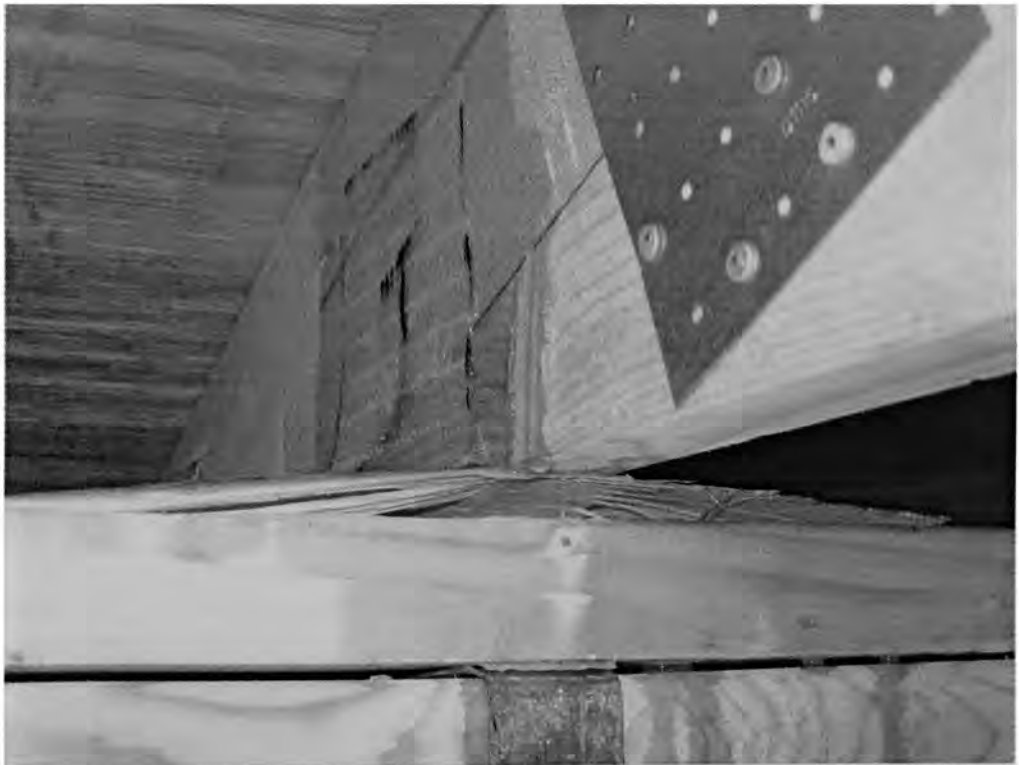
**Figure 4.15 - Initiation of failure in FRP ties 13 and 14 at 20,716 lbs**

The initial failure of FRP ties was seen at connections 13 and 14 at a total load of 20,716 lbs. The failure of these two ties started as both began to peel off from the top plate. Although most of the portion of the FRP ties 13 and 14 were detached from the top plate, the system was still able to sustain the applied load. As the load was further increased to 23,659 lbs, FRP ties 7, 8, 11, 12, 19 and 20 failed at the same time, following the complete detachment of FRP ties 13 and 14 in a domino pattern. FRP tie 13 detached from the top plate completely, in the same manner observed in the component level tests, while FRP tie 14 remained on the top plate and its failure was at the interface between the FRP and the truss. The two different modes of failures observed on the two different sides of the same truss may suggest that the FRP-wood bond strength in Mode I and Mode II are very close to each other, as also noted in the component level tests. The initiation of failure of FRP ties 13 and 14 at 20,716 lbs is shown in Figure 4.15. The complete failure of these two FRP ties at 23,659 lbs is shown in Figure 4.16. Failure of

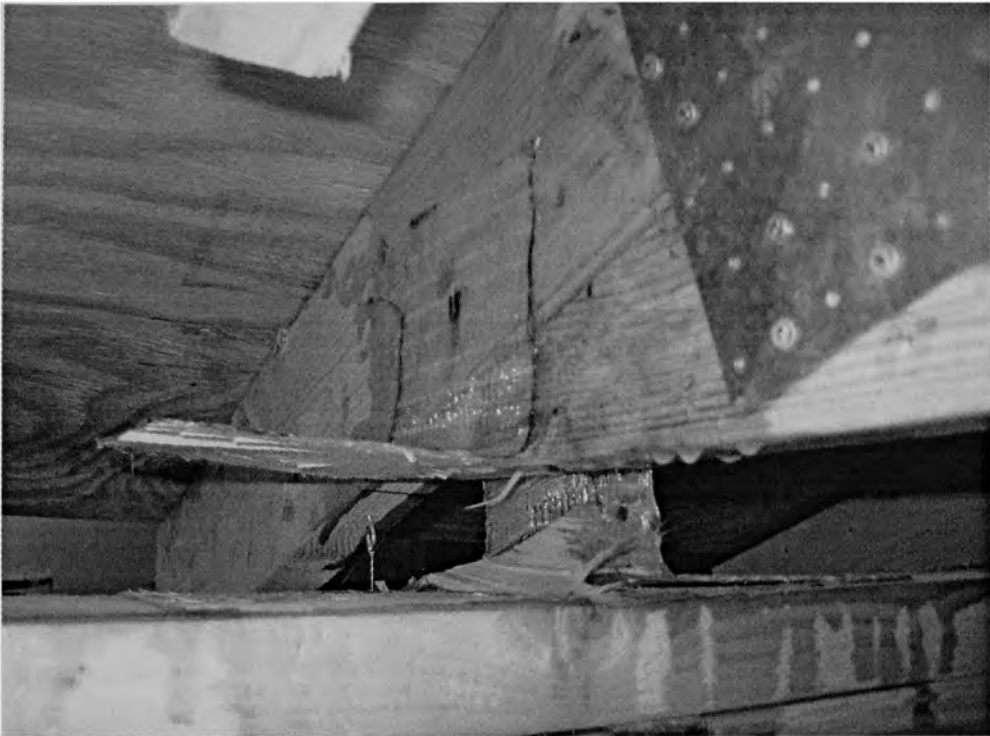
**Figure 4.16 - Complete failure of FRP ties 13 and 14 at 23,659 lbs**

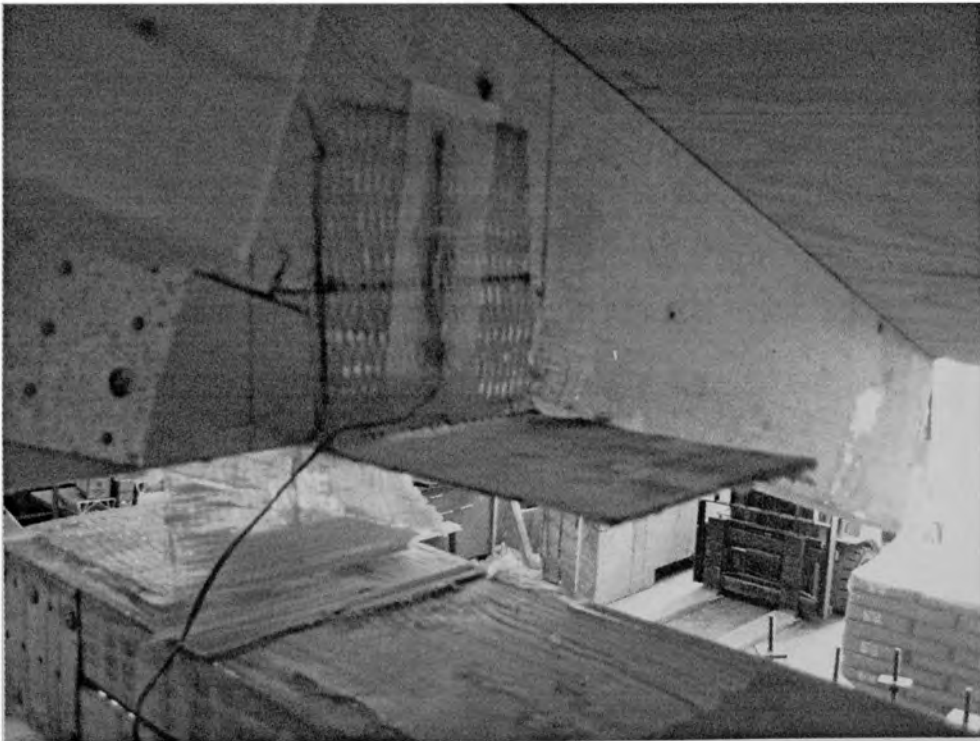
**Figure 4.17 - Failure of FRP ties 11 and 12**

FRP ties 11 and 12 was very similar to that of FRP ties 13 and 14. Although most of the FRP tie on the top plate was detached, FRP tie 11 remained attached to top plate and its failure took place at the interface between the FRP and the truss. FRP tie 12 remained attached to the truss, and peeled off from the top plate completely (Figure 4.17). FRP ties 19 and 20 failed as the FRP peeled off from the top plate. At the failure load, some parts of these ties were still attached to the top plate as seen on Figure 4.18. Figure 4.19 shows the FRP ties 7 and 8 at the ultimate load. A complete failure was not observed but considerable peel off of FRP from the top plate along with wood fibers was noted. As seen in the photographs, significant amount of wood fibers remain attached to FRP in the failed ties. Especially, in FRP ties 7 and 8, the failure was observed within the wood rather than at the FRP-wood interface.

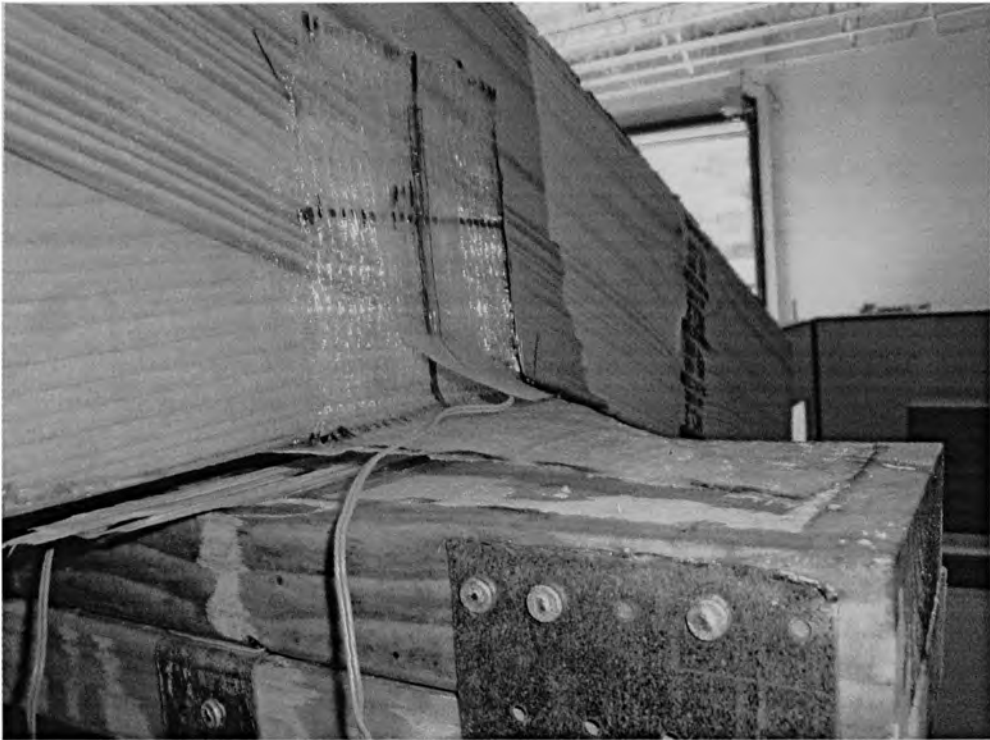
**Figure 4.18 - Failure of FRP ties 19 and 20**

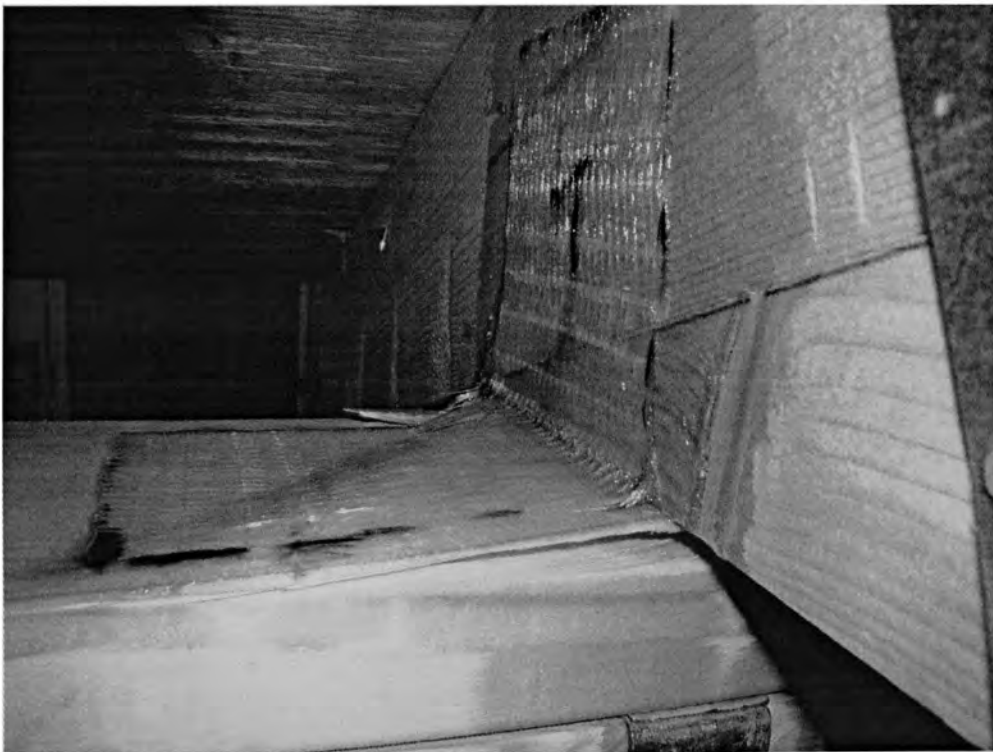
**Figure 4.19 - Failure of FRP ties 7 and 8 and separation of wood fibers**

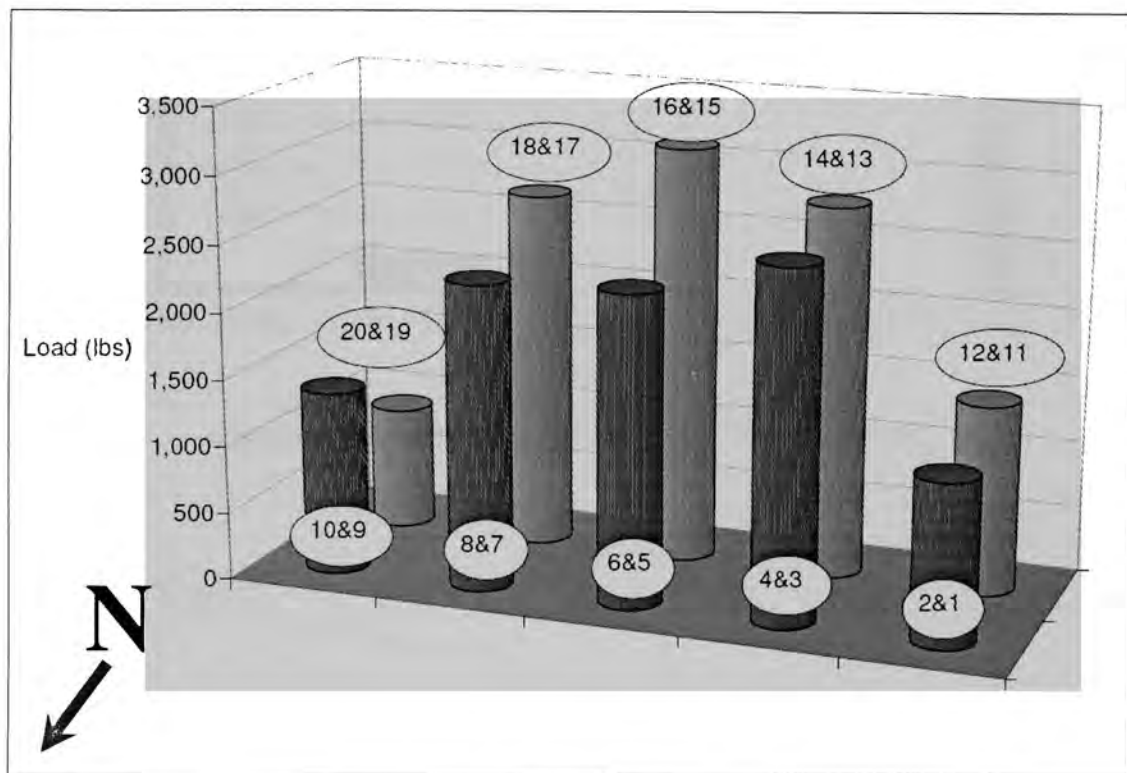
Figure 4.20 - The loads at pairs of FRP ties at initiation of failure

If it is assumed that loads applied from each jack is transferred to the closest connections, loads at pairs of FRP ties are as shown in Figure 4.20. Based on this assumption, the load versus displacement values of string pots located at the outer walls are presented in Figures 4.21-30.

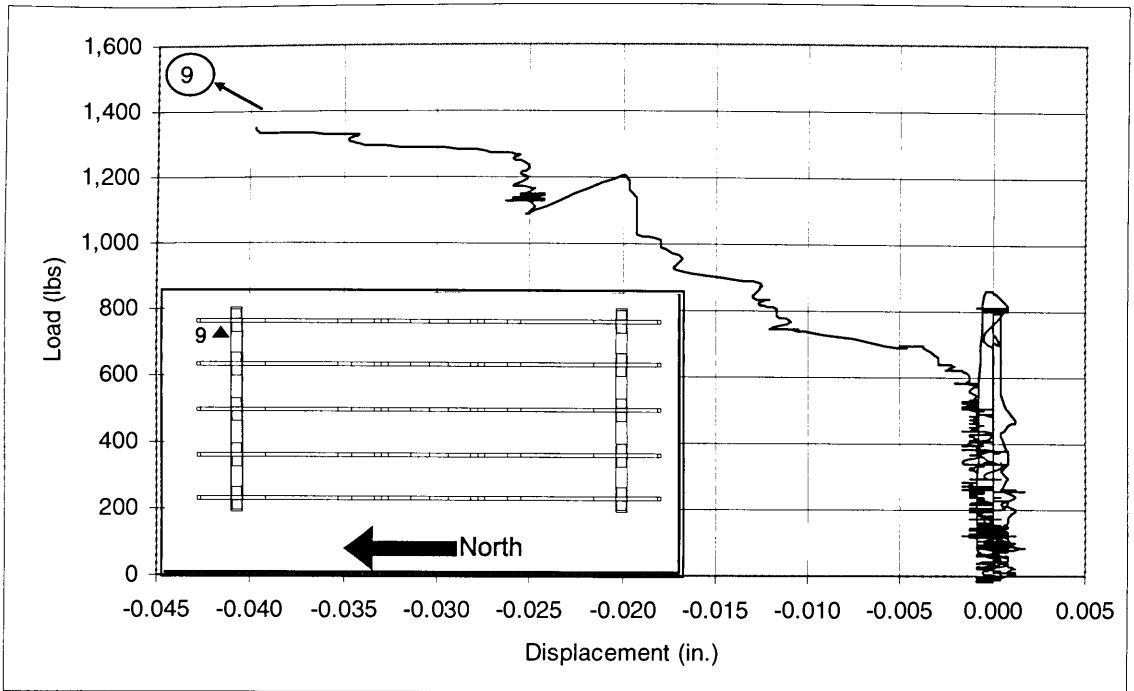
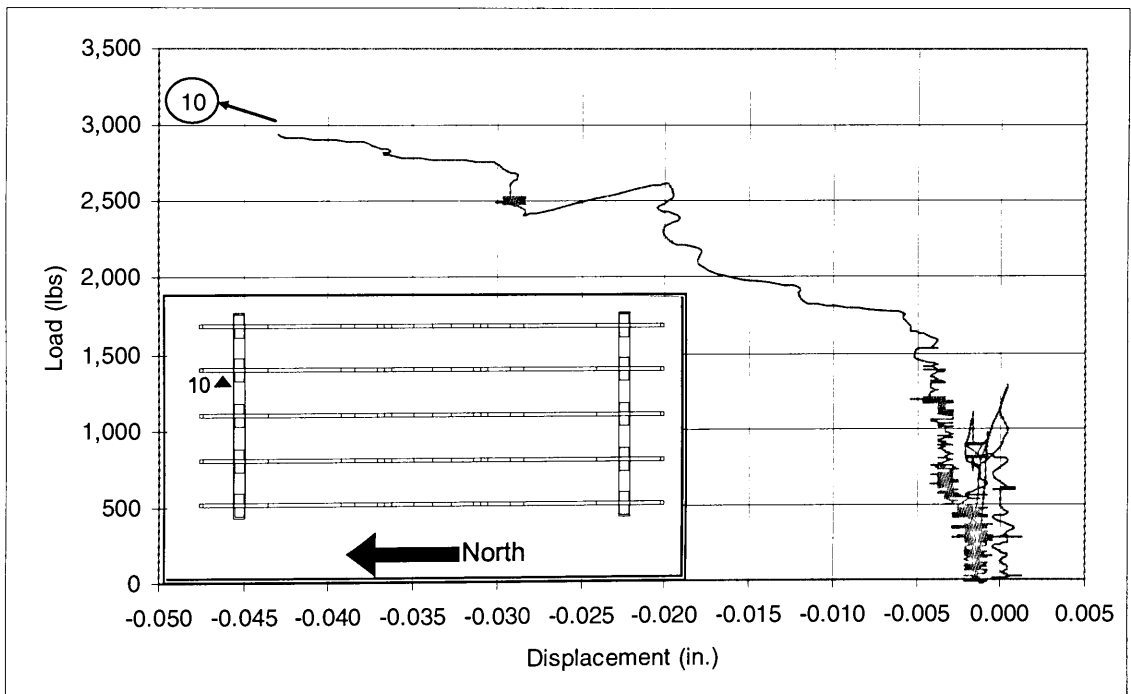
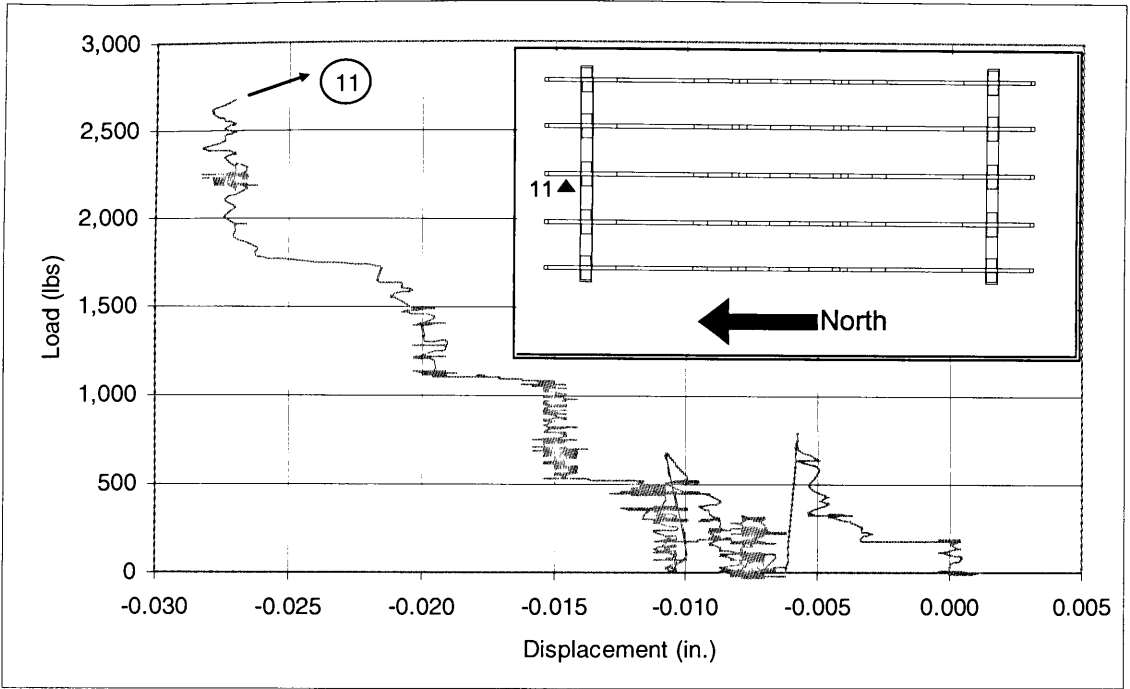
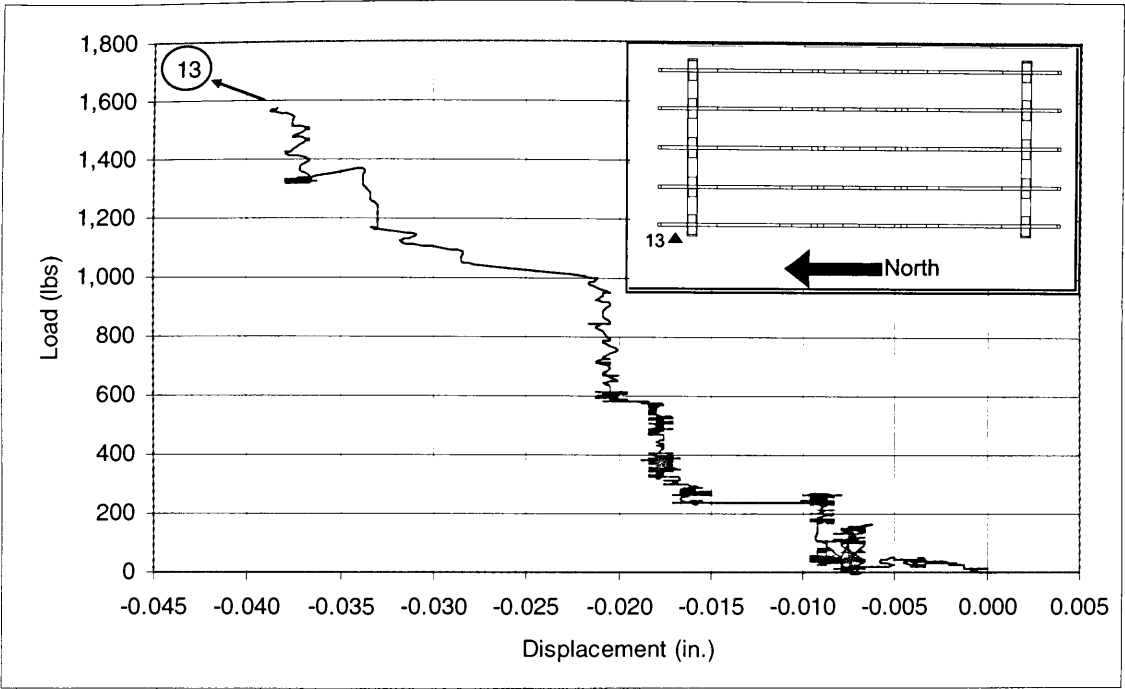
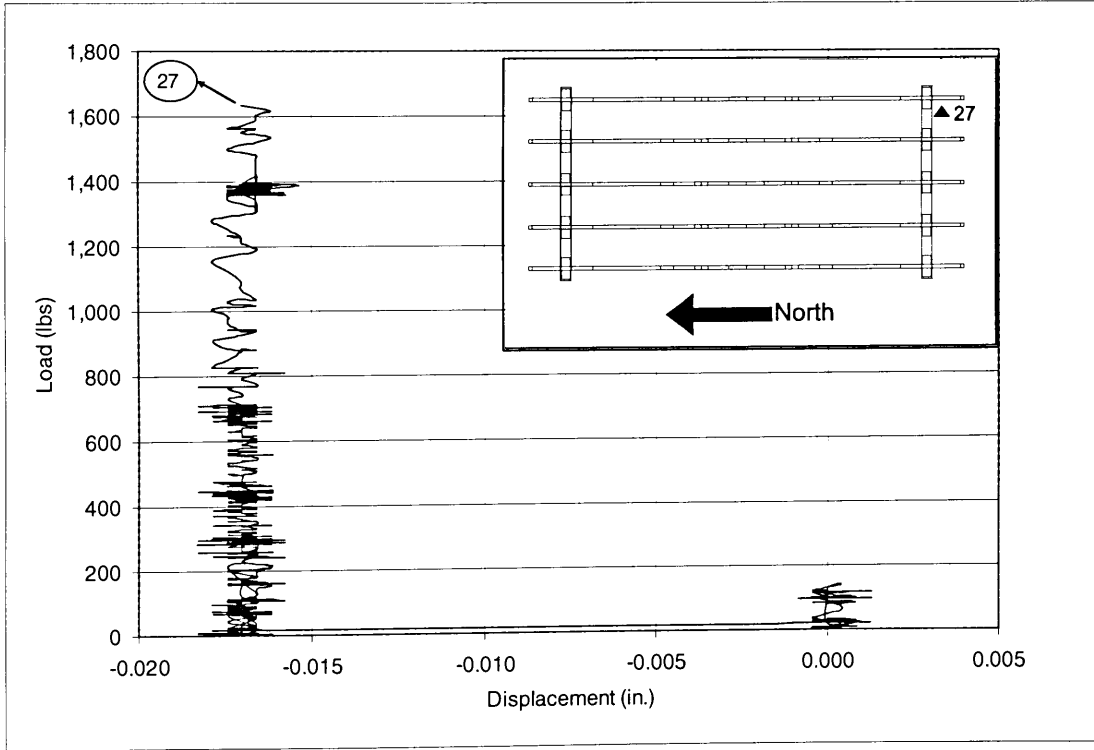
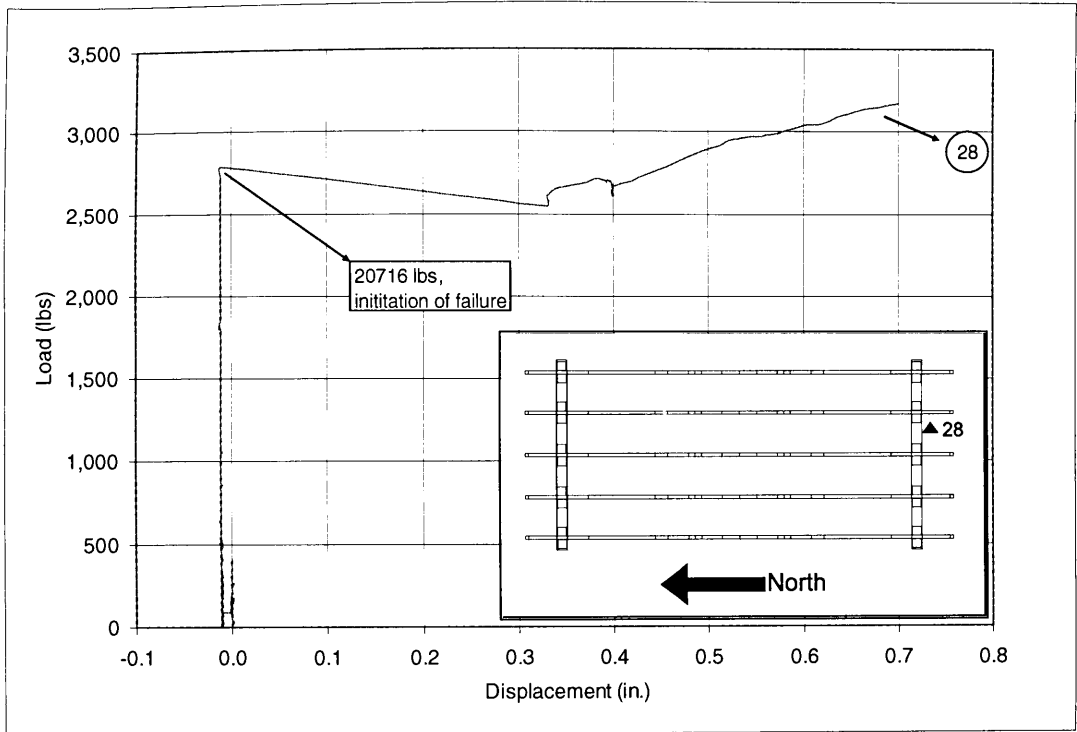
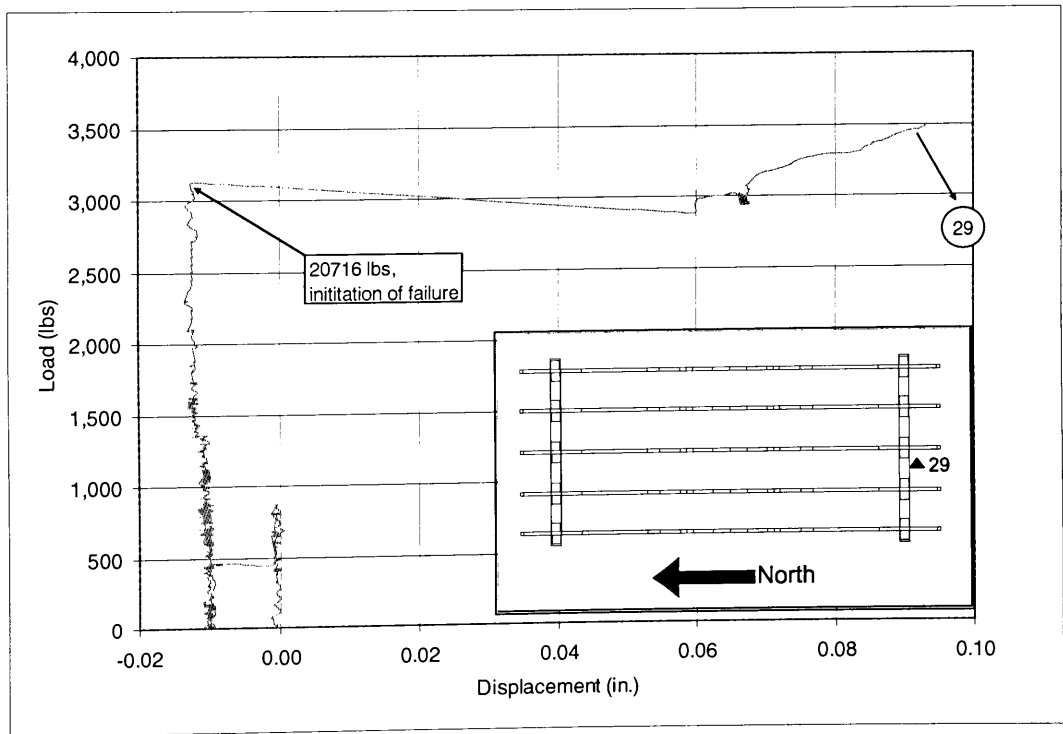
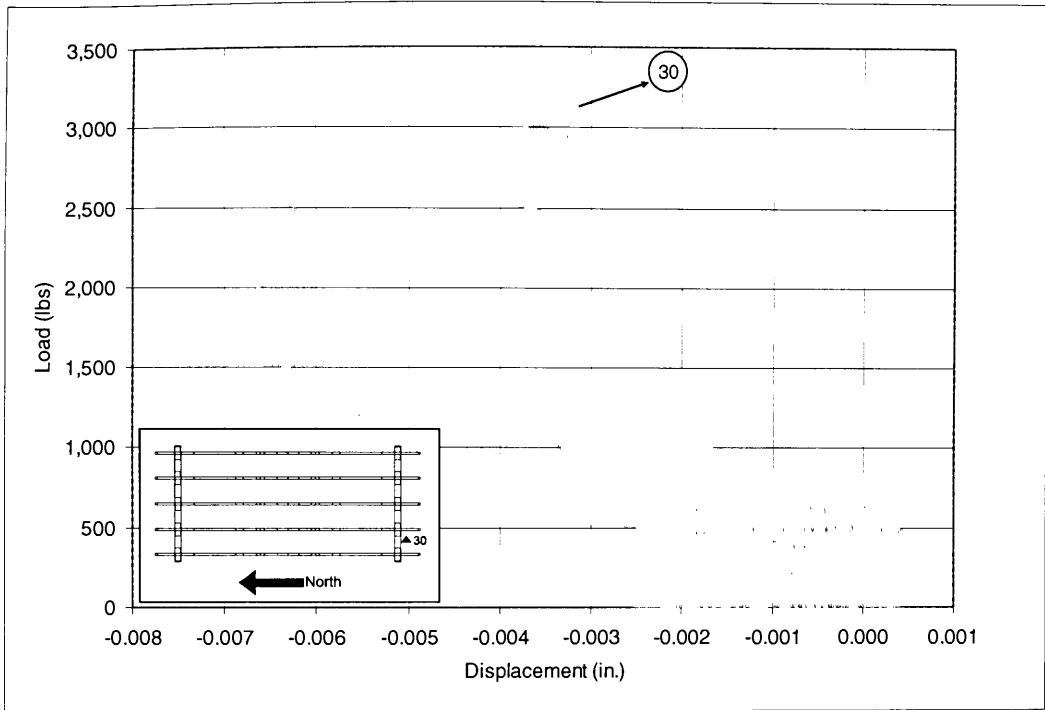
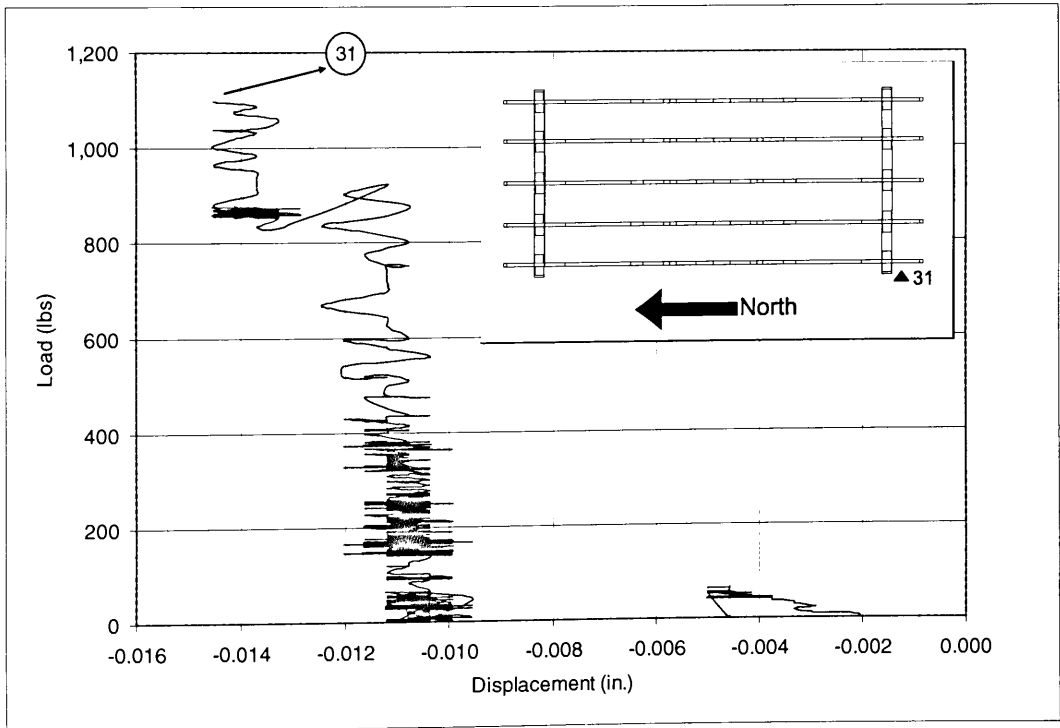
**Figure 4.21 - Load-displacement for FRP ties 1 and 2**

**Figure 4.22 - Load-displacement for FRP ties 3 and 4**

**Figure 4.23 - Load-displacement for FRP ties 5 and 6**

**Figure 4.24 - Load-displacement for FRP ties 7 and 8**

Figure 4.25 - Load-displacement for FRP ties 9 and 10

Figure 4.26 - Load-displacement for FRP ties 11 and 12

Figure 4.27 - Load-displacement for FRP ties 13 and 14

Figure 4.28 - Load-displacement for FRP ties 15 and 16

**Figure 4.29 - Load-displacement for FRP ties 17 and 18**

**Figure 4.30 - Load-displacement for FRP ties 19 and 20**

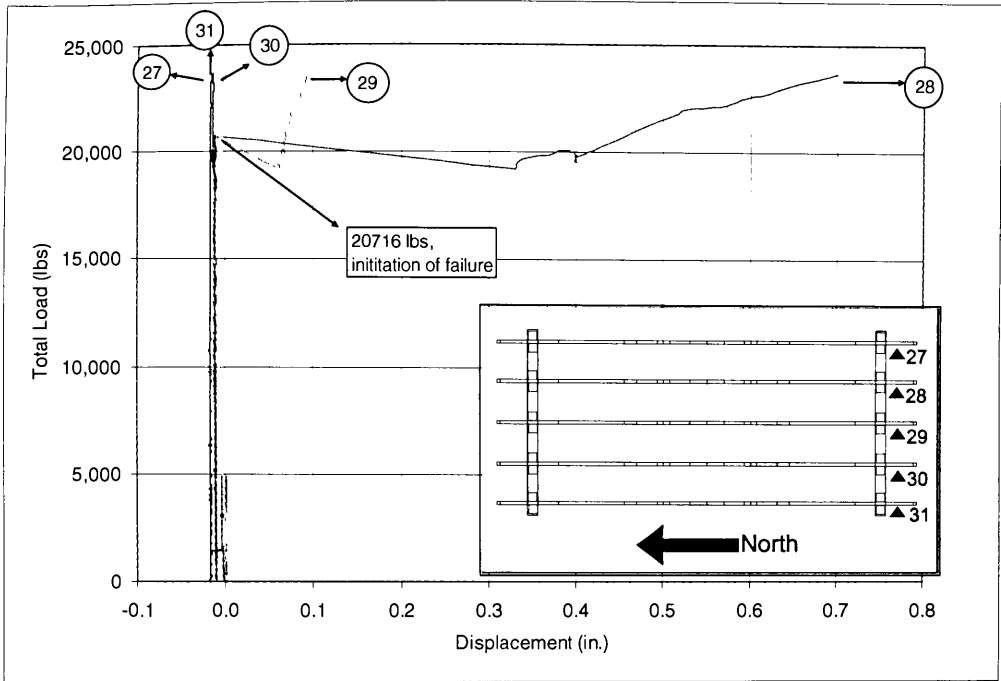
**Figure 4.32 - Total load-displacements on the south side of the truss versus total load**

The displacement readings obtained from string pots 9 through 13 on the north side of the trusses are shown in Figure 4.31. Figure 4.32 illustrates the displacement readings obtained from string pots 27 to 31 on the south side of the trusses. The data obtained from string pots 18 to 22, which were displacements at the center of the bottom chord of the trusses are shown in Figure 4.33. The displacements in these figures are plotted against the total load applied. Upward displacements are considered positive. The three figures collectively suggest that the FRP tie connections provide very rigid and stiff load transfer mechanism from roof to the wall. It can be seen that the displacements are very small at each connection, and that the 1/8 in. deflection limit is never reached. This is in full agreement with the component level tests described in Chapter 3.

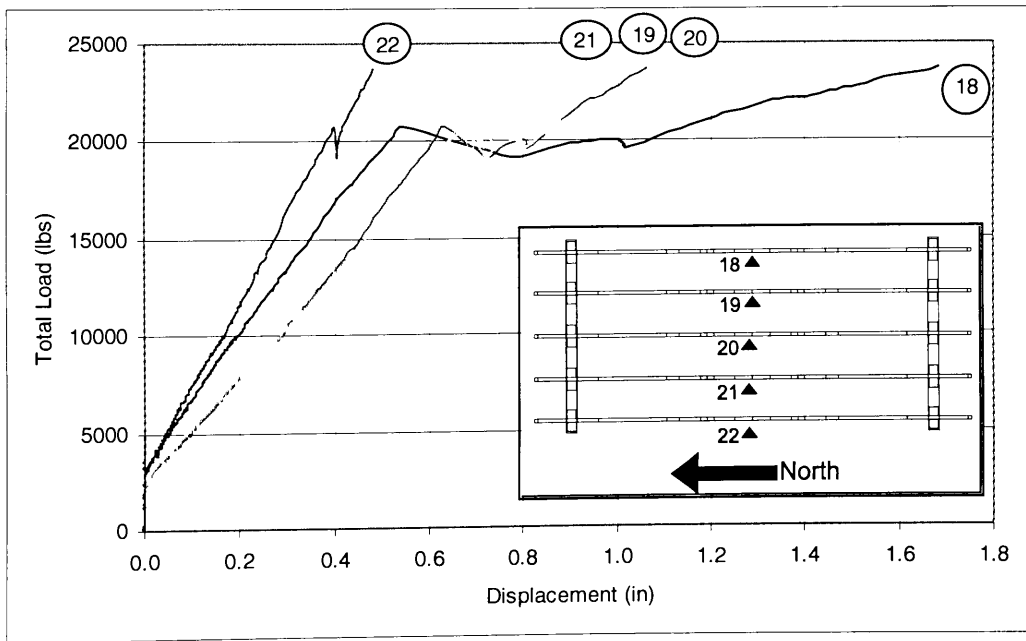
**Figure 4.33 - Total load-displacements at the center of the bottom chord of the truss**

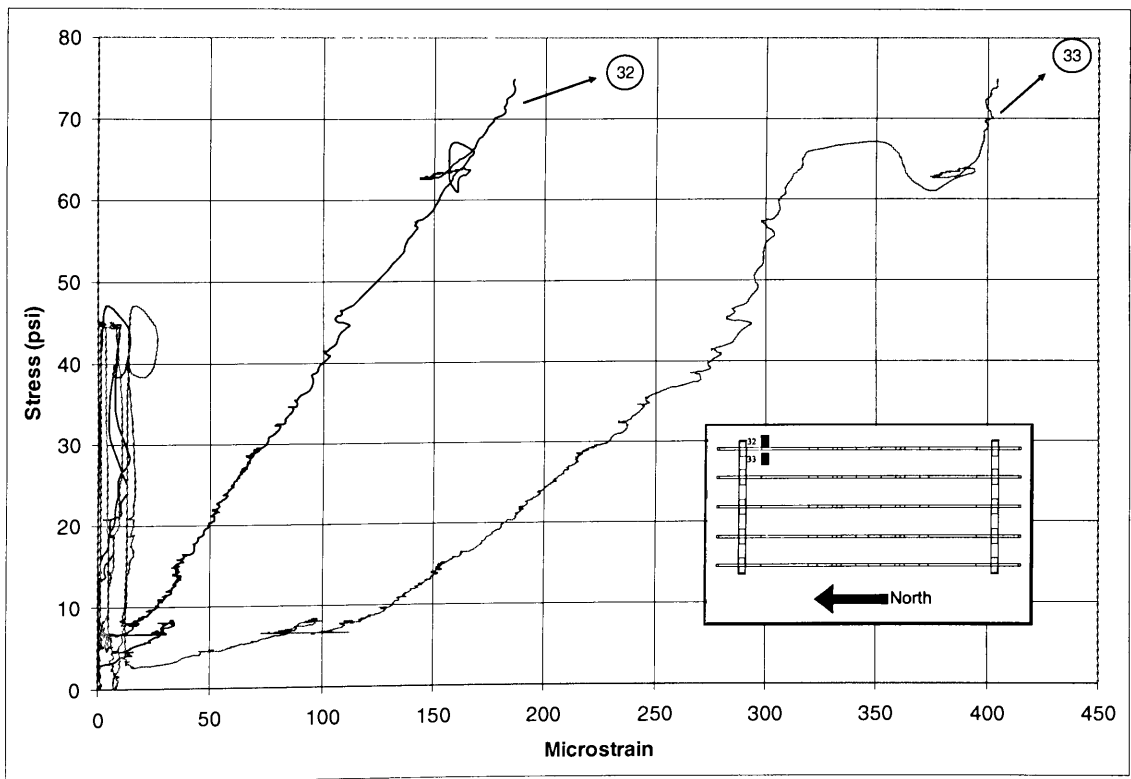
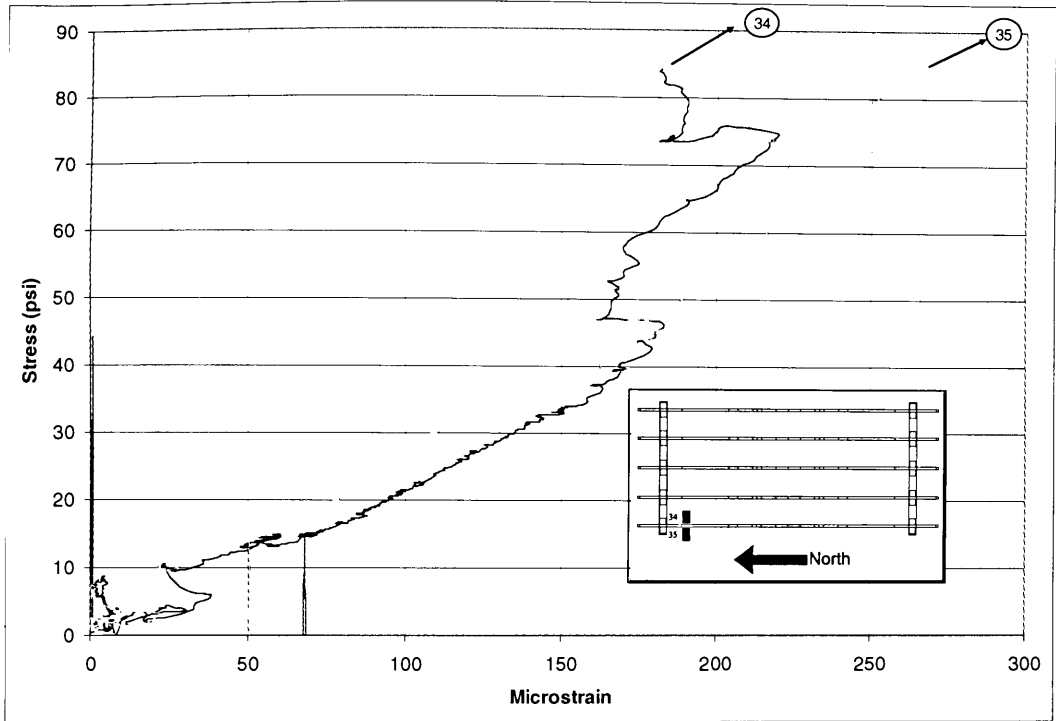
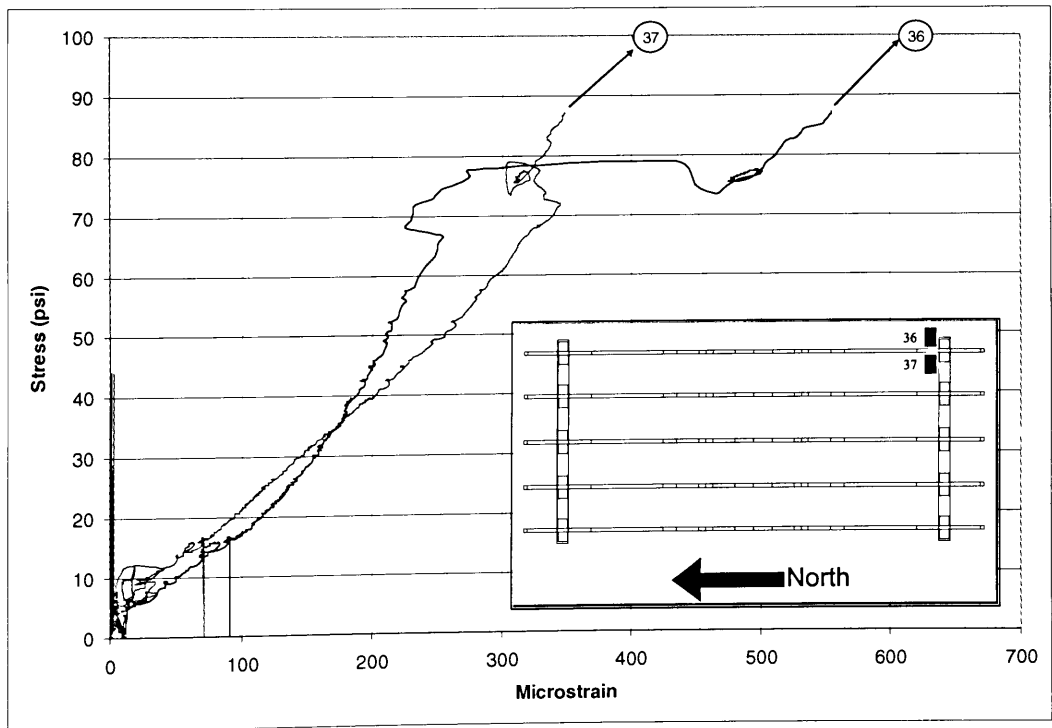
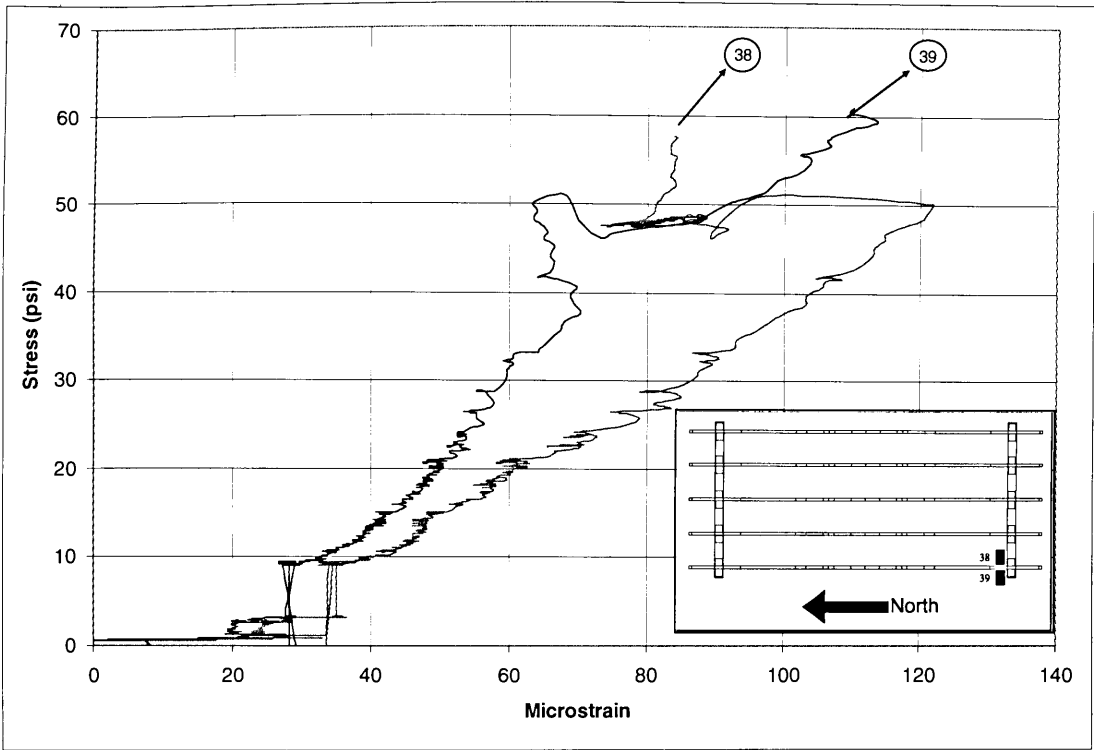
**Figure 4.34 - Stress-strain for FRP ties 1 and 2**

Figure 4.35 - Stress-strain for FRP ties 9 and 10

Figure 4.36 - Stress-strain for FRP ties 11 and 12

Figure 4.37 - Stress-strain for FRP ties 19 and 20

In Figures 4.34 through 4.37, strains at pairs of FRP ties at the corners are plotted versus the stress in vertical leg of FRP ties. Here it was assumed that the loads applied from each jack are equally shared between nearest pairs of FRP ties. The figures show that the ultimate stress values in failed ties are very close to bond strengths calculated in component level tests. The strains obtained from the strain gages placed on FRP ties at the corners are plotted versus time and versus total load in Figures 4.38 and 4.39 respectively. A maximum strain of 0.000581 was observed at one of the failed connections. According to the manufacturer's specifications, the GFRP used has an elastic modulus of 3,790 ksi, a tensile strength of 87 ksi and a maximum elongation of 0.023 in./in. Therefore, the average stress in the vertical leg of the FRP tie on the joist is about 2.2 ksi, which is much less than its rupture strength.

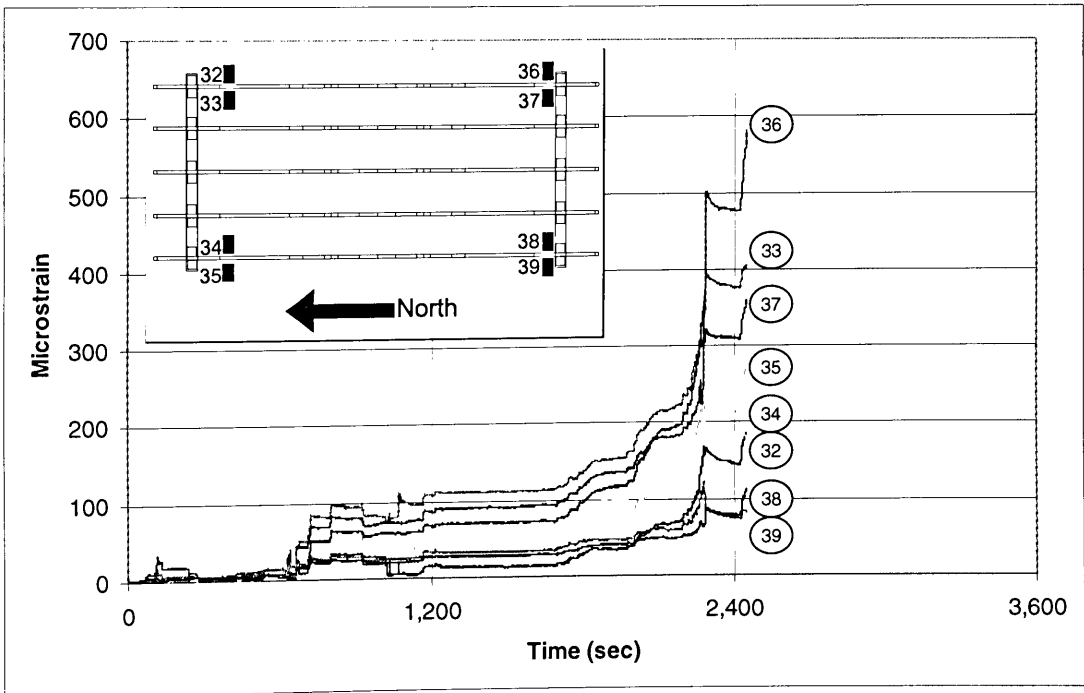
Figure 4.38 - Strain values of FRP ties located at the corners of the truss

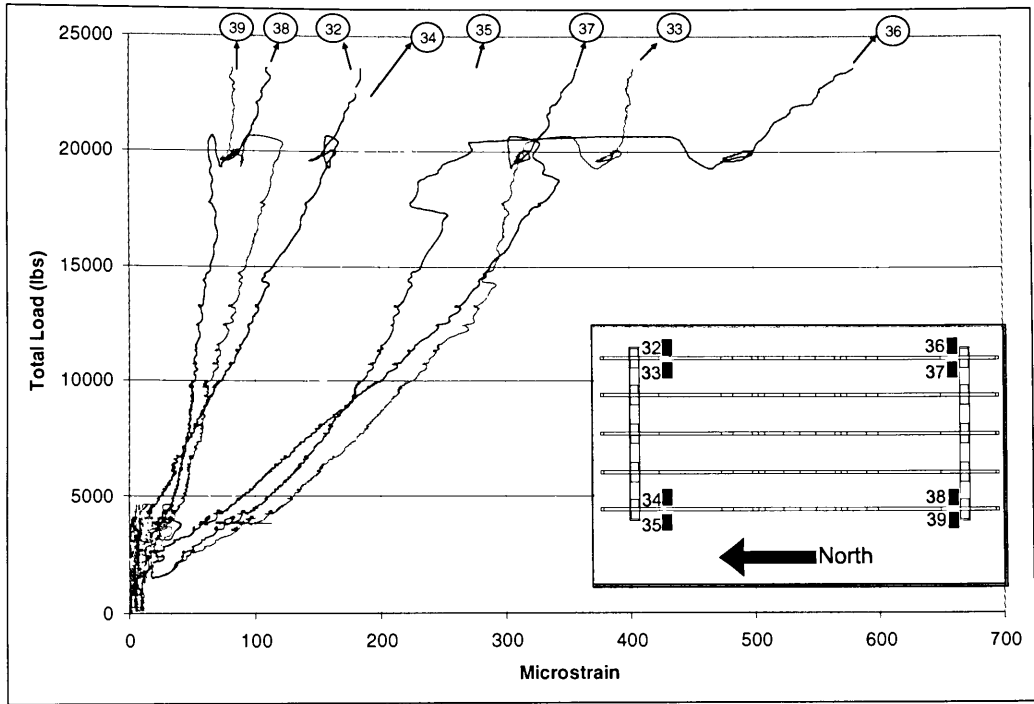
**Figure 4.39 - Total load-strain for FRP ties located at the corners**
