# Advanced Silicate-based Lubricant Additive Induced Diamond-like Carbon Structured Restoration Layer

An advanced silicate based lubricant additive has been employed in long-term pin-on-disk tribological experiments. The worn steel/steel surfaces were characterized using nano-indentation, SEM, XPS, and Raman spectroscopy for their physical, mechanical, and chemical properties. The average nano-hardness of the repaired layers on the disk and the pin is 10.2 GPa and 16.7 GPa respectively, which is substantially higher than that of the disk (HV 221, or 0.71 GPa) and the pin (HRC55, or 1.8 GPa) before tribological tests, forming super hard surfaces on the contact pair surfaces. Combined Raman spectroscopy and XPS studies suggest the formation of diamond-like carbon based restoration layers. A new formation mechanism of the restoration DLC layer contributing to hard and smooth contact surfaces is proposed.

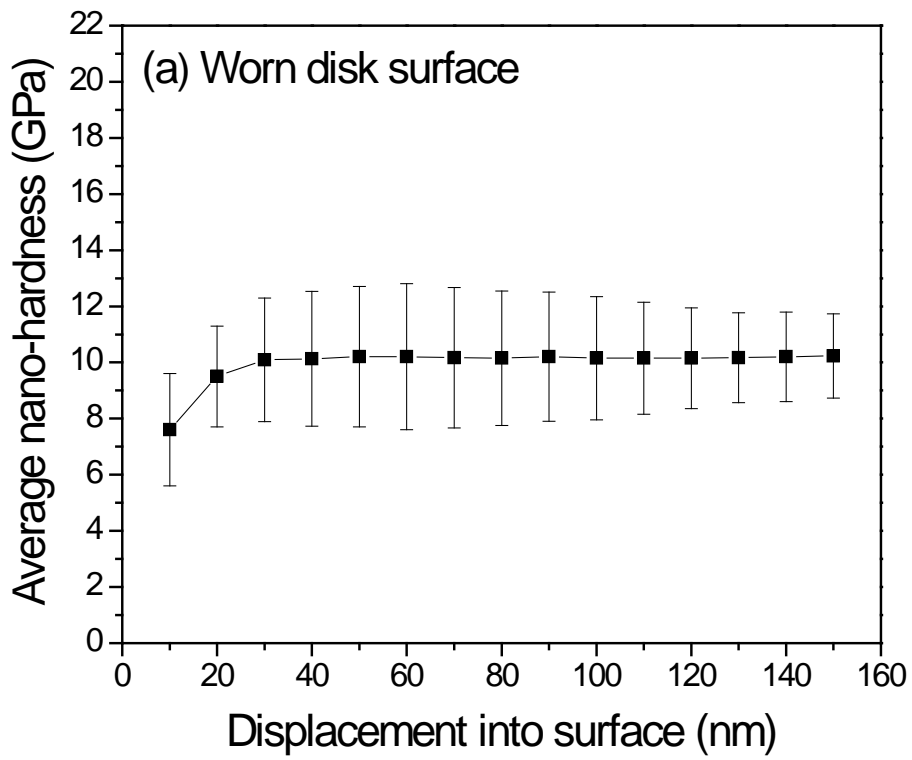
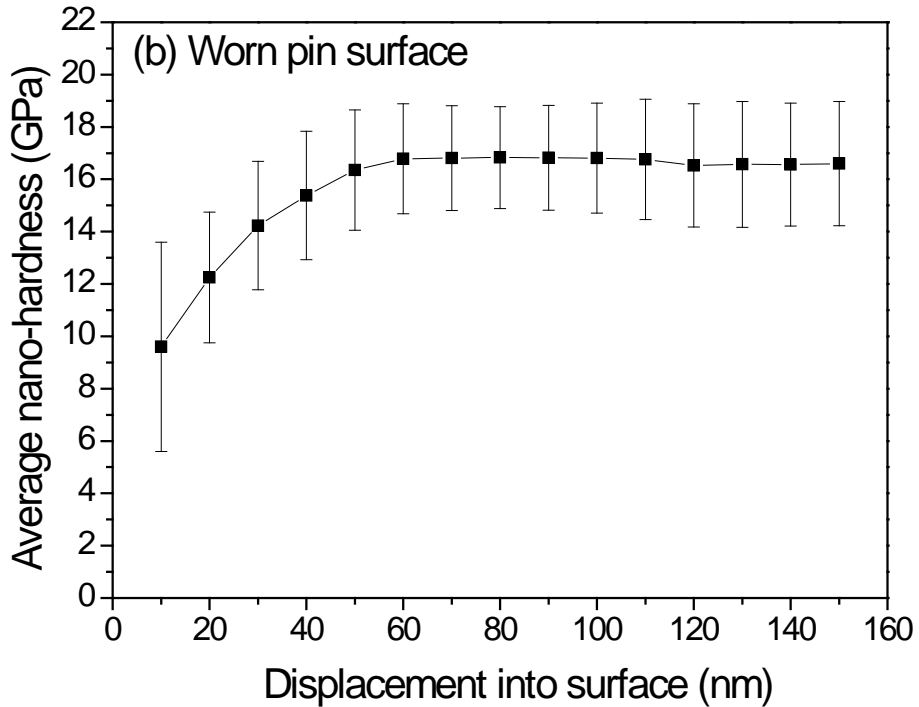
The average results of nano-hardness at five different locations on the worn surfaces are shown in Fig.1. The depth of indentation in the nano-hardness test was  $150\ \text{nm}$ , indicating the hardness of the repaired layer. The average nano-hardness of the repaired layers on the disk and the pin is  $10.2\ \text{GPa}$  (Fig. 1a) and  $16.7\ \text{GPa}$  (Fig. 1b) respectively. The hardness values are substantially higher than the hardness of the disk (HV 221, or  $0.71\ \text{GPa}$ ) and the pin (HRC55, or  $1.8\ \text{GPa}$ ) before the tribological tests, suggesting forming super hard surfaces on the contact pair surfaces. It should also be mentioned that the nano-hardness of the worn surface on the pin was 50% greater than that on the disk, suggesting the running time influenced the mechanical properties of the repaired layer significantly. It was also noted that the nano-hardness data of the worn disk was more scattered than that of the worn pin, which indicated, the effect of the silicate additive possessed certain selectivity at different locations of the worn surface [13].

Fig. 1 Nano-hardness of (a) worn disk surface (b) worn pin surface

This is why the nano-hardness of the worn surfaces was scattered. The carbon content of the 45 steel substrate was 0.42–~0.50 wt%; however, XPS detected 42.32% carbon on the worn surface of the pin. Several ideas exist as to where the high-content carbon came from. It could be from carbon chain decomposition of the lubricating oil during the wear with the catalytic function of silicate particles. Raman analysis has indicated positively the restoration layer is DLC film.

Fig. 1 Nano-hardness of (a) worn disk surface (b) worn pin surface

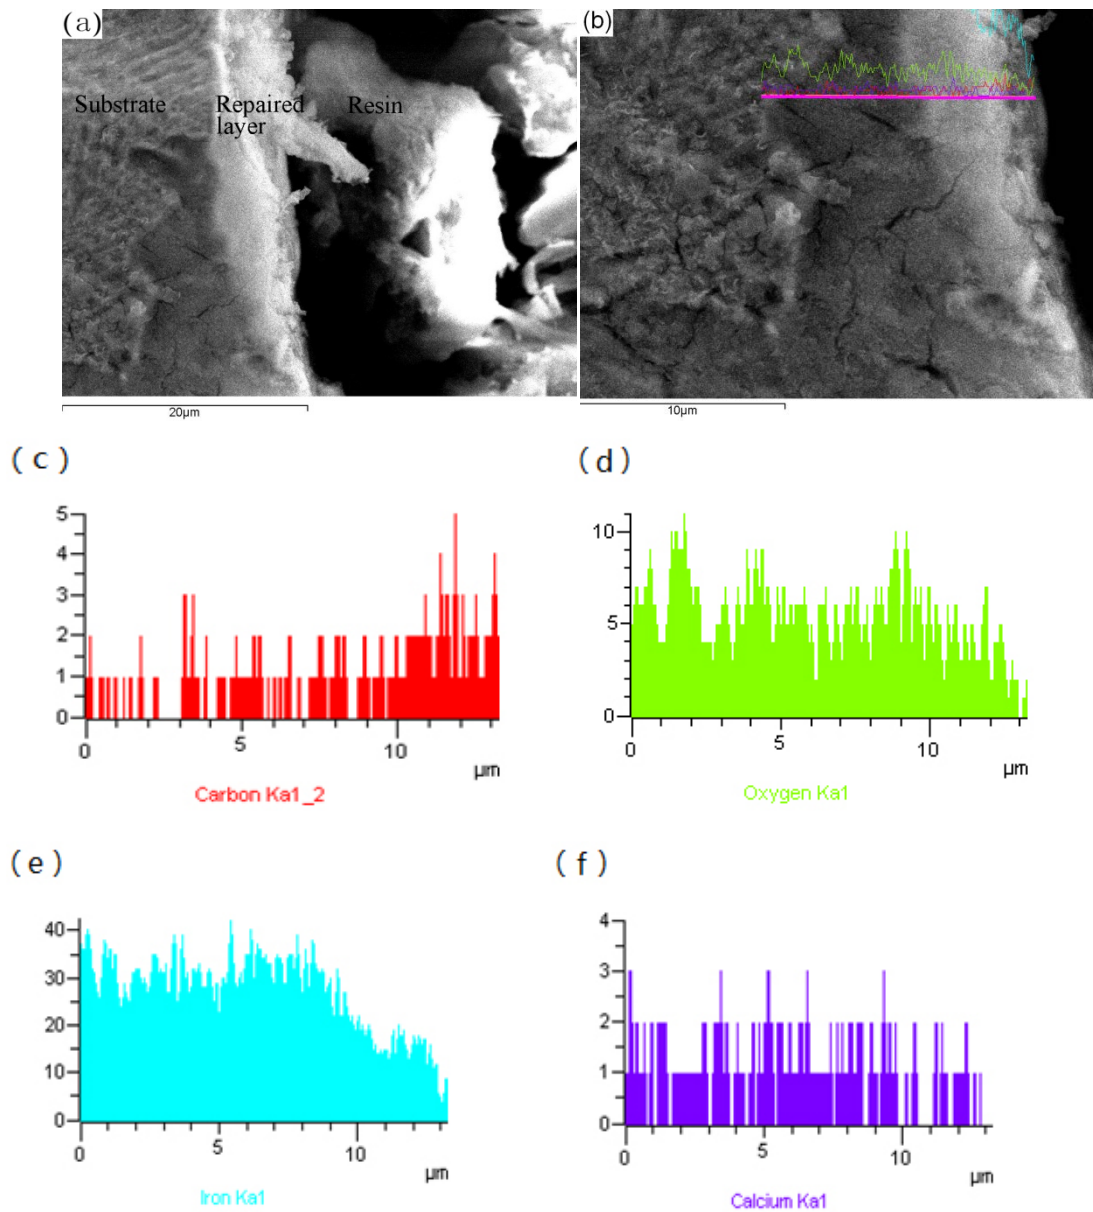
Fig. 2 Cross sectional SEM images and line scan spectra. (a) cross section view of the pin; (b) scan line position on the pin on a higher magnification view of the pin; (c) EDX data of carbon concentration variation along the scan line; (d) oxygen concentration variation; (e) iron concentration variation; (f) calcium concentration variation.

Fig. 2 shows the cross-sectional SEM images of the worn pin and line scan of several elements. Low-magnification SEM image of the cross section of the worn pin can be seen in Fig. 2a, a clear white and transparent repaired layer can be estimated to from 1 μm to 5 μm, the bottom of this cross section showed the smallest value of 1 μm. It is

also noted that there is no obvious interface with the substrate, and crack was inhibited. The repaired layer of the worn pin is not even and the thickness is also different at the different worn areas, which demonstrated the repairing process is selective.

After it was amplified as Fig. 2b, line SEM/EDX scan was conducted along from the substrate to the repaired layer on the cross section of the pin. Fig. 2c-2f shows the EDX data of concentration of the element of carbon, oxygen, iron and calcium respectively. It can be seen that carbon concentration increased significantly on the area of the repaired layer, while iron concentration decreased with the distance from the substrate. High carbon content on the top surface would probably be diamond like carbon film. The DLC films are well known for their amorphous carbon microstructure, high hardness, low friction, and they show excellent wear resistance in oil-lubricated conditions. The hardness of the synthetic DLC films ranged from 10 to 60 GPa [14, 15] , which is consistent to the hardness measured using nanoindentation as discussed in Section 3.1. The low friction coefficient and wear resistance had been verified in previous studies [10]. The detailed structural characterization of DLC films is carried out by using Raman spectroscopy as discussed in Section 3.3.

Approximately 1  $\mu\text{m}$  thick carbon-rich repaired layer was formed on the worn surface of the pin, but the SEM cross-sectional image showed its thickness was not uniform.

Fig. 2 Cross sectional SEM images and line scan spectra. (a) cross section of the pin (lower magnification) (b) line scan position on the cross section of the pin (higher magnification) (c) carbon concentration variation (d) oxygen concentration variation; (e) iron concentration variation (f) calcium concentration variation

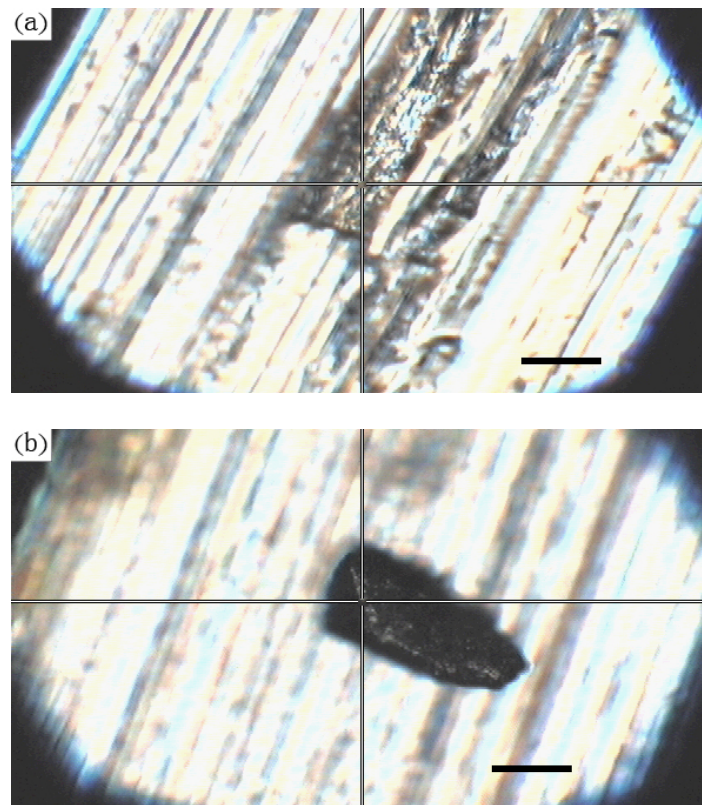
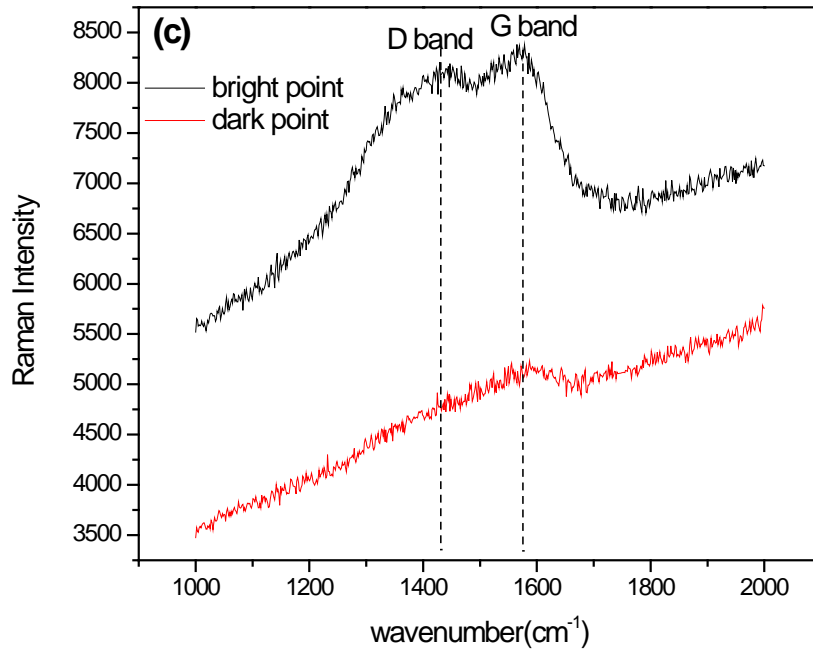
Fig. 3 shows the Raman spectra of restoration films formed on the worn disk in two different areas.

Fig. 3 Raman spectra for restoration film on the disk after 300-h test. Optical images of (a) bright area (b) dark area (c) Raman spectra. The scale bar in (a) and (b) is 100  $\mu\text{m}$ .

Two points in bright area (Fig. 3a) and dark area (Fig. 3b) were chosen to do Raman tests. As can be seen in Fig. 3c, the film formed on the disk has typical shape of DLC spectrum. Two points were selected to carry out the Raman spectroscopy test. For the dark point, the G-band located at  $1564\text{ cm}^{-1}$  and the D-band appeared around  $1426\text{ cm}^{-1}$ . On the other hand, for the bright point, the G-band was weak and narrow in shape and located at  $1578\text{ cm}^{-1}$ . This suggested that the bright point has more of a graphite-like structure than other points. But this indicated that the restoration film is not even and thin, therefore, the G-band peak is not strong.

Fig. 3 Raman spectra for restoration film on the disk after 300-h test. (a) bright area (b) dark area (c) raman spectra. The scale bar in (a) and (b) is 100  $\mu\text{m}$

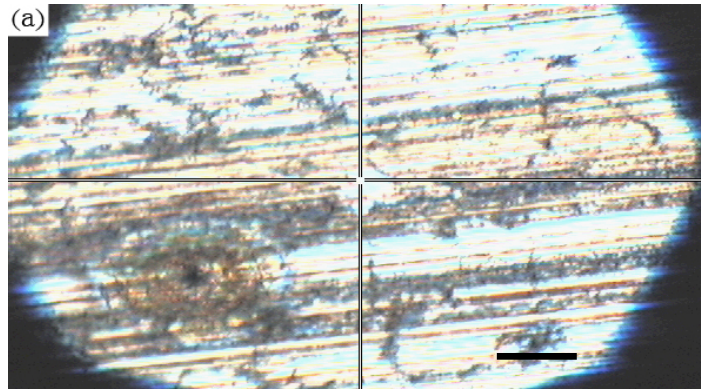
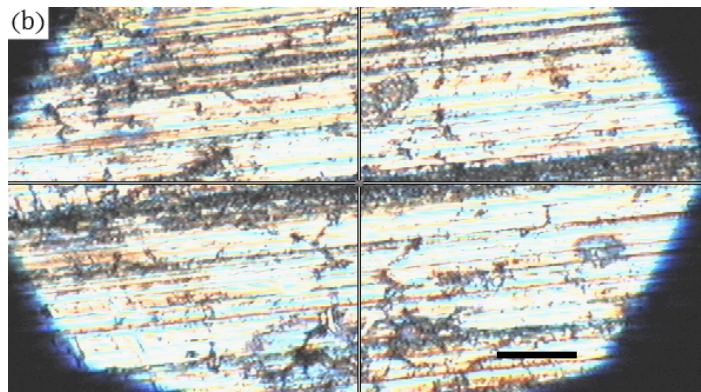
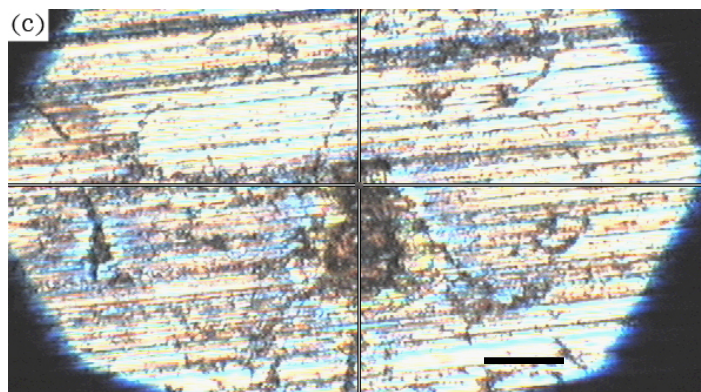
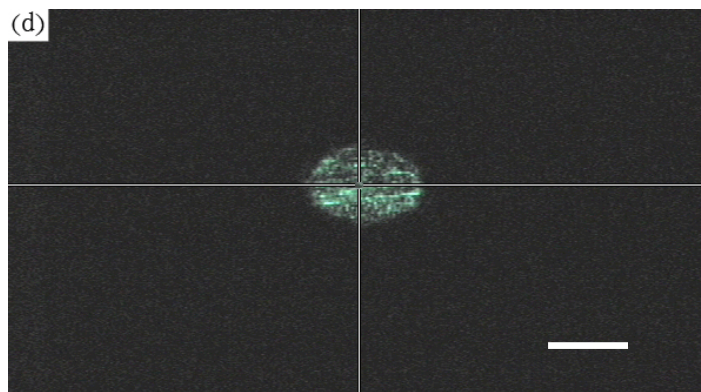
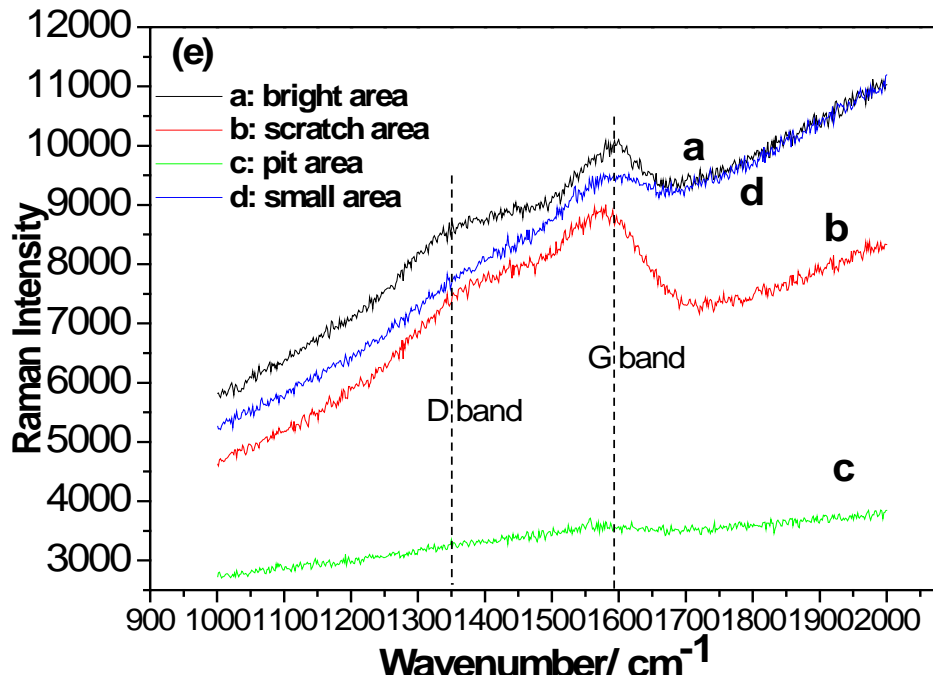
Fig. 4 Restoration films on the pin after 300-h test. Optical images of (a) bright area, (b) scratches area, (c) pit area, and (d) small area; (e) Raman spectra. The scale bar in (a)-(d) is 100  $\mu\text{m}$ .

In view of thicker restoration layer of the pin during the friction and wear, the pin was also examined by using Raman spectroscopy test. Four areas (bright area, scratch area, pit area and small area) were selected to carry out the Raman spectroscopy test as shown in Fig.4 (a) – (d). Fig.4(e) shows the Raman spectra for restoration film on the pin after 300-h test. For the bright area in Fig. 4a, the G-band located at  $1580\text{ cm}^{-1}$  and the D-band appeared around  $1347\text{ cm}^{-1}$ . For the scratch area in Fig. 4b, the G-band was weak and narrow in shape and located at  $1580\text{ cm}^{-1}$  and the D-band appeared around  $1405\text{ cm}^{-1}$ .

For the pit area in Fig. 4c, no apparent G-band peak occurs. For the small area in Fig. 4d, the G-band located at  $1580\text{ cm}^{-1}$  and no D-band. The spectrum shapes for the films at bright area, scratch area and a random small area are typical DLC shapes.

Fig. 4 Raman spectra for restoration film on the pin after 300-h test. (a) bright area (b) scratches area (c) pit area (d) small area (e) raman spectra. The scale bar in (a)-(d) is 100  $\mu\text{m}$

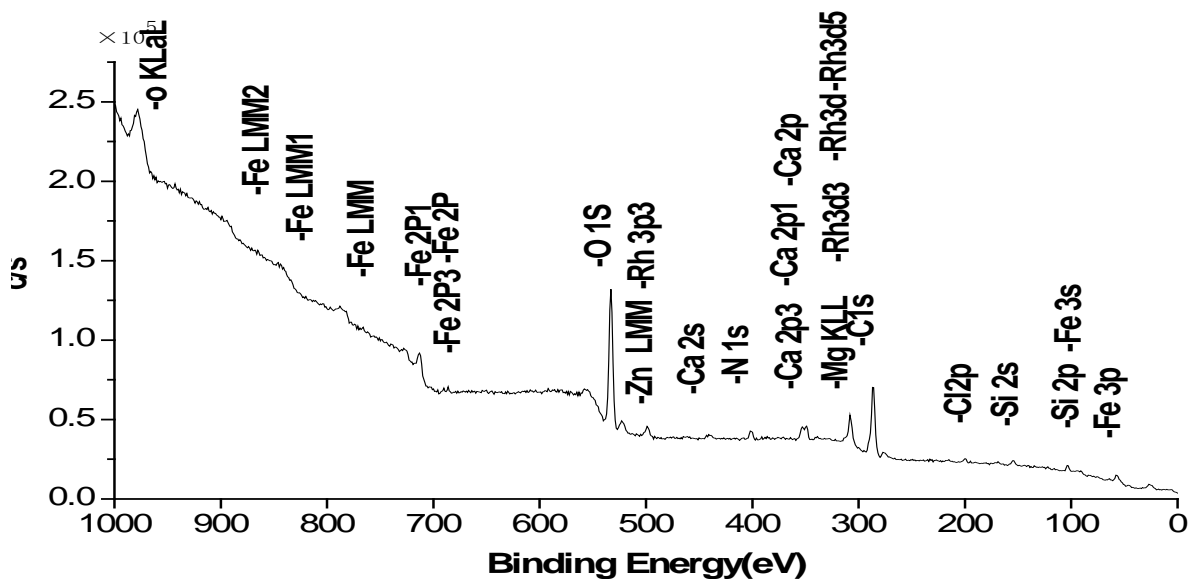
Fig. 5 shows XPS wide scan spectrum and high resolution XPS spectra for O 1s, C 1s, and Fe. The XPS wide scan spectrum indicates that the repaired layer on the pin appears to contain carbon, oxygen, iron, magnesium, silicon, calcium and zinc.

Fig. 5 XPS spectrum of the worn pin

From the XPS analysis, the contents of elements on the worn surface of the pin are: C 42.32 at %, O 33.66 at %, Mg 10.70 at %, Fe 5.84 at %, Si 3.87 at %, Ca 2.42 at %, and Zn 1.18 at %. A lot of carbon exists on the surface of the worn pin, and the value reached 42.32%. This high carbon concentration on the worn pin surface is supposed to form DLC film, which was verified in Fig. 6.

Fig. 5 XPS spectra of the worn pin

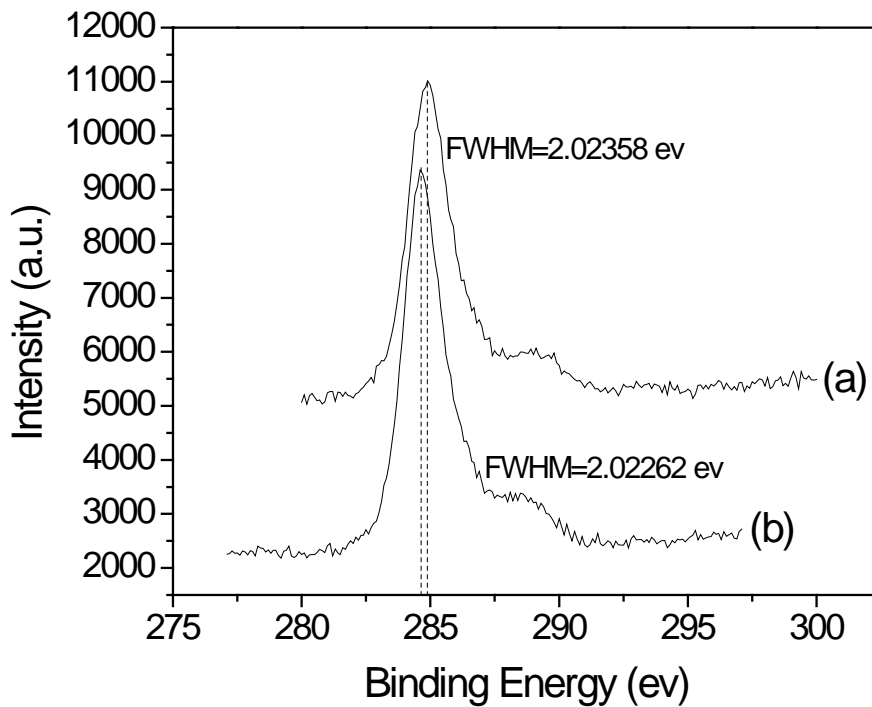
Fig. 6 XPS C 1s spectra for restoration films at the (a) worn pin (b) worn disk

As shown in Fig. 6, the C 1s peak position and the full width at half maximum (FWHM) were compared to those of diamond spectrum. In [20], the structures of the DLC films were analyzed by means of the peak positions and FWHMs of C 1s spectra for the films, and 285.50 eV and 284.15 eV were adopted as the C 1s peak position of

Fig. 6 shows C 1s spectra for DLC restoration film on the worn pin and worn disk.

The peak positions for the DLC films formed on the pin and the disk shift from 284.9 eV (Fig. 6a) toward 284.6 eV (Fig. 6b). Hence, the peak position approached that of diamond (285.50 eV). FWHM values for the restoration film on the worn pin and disk were 2.02358 eV and 2.02262 eV respectively, which also is close to that of diamond (2.20 eV). Both measurements indicated that the restoration layer is DLC film.

Fig. 6 XPS C 1s spectra for restoration films at the (a) worn pin (b) worn disk

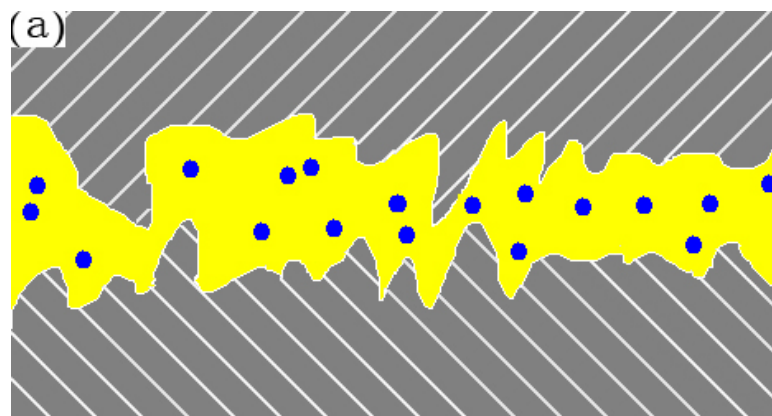
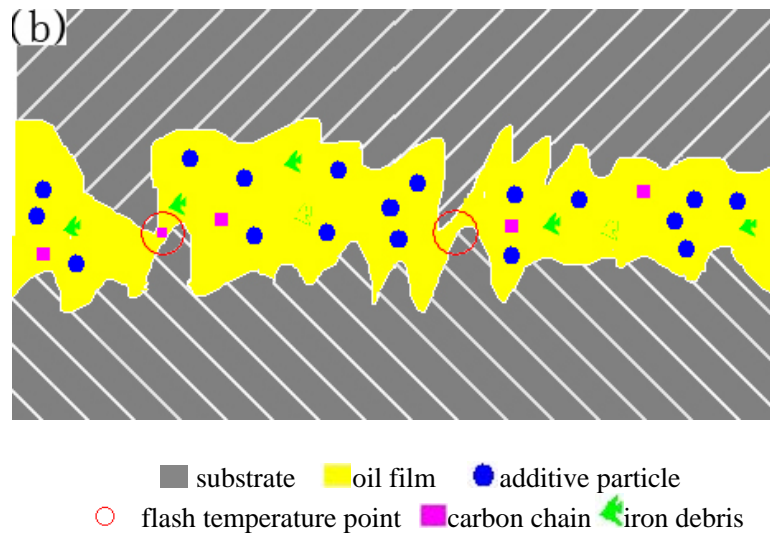
Micro morphology of friction pair contact surface is composed of micro convex and concave pits. Before the machine operates, concave pits are filled with lubricant and additive particles, as shown in Fig. 7a.

When the machine operates, a mechanical load forces the friction surface to be close. Micro convex points on the two surfaces penetrate into oil film, and collide and fracture, and then new abrasive particles get into oil. During a severe wear process, local temperature and pressure are remarkably large. Plastic deformation and fracture of a portion of micro concave would cause a rapid temperature increase, which leads the lubricant oil and additive to begin decomposition. After the additive is added, micro concaves function as the teeth of the grinding machine, and super-precisely grind the additive particles, breaking down the particles. Under high temperatures, micro metallurgical process occurs at the fracture section of micro concaves, as shown in Fig. 7b.

Fig. 7 Super-precision grinding process. (a) Concave pit is filled with lubricant and additive particles; (b) Under high temperatures, micro metallurgical process occurs at the fracture section of micro concaves

Fig. 7 Superprecision grinding. (a) Concave pit is filled with lubricant and additive particles; (b) Under the high flash temperature, micro metallurgical process occurred at the fracture section of micro concaves

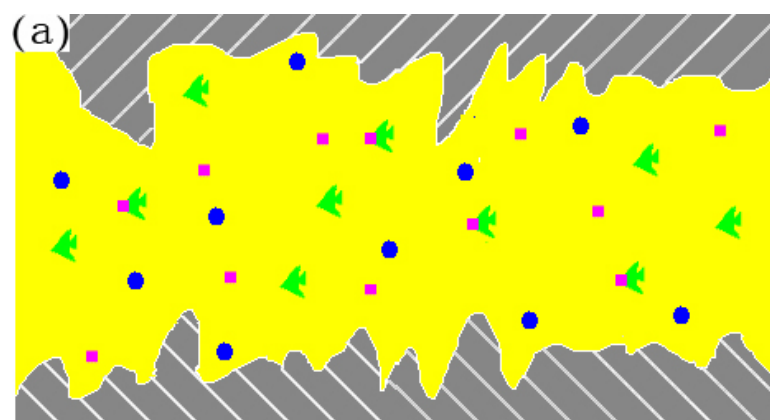
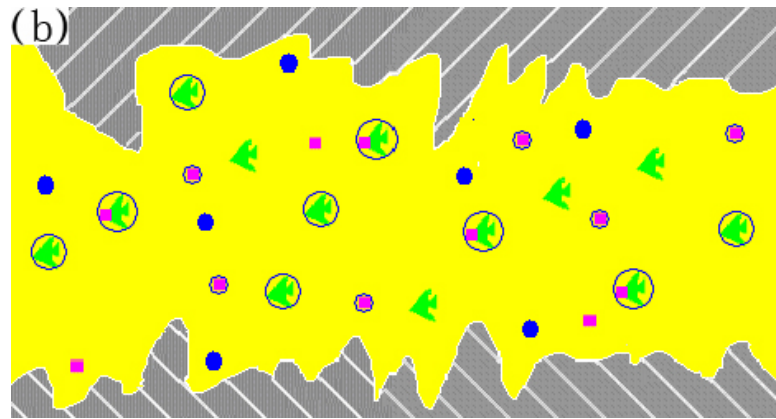
With the machine running, lubricant oil decomposes gradually and the metal is ground gradually. Therefore, carbon chain and grinding debris are produced in the lubricant oil. These two situations may exist separately, or these two combine together, shown in Fig. 8a.

During high speed and high pressure friction and wear took place, and surface activity of carbon chain and iron debris was activated by active components of the additives, consequently, surface energy gradually increased, shown in Fig. 8b.

Fig. 8 Energy activation process. (a) The existence state of carbon chain and grinding debris; (b) Surface activity of carbon chain and iron debris is activated by active components of the additives

Fig. 8 Energy activation. (a) The existence state of carbon chain and grinding debris; (b) Surface activity of carbon chain and iron debris was activated by active components of the additives

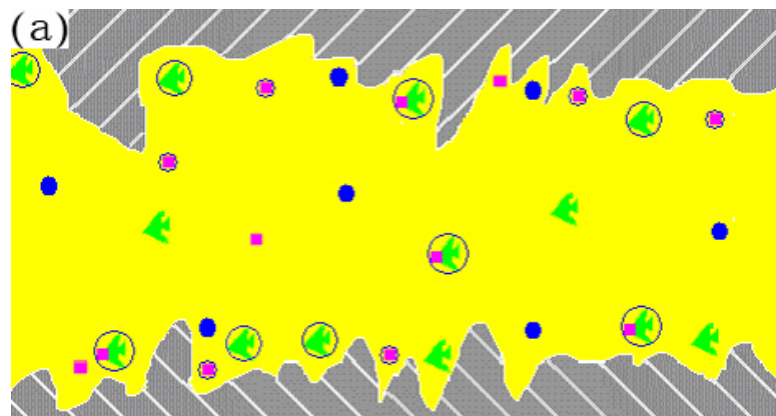
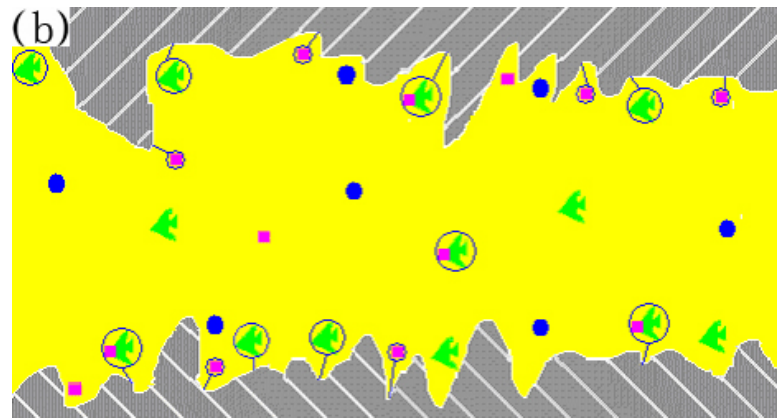
Because of the friction, under local high temperature high pressure, carbon chain and iron debris are activated by additive particles move to the new surface and concave pits, and are adhered to the surface, as shown in Fig. 9a. With continuous friction running, a portion of particles goes into the lubricant oil, while another portion of particles is deposited on the surface of the substrate, as shown in Fig. 9b. For the concave pits and scratch sections, it is easier for the wear debris to be deposited and adhered, because friction occurs severely, causing more energy accumulation and adequate function of lubricant additive.

Fig. 9 Adhesion process. (a) Carbon chain and iron debris moved to concave pit; (b) Some portion of particles was deposited on the surface of the substrate.

Fig. 9 Adhesion. (a) Carbon chain and iron debris moved to concave pit; (b) Some portion of particles were deposited on the surface of the substrate

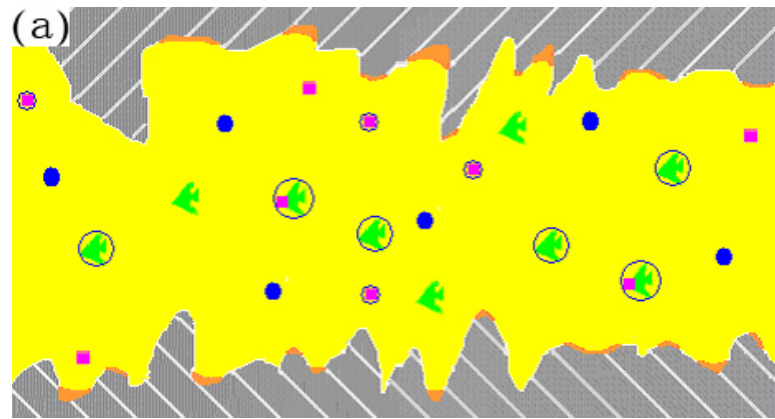
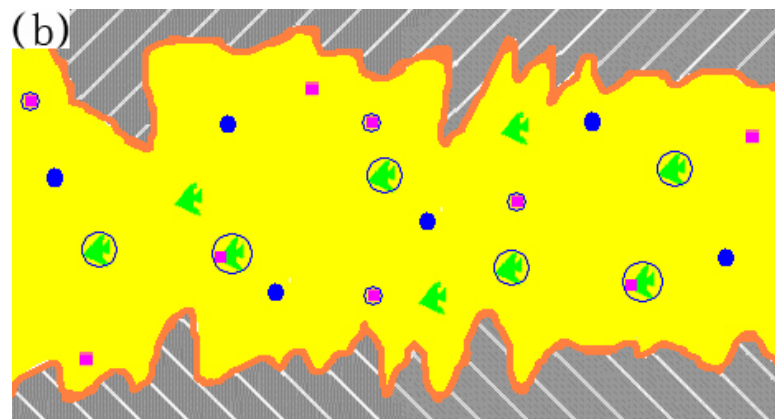
In continuous repetition of adhesion process, partial particles are deposited on the surface of partial concave pits and scratches. With the friction running, the energy accumulates continually. The deposited particles start to recombine in the structure, and finally partial restoration layer is formed, as shown in Fig. 10a. New surface is formed constantly as the friction process continues. The particles in the lubricant oil are deposited and partial restoration is constantly formed. Therefore, restoration film spreads out into the whole friction surface, as shown in Fig. 10b. For the convex section, the final restoration film is very thin because it is destroyed throughout the wear process. It can be concluded that the silicate additive possesses certain selectivity at different locations of the worn surface. Therefore, the thickness and distribution of the restoration film are not uniform throughout the interface.

Fig. 10 Partial restoration process. (a) Deposited particles started to recombine in the structure, and small partial restoration layer was formed; (b) Restoration film spread out into the whole friction surface

Fig. 10 Partial restoration. (a) Deposited particles started to recombine in the structure, and small partial restoration layer was formed; (b) Restoration film spread out into the whole friction surface

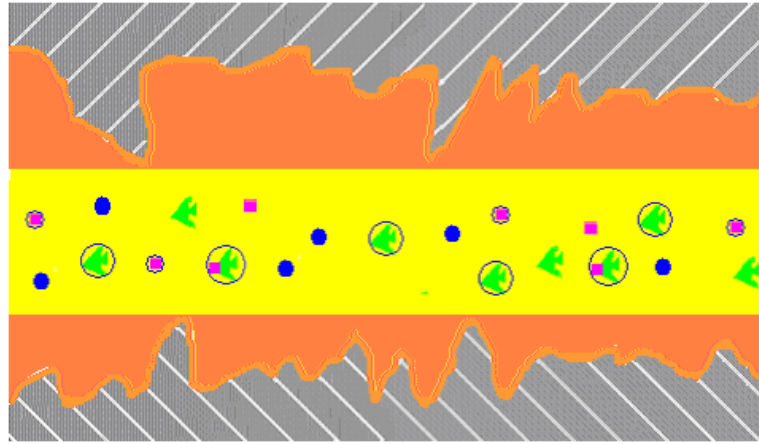
In ideal conditions, with the additive particles, the particles of the lubricant oil are deposited on the friction surface with high surface energy. If this process runs infinitely, a complete and thick restoration film would be formed on the friction surface, as shown in Fig. 11.

Fig. 11 Formation of complete restoration layer

Fig. 11 Formation of complete restoration layer
