Project Title: "Wrong-Way Traffic Movements on Freeway Ramps."

Project No: E-20-624

Sponsor: Georgia Department of Transportation

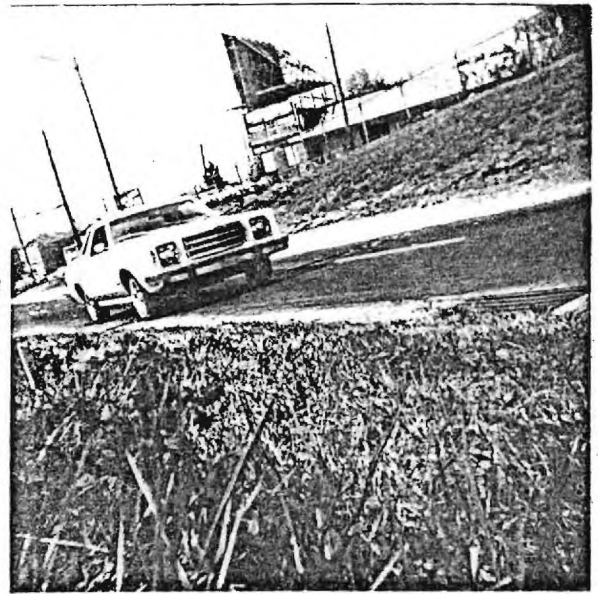
ABOVE LEFT: Fig. 2: False actuation by vehicle rollback.

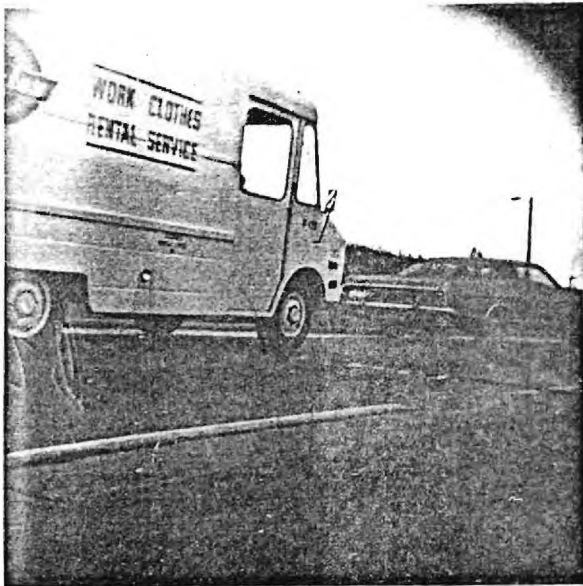
TOP RIGHT: Fig. 3: Daytime wrong-way movement.

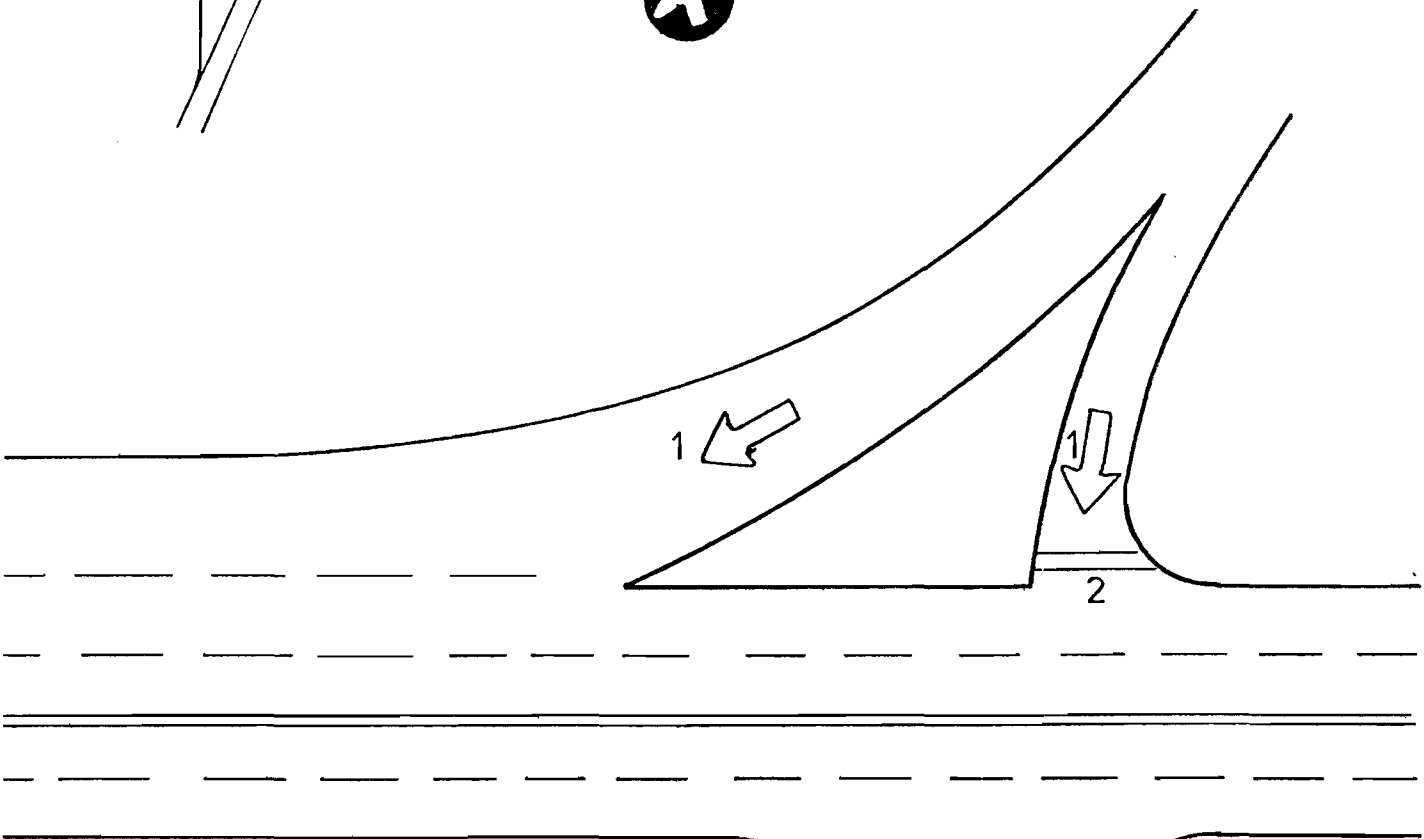
# GA 400 & HOLCOMB BRIDGE RD

## PARCLO 3-QUADRANT DIAGONAL RAMP

1. Large pavement arrows
2. 24 stop bar; 4' from curb

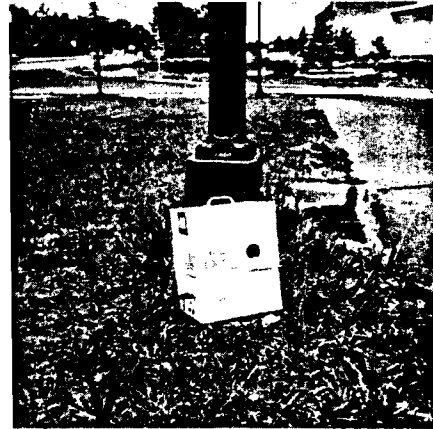
Figure 2. The wrong-way camera unit, installed and chained to light standard

The camera and road tubes were placed approximately 160 feet from the Central Avenue end of the off-ramp, past all Wrong-Way and Do Not Enter signs. The camera set-up and road-tube installation are shown in Figures 2, 3, and 4.

The camera and road tubes were placed approximately 160 feet from the Central Avenue end of the off-ramp, past all Wrong-Way and Do Not Enter signs. The camera set-up and road-tube installation are shown in Figures 2,3, and 4.

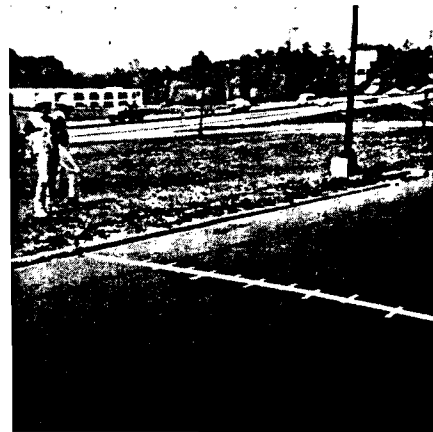
Figure 3. The road-tube installation, and its position relative to the camera. Gore area for this ramp is in background.

The road tubes are of semi-circular cross-section, flat on the bottom, in order that they will remain 3 to 4 inches apart. Industrial tape (Nashua 200) was applied to hold the tubes in place (Figure 3).

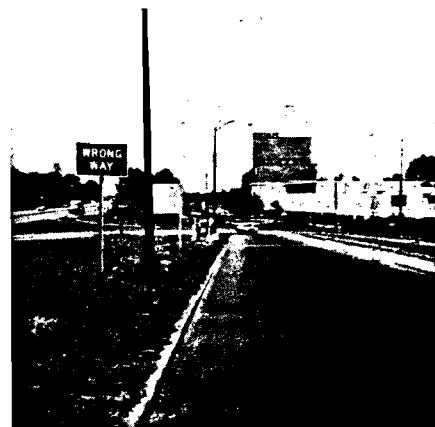
Figure 4. View of the camera and road-tube from the Central Avenue end of the ramp

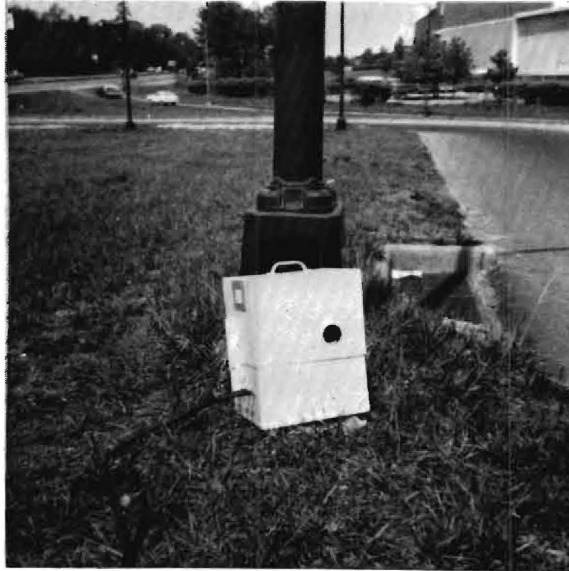
Figure 2. The wrong-way camera unit, installed and chained to light standard

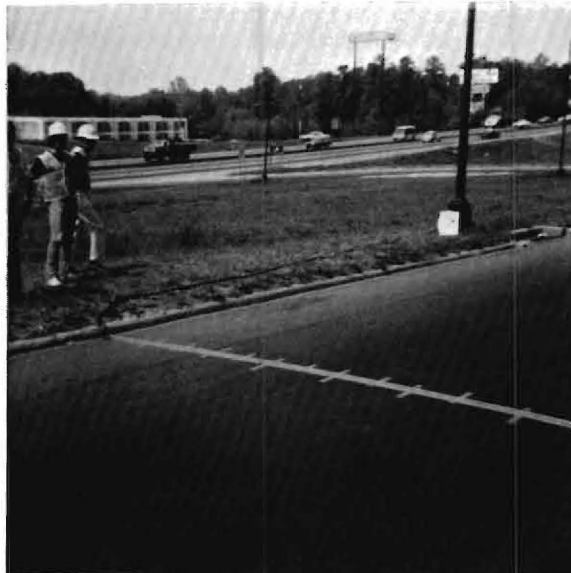
Figure 3. The road-tube installation, and its position relative to the camera. Gore area for this ramp is in background.

The road tubes are of semi-circular cross-section, flat on the bottom, in order that they will remain 3 to 4 inches apart. Double-faced carpet tape was placed between the tubes and the road, to minimize movement and to maximize the life of the hose. Industrial tape (Nashua 200) was applied to the tops of the tubes for the same reasons.

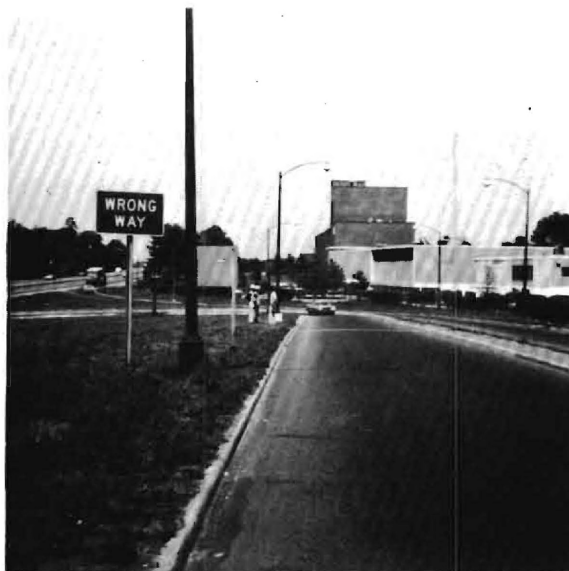
Figure 4. View of the camera and road-tube from the Central Avenue end of the ramp

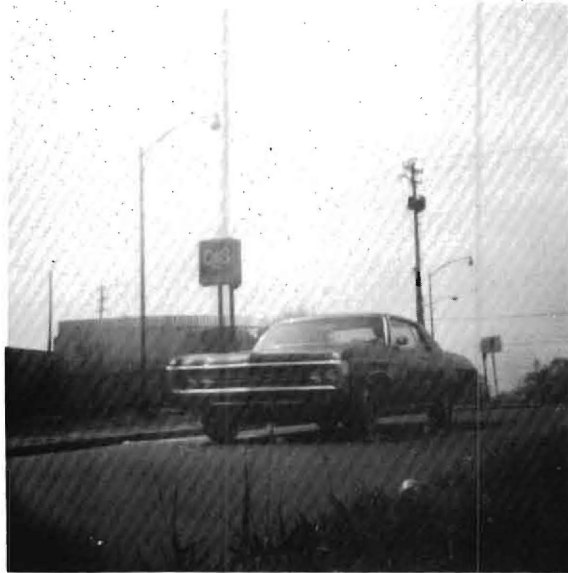
Figure 6. Daylight wrong-way movement

Three sample photographs are shown as Figures 5,6 and 7. Figure 5 shows a night-time wrong-way movement. It is easy to see that the vehicle's lights are headlights, not tail-lights, thereby confirming that the vehicle is in fact moving in the wrong direction on the ramp. Figure 6 shows a vehicle firmly committed to making a wrong-way movement in broad daylight. Such a photo is the exception rather than the rule, as most such movements occur at night. Figure 7 shows a right-way vehicle rolling back across the tubes and causing a wrong-way movement to be registered. It is not uncommon for a car waiting in a queue on an upgrade to roll back a foot or two, especially if it has manual transmission.

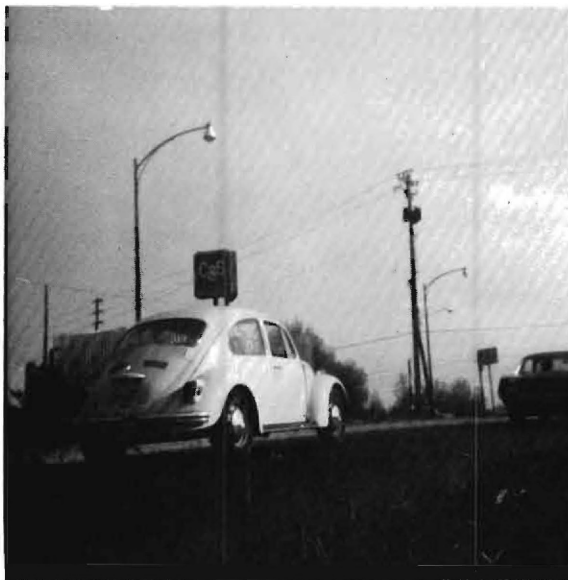
Figure 7. False actuation caused by vehicle roll-back

Therefore it is important that the equipment include a camera, not just a digital counter. Of the 57 photos obtained at I-75 and Central Avenue, five were of cars rolling back.

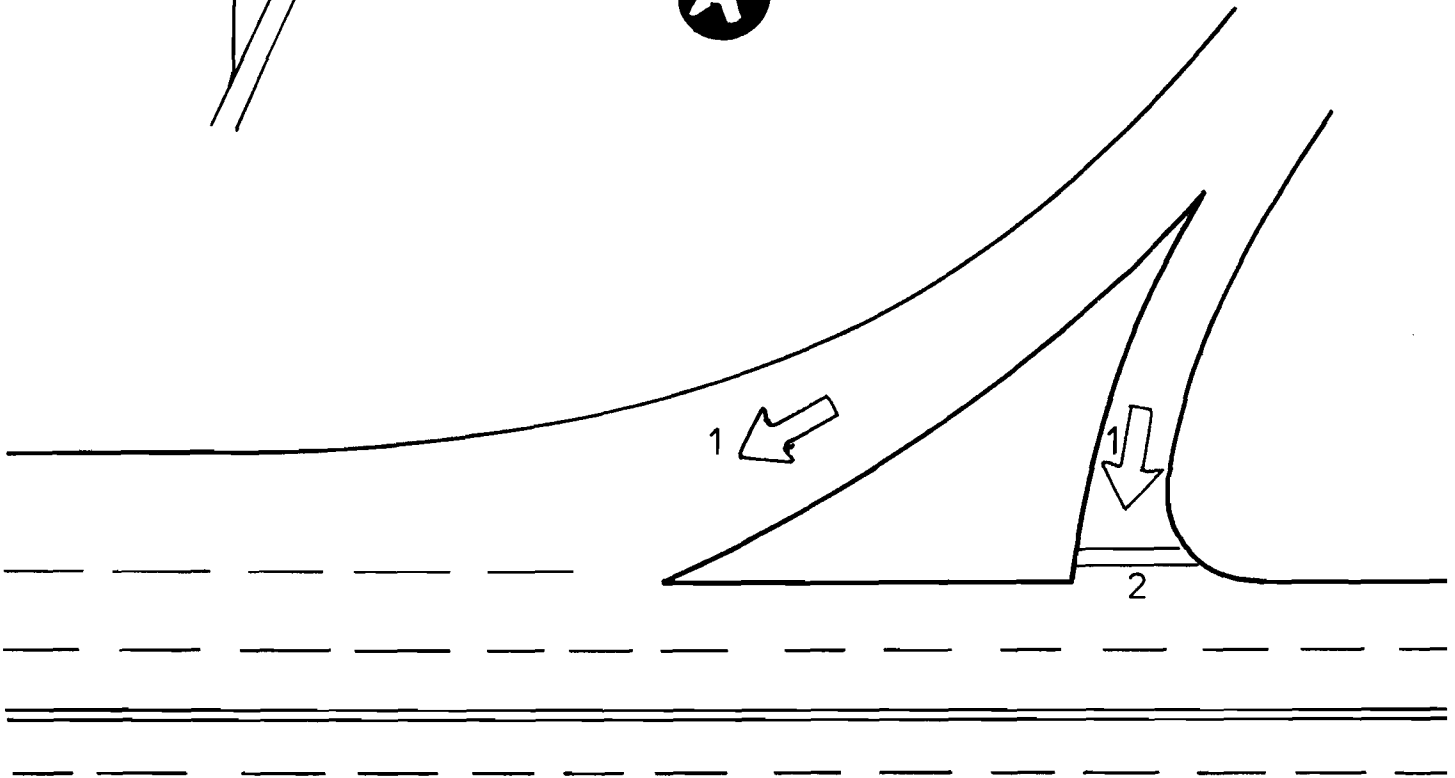
APP SCALE : 1" = 40'

## PARCLO 3-QUADRANT DIAGONAL RAMP

### COUNTERMEASURES :

1. Large pavement arrows
2. 24 stop bar; 4' from curb
