Archaeological Investigations in Front of the Spanish Governor's Palace in Plaza de Armas, San Antonio, Bexar County, Texas

Kristi Miller Nichols

In June of 2015, Raba Kistner Environmental, Inc. (**RKEI**) was contracted by K. Friese + Associates to perform archaeological investigations related to the replacement of a section of water main located to the east of the Spanish Governor's Palace and City of San Antonio (COSA) offices within the Vogel Belt Complex. Since the project was sponsored by a political subdivision of the state and impacted land owned by the COSA, it fell under the jurisdiction of the COSA's Preservation Ordinance (Division 3, Article VI Historic Preservation and Urban Design, Texas Unified Development Code) administered by the Office of Historic Preservation (OHP). Furthermore, the project also falls under the jurisdiction of the Antiquities Code of Texas, as overseen by the Texas Historical Commission.

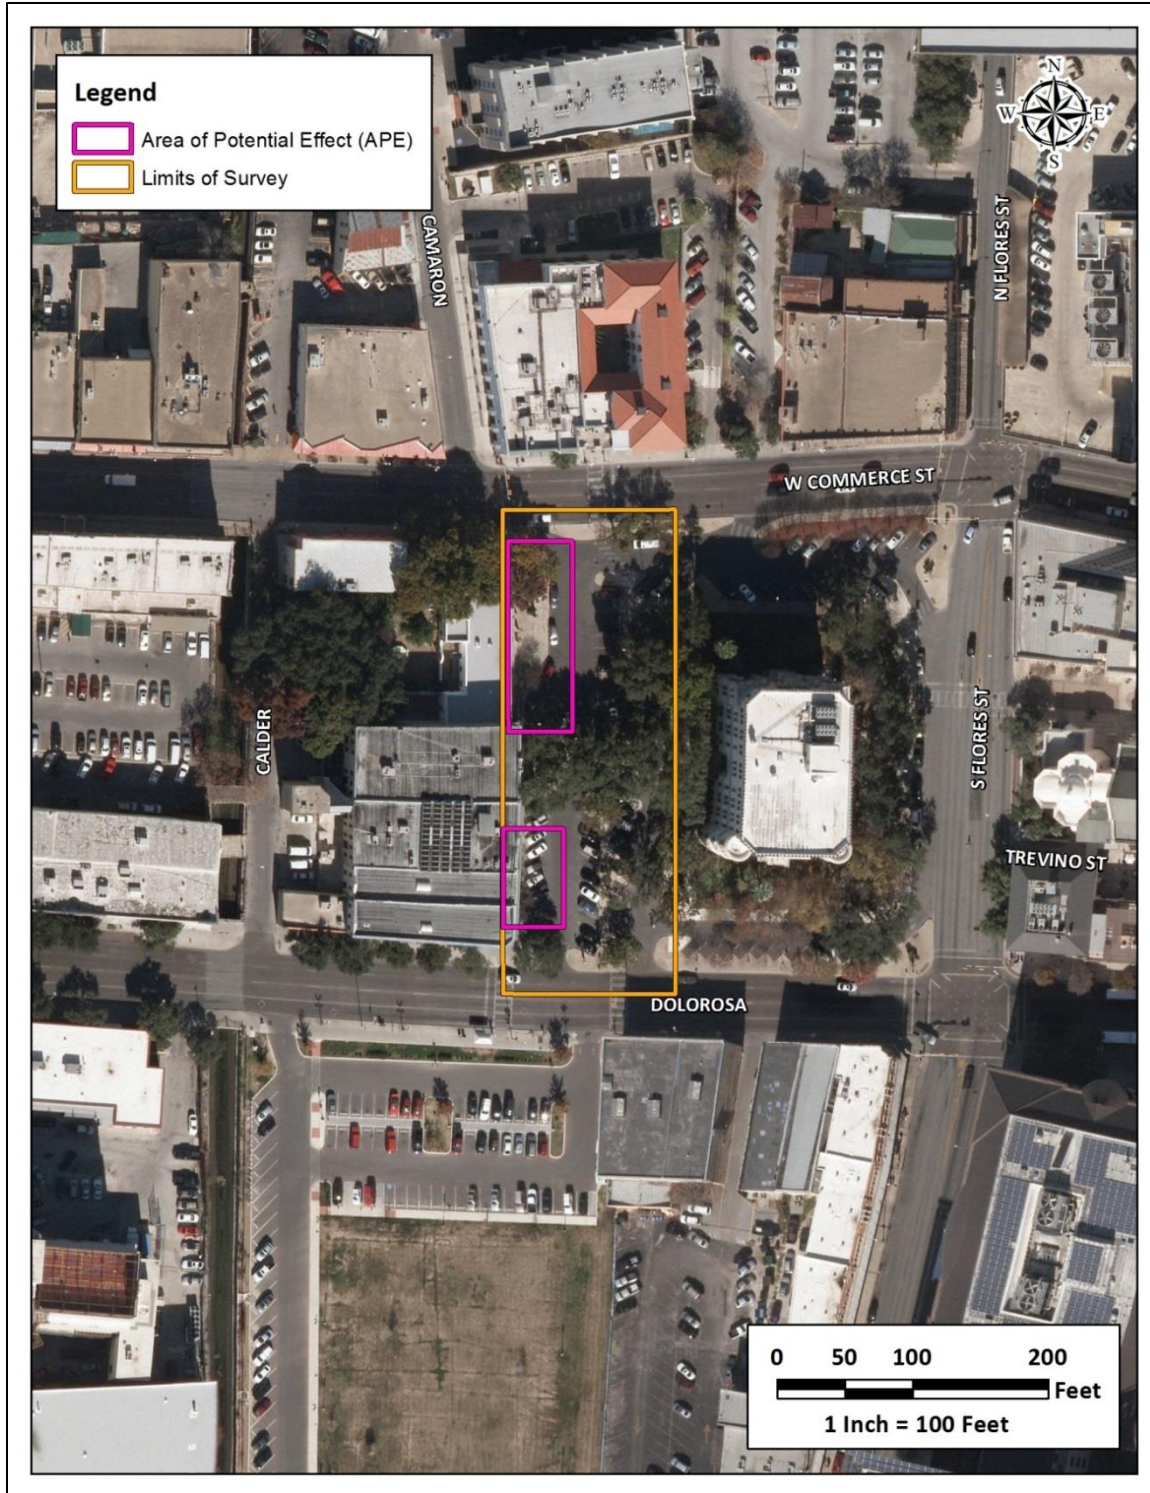
Figure 1-2. The two phases of the installation project that form the APE.

The project area is located in downtown San Antonio, bounded on the north by West Commerce Street, on the south by Dolorosa Street, on the west by the Spanish Governor's Palace and the Vogel Belt Complex, and on the east by the San Antonio City Hall building. **Figure 1-1** provides a map of the project Area of Potential Effect (APE) plotted on the *San Antonio East* (2998-133), 7.5 minute United States Geological Survey (USGS) topographic quadrangle. **Figure 1-2** shows the APE on current aerial photography.

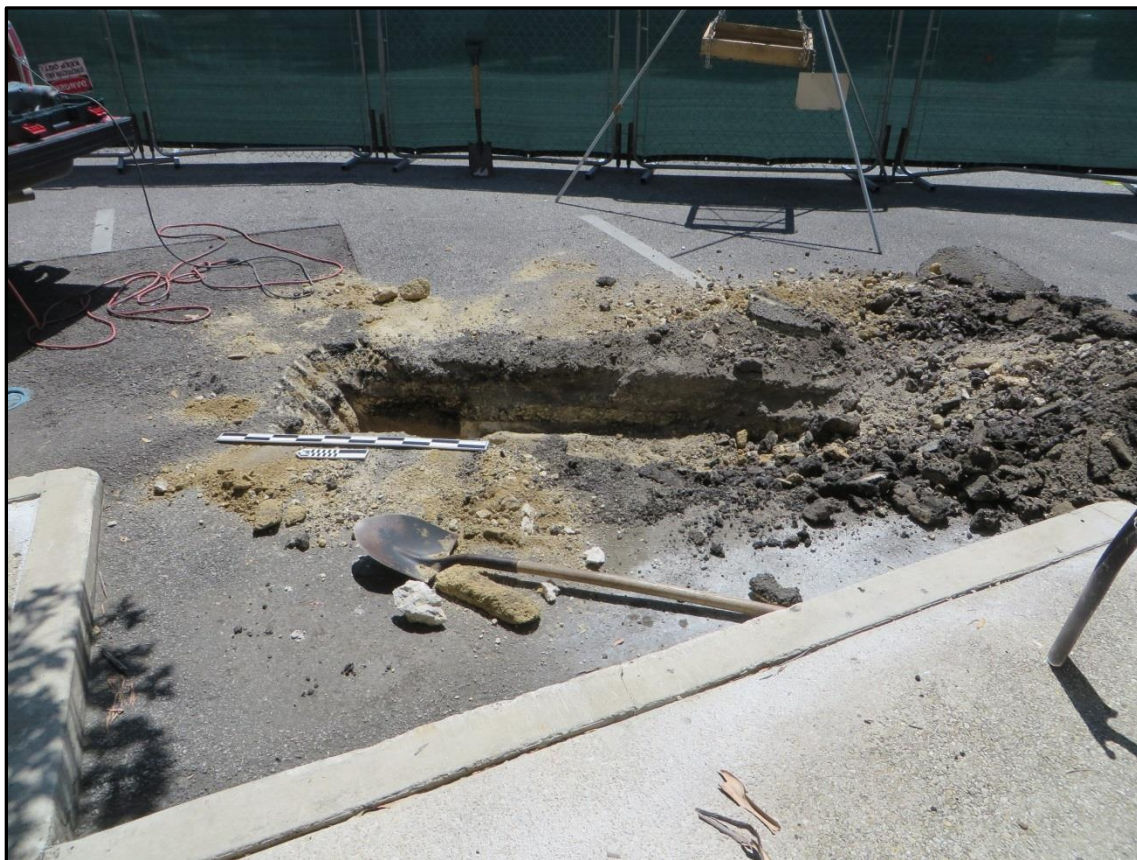
Figure 4-2. The RKEI exploratory trench in Phase I.

On June 9, 2015, staff of **RKEI** assisted by Alamo Backhoe and operator Rick Cavaness, excavated a short exploratory trench in front of the Vogel Belt Complex near the eastern beginning point of Phase I. The goal of this trench was to expose the fill in the original water main trench and examine its contents and the stratigraphy of the trench wall. A water main break that occurred a few years earlier resulted in trenching to expose and repair the valve. The outlines of this trench were still visible in the pavement allowing **RKEI** to place the exploratory trench to straddle the recent work by SAWS and the older portion of the water main line (**Figure 4-2**). A mini-excavator was used to dig the exploratory trench.

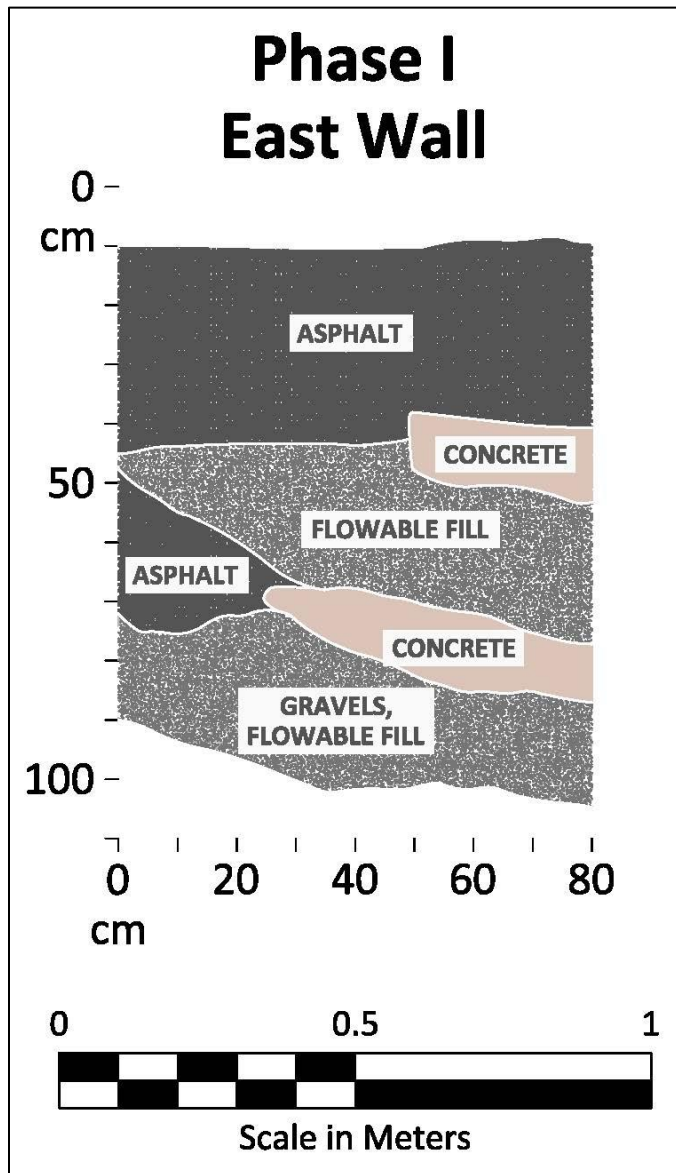
Figure 4-3. East Wall profile of Phase I trench.

In the southern portion of the trench, the upper 40 cm of matrix consisted of a layer of asphalt followed by base (**Figure 4-3**). A layer of concrete was encountered 40 cmbs. The recently patched area in the northern portion of the trench contained a layer of asphalt underlain by flowable fill. The mini-excavator had difficulty breaking through the concrete and the flowable fill. A hammer drill was utilized to help

break through the material. The upper layer of concrete extended to approximately 50 cmbs. Beneath the concrete was a layer of flowable fill followed by another layer of concrete at 68 cmbs. The second layer of concrete was approximately 15 to 20 cm thick. Below the concrete, the remainder of the matrix consisted of a mix of gravels and flowable fill. The trench was excavated to a terminal depth of 3 feet (1 m) bs to insure that the old water main line would not be damaged during the excavations.

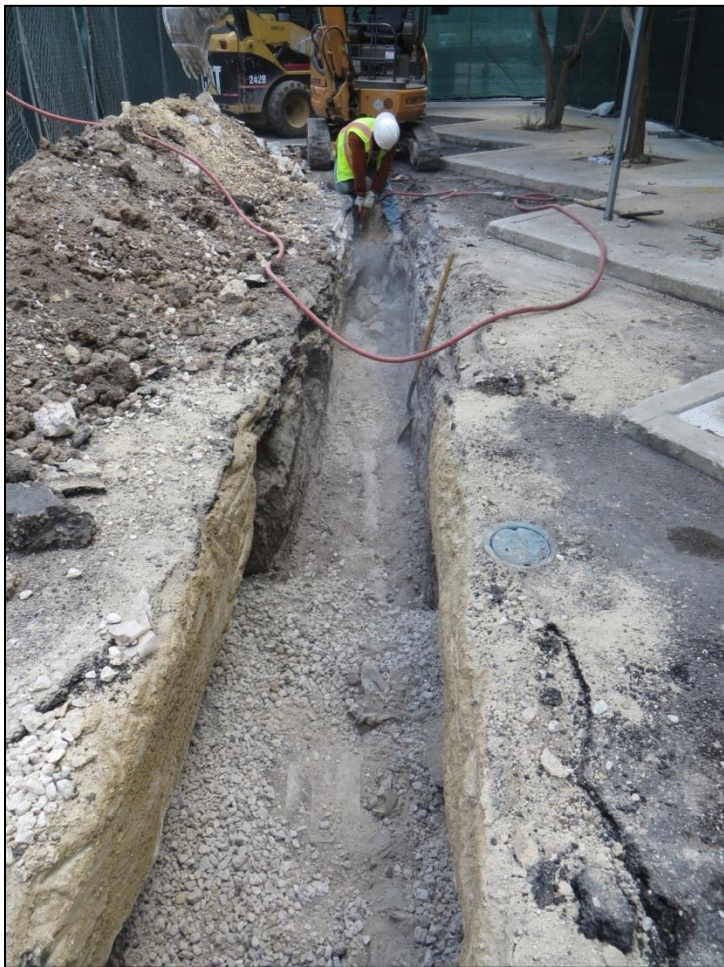
Figure 4-4. The remainder of the Phase I trench excavation.

The SAWS excavations were monitored by the **RKEI** Project Archaeologists. These excavations also encountered the layers of asphalt, flowable fill, and concrete noted in the **RKEI** exploratory trench

(Figure 4-4). In addition, near the middle of the trench, the monitor noted a section of clay loam matrix in the wall of the trench. The matrix noted in the wall of the trench did not appear to be disturbed. Careful inspection of the trench walls noted gravels and roots but did not reveal any cultural material embedded in the clay loam matrix. Near the southern end of the trench, excavations exposed a thick layer of concrete that extended from approximately 40 cmbs to just above the water main, measuring nearly 1.1 m in thickness. This concrete layer capped an old bend in the pipe. A hammer drill and jackhammer were used to remove the concrete to expose the water main. In the west wall of the southern portion of the trench, a pocket of clay loam soil was encountered. No cultural material was noted in the wall or the removed matrix. Roots from a nearby tree were present.

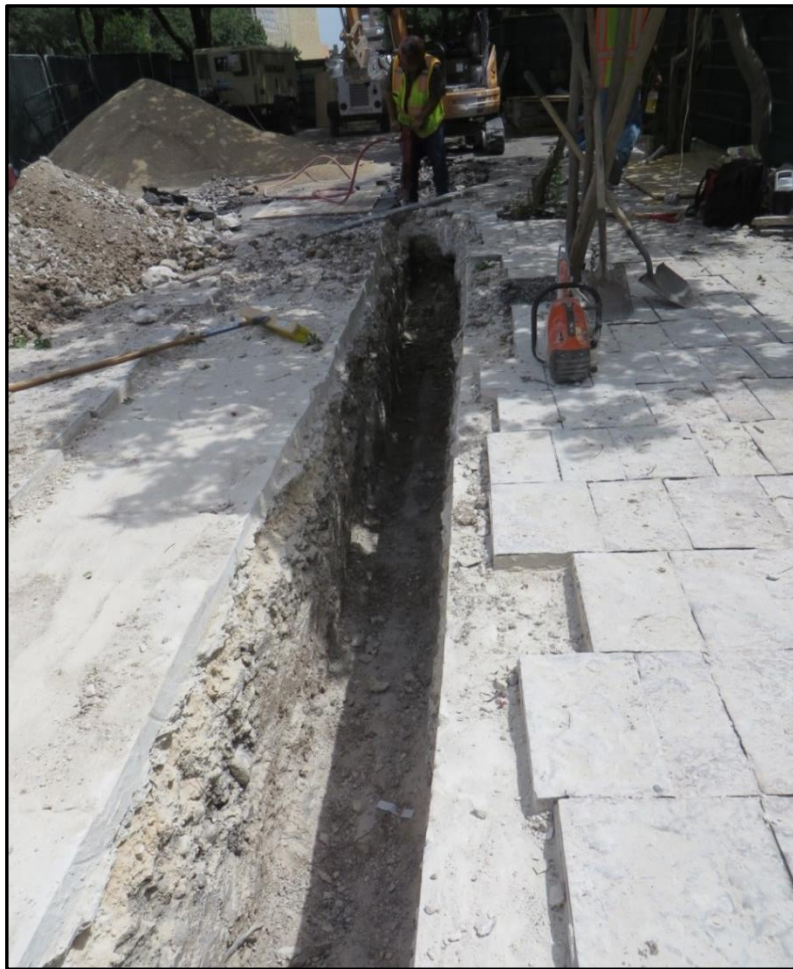
Figure 4-5. Use of the impact hammer. Portion of the Phase II trench, facing south.

Prior to the inception of the trenching, the limestone pavers had to be removed. The pavers were imbedded into a layer of concrete that was approximately 20 cm in thickness. Once the limestone paver blocks were removed, an impact hammer and small jackhammer were used to break through the underlying concrete. Approximately 10 m of the northern section of the trench, contained caliche gravels below the flowable fill (**Figure 4-5**). The water line was encountered within the gravels. A small section of the trench exhibited brown clay loam soils associated with landscaping, specifically nearby trees that are planted through the sidewalk. No cultural material was noted within the matrix associated with the trees.

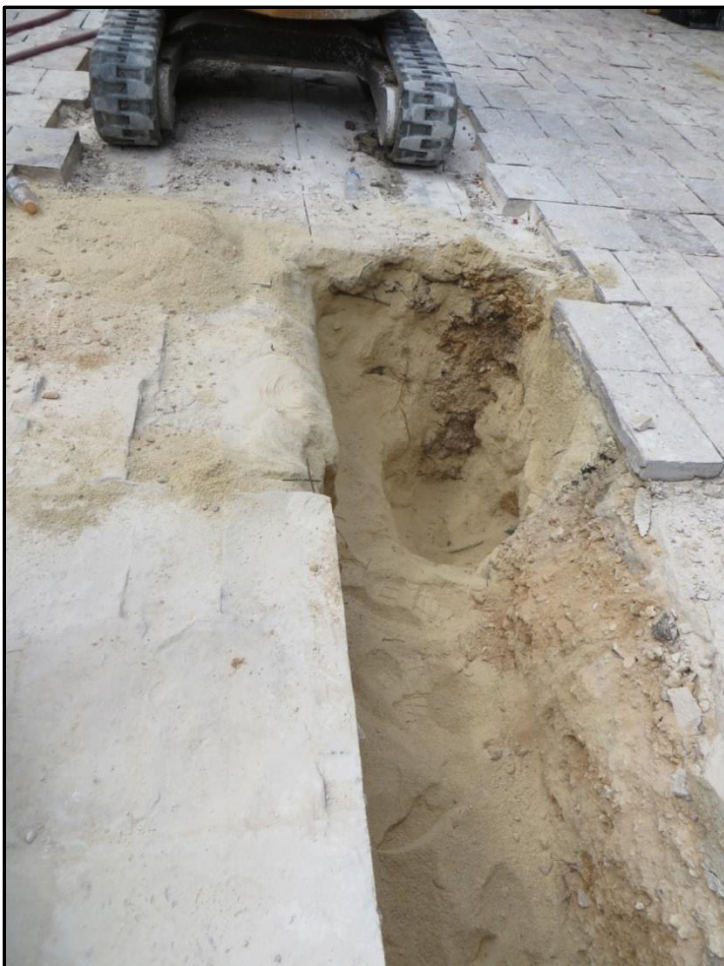
Figure 4-6. Phase II trench showing sand and water line servicing the Spanish Governor's Palace.

A section of the trench, approximately 2 m in length, contained construction sand and water utility lines that serviced the Spanish Governor's Palace (**Figure 4-6**). The matrix surrounding the line leading to the Spanish Governor's Palace was very moist in comparison to the rest of the trench.

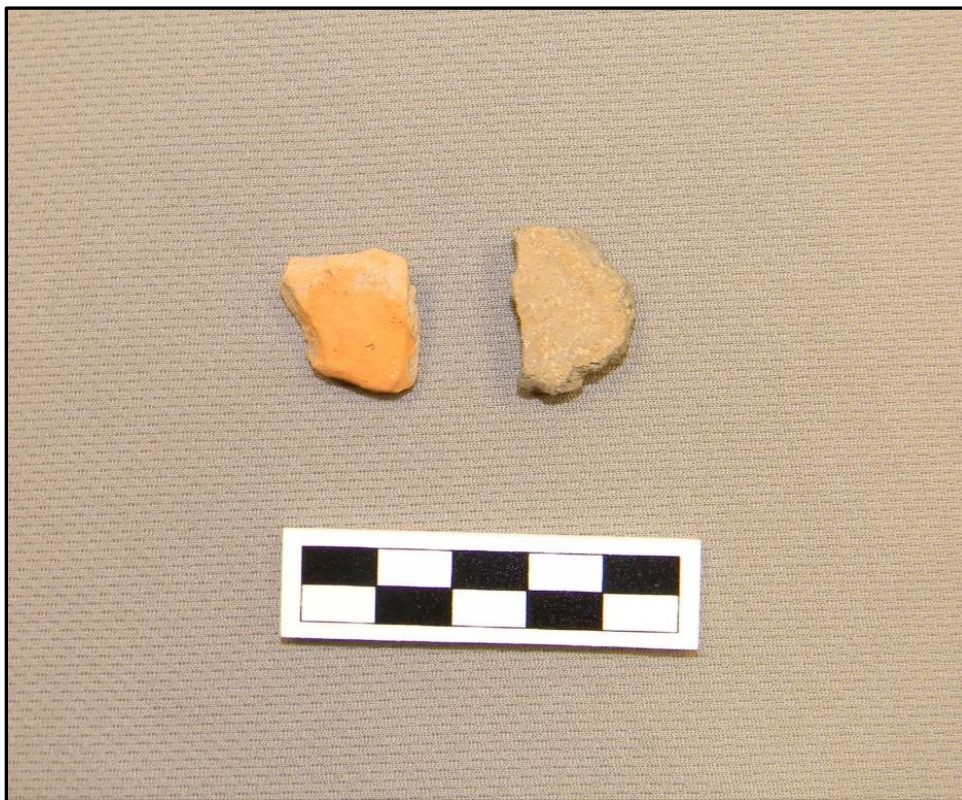
Figure 5-1. Native American Ware recovered from the southern end of Phase II trench.

Prehistoric Toyah Phase, archaeologists generally assume that Goliad Wares are a continuation of the Toyah Phase technological tradition into historic times. However, the exact relationship between Goliad and Leon Plain Wares is not known, nor do we have a clear understanding of how indigenous groups acquired the knowledge to make bone tempered ceramics. The continuity of the technological details between the two types suggests that historic Indians were directly exposed to descendants of Toyah Phase potters or that vestiges of the Toyah Phase extend into the Spanish Colonial Period. Two fragments of Native-made ceramic were recovered from the back dirt derived from the short off-set trench near the southern terminus of the Phase II trench (**Figure 5-1**).

The two small fragments recovered from the trench range from reddish brown to brown color and have an even core that matches the color of the two faces. The lack of a dark gray core indicates that the specimens were fired in an oxidizing environment and at sufficiently high temperatures to burn off the organics that typically accumulate and remain in the center of the typical Goliad specimens. The paste lacks a noticeable sand component and as such it matches the Navarro clays found in abundance throughout the upper reach of the San Antonio River basin. The small specks of white inclusions appear

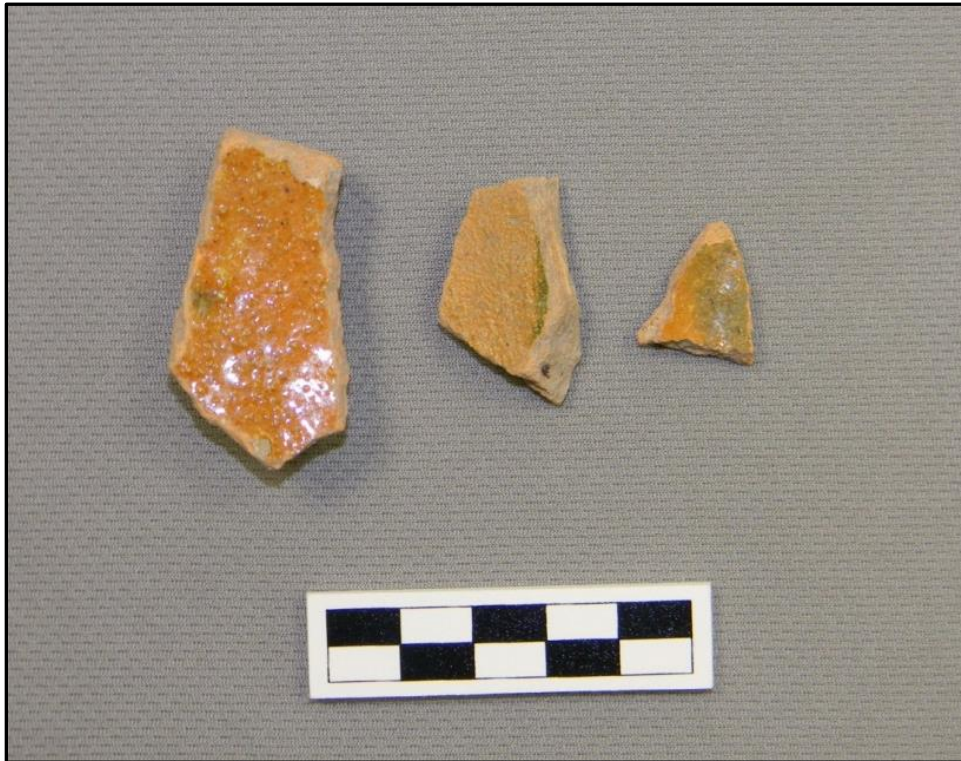
Figure 5-4. Yellow and Green Lead Glazed wares.

Yellow and Green Glazed is another variety of the Sandy Paste Lead Glazed Wares. The vessel walls of this type are often thicker than the tin glazed ceramics. The glaze used on these vessels appears to have a yellow and/or green tint. Green decorations on the rim are often seen (although can be broken down into the Yellow and Green Glaze II variety). Vessel forms were often utilitarian and held up well during the transit from Mexico to San Antonio (Fox and Ulrich 2008). Four lead glazed sherds were recovered from the southern portion of the Phase II trench: three Yellow and Green Lead Glazed, and one

immature lead glazed. One of the three Yellow and Green Glazed sherds was located in the profiled wall of the trench. The sherd was recovered from Layer 4 as the wall was cleared for the profile. The sherd represented a vessel base. The remaining three sherds were body sherds that were collected from the trench (**Figure 5-4**).
