MECHANISTIC STUDIES OF STRESS
CORROSION CRACKING IN AUSTENITIC
STAINLESS STEELS AND IN 70CU-30ZN

XIAOZHU WU
DÉPARTEMENT DE GÉNIE PHYSIQUE
ET DE GÉNIE DES MATÉRIAUX
ÉCOLE POLYTECHNIQUE DE MONTRÉAL

THÈSE PRÉSENTÉE EN VUE DE L'OBTENTION
DU DIPLÔME DE PHILOSOPHIAE DOCTOR (Ph.D.)
(GÉNIE MÉTALLURGIQUE)

JUILLET 1998

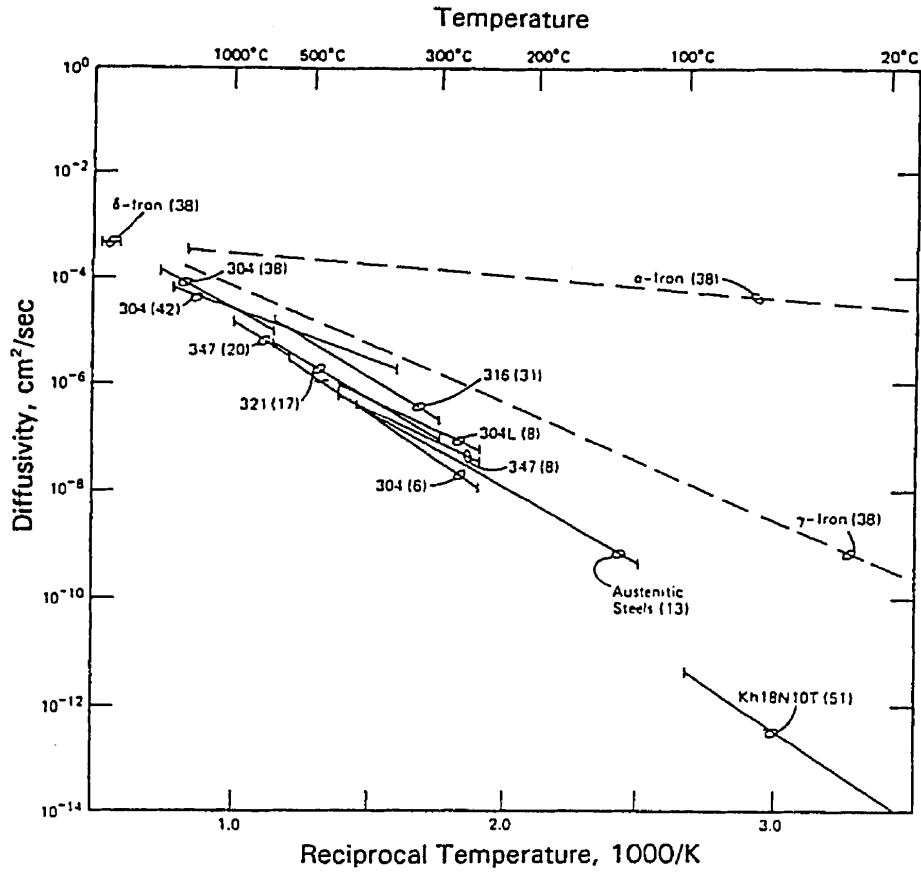
Figure 1.2 Hydrogen diffusivity in stainless steels.

Trapping increases the solubility, but it is only marginally measured below 600 K for a trap density 10^{25} m^{-3} and would be negligible for smaller trap densities [30]. Fig. 1.2 shows the hydrogen diffusivity in austenitic steels [25]. The diffusivities are lower than extrapolated values for pure γ -iron and vary with alloy composition. Overall, trapping effects in austenitic steels are not as pronounced as in ferritic steels.

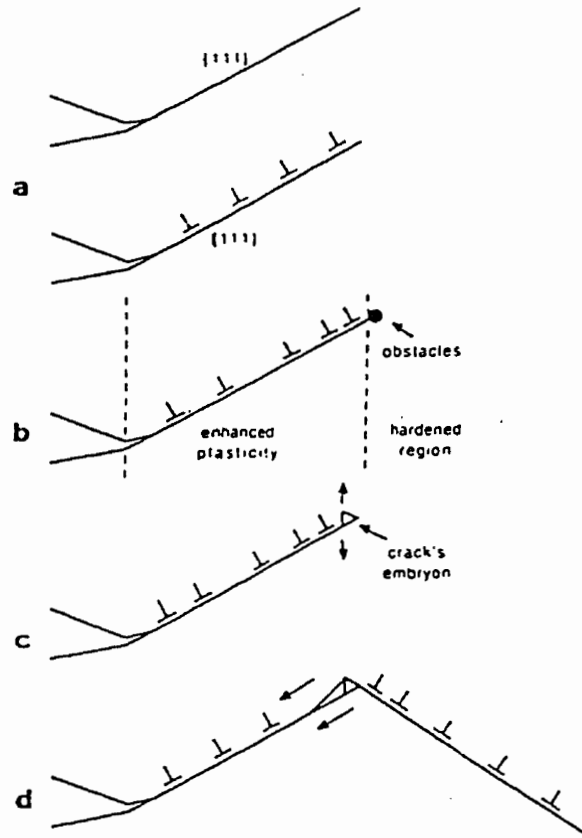
Figure 1.15 Schematization of corrosion-enhanced plasticity model.

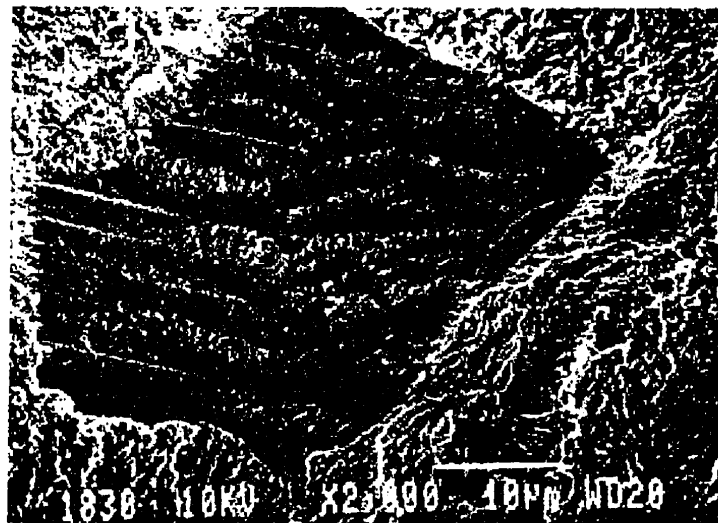
Figure 3.12 A large $\{100\}$ facet with microvoids formed during fatigue in 316L stainless steel.

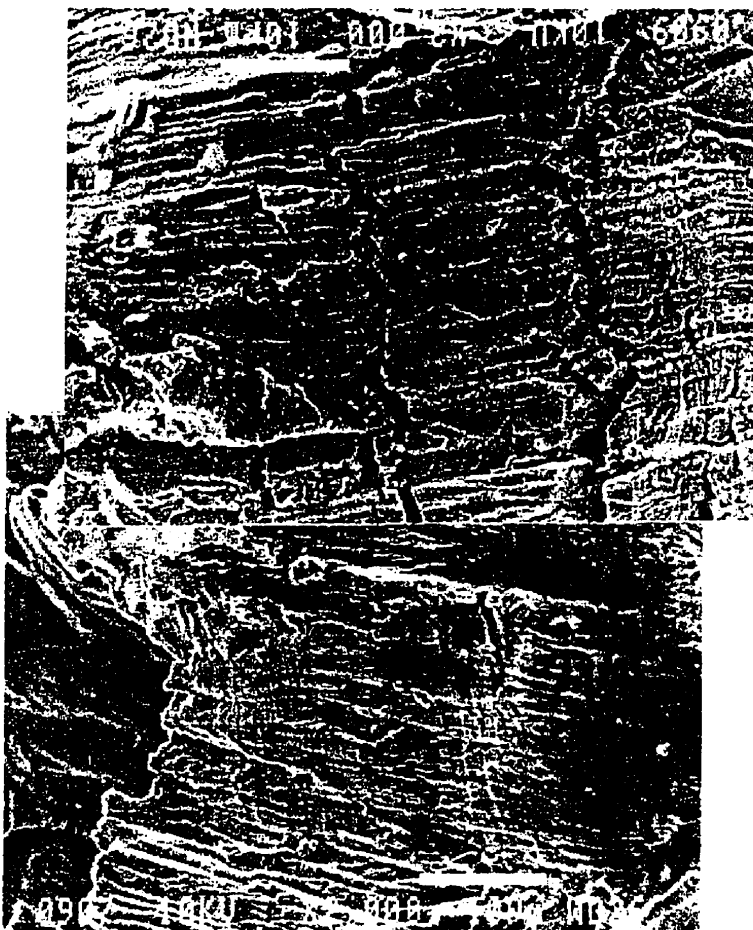
Figure 3.20 Striations on matching fracture surfaces produced at a slow COD opening rate in MgCl_2 solution in a 310 stainless steel specimen. Not all the striations, such as in regions A and A', are matching on the opposite fracture surfaces.

austenite in slowly opened 316L specimen in solution (section 3.4.1). However, the opposite fracture surfaces were not easily matched because secondary cracks were opened and uncracked ligaments were pulled out. On the matching fracture surfaces shown in Fig.3.20, not all the striations match on the opposite fracture surface. Such pronounced striations shown in Fig. 3.20 were claimed [18,22,23,129] as evidence of propagation discontinuity in slow strain rate SCC tests. The present observations show, however, that these non-matching striations are produced by slip after fracture, most probably due to the high strain at the crack tip during crack opening.

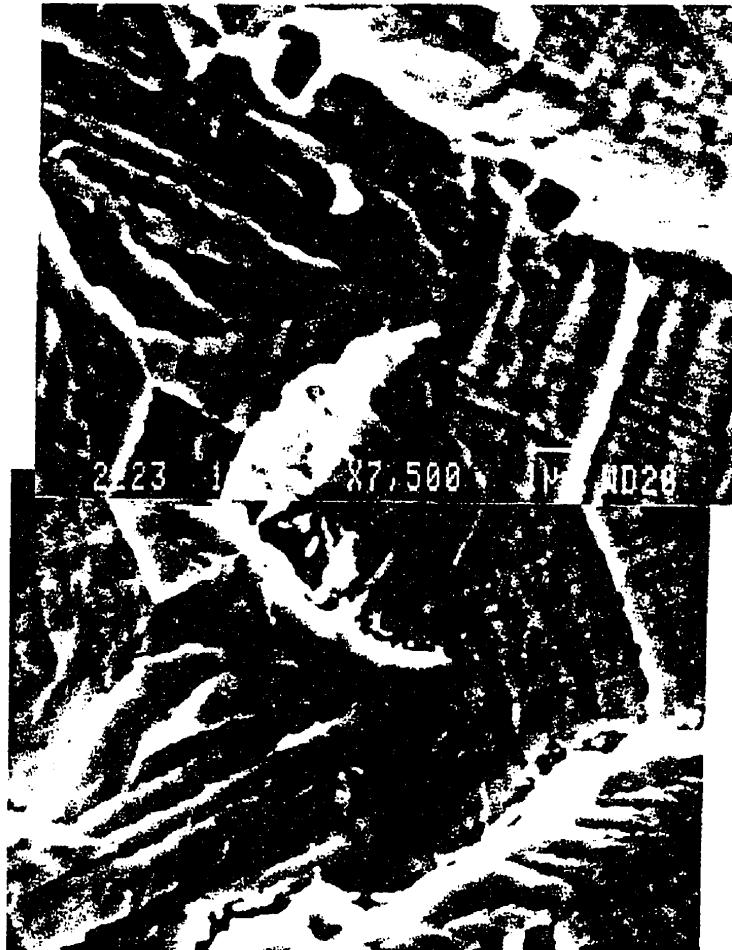
Figure 5.4 Matching fractographs of the PSCC crystallographic fracture in the δ -ferrite.

The $\{100\}$ planes were quite serrated at high magnification (Fig. 5.4). Many striations were perpendicular to the river lines and interlocked on opposite fracture surfaces. Microfacets appeared and were obviously inclined to the $\{100\}$ planes. In the δ -ferrite, the real cleavage facets produced in liquid nitrogen, at the same COD rate as PSCC fracture, presented $\{100\}$ cleavage facets (Fig. 5.5). Some inclined facets can be seen in Fig. 5.5, but they are parallel to river lines and correspond to deformation twins. At high magnification, the cleavage facets are perpendicular to each other and no inclined microfacets are present except for the "tongues" of deformation twins (Fig. 5.5b). The difference between the two cases suggests that the microfacets inclined to the primary $\{100\}$ planes in PSCC (Fig. 5.4) are very probably the $\{110\}$ or $\{112\}$ slip planes which can make acute angles with the $\{100\}$ planes.

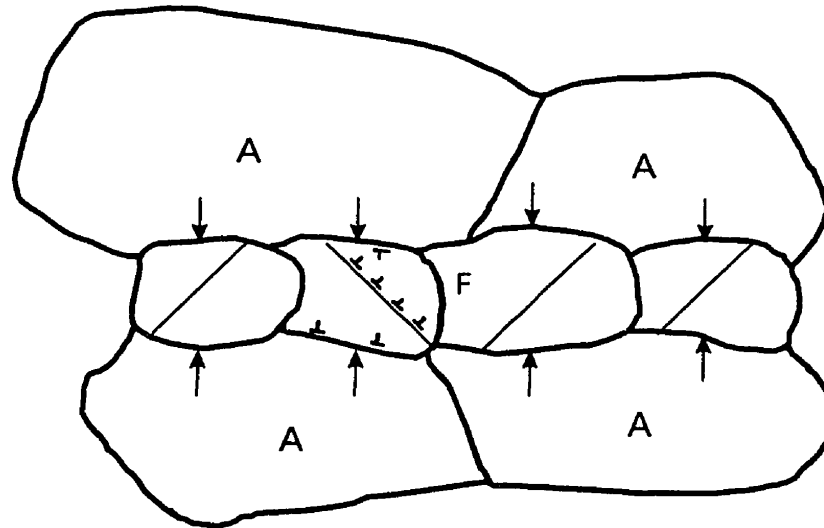
Figure 5.6 Schematic illustration of residual stresses generated by the hydrogen absorption and diffusion in the δ -ferrite and in austenite (a) in SCC and (b) in PSCC.

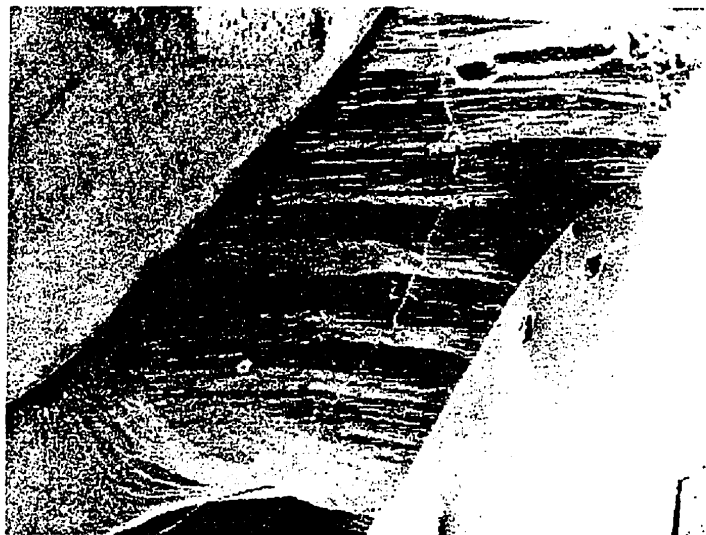
Figure 6.5 A zigzagged grain boundary in the intergranular SCC region of annealed 70Cu-30Zn.

The technique of using periodic overload pulses on an otherwise constant load to delineate the crack front is not new. It was employed to investigate the discontinuity of crack propagation and the cleavage features of transgranular SCC [18,19,21,22]. The general morphology of crack front markings produced by load pulses in the present study agrees with the previous descriptions. However, the detailed fractography of crack front markings in the present study showed that the crack front markings were parallel to the striations on the primary facets. These striations were not always the crack arrest markings, but more precisely, the intersections of $\{111\}$ secondary facets to make up the primary facets in fcc metals. In other words, the transgranular SCC propagation follows slip planes, at least in fcc materials. The crack front markings were also found on grain boundaries. At low magnification, they did not appear crystallographic, but at high magnification, they locally followed the slip traces on the grain boundaries (Fig. 7.10 and Fig. 7.11). This means that such intergranular SCC propagation also has crystallographic features. The other observations supporting this statement are the linear transitions of intergranular to transgranular fracture (Fig. 7.10) and the occurrence of quasi-intergranular fracture (Fig. 6.5).

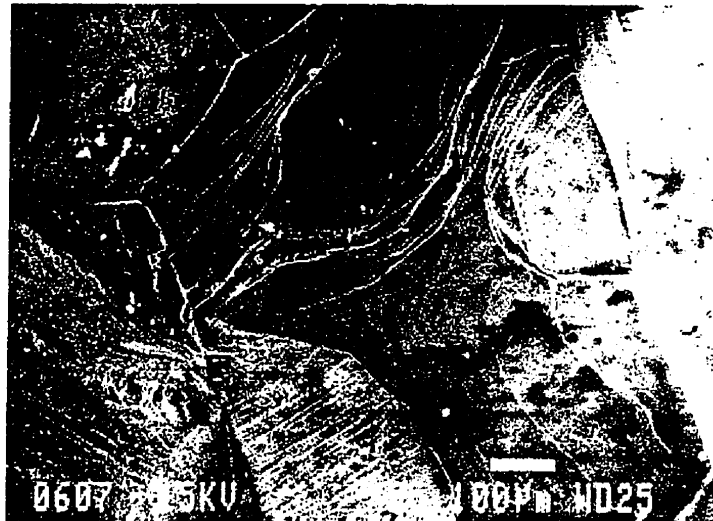
Figure 6.6 Large crystallographic facets observed in SCC of annealed 70Cu-30Zn. These facets are approximately perpendicular to the tensile axis and are linked by steps initiated from grain boundaries. Corrosion pits on the facets indicate the $\{111\}$ orientation of the facets.

Occasionally, large crystallographic planes approximately perpendicular to the tensile axis were found in some isolated grains. These facets were quite large and layered together in one grain. The orientation of the large facets shown in Fig. 6.6 was determined as $\{111\}$ with the help of corrosion pits in this region by stereomicroscopy. There were some transgranular regions attached on those large facets. The steps linking parallel $\{111\}$ planes were perpendicular to $\{111\}$ planes. These steps often initiated from grain boundaries and coarsened towards the center of the grain, resembling those steps in the twin of Fig. 6.4b. Very probably, the facets connected by crystallographic steps in the twin of Fig. 6.4b are also $\{111\}$.

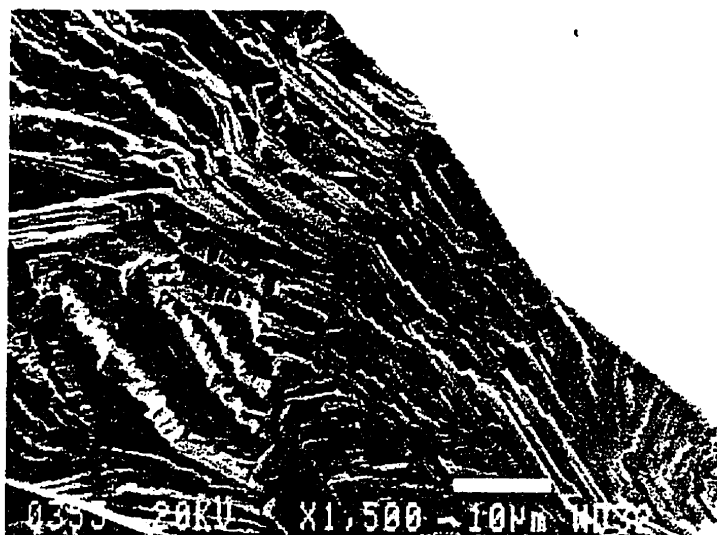
Figure 6.8 Relatively low K features of transgranular SCC fracture in annealed CT specimens.

The transgranular fracture features appeared to be more complicated than those reported [113] at the same K level. Relatively large and flat primary facets with less serrated river lines and fine striations, the character reported at low K region (from 10 to $15 \text{ MPa}\sqrt{\text{m}}$), presented only at K lower than $12 \text{ MPa}\sqrt{\text{m}}$ by a certain amount in the present study (Fig. 6.8). More often, the transgranular cracking showed thick river lines associated

with many serrations as those in the twin of Fig. 6.8. With increasing K , the number of serrations and the size of microfacets increased. Fig. 6.9 is an area found at $K \approx 14 \text{ MPa}\sqrt{\text{m}}$ which shows the complexity of the fracture surface. There are pronounced microfacets in the bottom area of the photo which is approximately perpendicular to the tensile axis. The region with corrosion pits is inclined with the striation density so high that it makes this region, as well as Fig. 6.7, have an appearance quite similar to a fatigue fracture. In the high K region, microfacets increased in size so that river lines disappeared in some areas, and only large microfacets were present (Fig. 6.10). On the two opposite fracture surfaces, complicated sets of microfacets still match and interlock, although the steps formed by microfacets intersecting are not sharp.

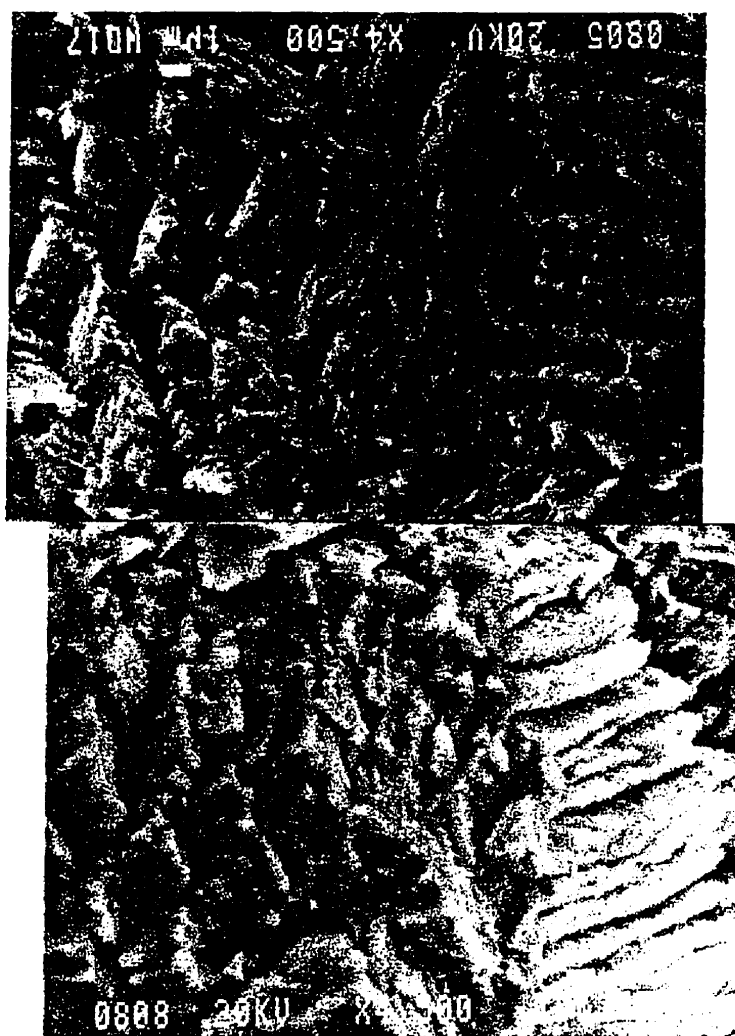
Figure 6.10 Matching fractographs shows complicated transgranular features at high K in an annealed CT specimen. Microfacets match and interlock on opposite fracture surfaces.

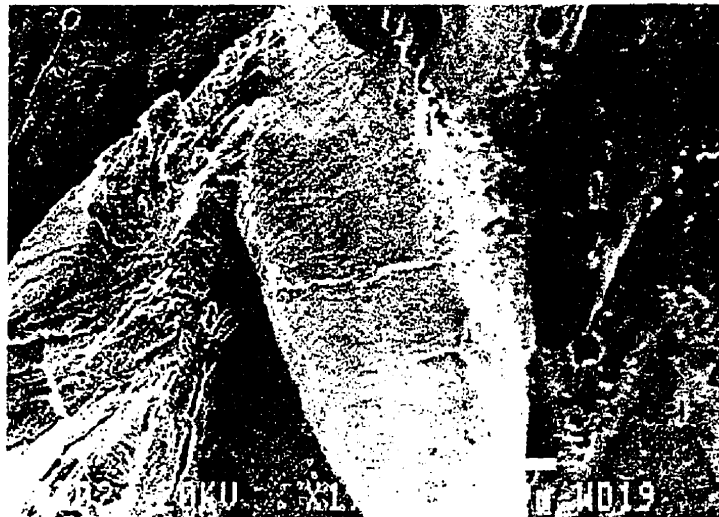
Figure 6.18 Slip steps on the grain boundary of cold worked CT specimen.

Because of its moderate prestrain, most of the intergranular fracture appeared on the cracking plane. It contained approximately 30% to 40% area of the cracking plane. The grain boundaries were essentially smooth. Some protrusions and slip steps were observed on grain boundaries. Compared to the highly prestrained TN-DCB specimens (Fig. 6.11), the slip steps tend to be fewer in number (Fig. 6.18) and smaller in height. The intergranular features did not appear to change with K .

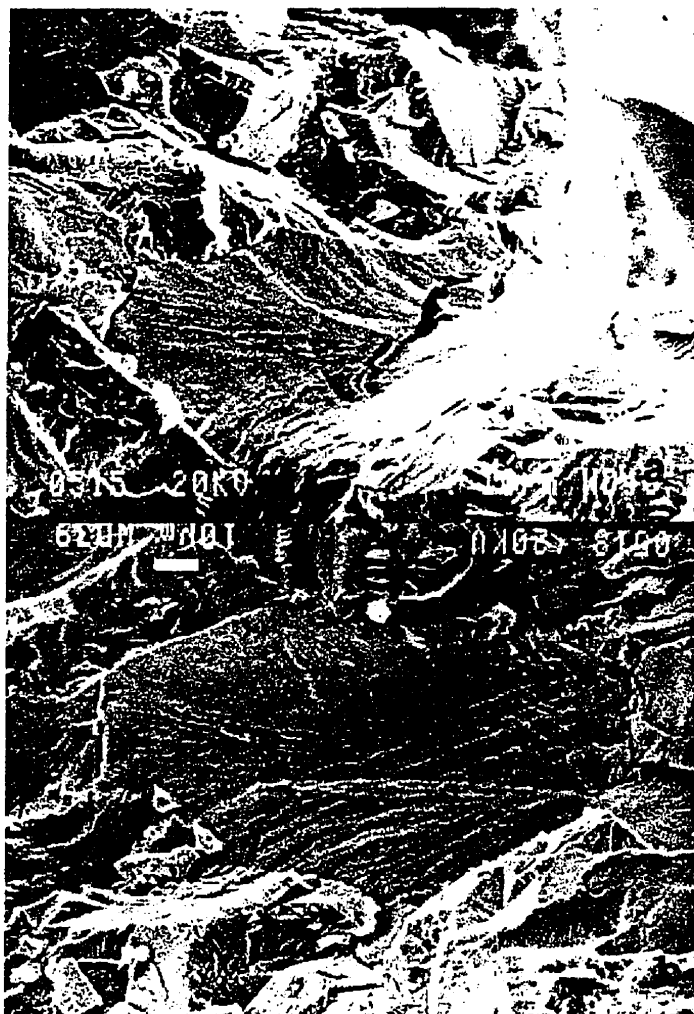
Figure 7.3 Matching fractographs show crack front markings in 310. The inclination is interlocked on opposite fracture surfaces but slightly in (b).

The magnitude of the load pulses influenced their appearance. Small load pulses did not produce blunting at the crack tip. However, it was observed that the appearance of crack front markings was also more likely determined by the local mechanics. As shown in Fig. 7.3a, the first load pulse introduced a secondary crack and made the cracking facet inclined. Later similar load pulses disturbed the propagation less. The crack kept going in the same direction after smaller crack tip blunting. This suggests that some load pulses might not make any markings on the fracture surface. Another reason for missing pulse traces was that load pulses often resulted in secondary cracks. Later propagation might go

Matching fracture surfaces were investigated in the regions of pulse traces, but the matching pulse traces were not always found. Often the matching pulse traces showed a small blunting corresponding to a step (Fig. 7.4). Pulse traces corresponding secondary cracks occurred at high K . Other features of matching pulse traces included interlocked inclined facets with fine traces as shown in Fig. 7.3 and interlocking fine steps which indicate only slight blunting produced by load pulses.

The matching crack fronts on opposite fracture surfaces also showed crystallographic aspects. The interlocked facets with fine markings shown in Fig. 7.3 and interlocked fine steps indicate that load pulses produce very limited yielding at the crack tip. The interlocked steps were very small and their inclination could not be examined. They may be larger $\{111\}$ microfacets induced by load pulses, because they were parallel

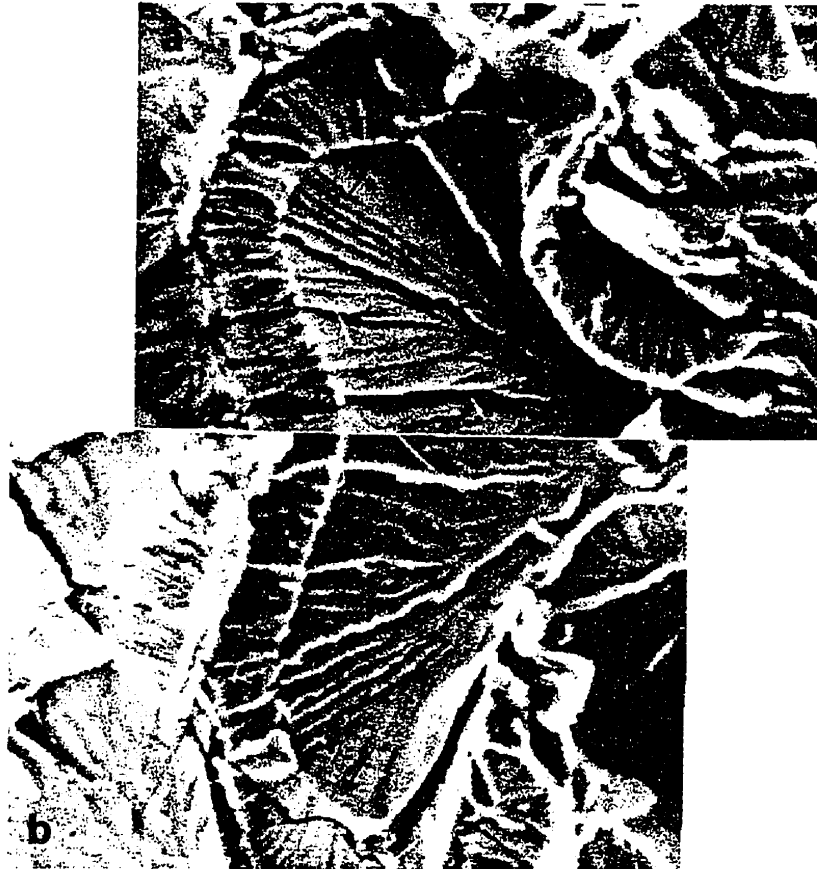
Figure 7.4 A matching pulse trace in 310 stainless steel on a $\{100\}$ primary facet. Arrows indicate the local corresponding step and blunting produced by the load pulse. The straight crack fronts are perpendicular to $\langle 110 \rangle$. The step in (b) indicated by an arrow is identified as $\{110\}$ since it is perpendicular to $\{100\}$ and to $\langle 110 \rangle$.

to striations. In the easy propagation direction $\langle 110 \rangle$, load pulse deviated the $\{100\}$ plane from its original orientation to form a $\{110\}$ step on one side (Fig. 7.4). The following propagation occurred on an inclined $\{100\}$ plane on the other side after a very small blunting. When the steps became larger, it made up of several tiny steps (Fig. 7.6). The observed blunting at the pulse traces actually corresponded to several tiny steps at the corner (Fig. 7.7).

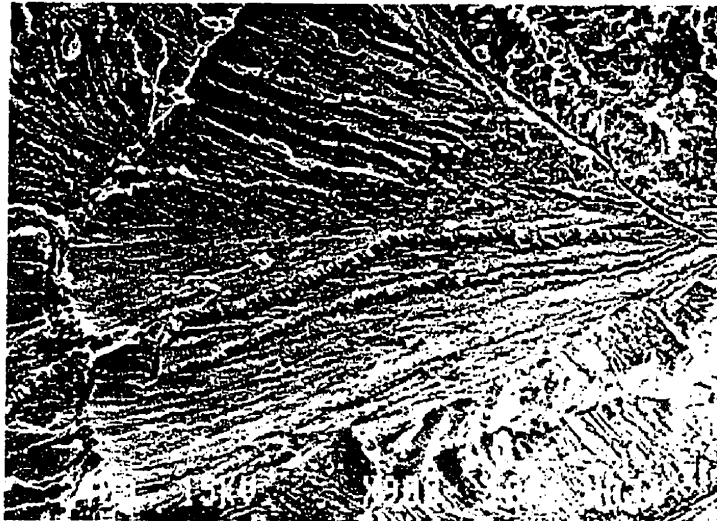
Figure 7.5 A crack front marking composed of two straight segments in 70Cu-30Zn.

The crack front defined by the load pulse traces is crystallographic. In 70Cu-30Zn, the large grain size allowed the crack front to be straight and parallel to striations along a certain distance (Fig. 7.5). Straight crack fronts were also found in 310 stainless steel when the crack propagated along $\{100\}\langle 110\rangle$ (Fig. 7.4). The crack front was then parallel to striations and curved to link straight segments, where the two cracking planes were joined by forming larger rivers. This indicates that the crack propagation follows $\{111\}$ planes because the striations during SCC of fcc materials are the intersection of two $\{111\}$ planes [2].

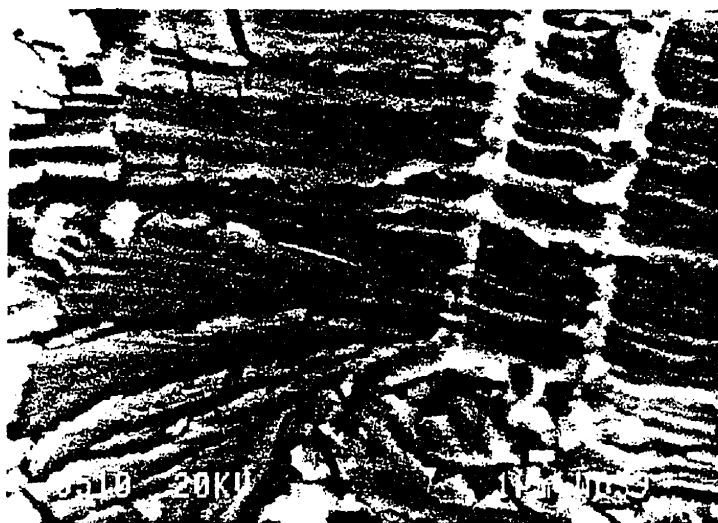
Figure 7.7 Two crack front markings produced by load pulses in 310 stainless steel. The blunting appears to be made up of tiny steps.

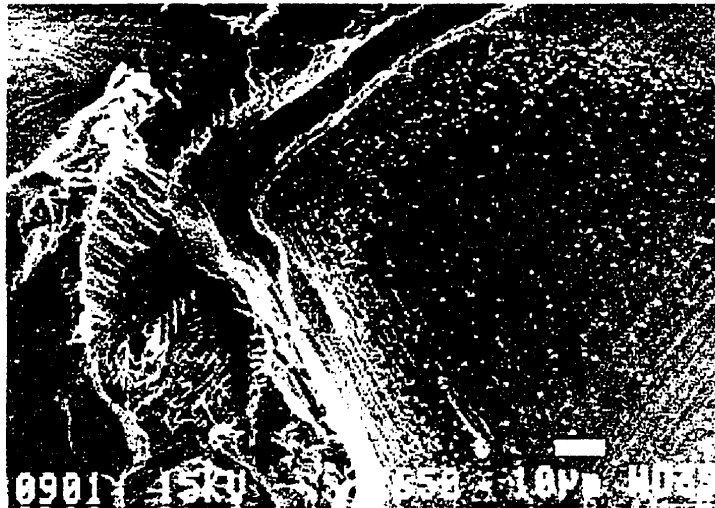
Figure 7.10 Crack front markings on a grain boundary of 70Cu-30Zn.

Very similar to the transgranular fracture, the crack fronts in intergranular regions curve when the local propagation direction changes (Fig. 7.10). The crack front seen in Fig. 7.11 is a step pulled out of the grain boundary and follows two sets of slip planes. Some fine and detached steps appear between two markings. Figure 7.12 shows that the intergranular crack front follows facets in twin and slip steps induced by load pulses on nearby smooth grain boundary. The matching markings on one side of grain boundary are steps, on the opposite grain boundary they are often secondary cracks.

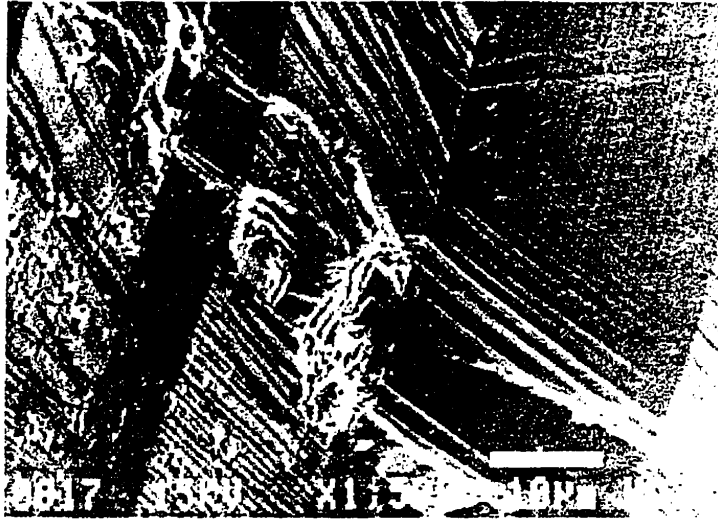
Figure 7.12 Two intergranular crack front markings are parallel to crystallographic orientations in twins and slip steps on the grain boundary.

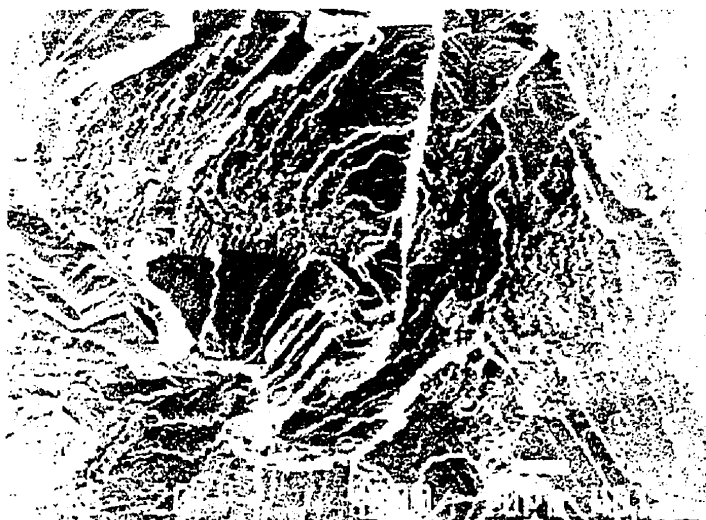
Figure 7.16 High K features ahead of a crack front marking in 70Cu-30Zn.

Transgranular SCC propagation after the load pulses tended to present complex features. The higher load resulted in larger microfacets produced ahead of crack front markings. As shown in Fig. 7.15, two $\{111\}$ planes which compose the $\{100\}$ primary facet become approximately 2 μm in width and another set of $\{111\}$ facets appears ahead of the crack front markings. A little further the crack front marking, four sets of $\{111\}$ planes are all operating. The high K features were more evident in 70Cu-30Zn where the primary facets were usually larger than in 310 stainless steel. The complexity appears for about 30 μm ahead of the crack front markings in Fig. 7.16, then the propagation returns

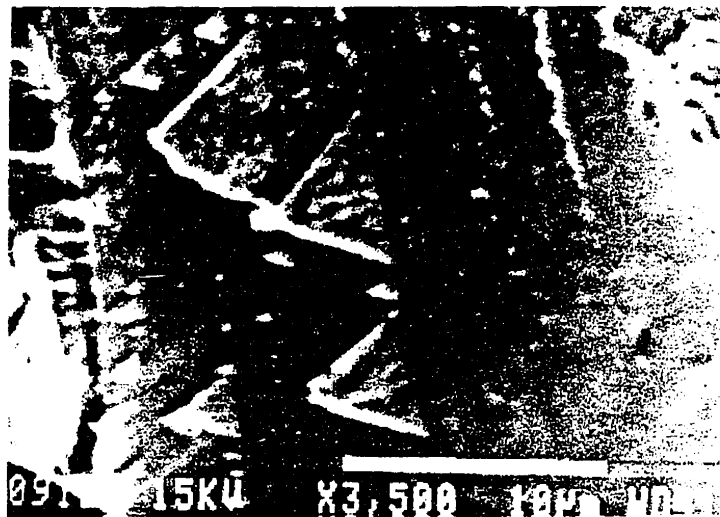
Figure 7.18 Tongue-like facets appear near a crack front marking in 70Cu-30Zn. The shape of these facets indicates that they lie on $\{111\}$ slip plane and grow perpendicular to $\langle 110 \rangle$.

The cracking patterns at times changed from intergranular fracture to either quasi-intergranular or transgranular fracture in the load pulse regions. It may then return to intergranular fracture as the crack propagated. Sometimes in the load pulse region, a thin layer of material was pulled out (Fig. 7.17) or lost, permitting the transgranular fracture to be observed in the vicinity of the grain boundaries. The quasi-intergranular fracture appeared as small protrusions or tongue-like facets near the pulse traces on the grain boundaries, such observations also indicate near boundary transgranular fracture (Fig. 7.18).
