Article

The Effect of Water Concentration in Ethyl Alcohol on the Environmentally Assisted Embrittlement of Austempered Ductile Irons

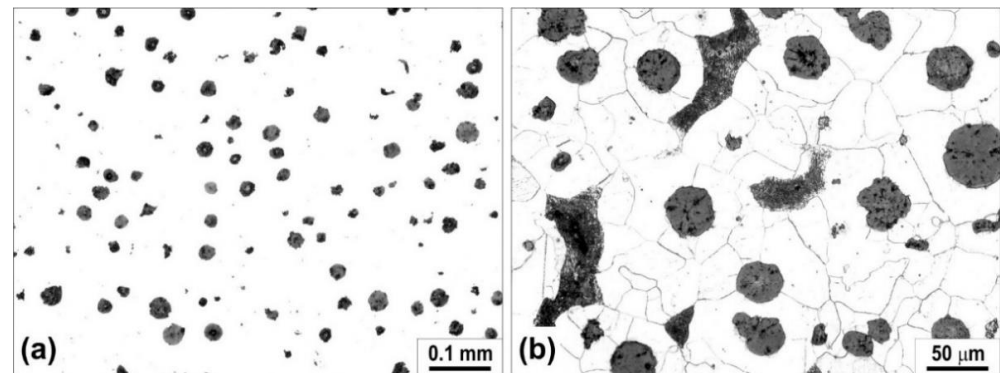
Microstructures before and after etching are shown in Figure 1. The graphite spheroidization (roundness) was more than 90%, the average graphite volume fraction was $12 \pm 1.6\%$, nodule count distribution was from 125 to 175 mm^{-2} , and nodule size was from 15 to

30 μm , which is shown in Figure 1a. Etched microstructure uncovered predominantly ferritic metal matrix with 10% of pearlite, as depicted in Figure 1b.

Figure 1. Microstructure of as-cast ductile iron: (a) Polished; (b) etched.

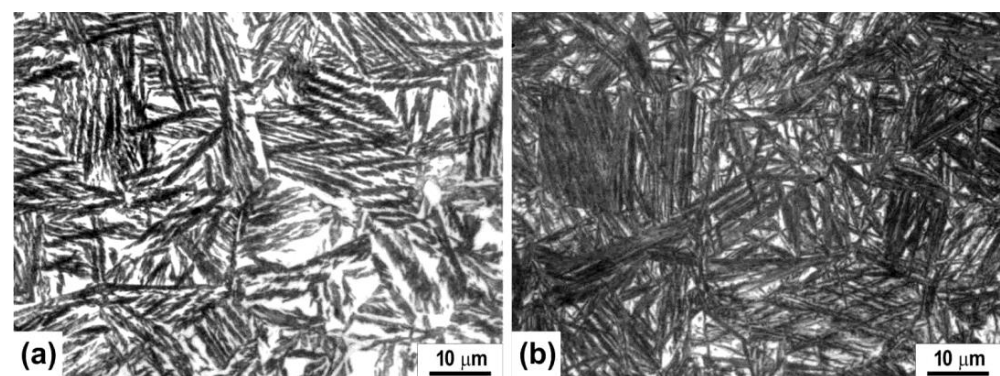
Time of austempering was selected on the basis of optimizing the maximum retained austenite volume fraction. On the other hand, different austempering temperatures affect the microstructure morphology. The resulting microstructures of ADI 904 and ADI 903 are shown in Figure 2. In both samples, the microstructure is fully ausferritic, consisting of a mixture of ausferritic ferrite and carbon enriched retained austenite, but with different morphology. In ADI 904, a plate-like morphology with $29.6 \pm 2.1\%$ volume fraction of the retained austenite (Figure 2a) was obtained, unlike ADI 903 where needle-like morphology with $14.4 \pm 1.8\%$ volume fraction of the retained austenite (Figure 2b).

Figure 2. Microstructure of austempered ductile iron (ADI) materials: (a) ADI 904; (b) ADI 903.

The fracture surface does not have typical brittle (cleavage) morphology, but it consisted of randomly oriented striation lines. This could be related to the random orientation of ausferritic ferrite and retained austenite plates seen in the microstructure (Figure 2). The

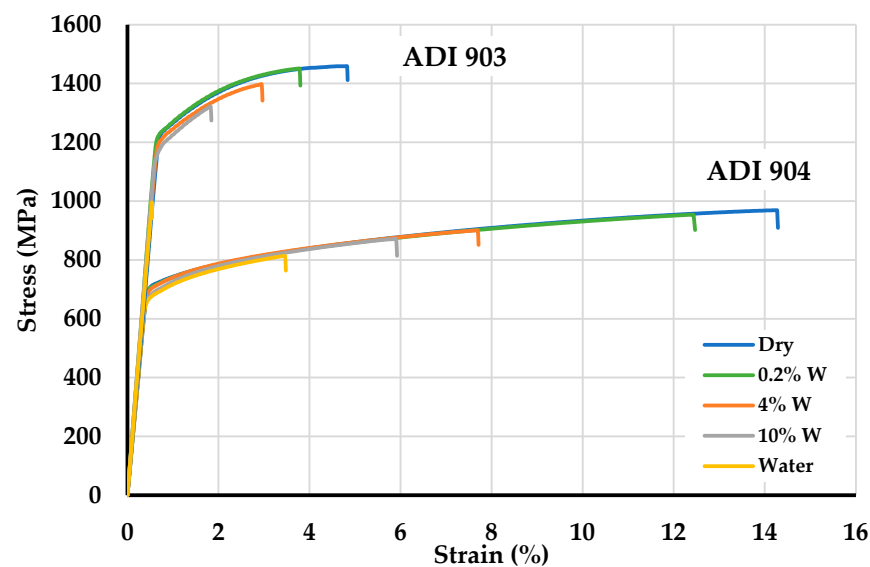
Figure 4. Representative stress-strain curves of ADI 904 and ADI 903 in various environments.

The representative stress-strain curves for each testing conditions are given in Figure 4. All specimens exhibited identical trend, that is the water environment curves coincide with that of the dry condition up to the point of premature final rupture. The ADI 903 has higher strength with lower elongation due to austempering on higher temperature of 400 °C and its finer ausferritic microstructure, which is maintained in all tested conditions. The rupture occurs in plastic deformation region of all specimens, except in the case of ADI 903 tested in water which fractures in elastic region.

The results of tensile properties of ADI 904 and ADI 903 in dry and different water environments are given in Figures 4–7 and Tables 3–5. In addition to the mean values of tensile properties, Tables 3–5 show the standard deviation and the P parameter.

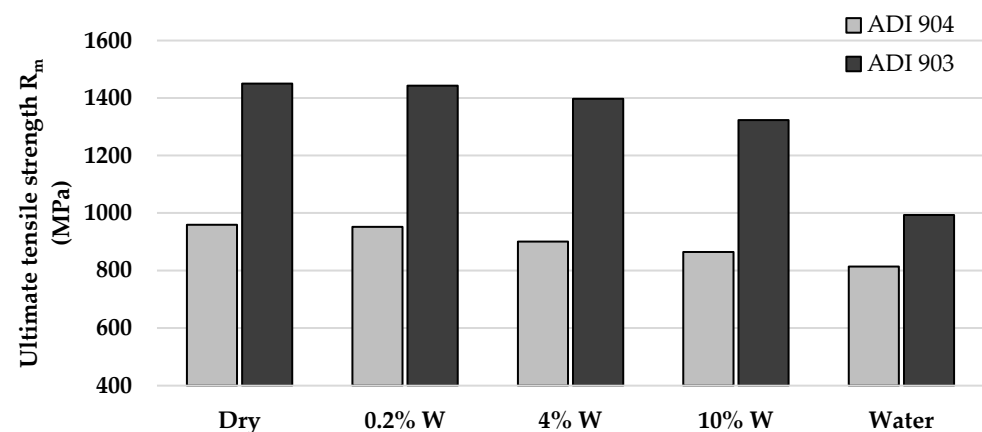
Figure 5. Ultimate tensile strength of ADI material in dry and in environments containing different water concentrations.

A column chart presenting ultimate tensile strength (UTS) in various exposure conditions is shown in Figure 5. It is clear that the results show there is clear tendency of UTS to decrease as the water content is increased in relation to the sample tested in dry condition. Furthermore, 0.2% of water content in the environment also does not cause a statistically significant decrease for both tested materials (Table 3). The maximum reduction in the UTS was obtained for ADI 903 in water (46%), while the reduction for ADI 904 was 17.8%, both in relation to the UTS obtained in dry condition.

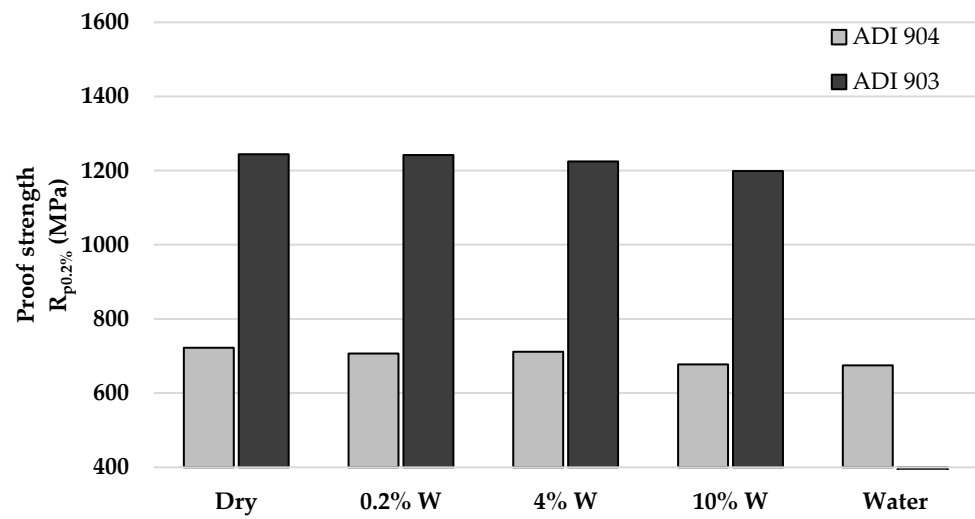
Figure 6. Proof strength of ADI material in dry and in environments containing different water concentrations.

The results of proof strength (PS) are shown in Figure 6 and Table 4. The results show a slight tendency to decrease in relation to the sample tested on dry, except for sample ADI 903 tested in water where fracture occurs suddenly at the UTS, and no PS could be determined. Standard deviations and *P* values are shown in Table 4. Statistically significant difference in relation to testing of ADI 904 in dry condition was obtained in specimens tested in environments containing 10% and 100% water, while for ADI 903, a statistically significant difference was only related to specimens tested in water environment.

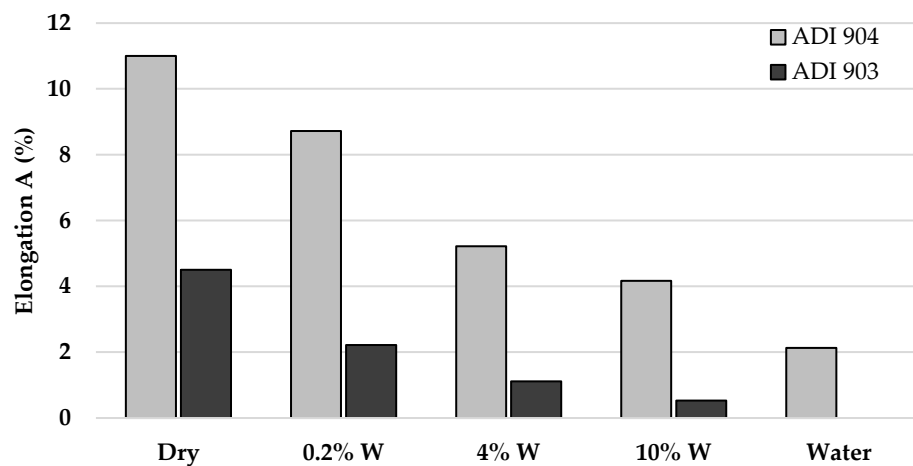
Figure 7. Elongation of ADI material in dry and different water concentrations environments.

The results of elongation (A) are shown in Figure 7. The column chart clearly indicates the tendency towards the decrease in elongation as the water content is higher in the tensile

testing environment, compared to the sample tested dry. The value for ADI 903W was not determined as the fracture was without measurable plastic deformation. Standard deviations and *P* values are shown in Table 5. All specimens (ADI 904 and ADI 903) tested in water environments exhibited statistically significant differences between obtained elongations, versus the elongation obtained in dry condition, the only exception being ADI 904 tested in 0.2 vol.% water environment.

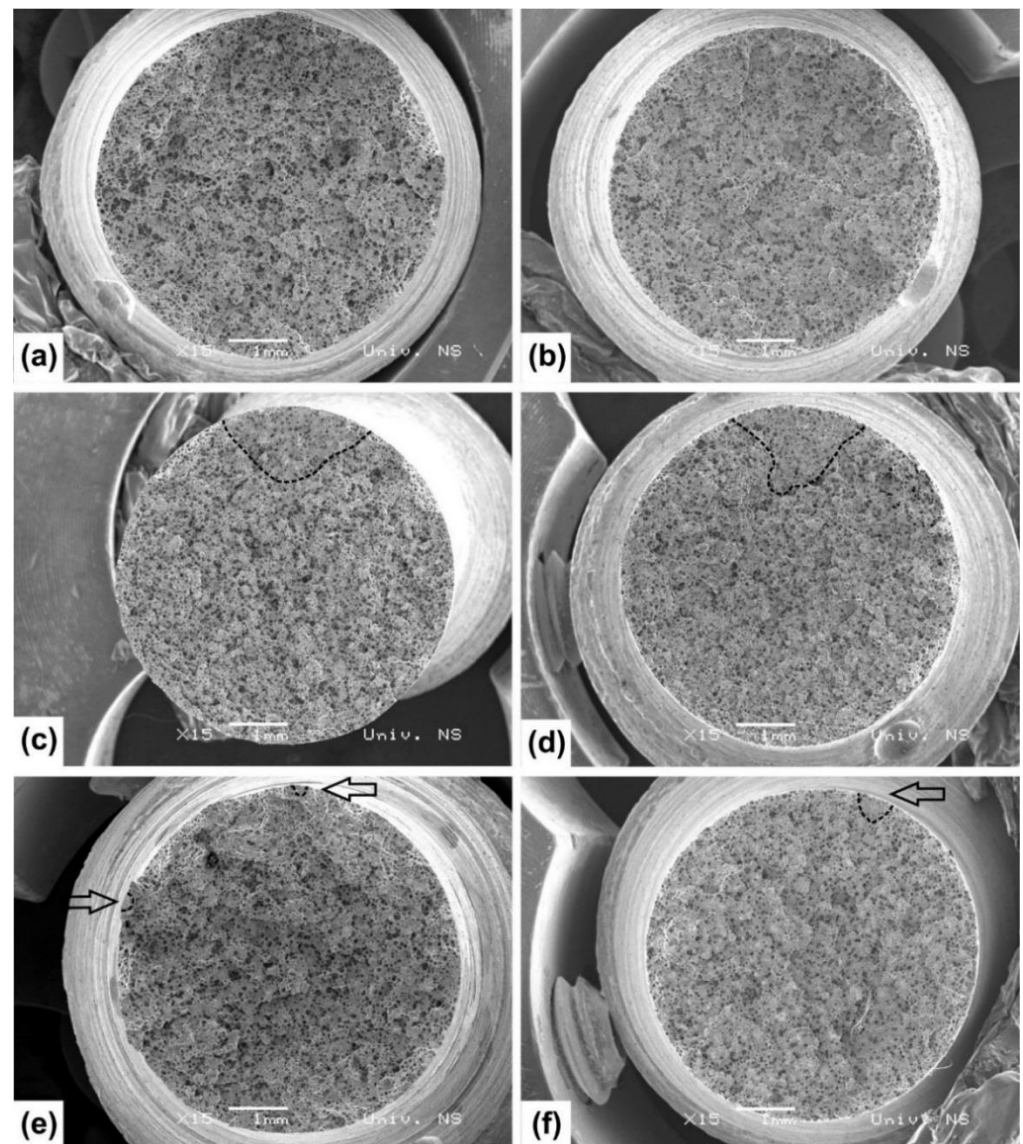
The macro appearance of the fracture surfaces of tensile specimens tested in dry condition, water (as the most extreme condition for the embrittlement as shown by tensile testing results), and 0.2 vol.% water concentration in ethyl alcohol (as lowest water concentration and thus the mildest condition for embrittlement), are represented in Figure 8.

Figure 8. Macro appearance of fracture surface: (a) ADI 903 in dry condition; (b) ADI 904 in dry condition; (c) ADI 903 in water; (d) ADI 904 in water; (e) ADI 903 in 0.2 vol.% water; (f) ADI 904 in 0.2 vol.% water (the embrittlement zone is enclosed by dashed line and indicated by arrow).

Both ADI materials (Figure 8a,b) exhibit the whole fracture surface comprised of uniformly distributed dimples and graphite nodules in dry condition. On the other hand, the fracture surfaces of samples tested in different water concentrations, expose two separate

fracture zones: A fracture zone that is flat and bright near the specimen surface, and a larger dimpled zone in the rest of the fracture surface. These two zones are easily observed for the testing in pure water (enclosed by dashed line in Figure 8c,d). Furthermore, the water embrittled zone area is decreasing with the reduction of water concentration in the environment. The two distinctive fracture zones are also present in specimens tested in 0.2 vol.% water concentration (enclosed by dashed line and pointed by an arrow in Figure 8e,f). These fracture features are difficult to be observed visually. While embrittlement of the ADI 904 in 0.2 vol.% water could be visually observed as a small bright zone, the embrittlement zones of the ADI 903 was determined only after the high magnification examination by SEM.

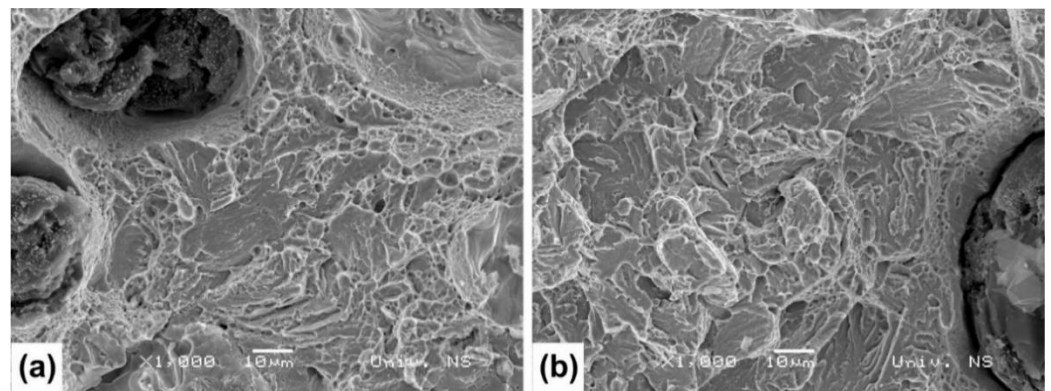
The fracture mode of dry samples is shown in Figure 9, while the characteristic fracture surfaces outside the embrittlement zone when tested in water are illustrated in Figure 10. As it can be observed, there is no significant difference between the fracture mode of samples tested in dry condition, and the fracture mode outside the embrittlement zone. In all aforementioned cases, the fracture mode has an appearance of a mix mode fracture: Ductile dimpled fracture and dispersed cleavage facets associated with brittle fracture. This mixed mechanism of fracture is referred as quasi-cleavage [30].

Figure 9. Fracture mode of the ADI materials tested in dry condition: (a) ADI 903; (b) ADI 904.

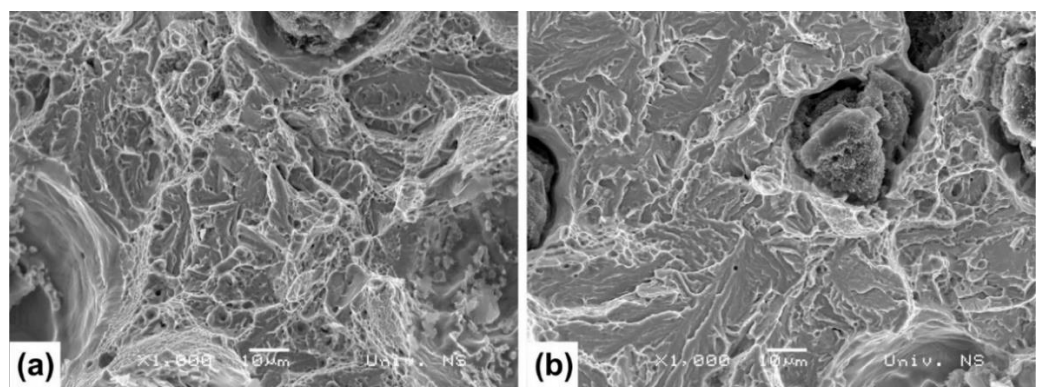
Figure 10. Fracture mode outside the embrittlement zone of the ADI materials tested in water: (a) ADI 903; (b) ADI 904.

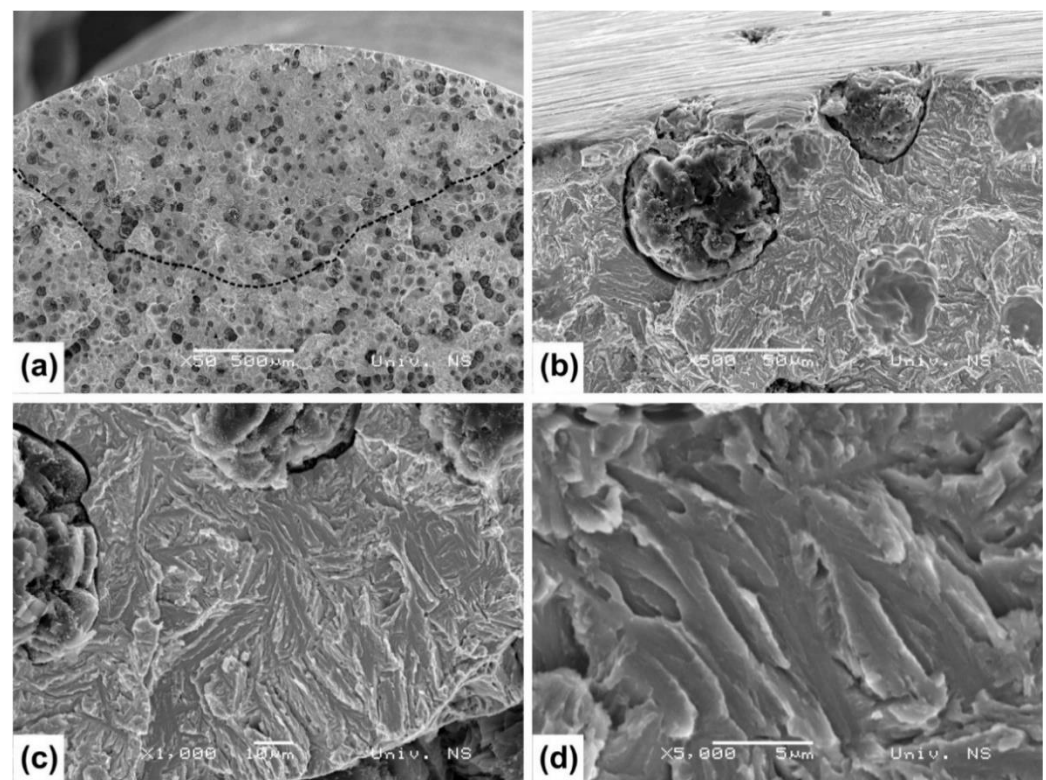
The ADI 903 tested in water the embrittlement zone has a semicircular appearance with radius of around 1.5 mm (Figure 11a). The zone starts from the free surface of sample. However, the point of origin could not be distinguished between machined surface and nodule pits. Furthermore, a small separation between graphite nodules and nodule pit walls could be observed, suggesting that water penetrates easily under the machined surface to the nodule pits during tension testing (Figure 11b). The striation lines are very fine with multiple serrated faces, steps, and tear ridges (Figure 11c,d).

Figure 11. Fracture mode of the embrittlement zone of the ADI 903 tested in water: (a) the embrittlement zone enclosed by dashed line; (b–d) striation lines in the embrittlement zone.

The detailed examination of the embrittlement zone is presented in Figures 11–16, for ADI 903 and ADI 904 tested in water and 0.2 vol.% water concentration in ethyl alcohol. It can be seen that the embrittlement zone, which appears flat and bright visually, exhibits transgranular brittle fracture.

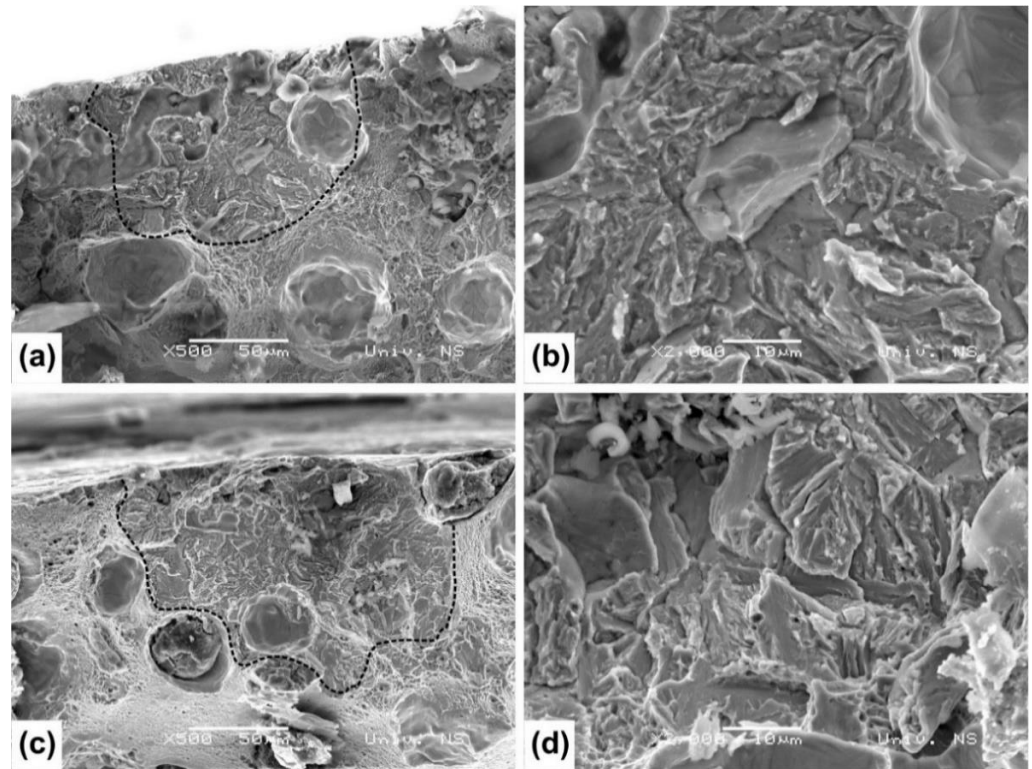
The embrittlement zone of the ADI 903 tested 0.2 vol.% water could not be observed visually, however through a thorough inspection by SEM, two small embrittlement zones could be identified (Figure 12). The zones have an irregular semicircle appearance with a radius of around 0.1 mm. Inside the embrittlement zone, like in previous cases, a striation appearance of fracture surface is present (Figure 12b,d). However, the embrittlement zone is enclosed with material exhibiting mixed mode fracture. The ADI 904 tested in water (Figure 13) exhibits similar fracture appearance as ADI 903. The fracture surface consisted of the embrittlement zone and the quasi-cleavage zone. The approximate depth of the embrittlement zone is about 1.5 mm (Figure 13a). The striation lines in the embrittlement zone are coarser with wider serrated facets (Figure 13b–d) compared to the ADI 903 (Figure 11d). Furthermore, the careful examination of the embrittlement zone revealed a presence of small, isolated brittle facets near sample free surface, indicated by arrows in Figure 14a. The small brittle areas have a fan-shaped form and exhibit a typical brittle fracture appearance with bright crystalline cleavage facets and river pattern strips (Figure 14b).

Figure 12. Fracture mode of the embrittlement zone of the ADI 903 tested in 0.2 vol.% water: (a,c) the embrittled zones enclosed by dashed line; (b,d) higher magnification of the corresponding embrittled zones, respectively.

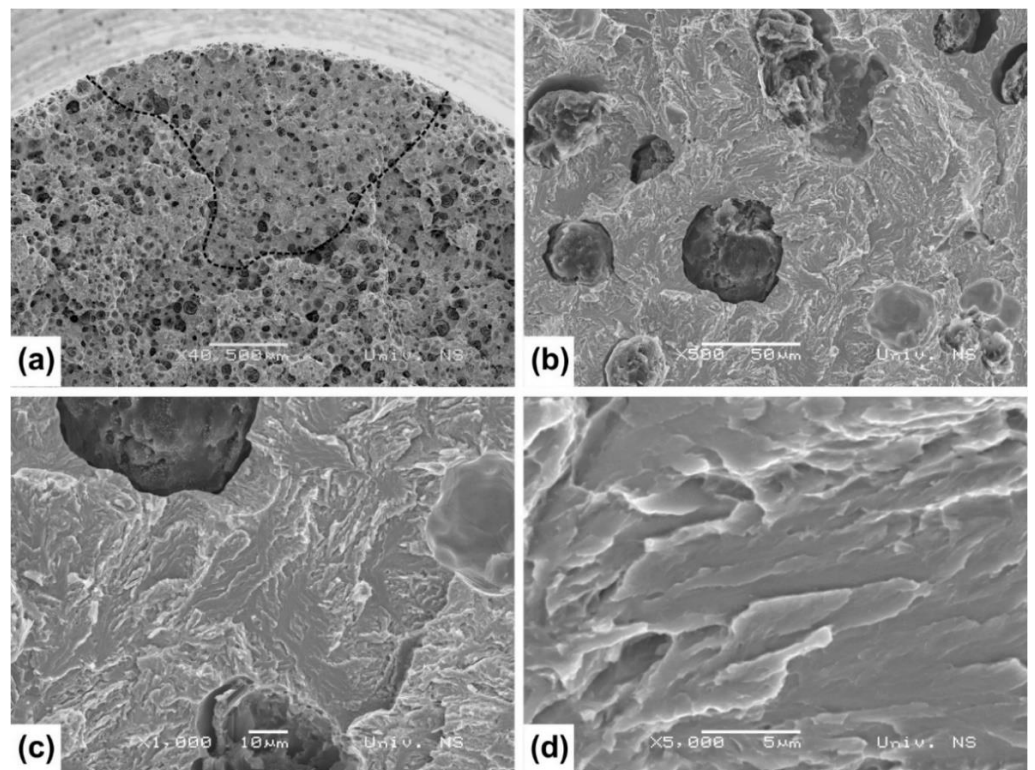
Figure 13. Fracture mode of the embrittlement zone of the ADI 904 tested in water: (a) the embrittled zone enclosed by dashed line; (b–d) striation lines in the embrittled zone.

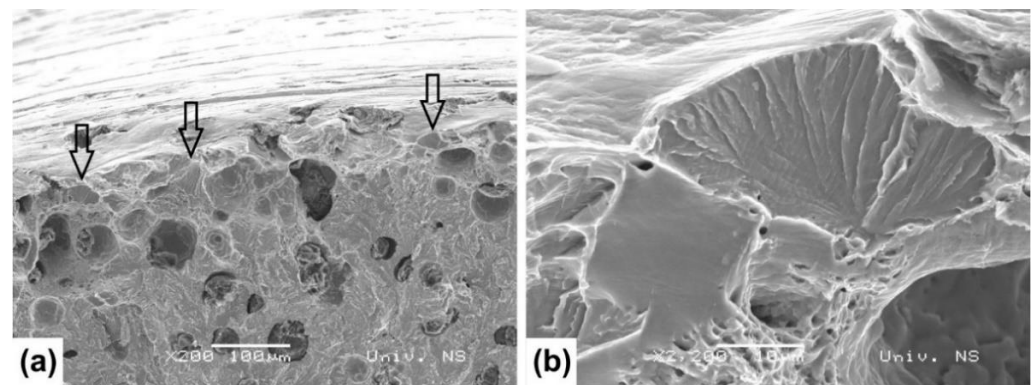
Figure 14. Surface detail of embrittlement zone of the ADI 904 tested in water: (a) fan-shaped, brittle facets indicated by arrows; (b) higher magnification of the fan-shaped brittle facet.

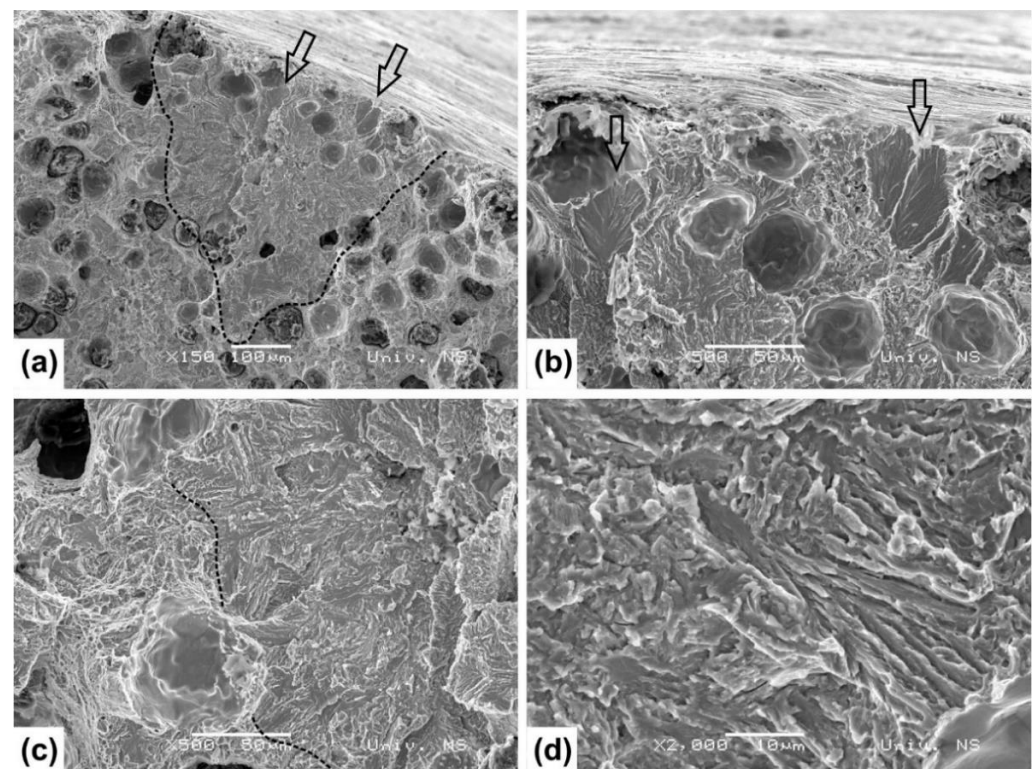
The embrittlement zone of the ADI 904 tested in 0.2 vol.% water is considerably smaller compared to testing in water and has a more wedge shape appearance (Figure 15a), compared to more semi-circle appearances in previous specimens. The depth of this zone is around 0.5 mm, with similar width at the free surface of the specimen. Furthermore, the presence of small brittle facets near sample free surface is observed, as well, indicated by arrows in Figure 15a,b. In Figure 15c, a transition line between the embrittlement and non-embrittlement zone is presented. The transition from striations lines fracture to the quasi-cleavage with pronounced dimpled (ductile) component can be seen.

Figure 15. Fracture mode of embrittlement zone of the ADI 904 tested in 0.2 vol.% water: (a) the embrittlement zone enclosed by dashed line; (b) fan-shaped, brittle facets indicated by arrow; (c) transition from striations lines to the quasi-cleavage fracture; (d) striation lines.

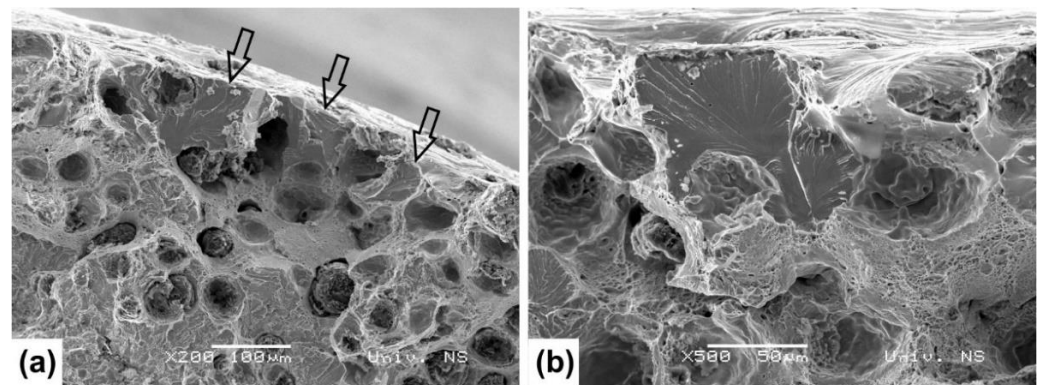
Besides fan-shaped small brittle facets in the embrittlement zone, the isolated brittle facets are also observed in the other parts of specimen, indicated by arrows in Figure 16a. The isolated brittle facets also have a fan-shape form with crystalline cleavage facets and

river pattern strips. They are located at the free surface of sample; enclosed in the region of mixed ductile (dimpled) and quasi-cleavage fracture mode, Figure 16b.

Figure 16. Surface detail outside of the embrittlement zone of the ADI 904 tested in 0.2 vol.% water: (a) fan-shaped, brittle facets indicated by arrows; (b) a fan-shaped brittle facet.
