BEHAVIOR DURING CONSTRUCTION OF RAMP B BRIDGE OVER I-40 IN NASHVILLE, TN

A Thesis Presented to The Academic Faculty

In Partial Fulfillment of the Requirements for the Degree Masters of Science in Civil Engineering

Georgia Institute of Technology May 2012

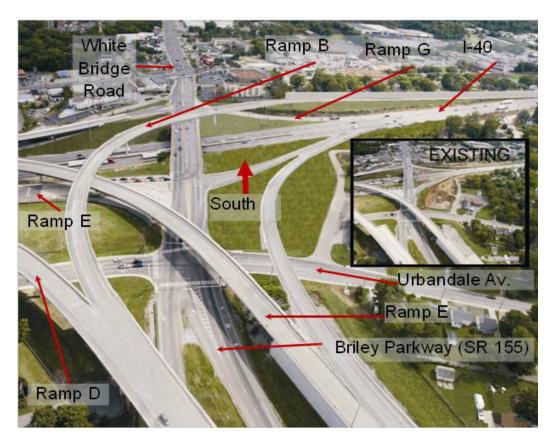
Ramp B is an eight-span, curved steel girder composite bridge with a total length of 462.3m (1516'-9"). As shown in Figure 2, Ramp B is the exit from eastbound I-40 to

Figure 2: Computer Generated View of Project

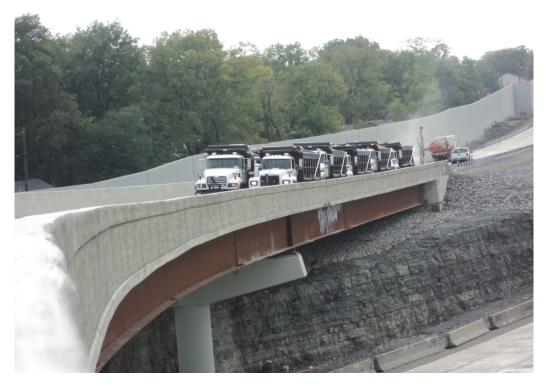
northbound Briley Parkway. Ramp B first goes over exit Ramp G and White Bridge Road, then turns sharply over I-40 and Ramp E (Figure 3), before joining Ramp D at its northern end.

Figure 3: View (Looking West) of Ramp B during Load Testing

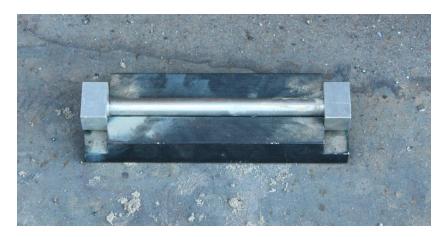
Figure 19: Jig used to ensure proper alignment of nuts for strain gage

The location of each strain gage was measured with a ruler and triangle and marked with chalk. The nuts were welded to the girder first, and then the strain gage was inserted and secured in place. A jig, shown in Figure 19, was used to ensure that the nuts were welded onto the girder at the proper spacing and alignment.

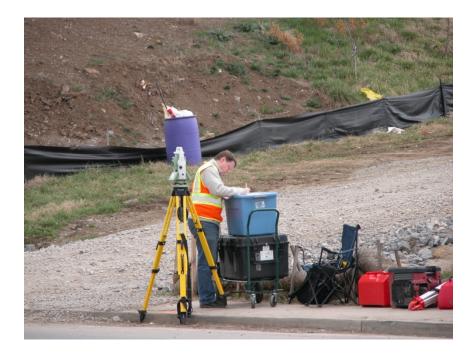
The *Leica TCRP 1201*+ is a quick, easy to use total station with a range of over 1000 meters. The total station can be set up and operated by one person, and requires less than five seconds to collect a measurement. The total station was used in conjunction with reflective targets placed at key points on the bridge girders. Figure 21 shows the total station and some of its support equipment, including a reference target, power supplies, and carrying cases.

Figure 21: Leica total station and support equipment 2.4 Field Instrumentation of Girders

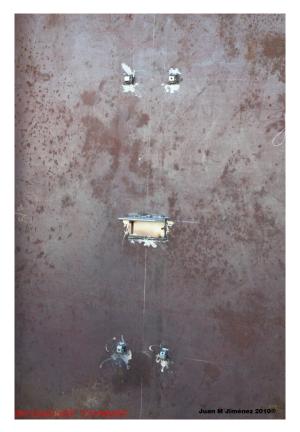
Support brackets for the clinometers were similarly located and welded onto the girders. Figure 22 shows a girder after welding of the nuts and bracket is complete but before installation of the sensors. As shown in the figure, strain gages are installed toward the top and bottom of the web and the clinometer is located at the center of the web. Figure 23 shows a girder with the instruments installed. Cables were secured to the girder to prevent them from catching on anything during construction and to minimize visibility of the instrumentation from the ground. This was initially done using duct tape, but after the erection of the first span, a switch was made to adhesive backed plastic clips and zip ties.

Figure 22: Nuts for two strain gages and support bracket for clinometer have been welded to the girder and are ready for installation of the instrumentation

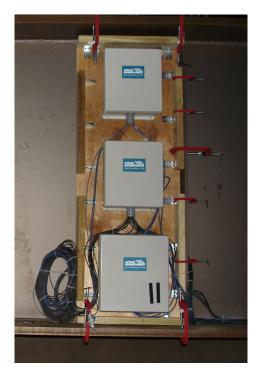
The data acquisition boxes were first mounted to a wooden frame, which was then attached to the girder. Typically each wooden frame held three boxes, one housing the datalogger and two housing the multiplexers for a set of clinometers and vibrating wire strain gages, respectively. A schematic of the boxes and their interconnections is shown in Appendix A, and a photo of an installed set of boxes is shown in Figure 24. On girders holding one of these sets of boxes, the gages could be connected and readings taken immediately upon installation, allowing for data collection during the erection of the girder. For all other girders, the connection back to the data acquisition boxes had to be made after erection with the use of a scissors lift or aerial platform. Once this connection was made, the data was collected via wireless transmission from the boxes. Figure 25 is a view inside of one of the data acquisition boxes, showing the CR1000, a power supply, and a radio transmitter. Figure 26 shows the downloading of data from one of the boxes to a notebook personal computer.

Figure 24: Data Acquisition Boxes

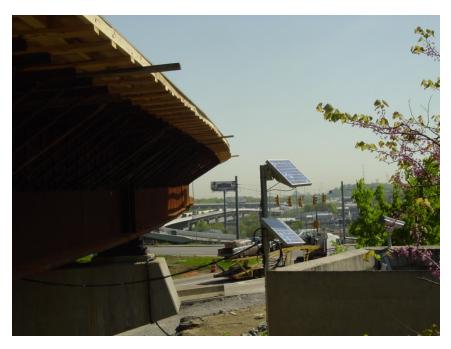
Electrical power for the data acquisition boxes was provided from batteries recharged from four solar panels positioned at the site. Figure 27 shows a solar panel mounted at Bent No. 2. The total station also utilized rechargeable batteries which could either be charged from a standard wall socket or from a small diesel generator.

Figure 27: Installation of solar panels at Bent No. 2

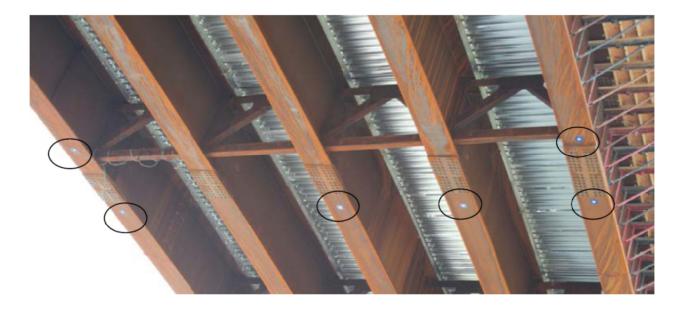
Reflective targets were attached to the girders in spans 7 and 8 in order to take measurements with the total station, as shown in Figure 28. These were placed while the girders were on still on the truck when possible, and after girder erection otherwise. The targets were magnetic, so no adhesive was needed to attach them, but a silicone sealant was applied around the edges of each target to help prevent weather damage. Figure 29 shows the layout of the targets. Figure 30 shows an operator taking an initial reading of a reference target before taking measurements of the bridge.

Figure 28: Underside of bridge showing reflective targets attached to bottom flanges

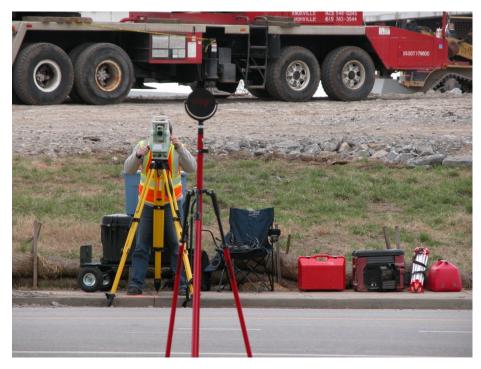
Figure 30: Initial reading of reference target taken to orient the total station

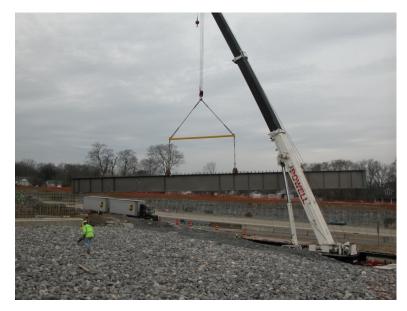
- The erection of the girders began on January 16, 2010 with span 1, starting with the outermost girder, girder 105A1.
- Girder 105A1 was lifted by the 175-ton crane, as shown in Figure 32, and placed on the abutment at the start of the bridge. After this, it was held in place by the 175-ton crane and the 40-ton crane (see Figure 33).
- At this stage it was realized that the 40-ton crane did not have sufficient capacity to boom out to the required positions, and was replaced by a larger truck crane.

Figure 32: Lifting of Girder 105A1

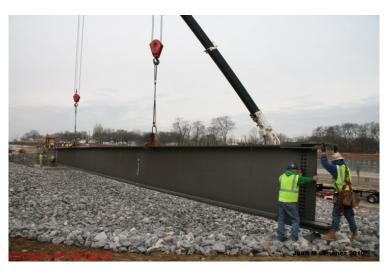
Figure 33: Holding of Girder 105A1 by the 175-ton and 40-ton cranes

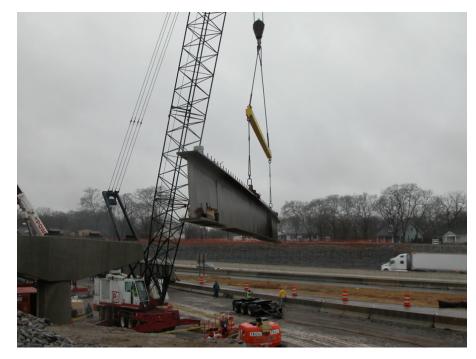
• Girder 110A2 was then hoisted using the 150-ton boom crane with a 40 foot long spreader beam, as shown in Figure 34.

Figure 34: Lifting of Girder 110A2

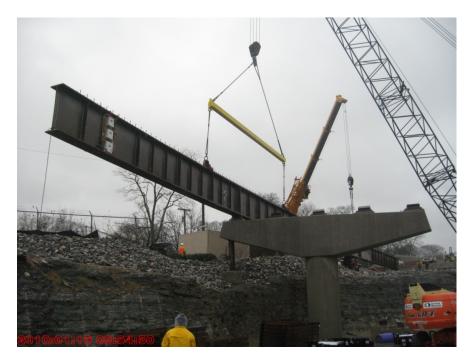
The splice between girders 105A1 and 110A2 was bolted. Figure 35 is a photo of Girders 105A1 and 110A2 at this stage of the erection.

Figure 35: Girders 105A1 and 110A2 located on supports, spliced together, and held by cranes

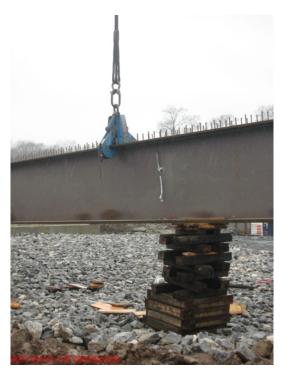
Cribbing was placed under girder 105A1, as shown in Figure 36, allowing the 175-ton crane to be released to lift girder 104B1. Note that the cribbing was not indicated in the erection plan.

Figure 36: Cribbing under Girder 105A1

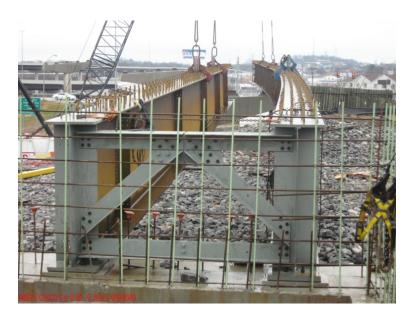
Figure 37: One Cross Frame Attached Between Girders 104B1 and 105A1

After girder 104B1 was hoisted into position at the abutment, the cross frames between 105A1 and 104B1 were installed. Figure 37 shows the first three girders erected with the first cross frame in place between girders 104B1 and 105A1. Figure 38 shows all of the cross-frames installed between these field sections. The cross-frames were generally installed one-by-one in progression from the starting end of the field sections.

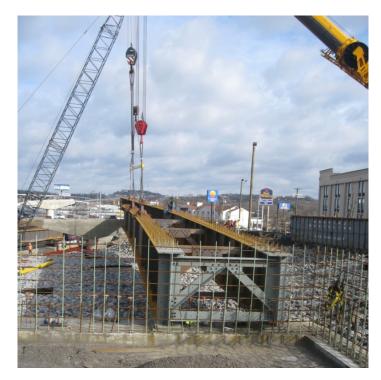
Figure 38: All Cross-Frames Attached Between Girders 104B1 and 105A1.

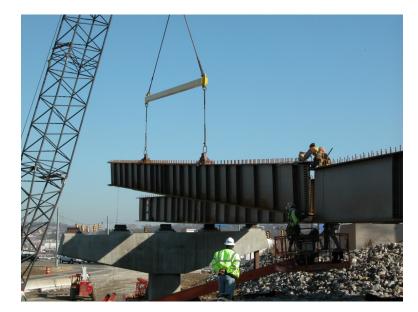
Figure 41: Placement of Girder 108C2

Girders 103C1 and 108C2 were erected in a similar manner but without the use of the holding crane (see Figure 41 and Figure 42). (The erector determined that the holding crane was unnecessary after the cross frames had been installed between the first two girder lines.)

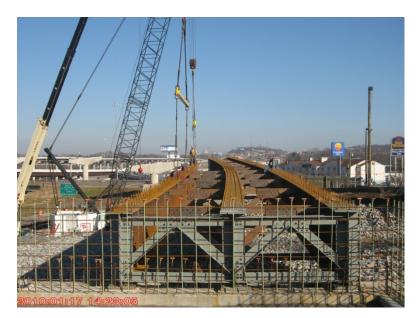
Figure 42: View showing two cranes holding the third girder line while making the splice between 103C1 and 108C2

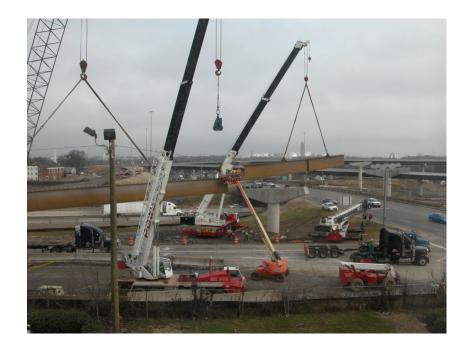
Figure 43: Positioning of girder 120A4 in Preparation for Splicing to Girder 115A3

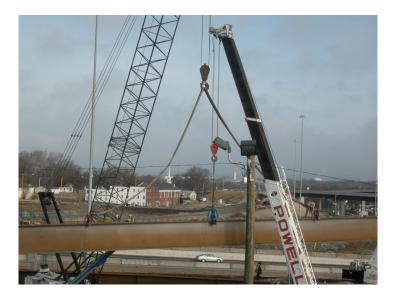
Figure 44: 150-ton Lattice Boom Lifting Crane Being Released from Girder 115A3

- The second span was constructed on January 23, 2010, using similar procedures to span 1.
- The only notable difference in the erection of span 2 is that the spreader beams used during construction of the first span were replaced with lifting straps. The lifting straps were used for the remainder of construction for all spans.
- Starting with the outside girder line, girder 115A3 was lifted and spliced to girder 110A2.
- Girder 120A4 was then lifted and spliced to girder 115A3, as shown in Figure 43.
 A separate 175-ton holding crane was attached to girder 115A3 so that the 150ton lattice boom crane could be released to lift girder 114B3, as shown in Figure 44.

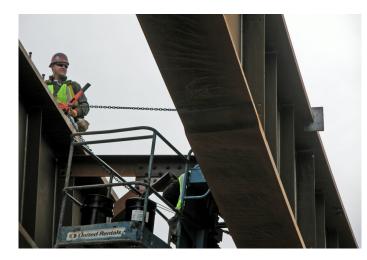
Figure 45: Use of a come-along between girders 120A4 and 119B4 near Bent 1

Girder 114B3 and 119B4 were then erected using the same steps. Figure 45 shows the use of a come-along between girders 120A4 and 119B4 during the installation of the cross-frames. The remaining three girder lines were then installed to complete span 2. Figure 46 shows the installation of the bearing line cross-frame between girders 119B4 and 118C4. Figure 47 shows the installation of cross-frames between Girders 117D4 and 116E4. The bearing line cross-frames were installed as multiple pieces, whereas the intermediate cross-frames each were a single piece.

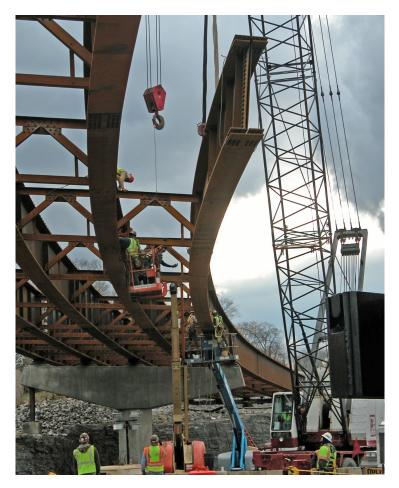
Figure 47: Installation of cross-frames between Girders 117D4 and 116E4

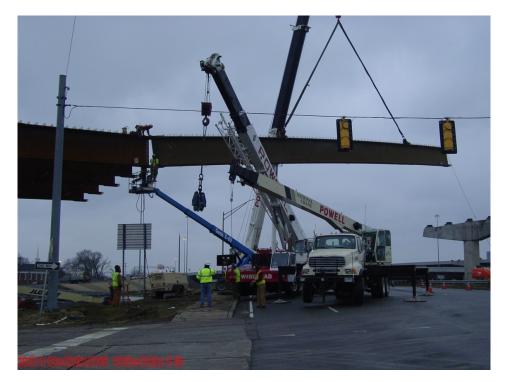
Figure 48: Positioning of Girder 125A5

- The erection of the third span was delayed due to snow conditions in Nashville. The girders were originally supposed to be erected on January 30-31, 2010 but did not get erected until February 6-7.
- The erection plans called for this span to be completed in the opposite order of the first two, that is, from the inside span to the outside span. This was changed on site and the construction took place in the same order as the previous two.
- Erection began with girder 125A5, hoisted by the 175-ton crane, which was spliced to girder 120A4 as shown in Figure 48.

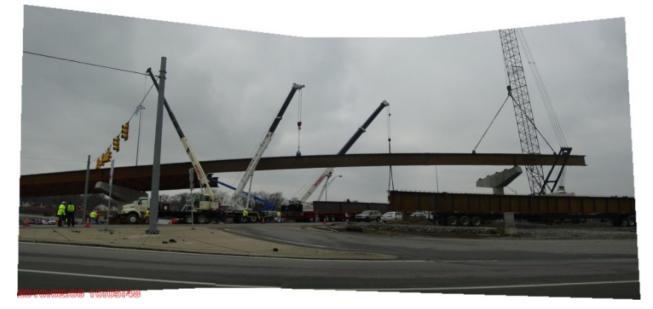
Figure 50: View showing girder 125A5 being stabilized by a holding crane and the lifting crane released to pick girder 124B5

- A holding crane was placed on girder 125A5, allowing the lifting crane to be released to hoist girder 124B5, as shown in Figure 50. Figure 51 shows the positioning of girder 124B5.
- Girder 124B5 was then spliced to girder 119B4 and the cross frames were installed between girders 124B5 and 125A5, after which girder 129B6 was lifted.
- Once girder 129B6 had been spliced to girder 124B5 and the cross frames attached between girders 129B6 and 130A6, the erection continued without the use of a holding crane as with the previous two spans.
- The span was completed with the erection of girders 123C5, 128C6, 122D5, 127D6, 121E5, and 126E6, in that order.

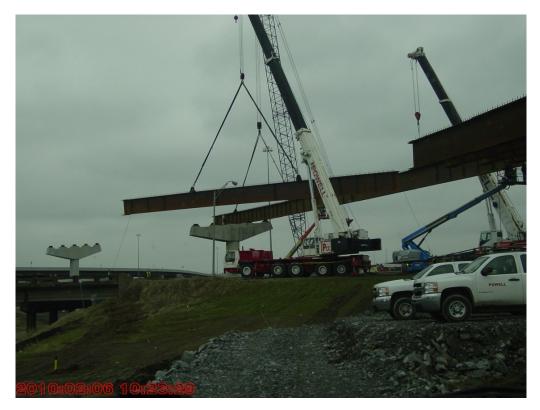
Figure 51: Positioning of Girder 124B5

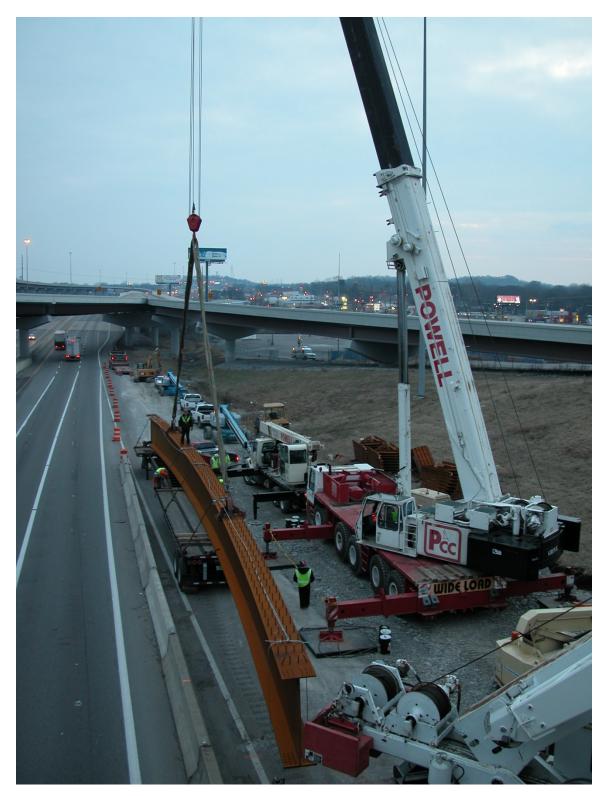
Figure 52: View of the175-ton lifting crane located on the south side of I-40 just prior to the lifting of girder 131E7 (Photo taken from the Robertson Ave. bridge)

- Span four was erected on February 13-14, 2010, beginning with the inside girder line (E) and ending with the outside girder line (A). This opposite sequence of erecting the girders was necessary due to site constraints on the crane placement. Figure 52 shows the position of the 175-ton crane on the south shoulder of Interstate 40 just prior to the start of the erection of Span 4.

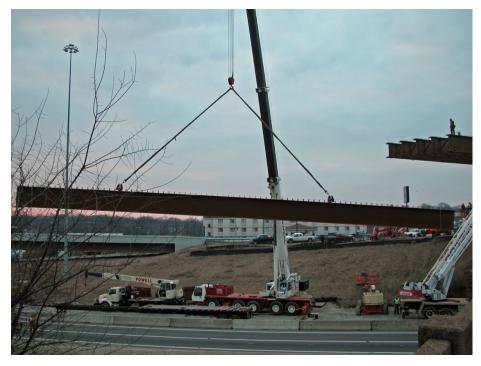
Figure 53: Lifting of Girder 131E7

- Erection started on February 13 with the girders on the inside of the horizontal curve, 131E7 and 136E8, with girder 136E8 sitting over top of bent 3. Figure 53 shows the lifting of girder 131E7 and Figure 54 shows the splicing of girders 131E7 and 136E8.

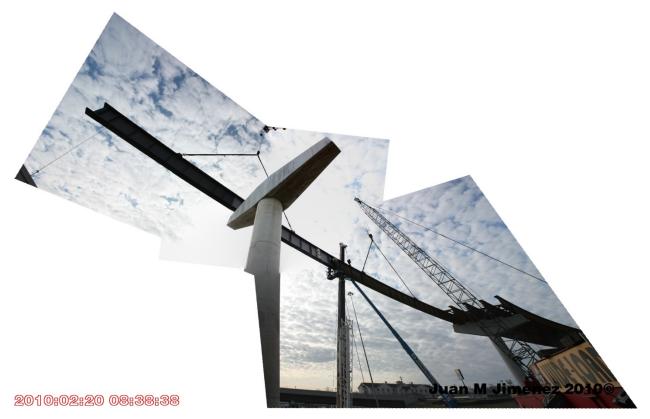
Figure 55: View of Span 5 with girders 145A9 and 150A10 up, with the lifting cranes still engaged, and with the holding crane attached to 145A9

Span 5 was erected on February 20-21 2010, starting with the outside girder line
 (A) and ending with the inside girder line (E). Figure 55 shows a view of the erection with girder 150A10 being spliced to girder 145A9.

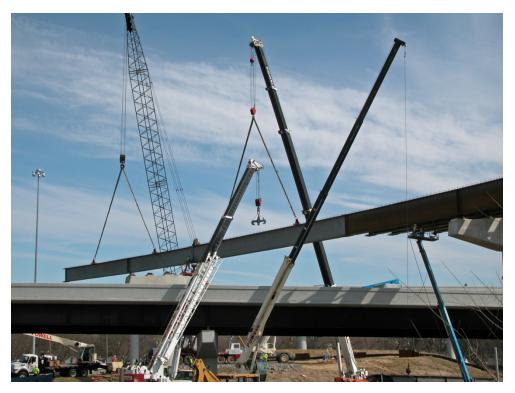
Figure 56: Connection of Girder 156E12 to Girder 151E11

- Span 6 was erected on February 27-28, 2010, starting with the inside girder line
 (E) and ending with the outside girder line (A).
- This span was completed in the same manner as the previous spans, starting with girders 151E11 and 156E12, as shown in Figure 56, and continuing the span with 152D11, 157D12, 153C11, 158C12, 154B11, 159B12, 155A11, and 160A12.

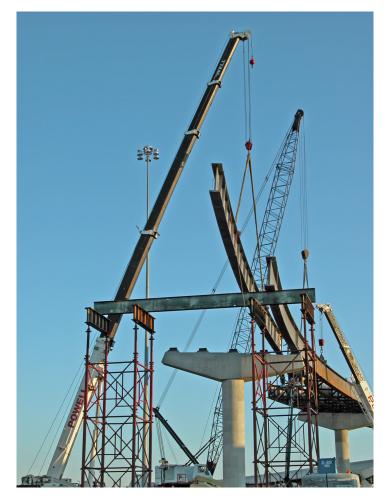
Figure 58: Lifting of Girder 167D14

- Girders 161E13 and 166E14 were erected first, and their splices made.
- A 40-ton holding crane was used for girder 161E13 during the lifting of girder 162D13.
- Girder 162D13 was aligned and spliced to 157D12, and the cross frames between girders 161E13 and 162D13 were installed. Figure 57 shows the state of construction after the erection of girder 162D13, with girder 166E14 resting on the shoring tower.
- Girder 167D14 was lifted into position next and spliced to girder 162D13, as shown in Figure 58.

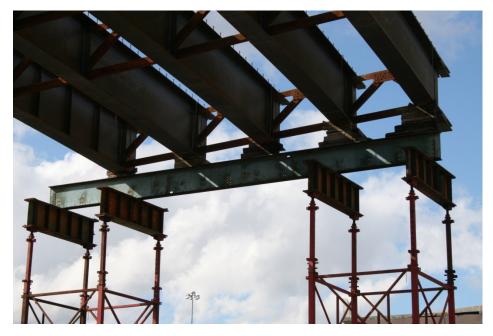
Figure 59: Cribbing Placed Between Top of Shoring Tower and Bottom of Girders

- The cross frames between 167D14 and 166E14 were then installed.
- From this point forward, none of the girders were in physical contact with the shoring tower.
- Span 7 was completed with the installation of girders 163C13, 168C14, 164B13, 169B14, 165A13, and 170A14 erected in the same manner.
- Cribbing was placed between the top of the shoring tower and the bottom of the girders to help restrain the cantilever span from oscillating during the subsequent week due to potential wind gusts, as shown in Figure 59.

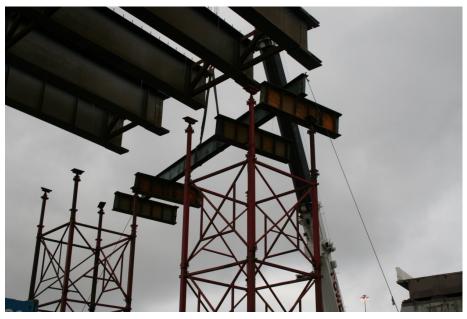
Figure 60: Shoring tower at span 7 after removal of cribbing

- The girder erection was completed with span 8 on March 13-14, 2010. The cribbing on the shoring tower from span 7 was removed and the shoring tower was dismantled before erection of span 8 began, as shown in Figure 60.
- The girders were erected from the outside girder line (A) to the inside girder line (E).
- Girder 175A15 was hoisted first and spliced to girder 170A14. At this time it was apparent that the girder was exhibiting twisting deformation as it approached the support at bent 7, as shown in Figure 61. A come along, shown in Figure 62, was used to restrain this twisting until the remaining girders were installed.

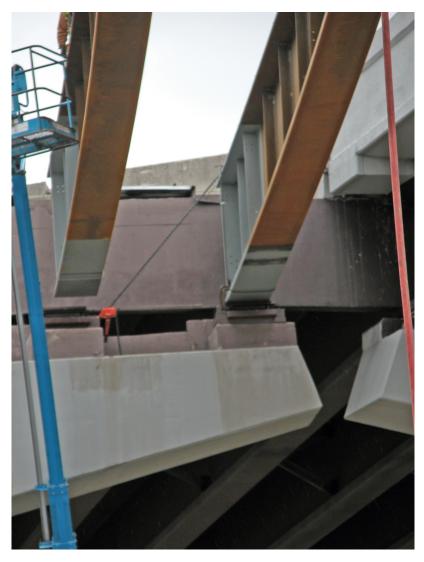
Figure 62: View of come along on girder 175A15

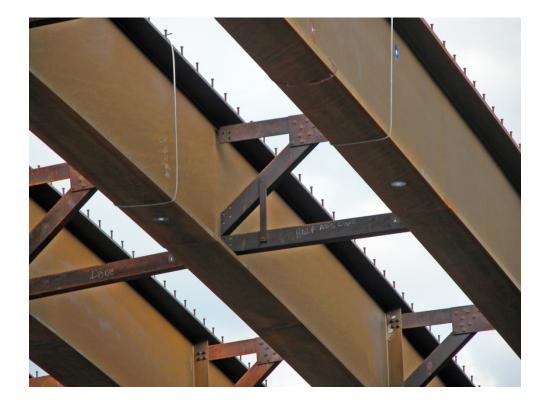
Figure 63: View of the cross frame with missing connection plate

- The lifting crane was then released from girder 175A15 and girder 174B15 was hoisted, spliced to girder 169B14, and set on the support at bent 7. Once the process of attaching the cross frames between girders 174B15 and 175A15 had started, it was noticed that a connection plate was missing from one of the girders, as shown in Figure 63. Therefore, one of the cross frames could not be fully connected.
- The lifting crane was then released from girder 174B15, and used to hoist girder 173C15.

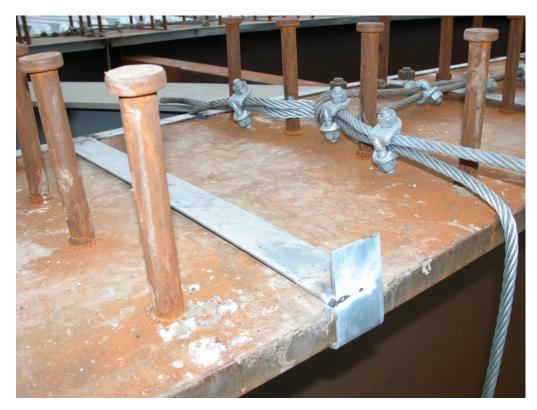
Figure 64: Light gage metal strap attached to the top flange of fascia girder

May. The deck reinforcing steel was placed after the installation of the metal decking was finished, and was completed in mid June. Details of the straps and angles used to attach the decking are shown in Figure 64 through Figure 68. Figure 69 shows the top of the bridge with a large amount of decking in place but before any reinforcing had been placed. Figure 70 shows the overhang brackets supporting the formwork beyond the outside girder. Figure 71 shows a portion of the bridge with all of the reinforcing in place and the screed set up in preparation for concrete placement.

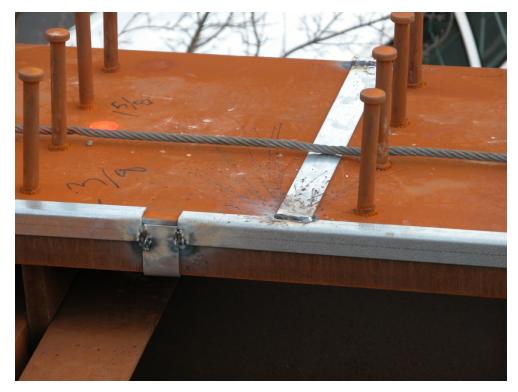
Figure 65: Light-gage metal strap attached to longitudinal light-gage angles on opposite side of fascia girder

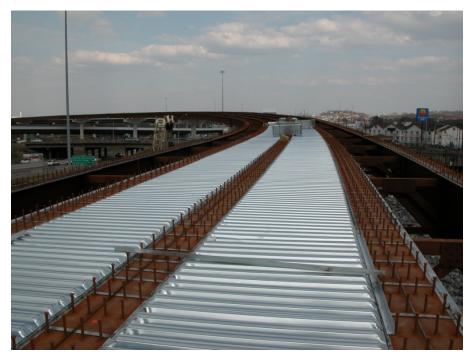
Figure 69: Metal decking partially installed

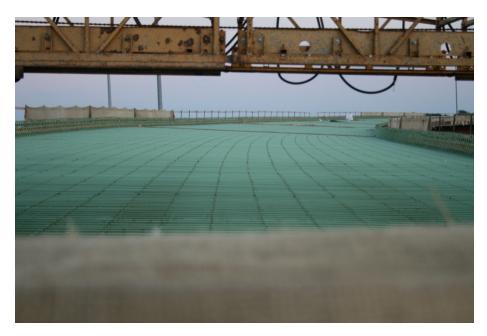
Figure 71: Reinforcing and screed in place, awaiting concrete

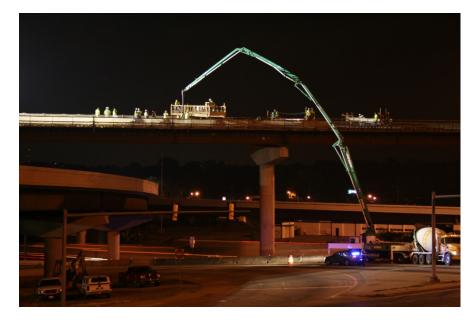
Figure 72: Concrete placement during coolest part of the day

The initial plan called for concrete to be placed on spans 1 and 8 first, and continue from each end until the two placements met in the middle. This plan was changed in mid-June at the request of the contractor. The revised deck placement sequence started with the positive moment regions of spans 6-8 for the first section. The second section consisted of the positive moment regions of spans 1-3. The third stage consisted of the negative moment regions of spans 1-3, and the fourth stage was the negative moment regions of spans 6-8. The final stage included all of spans 4 and 5. The concrete placement for each stage was scheduled to begin between 2:00 a.m. and 3:00 a.m. in order to complete the work before the hottest part of the day, as shown in Figure 72.

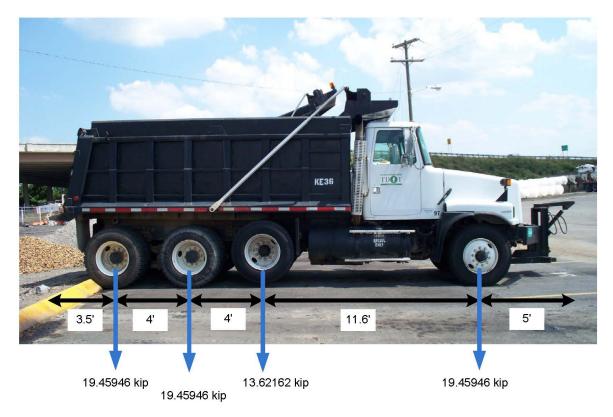
Figure 79: Force distribution of truck used during live load testing

After construction was completed, but before the bridge was opened to traffic, a live load test was conducted. This was completed using ten dump trucks. The trucks were loaded with gravel to a weight of approximately 72 kips each. The trucks were weighed in the morning before the test and again afterward. The locations and magnitudes of the forces applied by the trucks are shown in Figure 79.

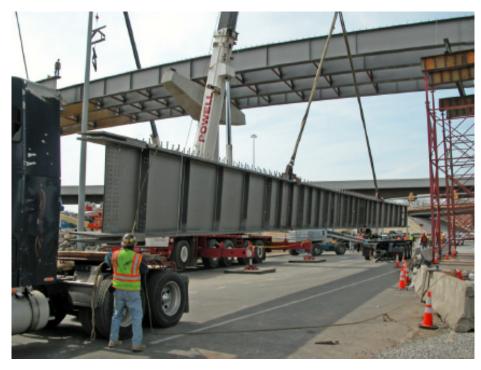
Figure 86: Girder 170A14 being lifted

The first set of plots show a comparison of the predicted and measured stresses at four locations on the girder cross section during the lifting stage (shown in Figure 86 and Figure 87).

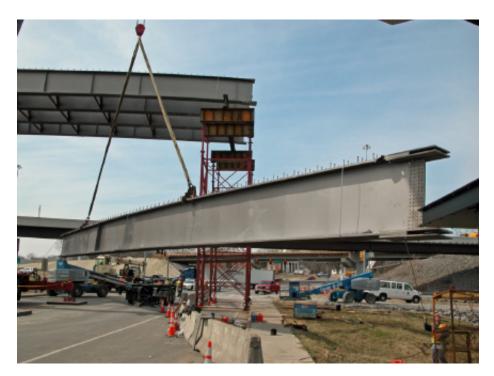
Figure 87: Girder 170A14 being lifted

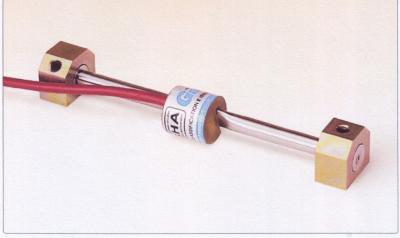
Model 4000 Vibrating Wire Strain Gage.

The vibrating wire is protected inside a stainless steel tube with 'O' ring seals at both ends for complete waterproofing. The electronic coil clips over the center of the tube and a thermistor is encapsulated with the coil to permit the measurement of temperature.
