## Retrofitting of Reinforced Concrete Beams Using a Fiberglass Jacketing System

**Abstract:** Building collapse that occurred mostly caused by structure failure in containment earthquake load. Factors that lead to the failure of the beam, among others is beam planning that does not calculate ductility or restraint, resulting decline of beams performance. One way to improve beam strength and ductility are to retrofit the beam by wrapping beams using fiberglass. Research aims to discover the increase amount of bending load capacity from concrete beam that has been retrofitted using jacketing fiberglass. Experimental testing was carried out on beam specimens with a cross section size of 150x200 mm and a length of 1400 mm. Three beam specimens were subjected to bending loads with a three point loading system, with different levels of damage, namely BL1 with collapse at level-1, BL2 at level-2, and BL0 at level-5 as a comparison. Then the BL1 and BL2 were retrofitted by being coated with 2 layers of fiberglass which were glued using epoxy resin. Beams BL-1 and BL-2 are then subjected to a bending test again until they reach level-5 collapse. The test results showed that retrofitted be

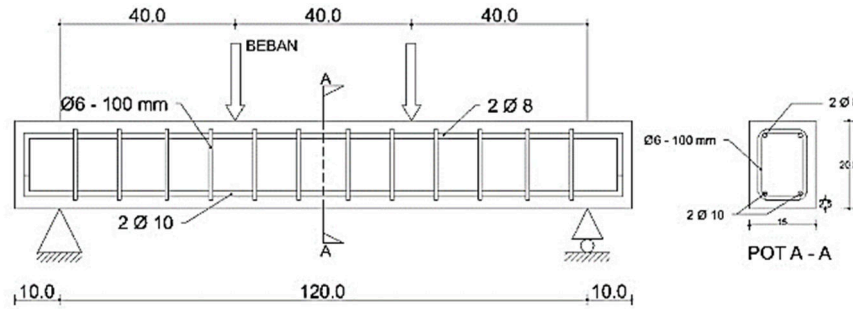
The reinforcement used is plain reinforcement 2Ø8 in the compressive area, and 2Ø10 in the tensile area, and stirrup reinforcement Ø6-100 mm. Details of the test object can be seen as in Fig. 1.

Fig. 1. Details of size and reinforcement specimen

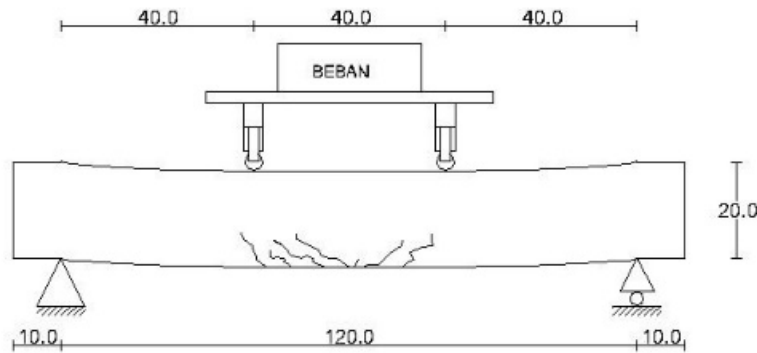
Pure bending testing by means of three-point loading, the load is distributed to third span in the left and right split the beam into three, so that the middle receive pure bending loads, as shown in Fig. 2.

Fig. 2. Three-point pure bending loading

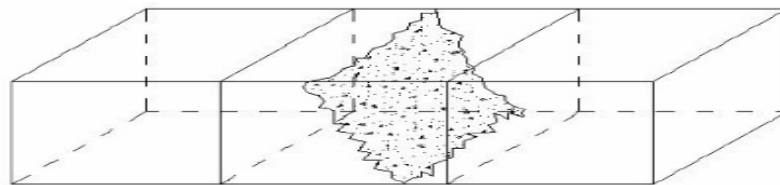
- If the cracked or fractured plane is located in the central area (area 1/3 of the distance to the placement point), then the flexural strength of the concrete is calculated according to the following equation

$$\sigma_1 = \frac{P.L}{B.H^2} \tag{1}$$

Fig. 3. Cracked or fractured at 1/3 Middle Span

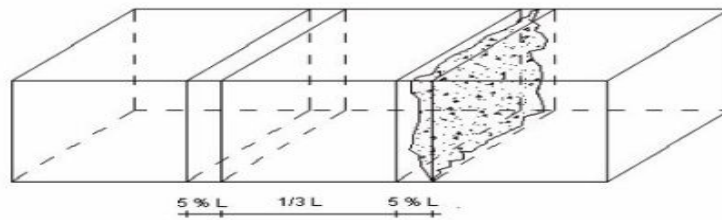
- If the crack or fracture plane is located outside the center (area 1/3 of the distance between the placement point) and the distance between the center point and the fracture point is less than 5% of the distance between the placement points ), then the flexural strength of the concrete is calculated according to the following equation

$$\sigma_1 = \frac{P.a}{B.H^2} \tag{2}$$

**Fig. 4.** Cracked or failed beyond 1/3 center span and broken lines less than 5% of span

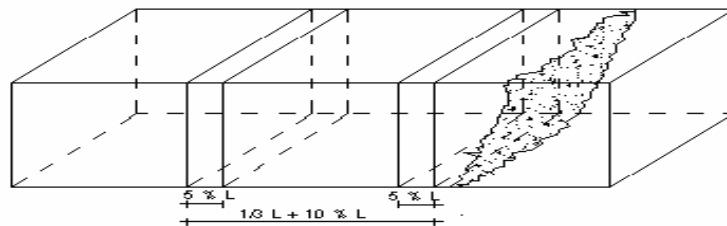
- If the crack or fracture occurs outside the center (area 1/3 of the distance between the placement point of the center) and the distance between the loading point and the breaking point is more than 5% of the span, the test results are not used.

**Fig. 5.** Cracked or failed beyond 1/3 center span and > 5% of span

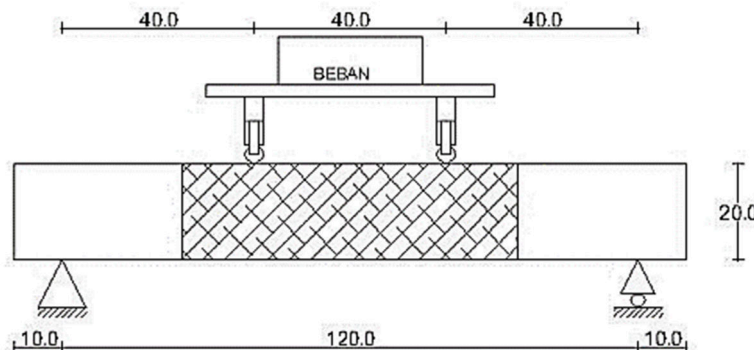
Fiberglass jacketing is carried out after the test object is loaded and collapsed according to plan. The fiberglass is wrapped in 2 layers of blocks using epoxy resin.

**Fig. 6.** Jacketing beam using WR400 fiberglass

Retrofitting was carried out on BL1 and BL2 beams by means of 2 layers of woven roving fiberglass jacketing CWR-400 using epoxy resin as adhesive.

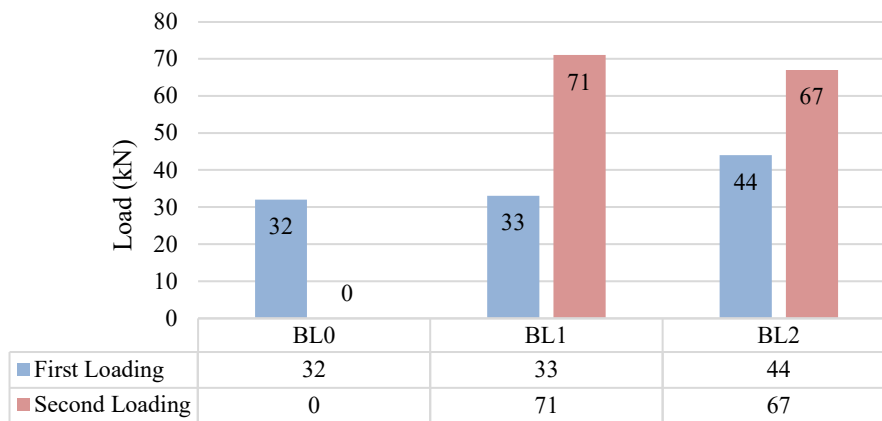
Fig. 7. comparison of bending loads before and after retrofit

From the graph in Fig. 7, it can be seen that the BL1 beam specimen with a damage level of 1 and a crack width of 0,20 mm, at the second loading received a load of 71 kN. The beam has increased by 38 kN or 115% from the first loading. The beam deflection is 1,8 cm.

From the graph in Fig. 7, it can be seen that the BL2 beam specimen with a damage level of 3 and a crack width of 0,5 – 2,00 mm, at the second loading received a load of 67 kN. The beam has increased by 23 kN or 52.27% from the first loading. The beam deflection is 2,2 cm.

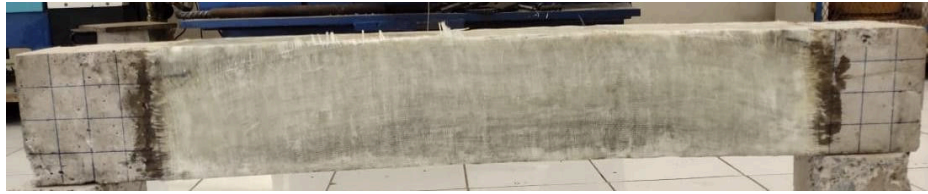
**Fig. 9.** BLR1 retrofit beam after loading, invisible cracks, hidden behind fiberglass

Retrofit with fiberglass jacketing method has the disadvantage that cracks invisible beam so that the beam collapse could only be observed from the magnitude of the beam deflection.

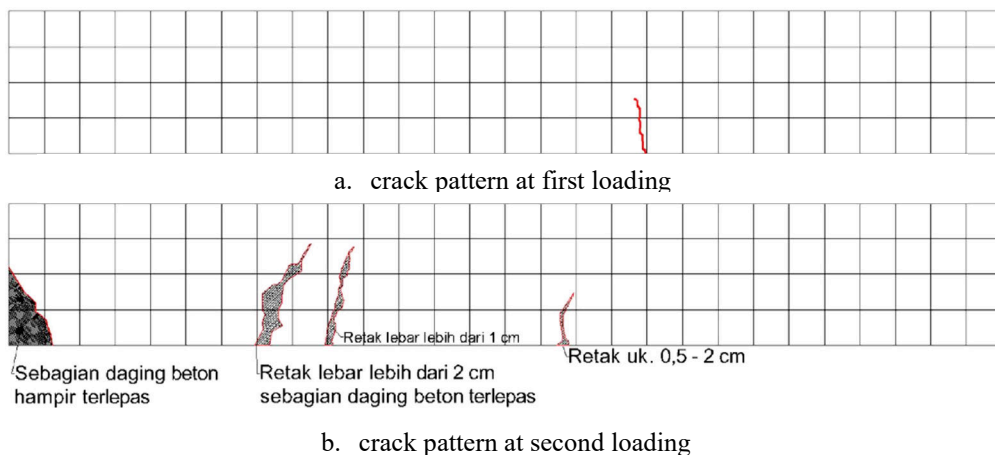
BLR2 beam is retrofitted BL2 beam. BLR beams had collapsed in a combination of bending and shear simultaneously. The collapse is different from during the first loading which only experienced flexible collapse. The shear failure can be seen clearly because the concrete cover on one outer side of the beam peels off so that the reinforcing bars are visible. Just like BL1, the fiberglass layer does not tear but the layer is debonded. Debonding can be seen because the fiberglass layer swells in the area that is experiencing cracks.

**Fig. 10.** comparison of beam crack pattern of BL2 and BLR2

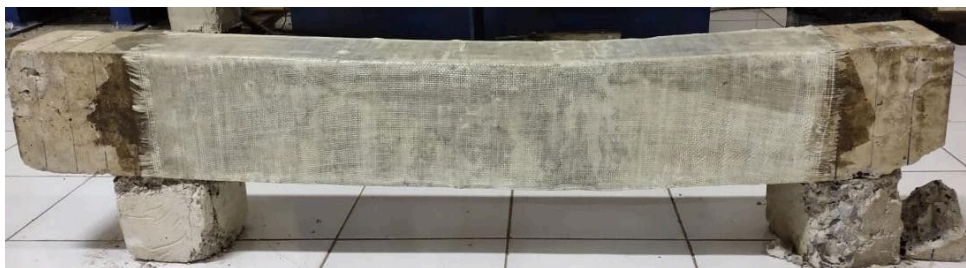
**Fig. 11.** BLR2 retrofit beam after loading, invisible cracks, hidden behind fiberglass
