DOCUMENTING ARCHITECTURAL REPAIRS WITH PHOTOGRAMMETRY: COLUMN DRUMS OF THE TEMPLE OF ATHENA ALEA AT TEGEA*

The Temple of Athena Alea at Tegea is one of the most important temples constructed in the fourth century BCE in mainland Greece. The architecture of the fourth-century marble temple was studied in detail by the author in the 1990s and the current project at the site aims to test whether new three-dimensional documentation methods can be used to settle the open issues in the design and construction of the temple. In 2016, aerial photography, reflectorless total stations and photogrammetry were used to document the archaeological site and produce a detailed georeferenced three-dimensional model of the temple. In 2019, the column drum repairs of the temple were modelled with photogrammetry to compare the documentation and reconstruction drawings made in the 1990s with the new digital models. The advantages of current three-dimensional methods are speed of documentation and very high accuracy in capturing the dimensions, geometry, toolmarks and textures of the architectural repairs.

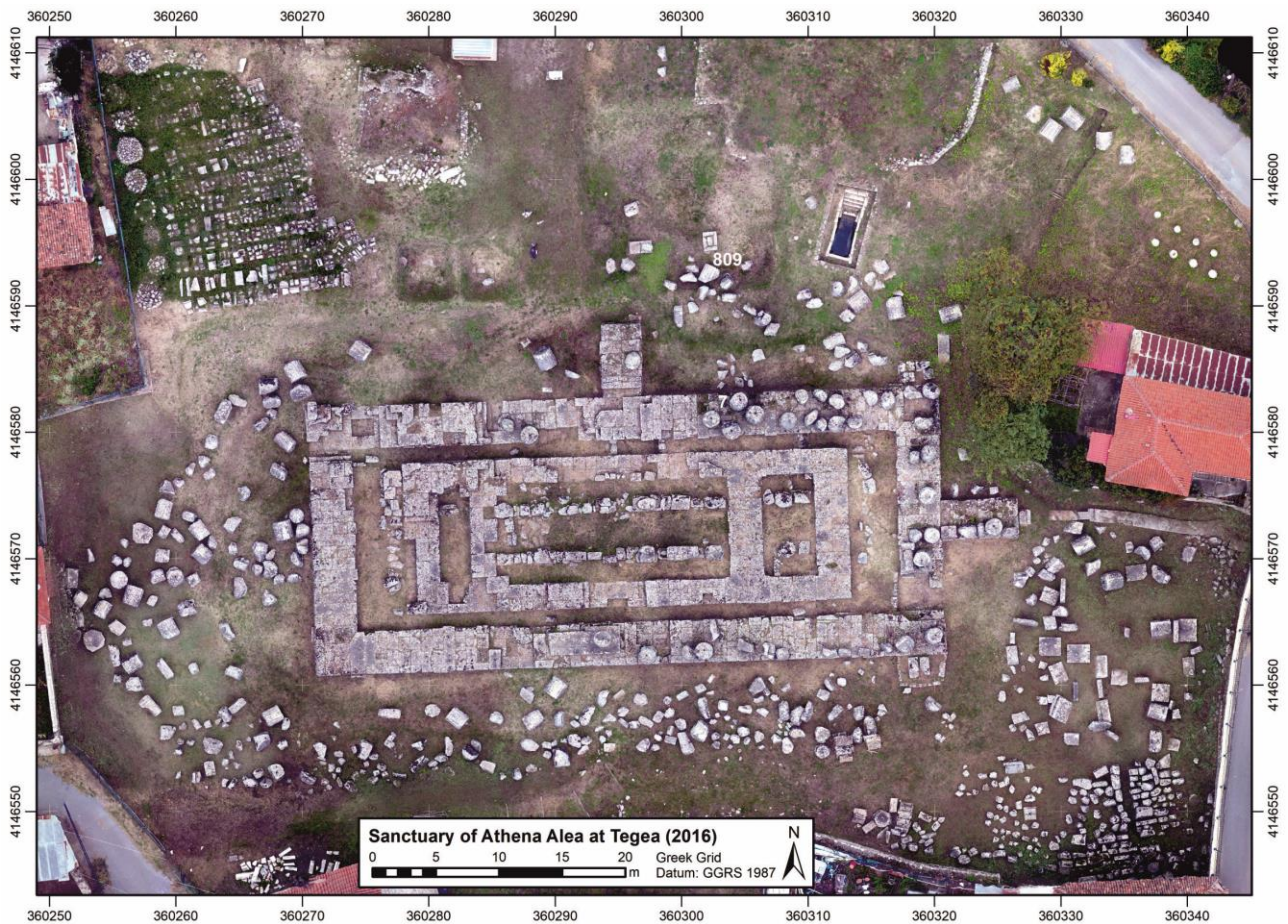
Fig. 1. Georeferenced orthomosaic of the archaeological site and foundations of the temple of Athena Alea at Tegea (plan by the author)

Block 809 was discovered in the Norwegian excavations carried out in 1990–1994.²⁷ The column drum is located to the N of the temple foundations (figs. 1–2) and it is from the middle of the column shaft.²⁸ The arrises of Block 809 have been repaired in two places. The smaller one has most of the repair pieces still in place and it is clearly visible on the side of the drum currently facing upwards (figs. 3–4). The second larger repair is in the present NE corner of the drum close to the ground (figs. 5–6).²⁹ The dimensions of the three repair pieces and the cutting were measured using a referenced orthomosaic exported from PhotoScan to ArcMap. Comparison with the documentation carried out in the 1990s using traditional methods reveals discrepancies of a millimetre as can be expected.

Block 7 is one of the column drums excavated at the beginning of the 20th century and documented by Mogens Clemmensen.³² The column drum is located on the N flank of the temple foundations (figs. 1–2) and it is from the middle of the column shaft.³³ Early photographs show that the drum was in this place already in the early 20th century,³⁴ though a stone was placed under the block at some point after the original photographs were taken, probably to facilitate drawing of the state plan of the temple foundations.³⁵ Block 7 has a large tapering cut on the current SE side of the drum.

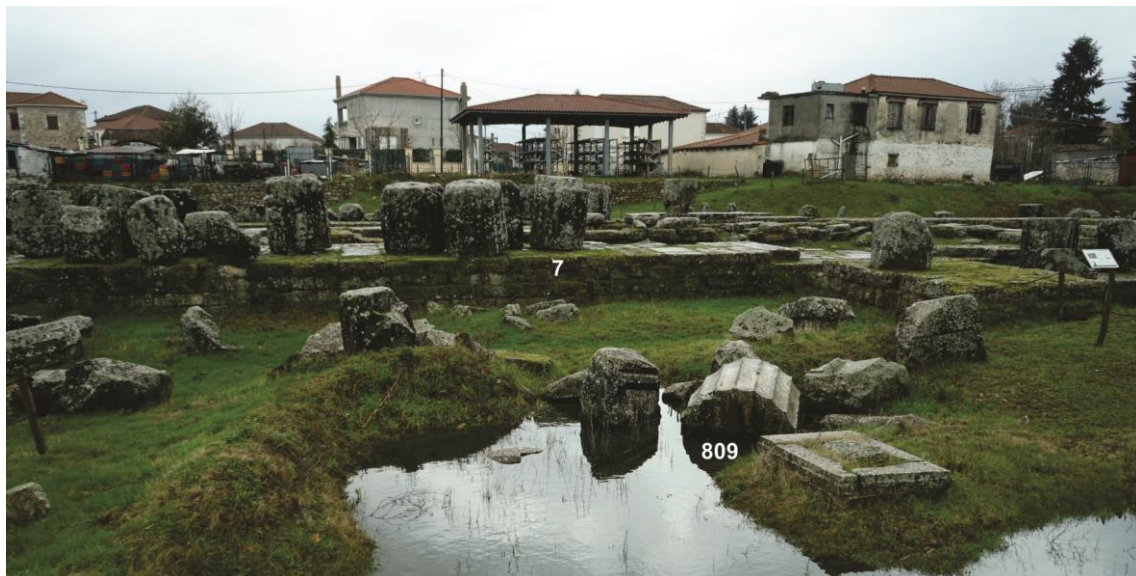
Fig. 2. The archaeological site in February 2019 from the north indicating the column drums with arris repairs (photograph by the author)

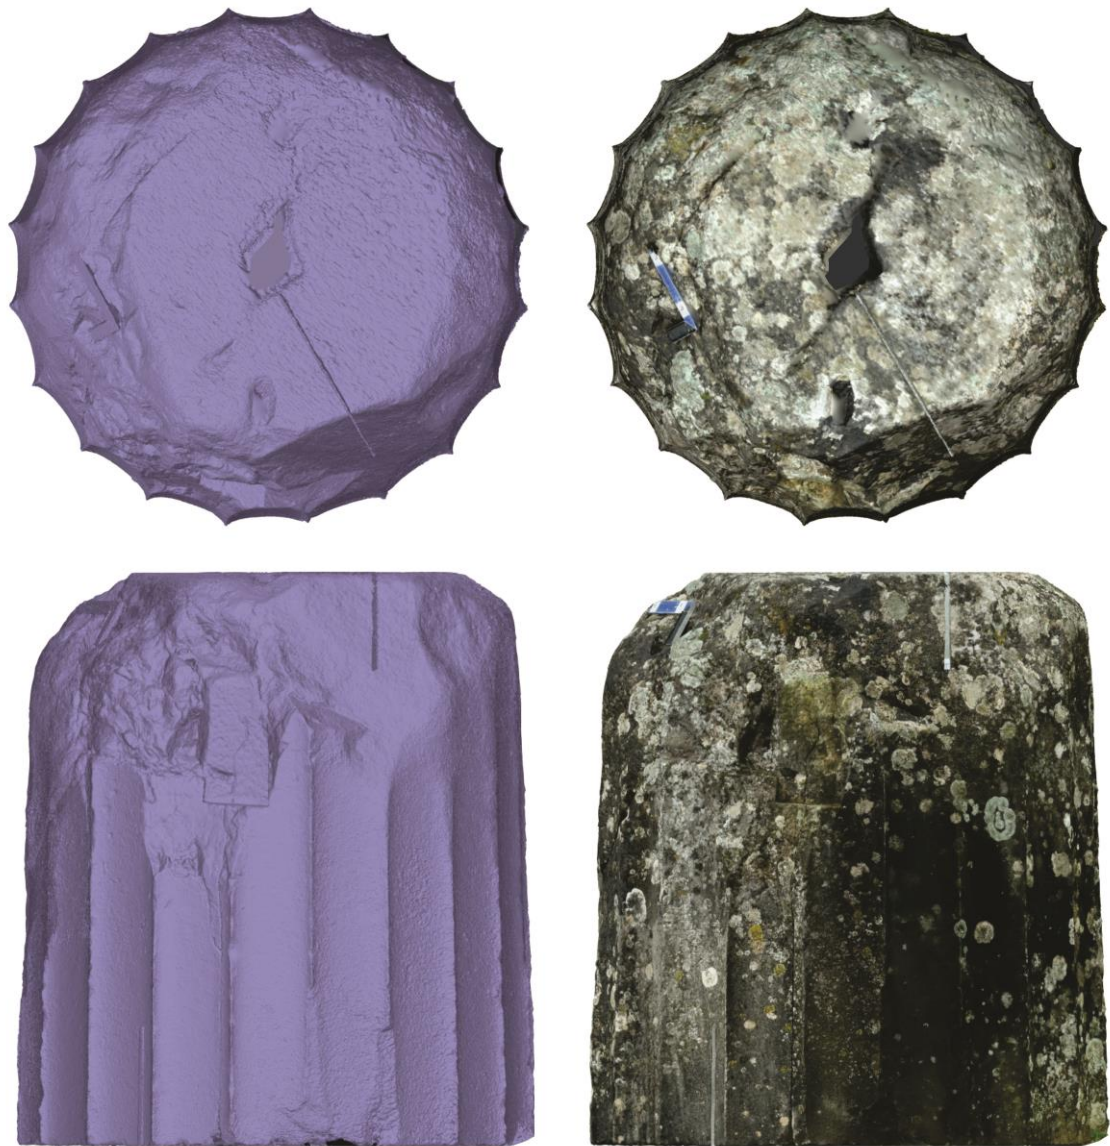
Temple of Athena Alea at Tegea. Block 7 0 500 1000 mm

Fig. 8. Solid and textured side and top surface views of Block 7 (illustration by the author)

It is in many cases easier to discern surface details and geometry of the block on the basis of the solid photogrammetry model (on the left in fig. 8) than on the textured model (on the right in fig. 8). The lichen growing on the marble surfaces is a distraction in the latter case. The second set of photographs without the scale bars could have been used to produce fig. 8, but my choice was to use the initial set so that the metal scales provide a colour and texture contrast to the marble block. Dimensions such as diameters, height and flute widths can be measured directly from the exported two-dimensional views of the model with millimetre accuracy. The dowel holes and the empolion cutting in the middle are slightly fuzzy because of the conditions during documentation: rain water was collecting in the depressions resulting in reflections in the photographs.
