Archaeological Investigations Associated With The 1886 Hidalgo County Courthouse And Jail, Hidalgo County, Texas

Mark P. Luzmoor

EGV Architects Inc. (Client), on the behalf of the City of Hidalgo, contracted with **Raba Kistner Environmental, Inc. (RKEI)** to perform archaeological services in support of the on-going restoration to the Old Hidalgo County Courthouse and Jail located in Hidalgo, Hidalgo County, Texas. Services requested included the documentation of two historic cisterns present in the vicinity of the Courthouse and Old Jail Building and the mapping of foundations recently uncovered during the restoration of the Courthouse Building.

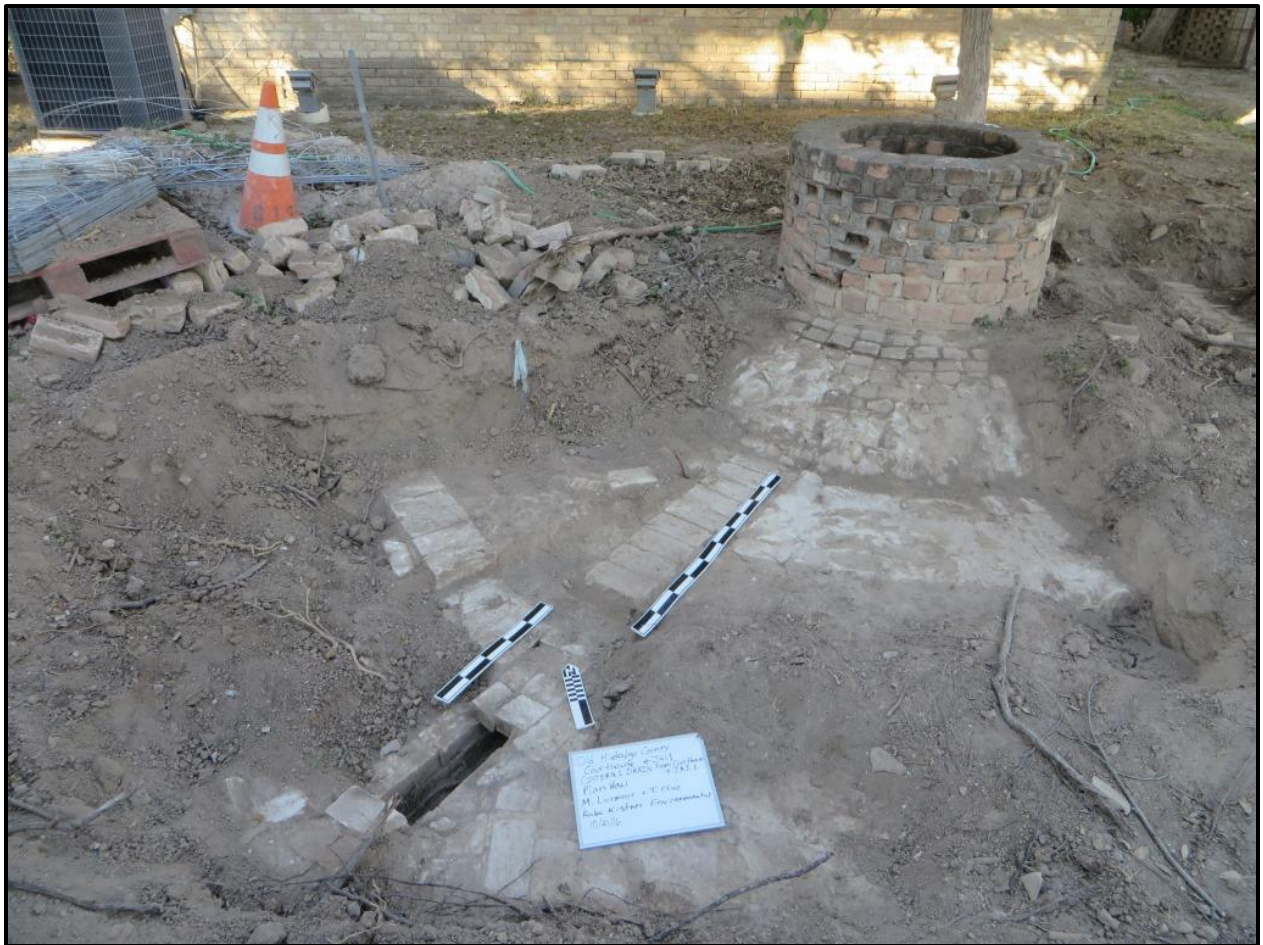
Figure 4-2. Cistern 1 after exposure of the edge of the cistern.

Since the very top of Cistern 1 was visible above the ground surface, RKEI wanted to try to find the edges of the cistern to determine its maximum diameter (**Figure 4-2**). After exposing the cistern, it was determined that the feature represented an example of a Bell Cistern (**Figure 4-3**) (Denton 2011). This cistern style dated from the 1880s-1900s and held between 3,000-20,000 gallons of storm water depending on their date of construction (Denton 2011:6). The top of Cistern 1 had a diameter of 1.22-m and extended 86-centimeter (cm) above the neck of the cistern. The diameter of the main body of the cistern was approximately 4.04-m. The depth was not able to be determined since there was soil up to neck of the inlet (**Figure 4-4**).

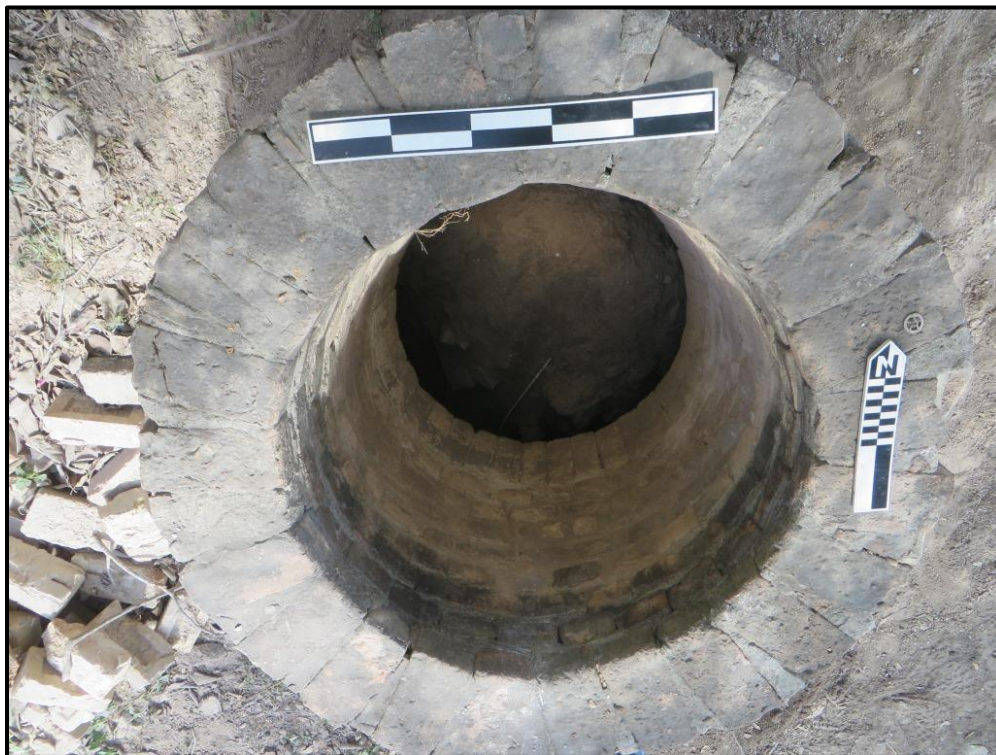
Figure 4-4. Top down view of the top of Cistern 1. Note the pile of dirt below the neck of the Cistern.

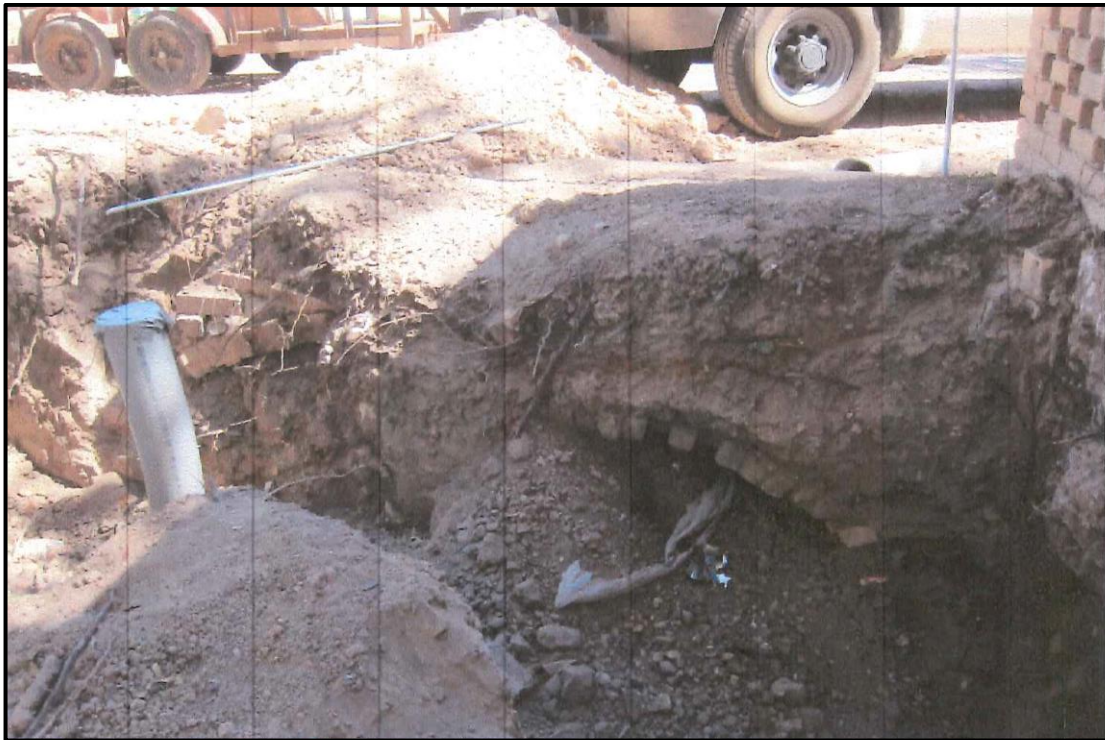
Figure 4-5. Original excavations of Cistern 2 in February, 2016. Note the two arches of the cistern and the parking lot in the background.

During the original excavations in February 2016, EGV Architects exposed Cistern 2 directly under the parking lot, approximately 4 m to the east of the Jail, during the installation of electrical PVC pipes (**Figure 4-5**). Half of the cistern was removed prior to these excavations. During the re-exposure of the cistern, RKEI archaeologists observed that approximately one meter of the top of the cistern was exposed underneath the parking lot. A 1-inch metal pipe was also noted running across the top of the cistern (**Figure 4-6**). The metal pipe contained an electrical line that powered the lights in the parking lot. Cistern 2 had a diameter of approximately 2.78 m, measured 1 m wide and approximately 55 cm of the profile was exposed within the trench (**Figure 4-7 and 4-8**). Cistern 2 was photographed and profiled after exposure (**Figure 4-9**).

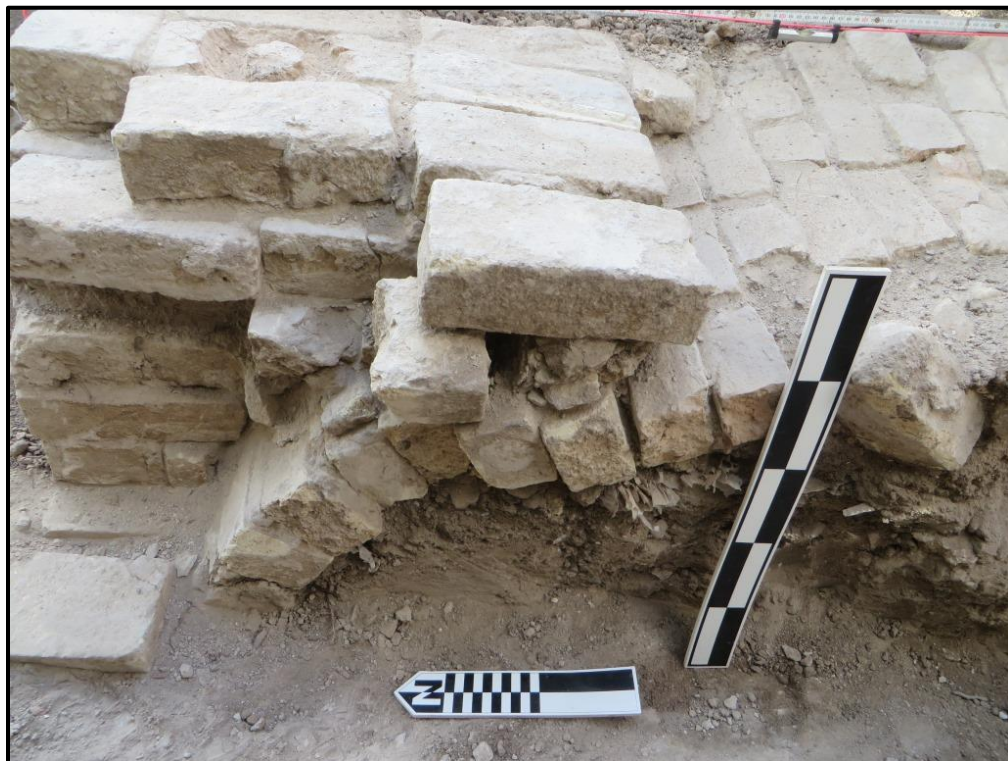
Figure 4-7. Profile view of the northern arch of Cistern 2.

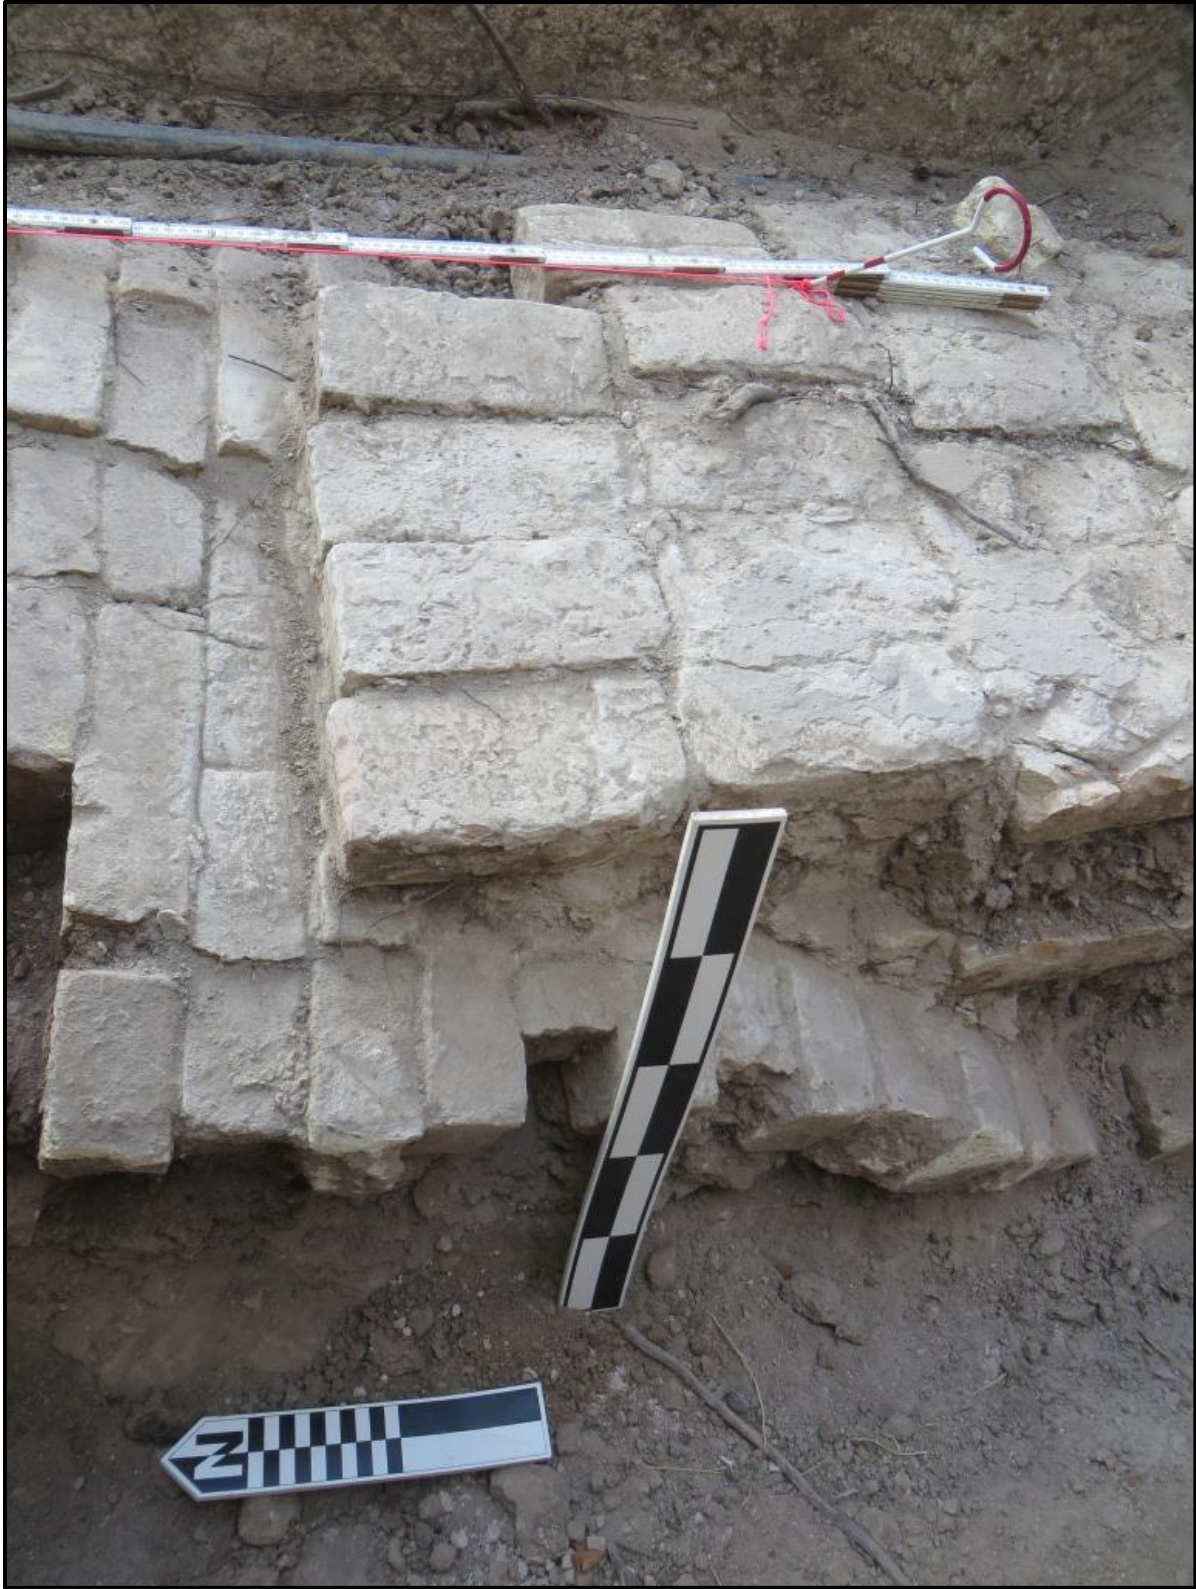
Figure 4-8. Profile view of the southern arch of Cistern 2.

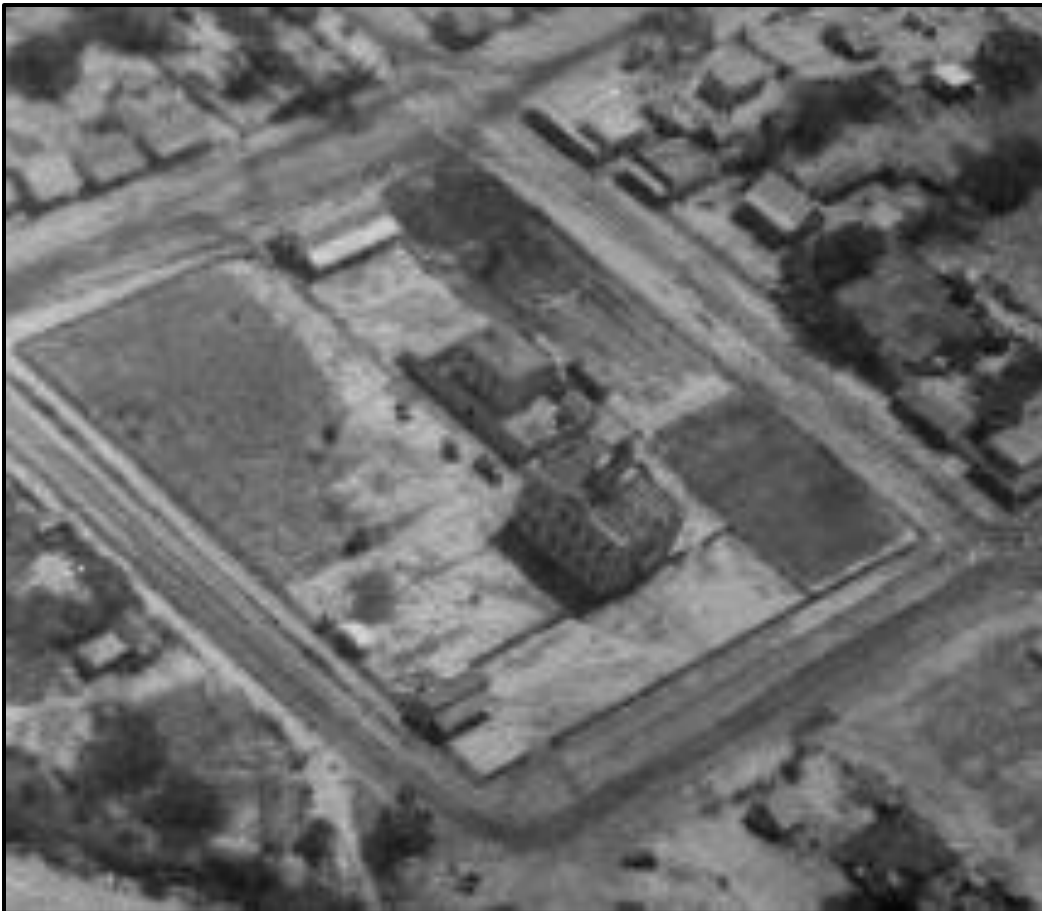
Figure 4-10. Old County Courthouse and Jail in a late nineteenth century aerial photograph. Photo is facing northeast. Note the wall surrounding the Jail and guard house on the southeast corner of the wall.

Previous excavations for utility installations encountered a network of buried, brick foundations. Historic maps and photographs depict a brick wall that once surrounded the Jail. Historic photographs also show a probable guard house on the southeast corner of the Jail (Figures 4-10 and 4-11). RKEI mapped the original foundations for both the wall and guard house during the exposure of the foundations (Figures 4-1 and 4-12). The wall foundation measured approximately 18.74 m N/S, 15.94 m E/W, and was two bricks wide (approximately 0.6 m). The guard house foundations measured approximately 5.2 m N/S, 5.2 m E/W, and was also two bricks wide (approximately 0.6 m).

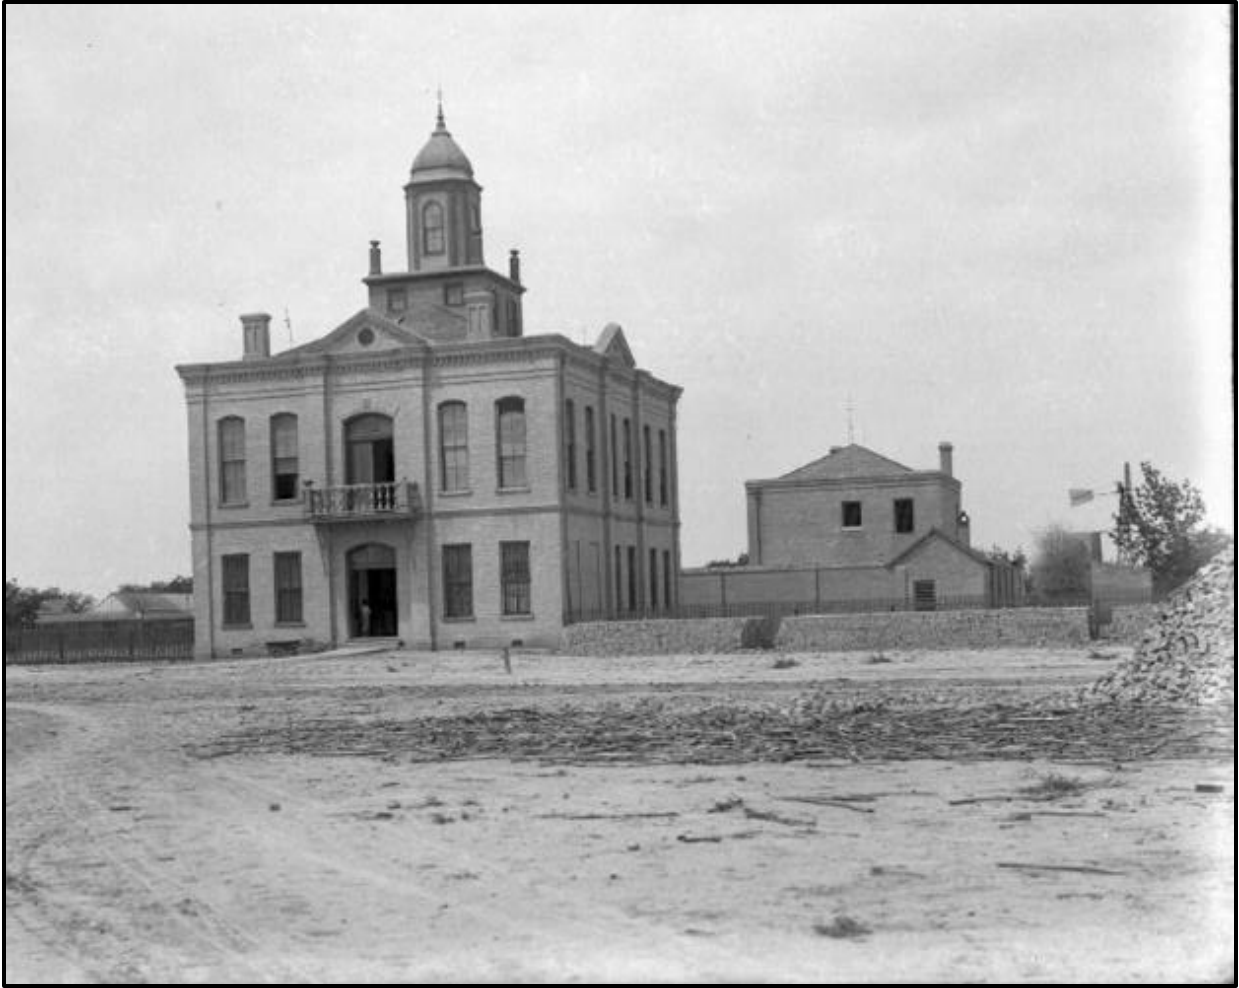
Figure 4-11. Old County Courthouse and Jail in a late nineteenth century photograph. Photo is facing north. Note the wall surrounding the Jail and guard house structure just in front of the Jail.

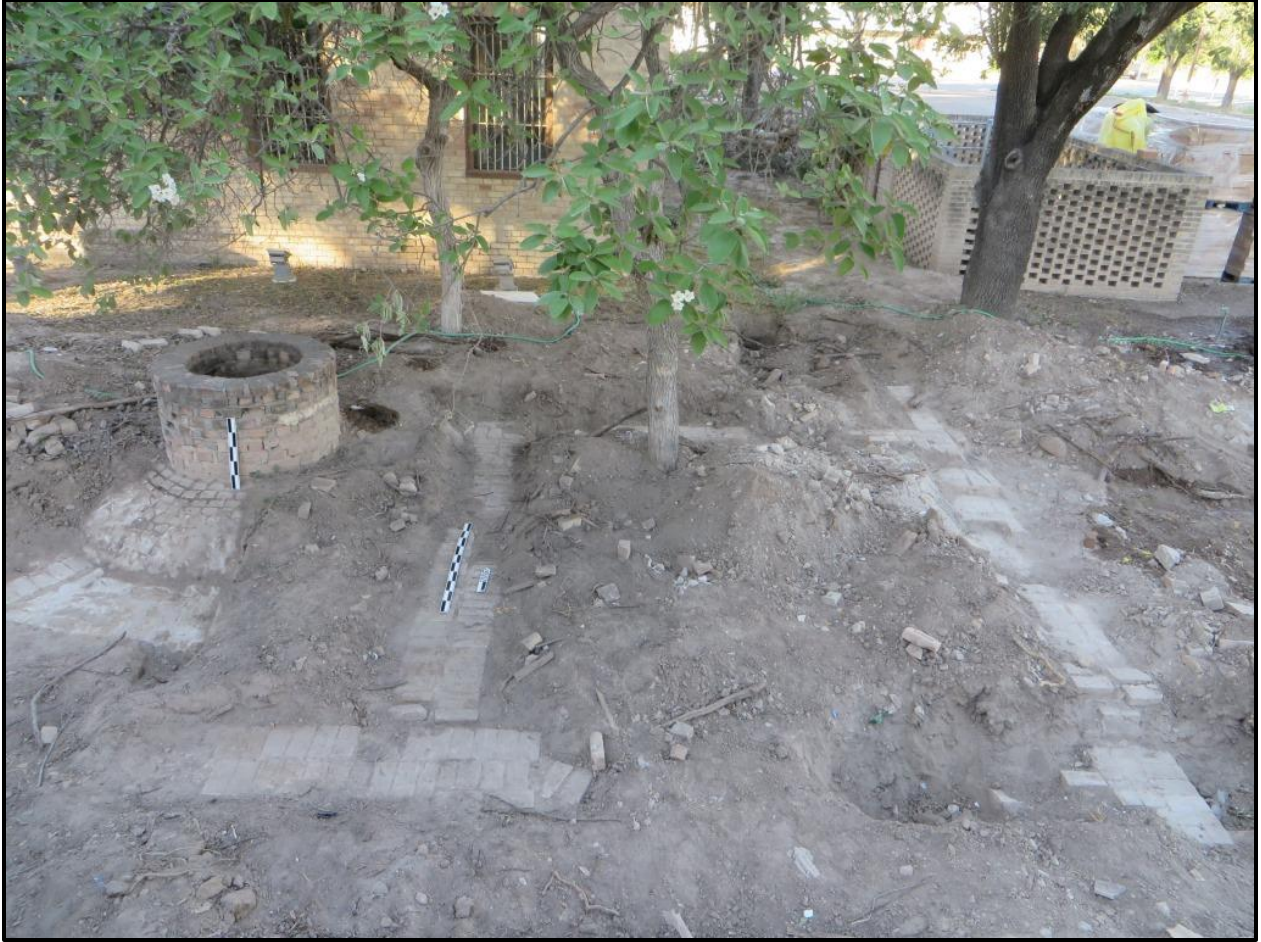
Figure 4-12. Southeast corner of the original wall and an overall view of the guard shack with the Jail in the background and Cistern 1 on the left.
