PROVO POLLUTION PREVENTION PROGRAM

A Pilot Study of the Cost-Effectiveness of an On-Road
Vehicle Emissions Reduction Program.

A study designed to show that cost-effective on-road emissions reductions can be achieved with a targeted repair program.

Prepared by
University of Denver
Chemistry Department
University Park
Denver, CO 80208-0179

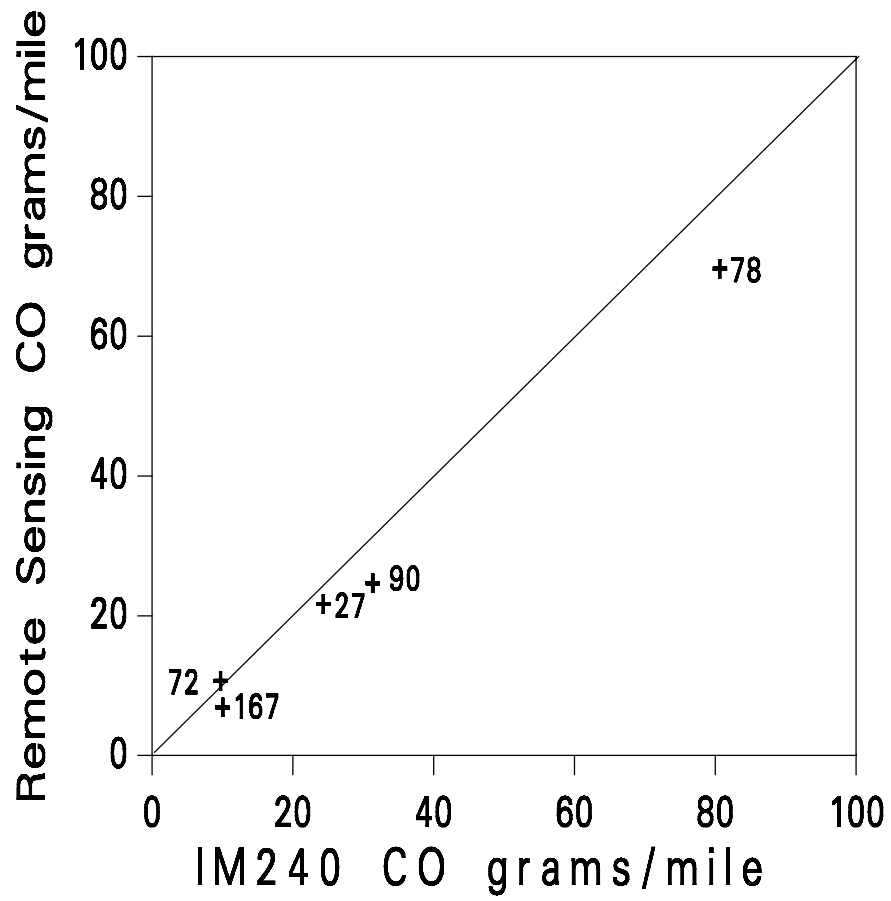
Figure 3. On-road fleet %CO emissions converted to grams/mile emissions compared to I/M 240 CO grams/mile emissions. Numbers next to the +'s are the fleet size.

According to Glover and Clemmens (1991) the on-road results of remote sensing test have similar predictive power to idle/2500 rpm testing when compared to the EPA I/M 240 test. Their report also shows that remote sensing is ten to one hundred times faster and more convenient. Glover and Clemmens used Corporate Average Fuel Economy (CAFE) gas mileage estimates to compare fleet on-road emissions with I/M 240 gCO/mile emissions for the same fleets. Data from a study of on-road gross pollutants in California added one more data point. The correlation is shown in Figure 3. The conclusion we draw from these data is that, even for small fleets of vehicles, I/M 240 emissions are in agreement with actual measured on-road grams/gallon emission data when that data is converted to grams/mile using CAFE gas-mileage estimates.
