ROLLING CONTACT FATIGUE STUDY OF RAILWAY RAILS

ABSTRACT

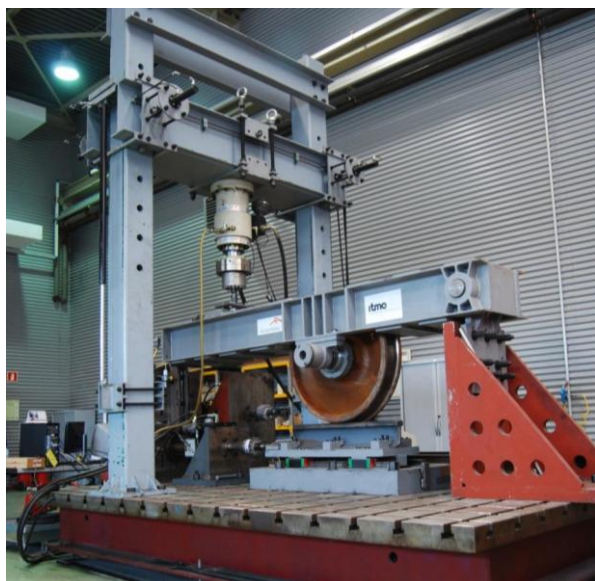
Figure 1. Test rig adapted to perform RCF tests

Numerous components were designed to adapt the test rig to this application, where the test configuration maintains the wheel axle fixed while the rail is moved alternatively, forward and backward. As can be seen in figure 1, the test layout is composed by the following components:

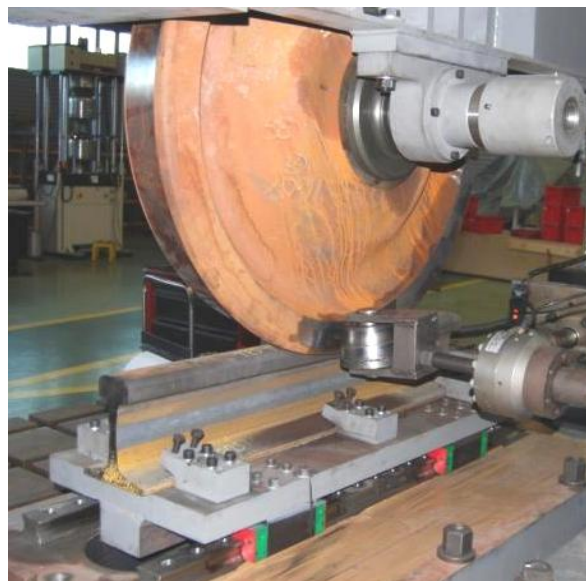
Figure 2. Detail of moving table and lateral load actuator.

c) Lateral load actuator. In order to simulate the rolling conditions on a railway turn, a hydraulic actuator applies a load to the external side of the wheel flange by means of a conical roller, as can be seen in figure 2. As the wheel axle is not fixed in the axial direction, the wheel moves laterally and the point of contact against the rail changes.

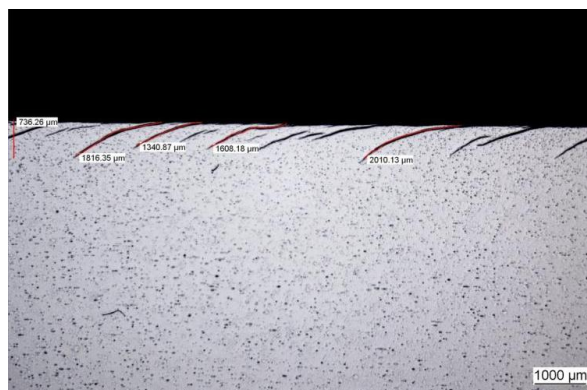
Figure 6. Longitudinal section of the center region of rail n°7 (12.5x). Maximum crack depth: 0.74 mm

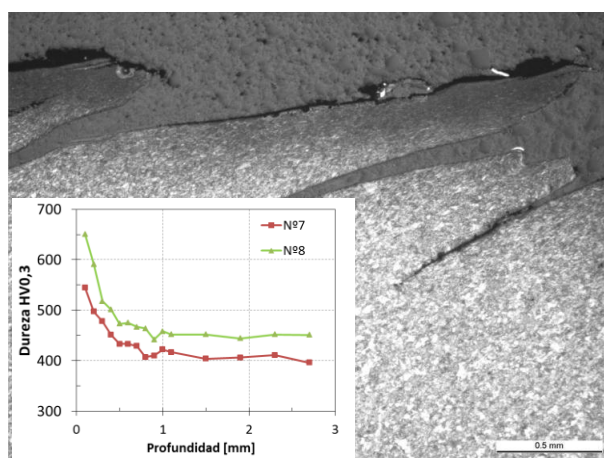
Figure 7. Longitudinal section (50x, rail n°8), showing surface deformation. Hardness profiles of rails.

Moreover, under the rolling area, a significant deformation of the pearlitic microstructure of the rail was noticed. Consequently, strain hardening takes place

under the rolling surface, raising the hardness from 400 HV to 500 HV in rail n° 7; while the hardness of rail n° 8 increased from 430 to 600 HV, as shown in figure 7.
