COMPARATIVE EVALUATION OF DELAMINATION IN
CARBON FIBER REINFORCED COMPOSITES (CFRPs)
UTILIZING VARIOUS COMMON NON-DESTRUCTIVE
INSPECTION TECHNIQUES

A THESIS

A THESIS APPROVED FOR THE
SCHOOL OF AEROSPACE AND MECHANICAL ENGINEERING

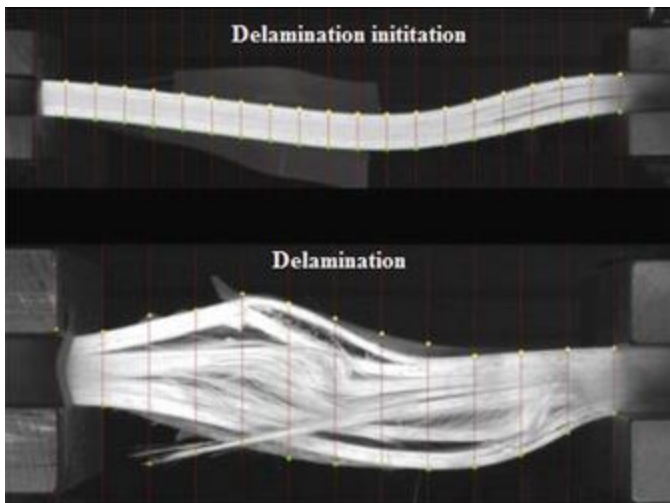
Figure 3: Extreme Example of Delamination in Fiber Reinforced Composite (Sheedev A. 2018)

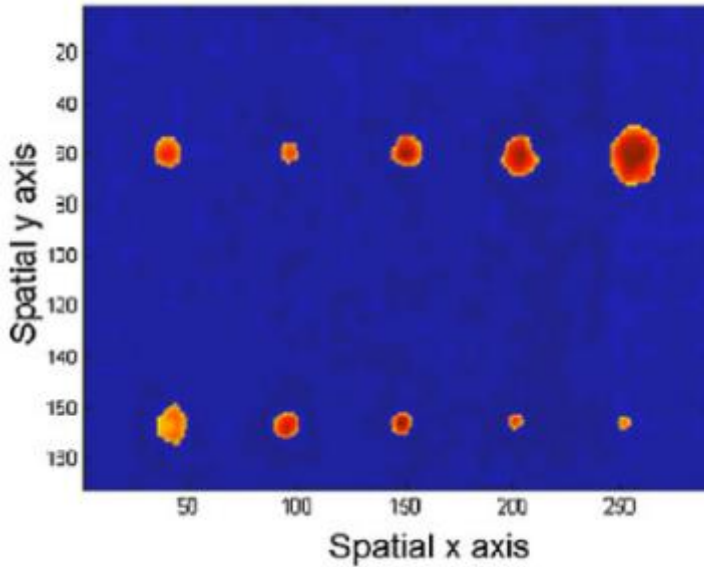
Figure 6: SEMF Processed PT Image (Ahmed J., et al. 2018)

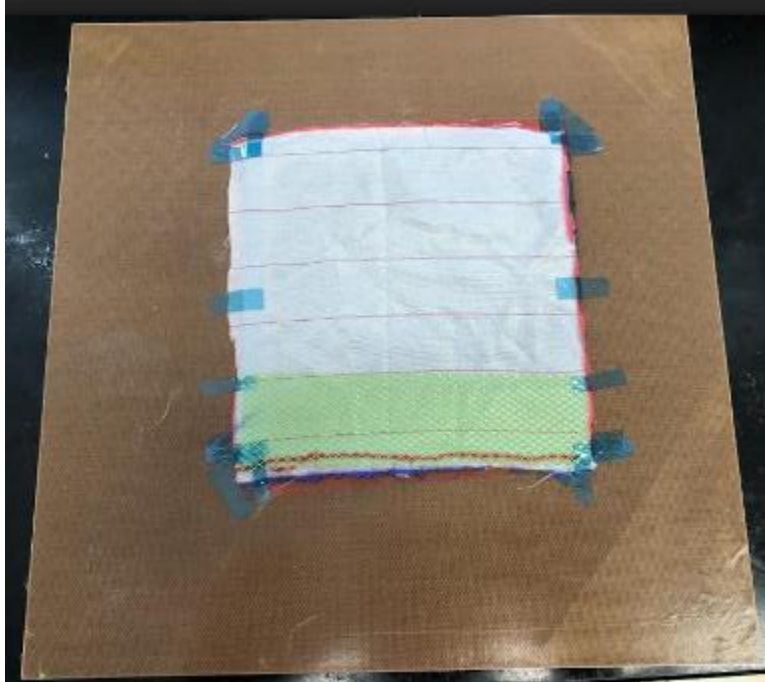
Figure 17: Distribution Medium at Infusion Entrance Edge

After the top peel ply layer was installed, a small 1" strip of distribution media was taped along the edge which the infusion resin would enter seen in Figure 17. Then, around the perimeter, a lining of tacky tape was placed with the backing still applied overlapping at the corners. Then the flow tubing was placed with flow holes, spaced 1" apart, facing the VARTM assembly entrance as well as exit locations as shown in Figure 18. The entrance tubing was cut to 20" in length while the exit tubing was cut to 45" in length. The additional length of the exit tubing allows for longer vacuum time before any resin would reach and thereby ruining the vacuum trap. Then, a 4" strip of tacky tape was wrapped around the tubing, aligning with the rest of the tacky tape as shown in Figure 18.

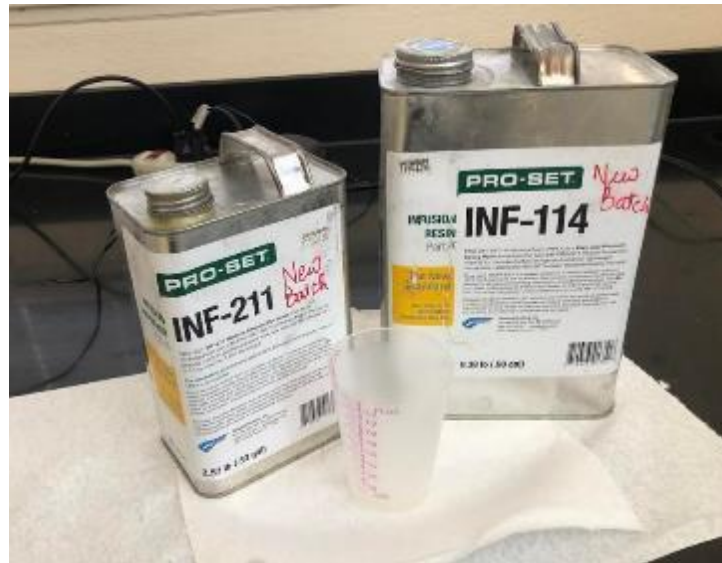
Before infusion the epoxy infusion resin was carefully mixed. The Gougeon Brothers Inc.'s PRO-SET Infusion Epoxy INF-114 Infusion Resin and INF-211 Medium Infusion Hardener being used, seen in Figure 22, have an overall density of 1.14g/cc.

Figure 22: Gougeon Brother's Infusion Resin

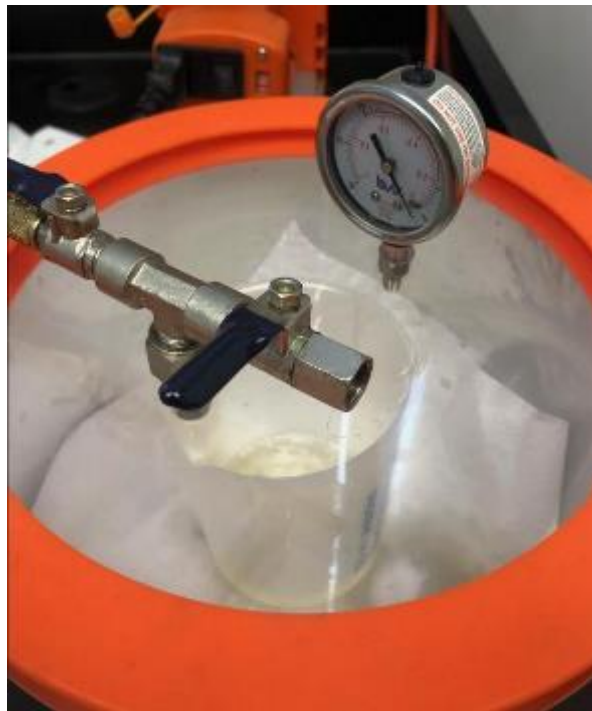
100°F (38°C). Vacuum off time at 72°F (22°C) is 9¾ hours in a typical laminate. Given this cure window the recommended time for degassing can vary, but a safe point found and utilized was 30 minutes. This does give the resin enough time for the majority of the air to escape the resin without gelling. Removing air in these samples was important as the introduction of unplanned defects can result in false positives or a poor test specimen for characterizing programmed defects.

Figure 23: Resin Degassing in Vacuum Chamber

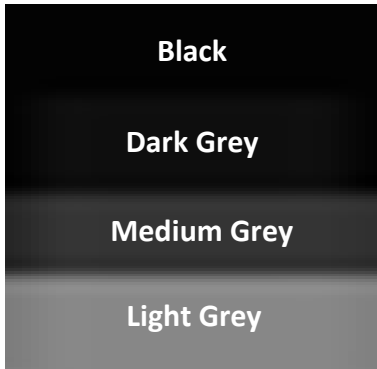
Figure 31: Ultrasonic C-Scan Gradient

As seen in Figure 31 from section 3.1.1, there is a gradient in shading indicating concentration of ultrasonic waves. For this study we assume that the darkest portion of each defect is the effective “center” of the scanned defect and then the area outside of regions seen in the black or dark grey coloring being the border of the defect interfacing with the rest of the bulk material. Concessions were made if the darkest color is lighter than dark grey. At these interfacing regions the area per pixel will be cut off 50% of the way between the “center” border and the interface. With this being the assumption that it is approximately half programmed defect and half bulk CFRP, as it is near impossible to know how much crossing there is at these zones. This is yet another limitation of the ultrasonic method, there is a reliance on assumptions that create an imprecise measurement from the resolution (down to 0.075 inches). The ImageJ image processing software was used to conduct this image analysis. The equation used to determine the error in area is:

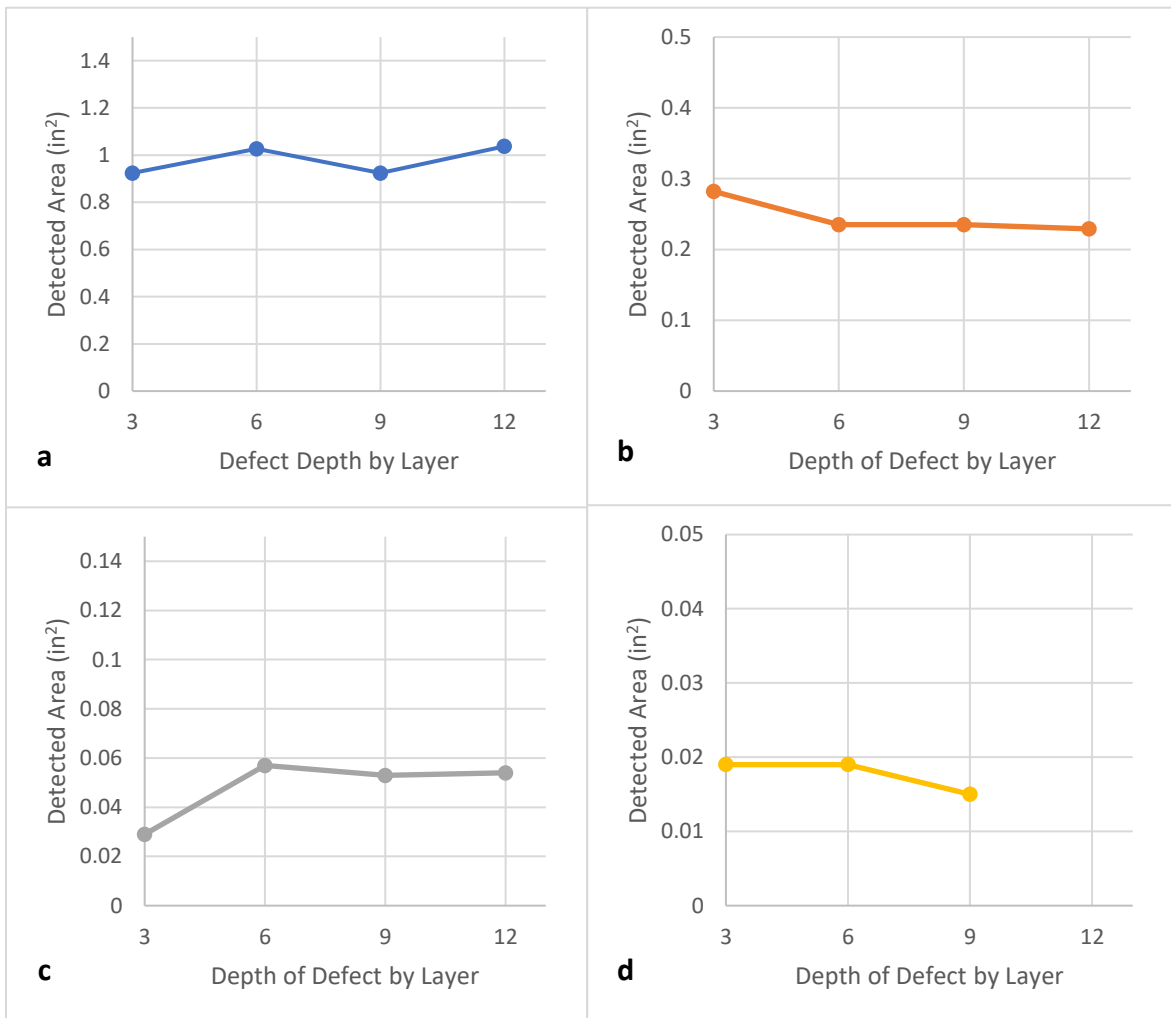
For ultrasonic scanning, the results across the various laminate thicknesses remained relatively steady, lacking any remarkable trends. Considering the near surface laminate dead zone limitations which impacts the thinnest and thickest samples respectively the results stay remarkably steady throughout, as seen in Figure 40. These finding are corroborated by a number of studies analyzing simulated delamination in CFRPs using ultrasonic scanning [17, 19]. The issues highlighted in the majority of these studies are the resolution of the scan and requiring some sort of image processing algorithm to predict what the scanned signature is more accurately. Within this study's data set we

see a number of issues beyond simple resolution flaws. The ultrasonic dead zone effect on area detection in near surface defects as it correlates to defect size is a parameter that has been identified through this study. Defects 1 and 2, being the largest, retained detectability throughout all of the samples whereas the smaller, Defects 3 and 4, had the most fluctuation and volatility across the Ultrasonic C-Scan tests. The range of thicknesses for the laminates used in this study are aimed to reflect actual use cases of aircraft skin assemblies, versus merely going to the extremes of CFRP thicknesses. A practical tool used in industry for

Figure 40: Ultrasonic C-Scan Defect 1 (1 in²) Detected Areas (a) Defect 2 (0.25 in²) Detected Areas (b) Defect 3 (0.0625 in²) Detected Areas (c) Defect 4 (0.0156 in²) Detected Areas (d)

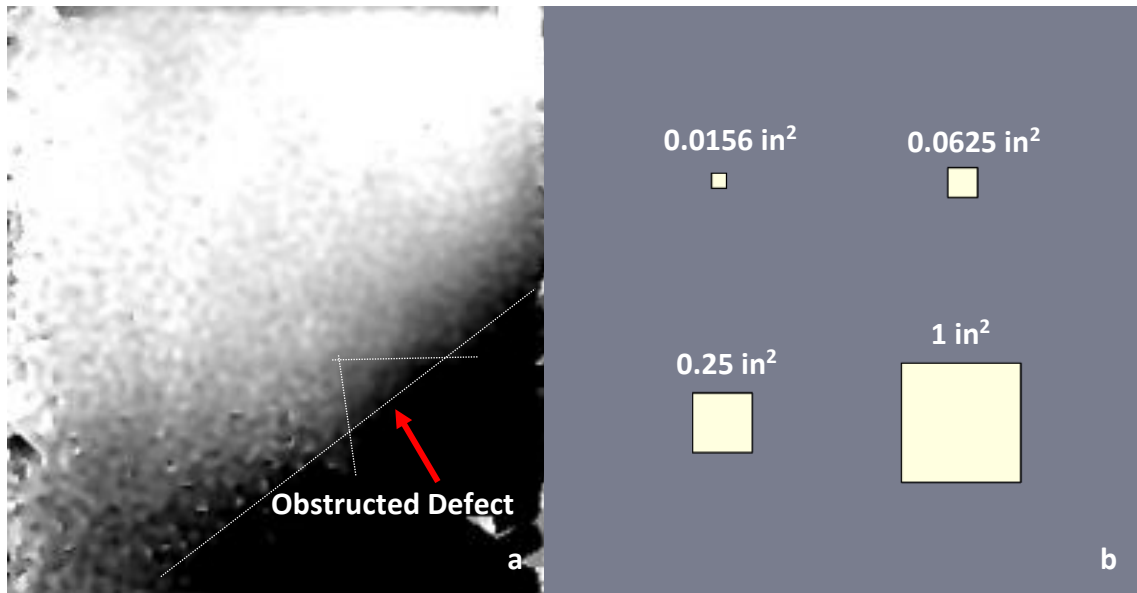
Laminate 3(4) experienced issues with the laser shearography system being used due to reflections. Even after application of an industrial-grade coat of matte spray penetrant to reduce glare, the surface was unable to be read well. The shearing angle of $+45^\circ$ can be observed given the reflections exhibited in Figure 43. The outline of the largest Defect 1's top left corner can be observed, however the glare resulting from the composite surface obstructs visual detection of the majority of the delamination defect. In a pure sense the largest defect was detected, however it is indiscernible that there are any other defects given the glare. It is likely that Defect 2 could be found given if surface finish was less problematic for the scanning device as it could be detected in Laminate 6(7) as well as trace

in 9(10). It is impossible to tell if Defect 3 or 4 could be detected at this thickness laminate sample.

Figure 43: Raw Shearography Data with Programmed Defect on 3rd Layer (a) and Laminate 3(4) Schematic (b)

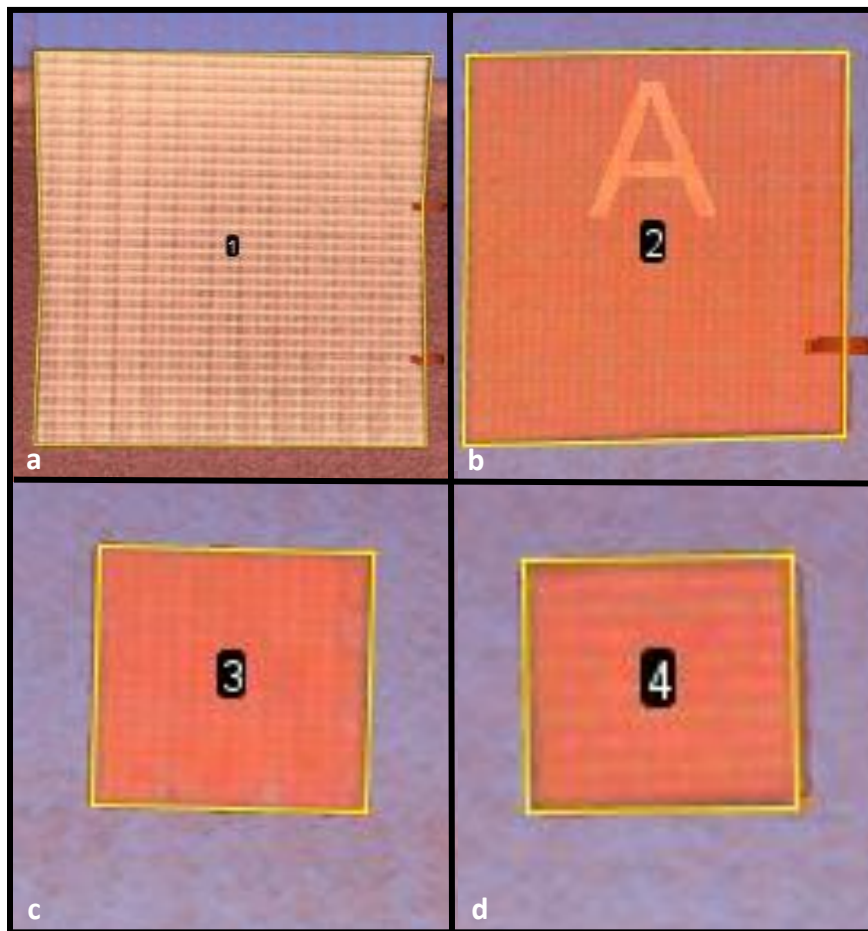
Figure 64: Laminate 3(4) Defect 1: 1 in² (a) Defect 2 (b)
Defect 3 (c) Defect 4 (d) Detected Area

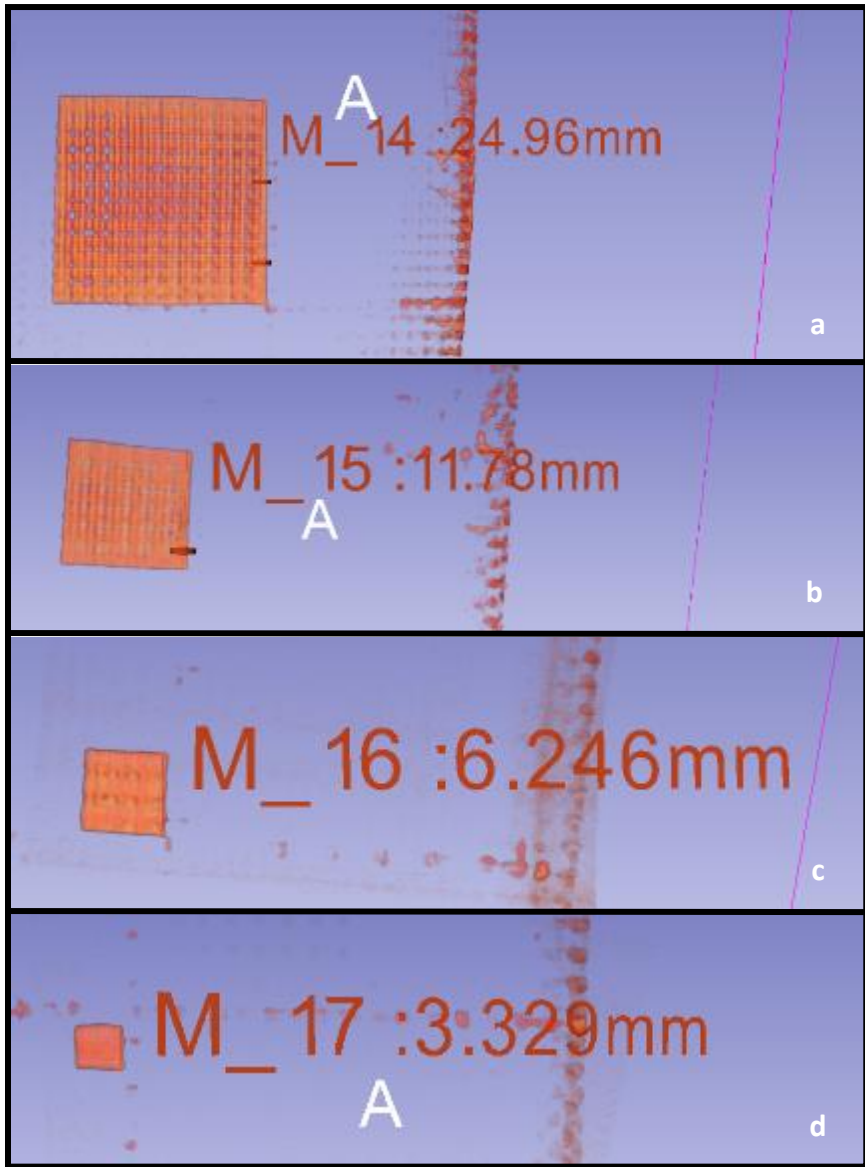
Figure 75: Laminate 12(13) Defect 1 (a) Defect 2 (b)
Defect 3 (c) Defect 4 (d) Raw Data (w/ Scale)

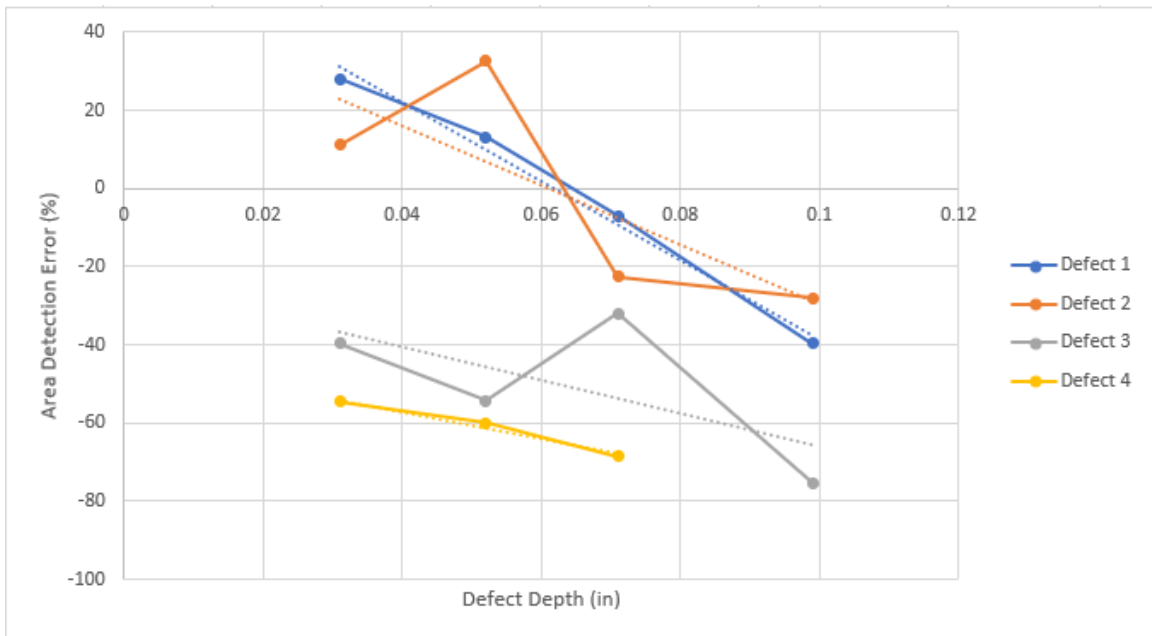
Figure 80: Thermography Defect Area Detection Inaccuracy Vs. Defect Depth

Figure 79 shows the relationship between depth and the inaccuracy of detecting various similarly defects for the thermographic scans conducted. The depths of the prescribed defects are those cited in section 3.5. What is obvious from the data presented is the trend towards undershooting the area prediction as the composite thickness increases. Additionally, smaller defects were under detected as well. The smallest delamination defects, Defect 3 and Defect 4, show high error across all laminates. This high error percent is due to the small defects absorbing larger amounts of heat relative to their size due to the reduction in surface area to volume, as heat conduction relies on surface contact between two mediums. Unlike Ultrasonic C-Scan, the defects observed had obvious trend as a relationship to area. Defect 1 follows a trend of $-1007.10x$ with an R^2 value of 0.9883. Defect 2 was found to have a trend of $-759.36x$ with an R^2 value of 0.5832. Defect 3 was found to have a trend of $-420.72x$ with an R^2 value of 0.4047. Finally defect 4 was found to have a trend of $-345.37x$ with an R^2 value of 0.9772. What is interesting about this is that not only do all defects in thermography experience a drop in area detection through thickness, larger defects experience harsher drop off in edge detection through thickness as well.
