## Implementation of safety management system for the domestic fleet in Myanmar

**IMPLEMENTATION OF THE SAFETY MANAGEMENT SYSTEM FOR DOMESTIC  
FLEET IN MYANMAR**

**MASTER OF SCIENCE**

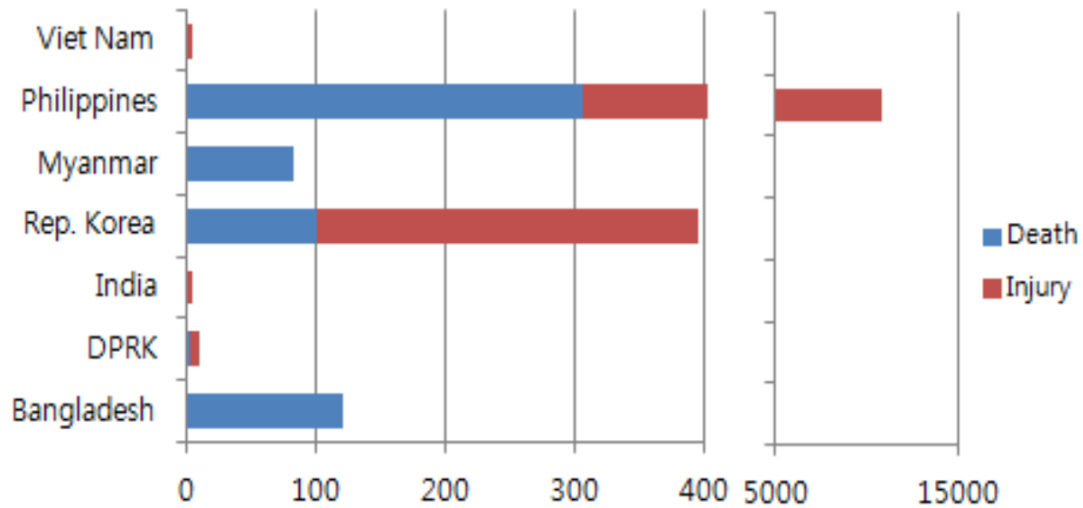
Figure 1- 2: Comparison for Number of Death and Injury between ESCAP Countries.

There is a significant difference in the number of casualties reported by countries responding. Figure 1-2 reveals that the Philippines, Bangladesh, the Republic of Korea, and Myanmar have more losses than others. On the other hand, other countries lack sufficient mechanisms to collect and manage casualty statistics (UNESCAP,2016). According to Dr Hebbert's (2020), the main problems which threaten the maritime safety of the domestic fleet are "overloading and overcrowding, pre-departure safety education, crew training for emergency scenarios and effective search & rescue efforts to alleviate fatal consequences". In addition, human factors are complex systems and errors affected by incompetence, overconfidence, carelessness, negligence, drinking, drowsiness, and fatigue.

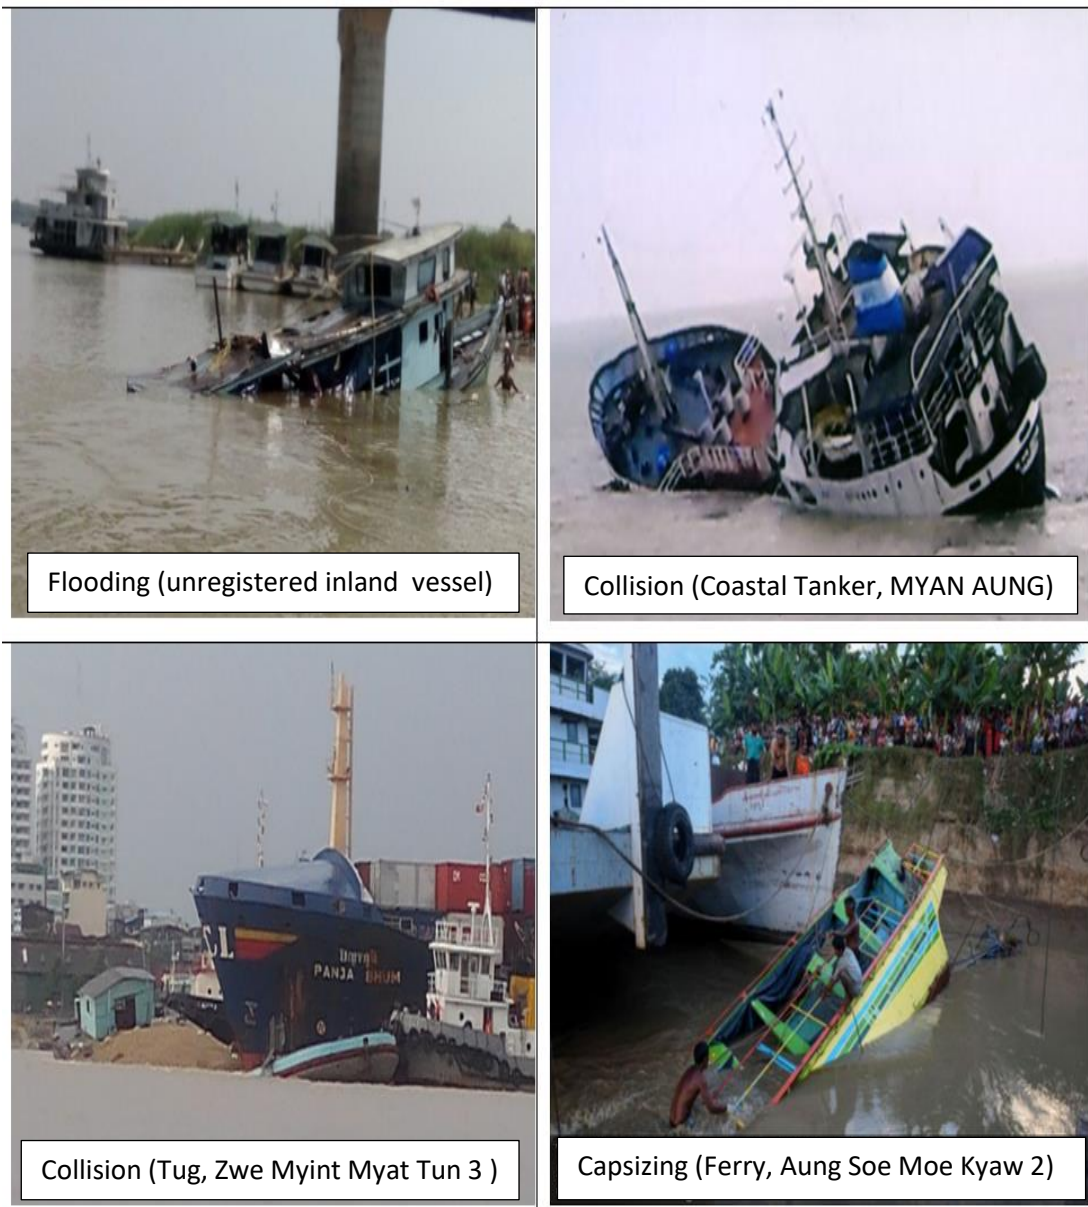
**Figure 1- 3:** Photos of domestic vessel accident in Myanmar.

third major maritime accident in Myanmar happened in 2017; a wooden boat carrying about 60 wedding guests collided with a container ship and sunk in Patheingyi, southwestern Myanmar, killing 20 people and leaving another dozen missing (Reuters,2017).

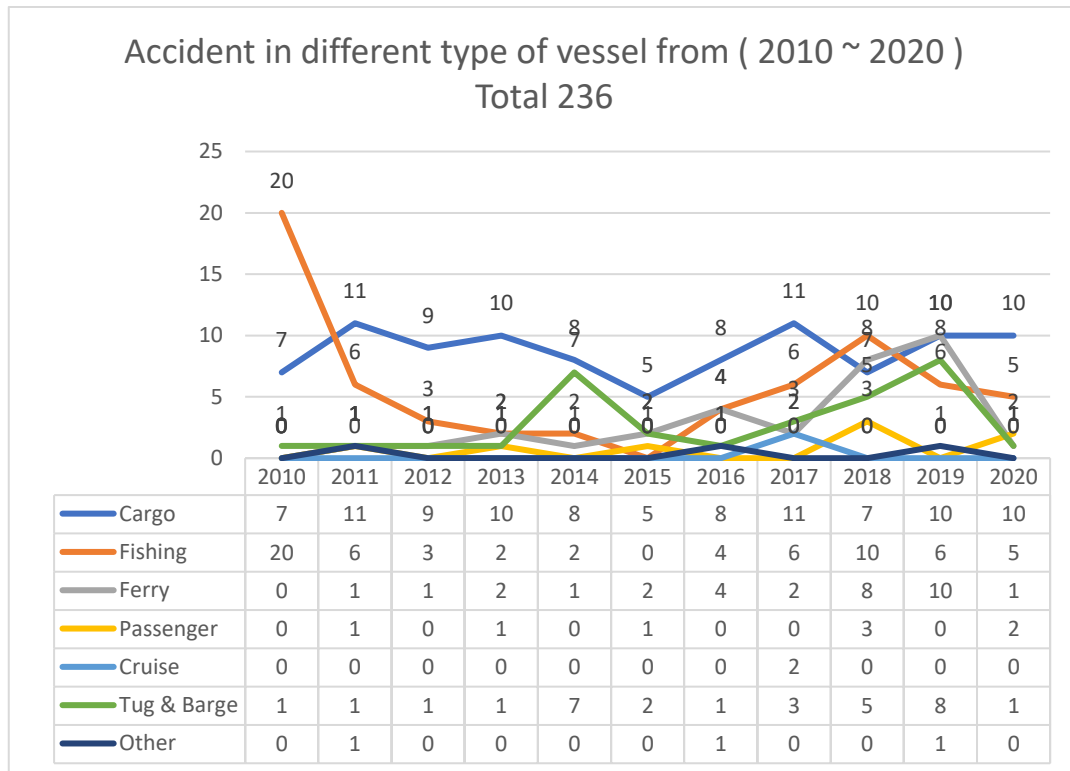
Figure 3- 1: Trend of Myanmar Domestic vessel accidents between 2010 to 2020.

The Domestic vessels are classified by Cargo, Fishing, Ferry, Passenger, Cruise, Tug and Barge, and other types based on design structure and nature of performing duty. The Cargo ships are about 1,0500 to 100 gross tonnage trading near Myanmar coastal and navigable river passage. Cargo ships : Trend highest number about 96 accidents while remaining stable during ten years cycle. Fishing vessels can be categorized by carrier, trawlers, and non-trawler which were the second number of the accident in Myanmar about 64 times in ten years cycle. However, the accident rate of fishing vessels was unstable due to a sharp decline from 2011 to 2015 and then significantly rose after 2015. Ferries, vital role of the transport sector in a rural area, third major accident in Myanmar about 32 cases between 2010 to the 2020

calendar year and accident trend peak up during 2019. Furthermore, Tug and Barge are the backbone of inland waterway transport and the largest fleet in Myanmar, nearly the same as the rate of Ferry accidents, about 31 cases during a decade.

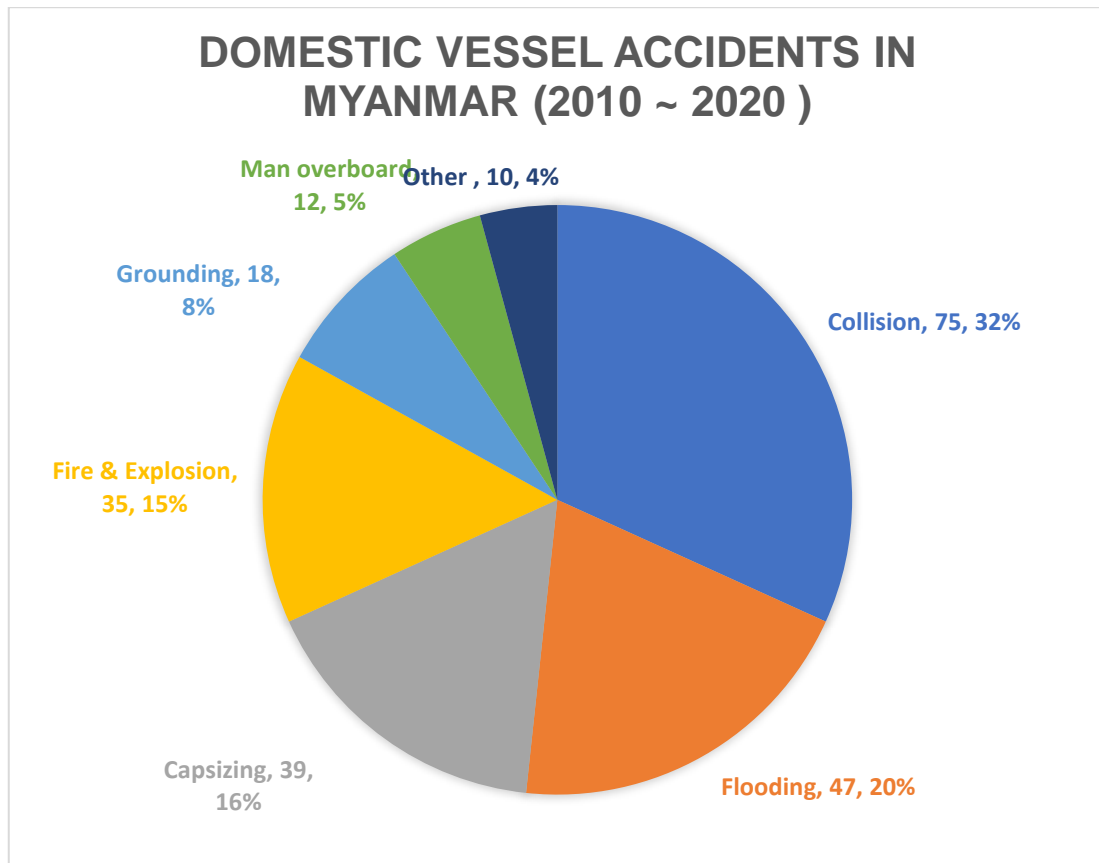
**Figure 3- 2:** Type of domestic vessel accidents in Myanmar between 2010 to 2020.

According to the Classification of Domestic vessel accidents in Myanmar, Collision is the highest and thirty-two percentage of total cases in Domestic fleet. Flooding is the second-highest number of accidents in Myanmar domestic fleet, about twenty percent. Capsizing and Fire are the second and third significant cases, about sixteen and fifteen percent of all total. Finally, grounding, man-overboard, and other unspecified accidents are least number of instances in Domestic vessels below ten percent.

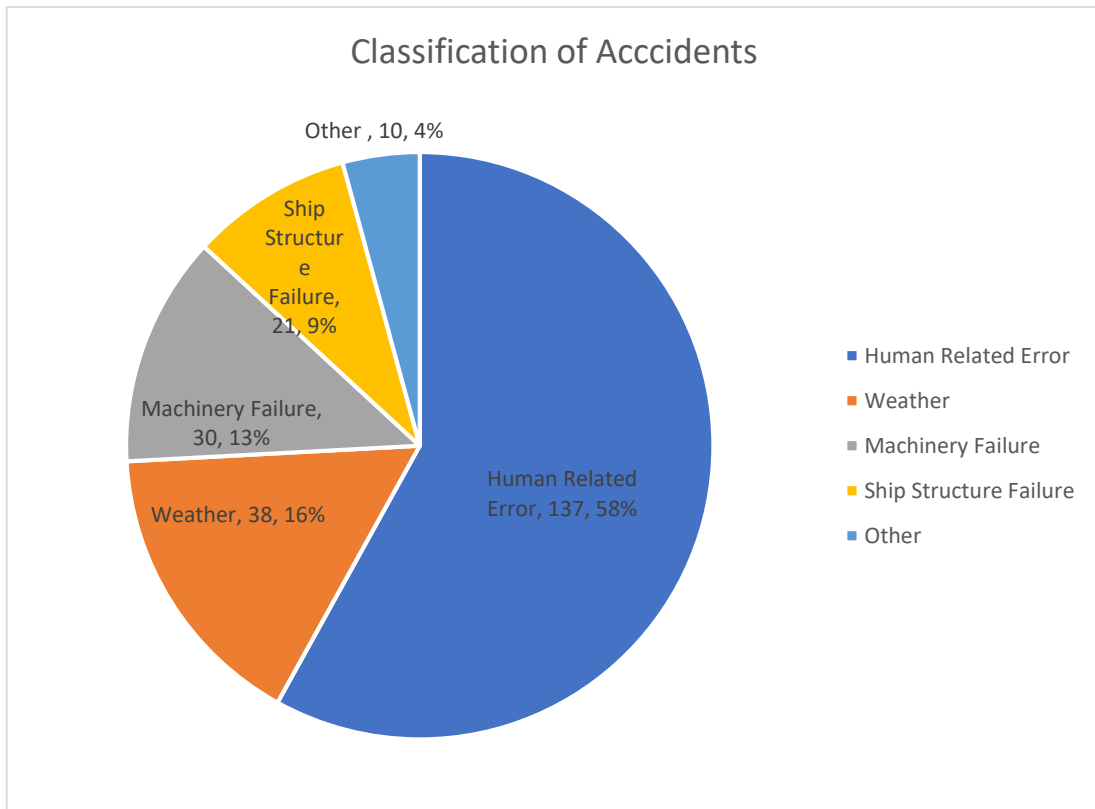
**Figure 3- 3:** Accidents classification for the domestic fleet in Myanmar.

According to accident records, about 236 cases were reported to authorities within eleven years, and 137 cases were based on human-related errors in the coastal and inland waterways. By comparison, the fatalities rate in domestic shipping is significantly higher than in international voyages. However, there is an incredible finding that the major root causes of all accidents in domestic and international voyages are nearly the same percent, with human-related error over 50 percent.

As the technology has advanced over the years, machinery cause to the accident has been reduced over time. However, there is more and more accident caused by human factor. Additionally, the figure 3- 3 in chapter 3.5 shows that human error contributes to 58% of Domestic vessel accidents, including the majority of navigation accidents and Fire and explosions. Therefore, the study needs to analyze with HFACS taxonomy to understand and prevent human error, which will be the key to improving safety.

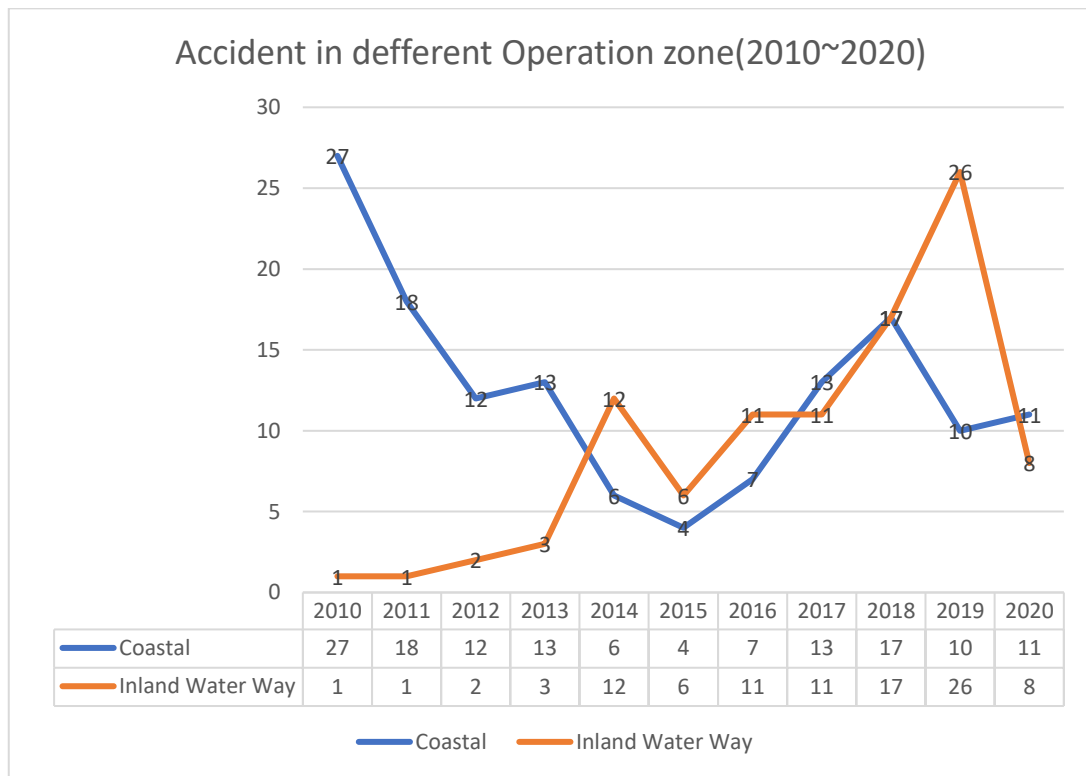
**Figure 3- 4:** Comparing between Coastal and Inland Water Way for accident cases from 2000 to 2020.

The above graph showed that total accidents cases for eleven years in inland and coastal areas were nearly the same. Therefore, trading areas are less influence by the implementation of a safety management system within Myanmar water. Within four years, from 2014 to 2018, insignificant trend of domestic vessel accident between inland and coastal vessel, while found the highest different rate between two area for the year of 2010 and 2019.

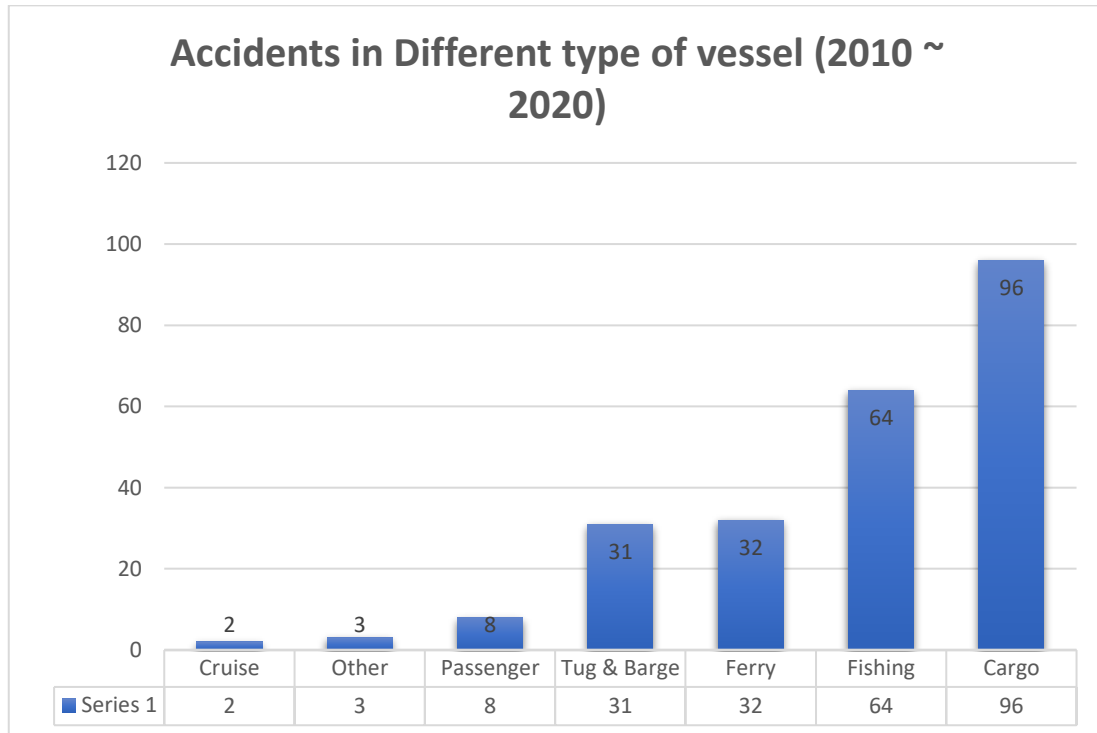
**Figure 3- 5:** Accidents rate in different types of vessels in Myanmar Domestic fleet between 2010 to 2020.

The highest number of accidents happened in cargo, fishing, ferry, and tug between 2010 to 2020. After comparing the total vessel and total accident rates, fishing, passenger, ferry, and cargo vessel are the highest in order. However, some accident cases happened in unregistered vessels and small boats that DMA did not control. The fishing sector is the highest rate for unregistered ships in Myanmar.

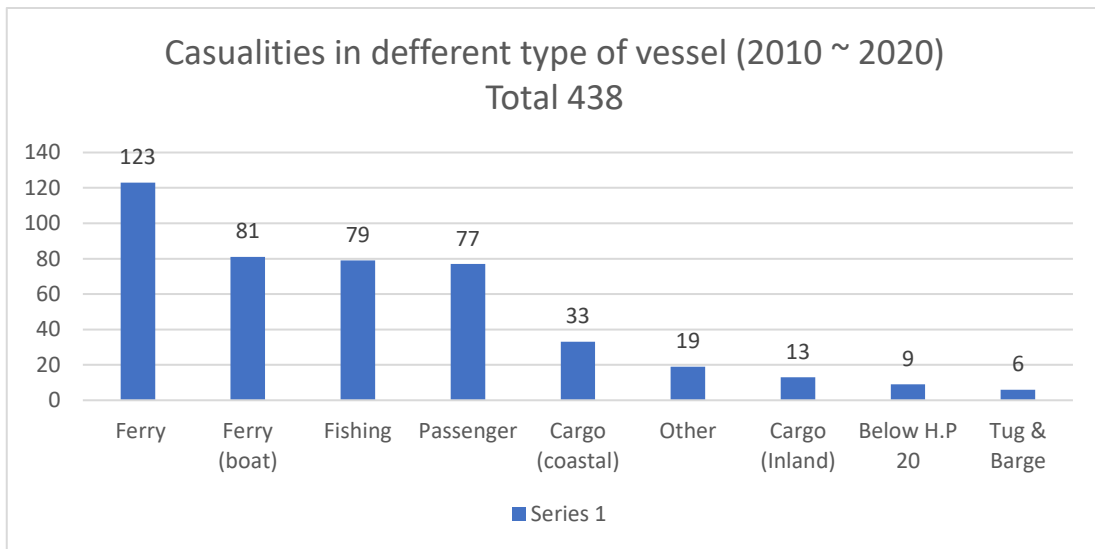
**Figure 3- 6:** Rate of casualties for a different type of vessels in Myanmar Domestic fleet 2010- 2020.

In Myanmar, significantly high casualties rates in the ferry sector and small boat, fishing, and passenger vessels are the second-highest fatalities rates in Domestic shipping. Very few fatalities rate in other sectors from 2010 to 2020, such as cargo, tug, barge, and other types of vessels.

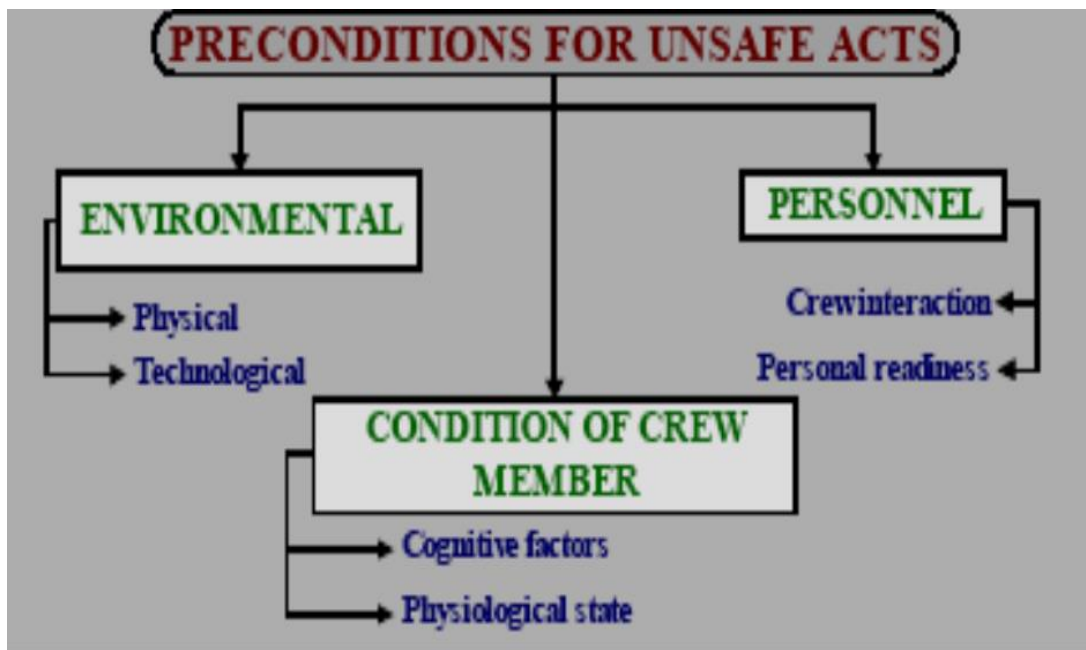
**Figure 4- 2:** Classification of preconditions for unsafe acts.

Active or latent preconditions for unsafe acts are essential factors in an accident. For example, environmental factors, operators, and employees influence individuals'

behaviours, resulting in an unsafe condition or operator error, resulting in an unsafe condition or operator error (Onsongo. E.K, 2017). The above figure exhibiting Individual elements and environmental factors embrace both physical condition and human-environment interactions (cognitive) that include all kinds of conditions. Cognitive factors that contribute to an error in cognitive or individual perceptions and performance are influenced by environmental factors, which might lead to human error or an undesirable condition and Improper body functioning, comprising the physical and chemical processes of cells, tissues, organs, and systems. Their complex interactions can cause an individual to make an error or engage in unsafe behaviour.

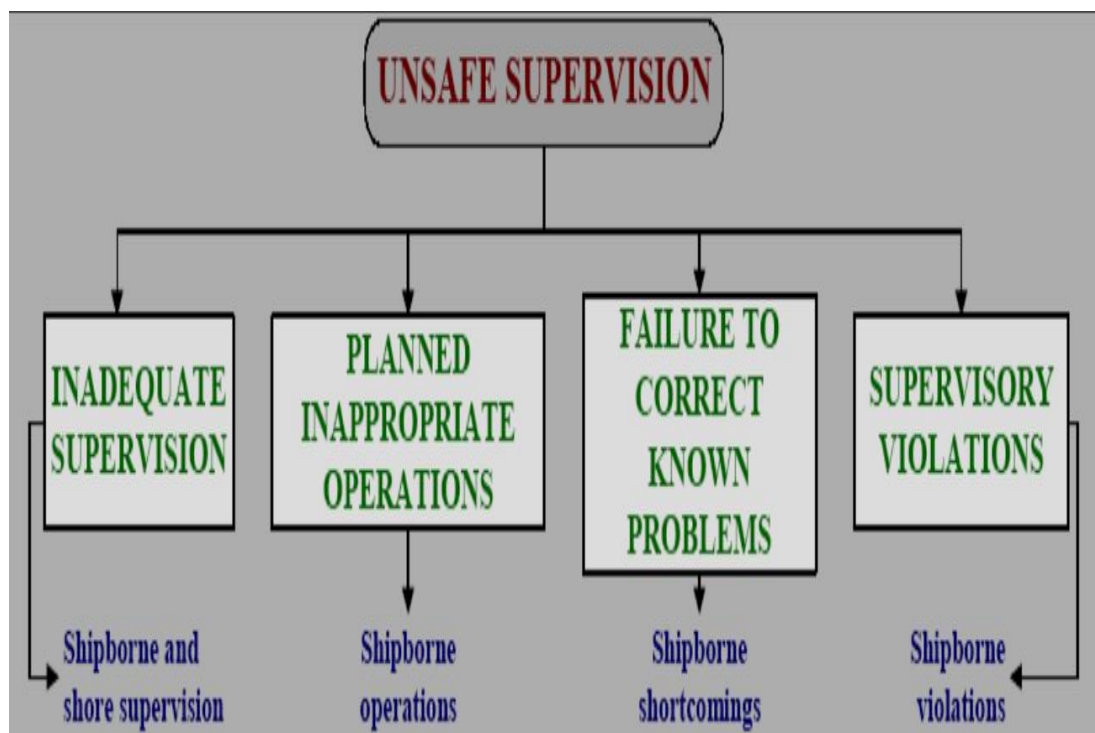
**Figure 4- 3:** Illustration of unsafe supervision.

Inadequate Supervision, planned improper operations, supervisory violations, and failure to rectify recognized problems are the four different factors of unsafe Supervision. The factors are directly affected by practices, conditions, or actions from management level decisions, procedures, or policies resulting in human error or a dangerous environment at the managerial level to technical or support level (Onsongo. E.K,2017).

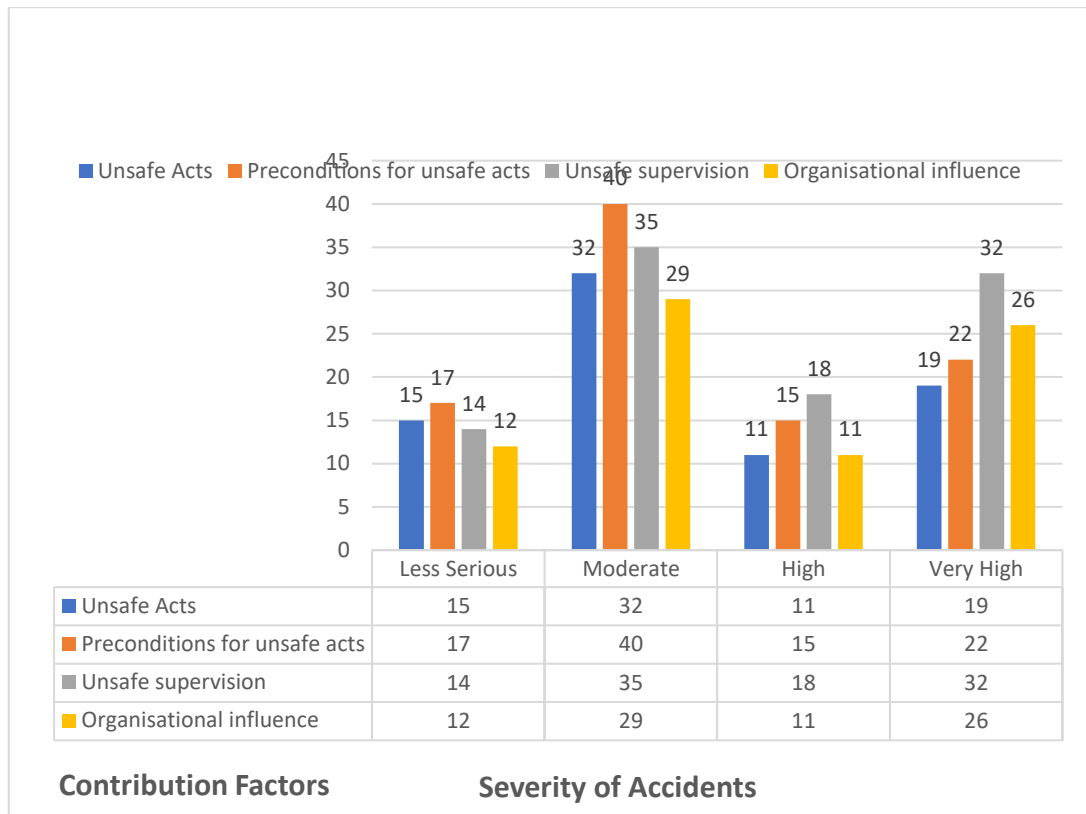
**Figure 4- 5:** Comparison between Severity and contribution factors.

According to HFCS analysis results from twenty investigation reports, the above chart illustrates how the severity of accidents is related to the contributing factors, i.e., unsafe acts, preconditions for unsafe acts, unsafe Supervision, and organizational influence.

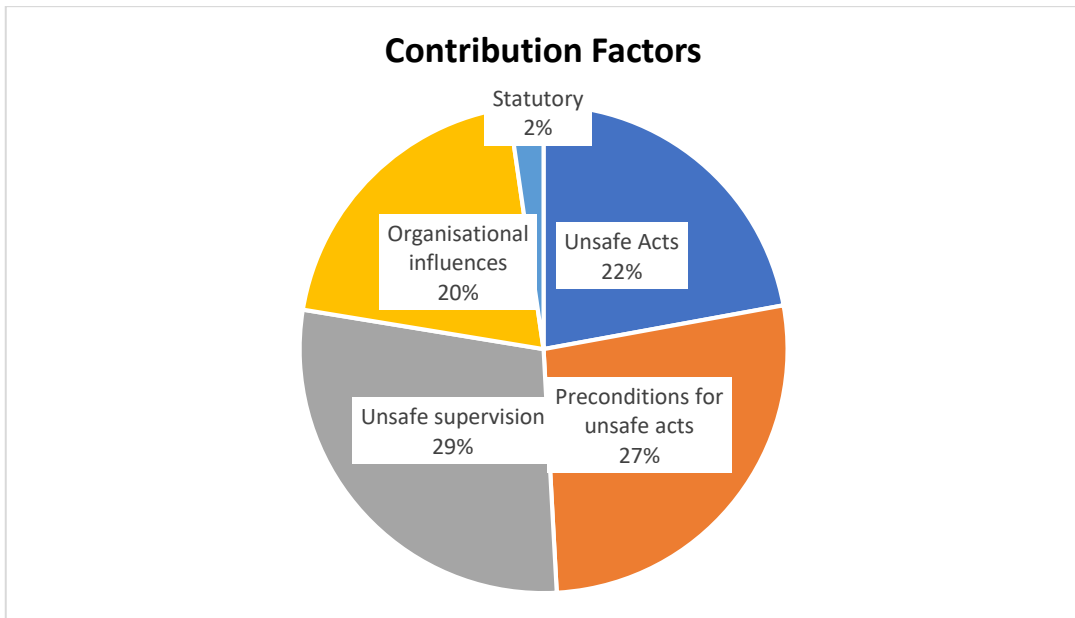
Figure 4- 6: Highlight of Contribution Factors.

This pie chart shows the highlighted description of the contributing factors identified in maritime accidents according to twenty investigation reports: (1) statutory; (2)

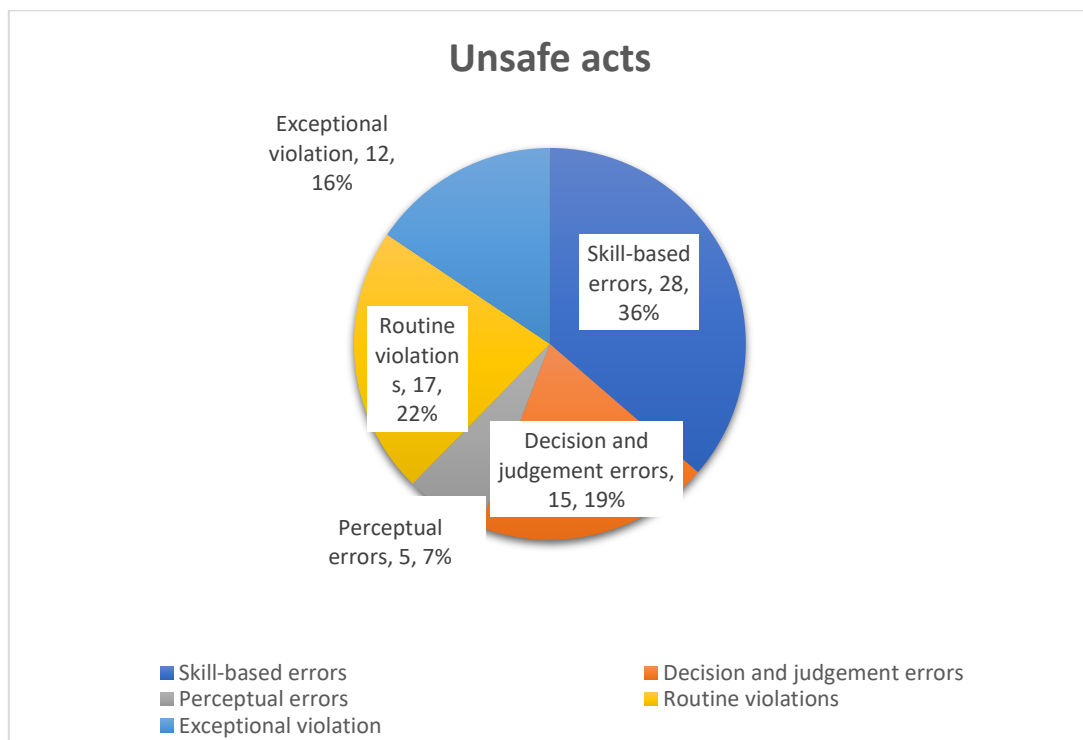
Figure 4- 7: Contribution of unsafe acts

Unsafe acts are causal factors at the lowest organizational level. It relates to active actions carried out by crew members where the outcome does not necessarily match the original intention.

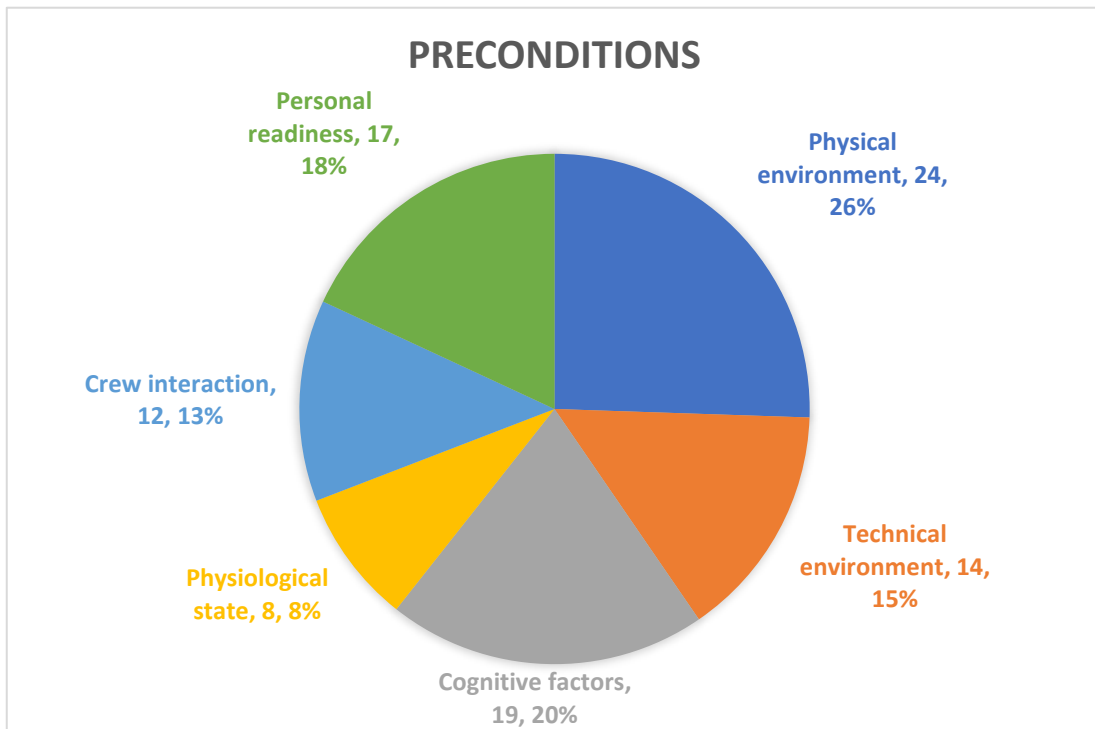
Figure 4- 8: Contribution of preconditions for unsafe acts.

Preconditions for unsafe acts were introduced in the HFACS framework to consider the immediate precursors to unsafe acts. Factors on this level relate to environmental (workspace) factors (e.g., faulty equipment), crew conditions (e.g., fatigue), or personnel factors (e.g., inadequate training).

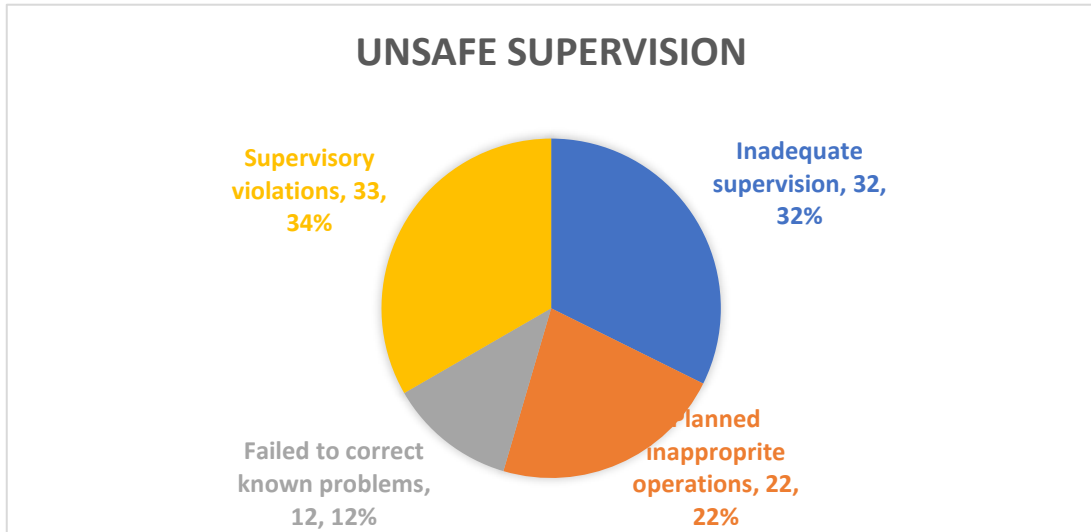
Figure 4- 9: Contribution of unsafe Supervision.

Unsafe Supervision is a factor in a mishap if the methods, decisions, or policies of the supervisory chain of command (officers at management level over operational and support levels) directly affect individuals' practices, conditions, or actions and result in human error or an unsafe situation.

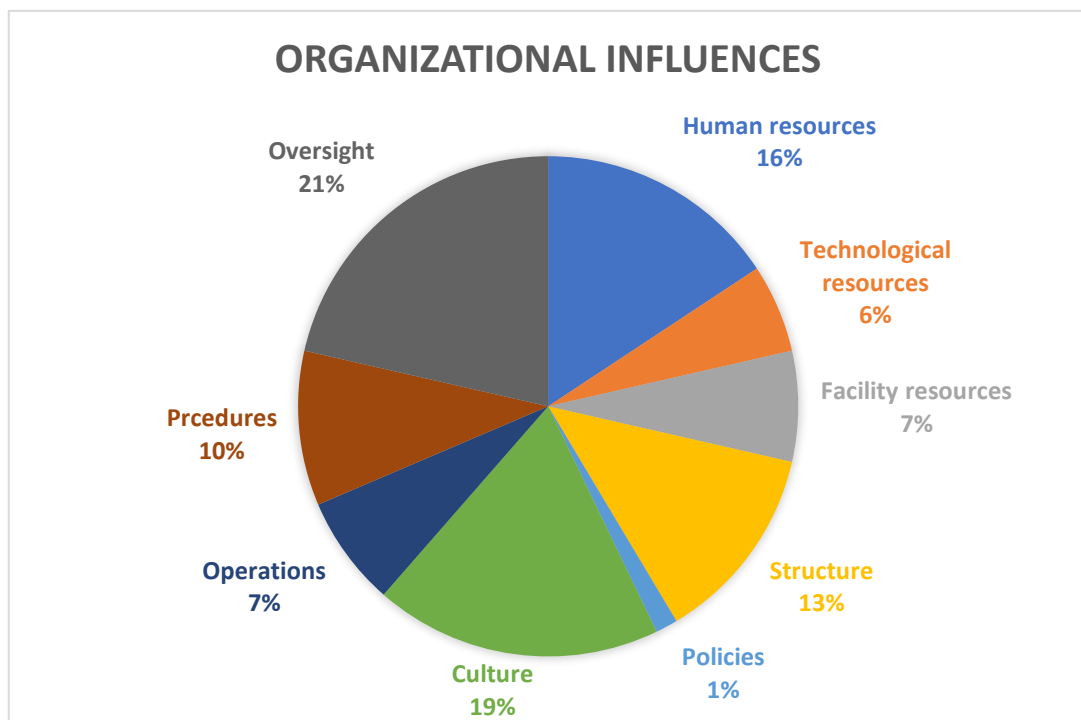
**Figure 4- 10:** Contribution of organizational influences.

Organizational influences are factors in a mishap if the communications, actions, omissions, or policies of upper-level management directly or indirectly affect

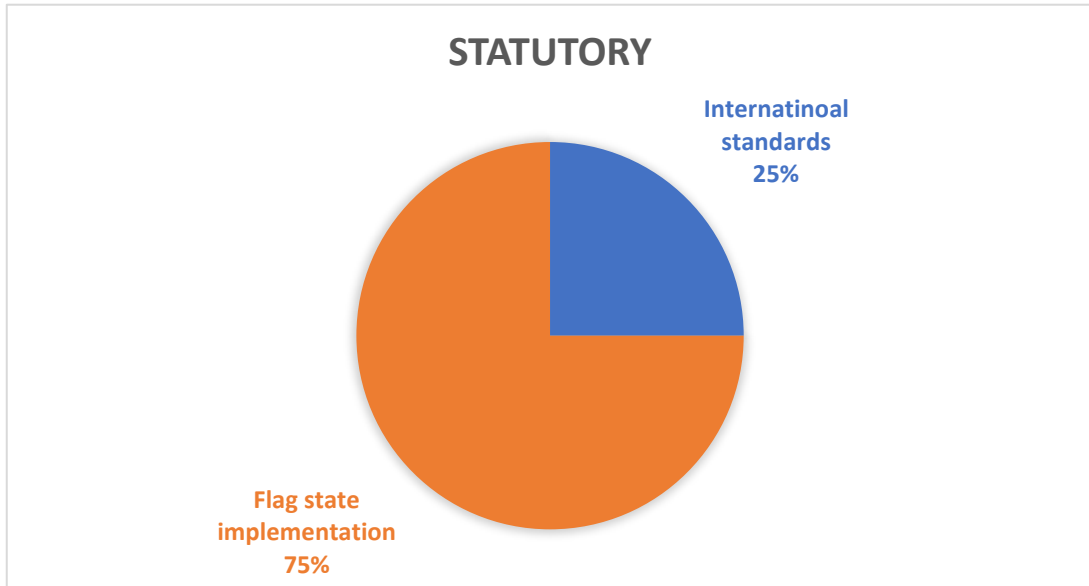
Figure 4-11: Contribution of statutory.

Statutory are factors in a mishap if the regulator's regime is either sub-standard or lacks the necessary depth, leading to an unsafe situation.
