Secondary peak of downstream light field modulation caused by Gaussian mitigation pits on the rear KDP surface

Abstract: Micro-milling has been proved to be the most effective method to mitigate the growth of laser-induced surface damage on potassium dihydrogen phosphate (KDP) crystals used in high power laser systems. However, the secondary peak of downstream light field modulation caused by Gaussian mitigation pits on the rear KDP surface would cause potential risk to damage downstream optics. In order to explore the effect of the mitigation pits on the secondary peak, we numerically calculated the downstream light field modulations caused by Gaussian mitigation pits on the rear KDP surface based on the angular spectrum diffraction theory. The results suggest that the secondary peaks are dependent on the parameters of the width, depth, depth error and tilt error. Among them, the tilt error and depth have greater influence on the mitigation effect. To reduce the laser damage risk caused by the secondary peak, the depth of the pre-designed mitigated contour should be optimized according to the actual operating conditions. The tilt error and depth error are proposed to be controlle

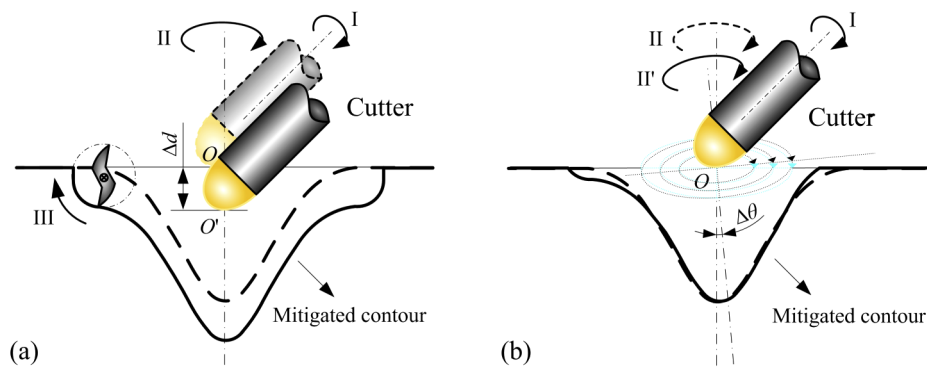
Fig. 2. Schematic diagrams of the machining error production during the micro-milling processes on the KDP surface. (a) The depth error Δd caused by the deviation on tool setting point. (b) The tilt error $\Delta\theta$ caused by the angle between the cutter revolution plane and the KDP surface.

In the actual processes of KDP surface mitigation, the geometric morphology of the mitigated contour is not only related to the pre-designed parameters, but also affected by machining errors, such as the depth error Δd caused by the deviation on tool setting point (Fig. 2(a)) and the tilt error $\Delta\theta$ caused by the angle between the cutter revolution plane and the KDP surface (Fig. 2(b)). In the schematic diagrams, the dash lines and solid lines represent the pre-designed contours and the mitigated contours of the pits, respectively. The micro-milling processes generally begin at the ideal tool setting point O . During the processes, while the tilt cutter is rotating at high speed in the direction I, it also spins around in the revolution direction II. The actual tool setting point O' is always below the KDP surface, which is the main reason of depth error Δd , in Fig. 2(a). Due to the local cutting effect on the edge of the mitigation pit in the direction III of sectional view, curved steps would be generated around the mitigated counter. In Fig. 2(b), the ideal and actual revolution planes of the cutter during micro-milling are shown by the dot circles of green and black, respectively. The axis of the outline is indicated by a dash-dot line. The tilt error $\Delta\theta$ would cause a significant change to repaired morphology as the solid of mitigated contour. The mitigation pit morphology began to become asymmetrical.

The solving results of the downstream light field modulation can be seen in Fig. 6. The three curves correspond to the Gaussian mitigation pits with the depth error Δd of 0 , $1\ \mu\text{m}$ and $2\ \mu\text{m}$, respectively. All these curves rise slightly after 100mm . From the inset, the modulation of $\Delta d = 1\ \mu\text{m}$ increases the most among the range from 100mm to 300mm . Compared with the secondary peak of $\Delta d = 0$, its value adds from 2.2 to 2.4 . But as Δd increases to $2\ \mu\text{m}$, the secondary peak is not larger than that of $\Delta d = 1\ \mu\text{m}$, even with some slight decline. This is similar to the effect of depth on the variation of the secondary peak. The depth error would alter the overall depth of the mitigation pit, which should be the reason for the similarity. However, different from the repair depth variation, the depth error only changes the local details of the contour. Thus, the depth error plays a minor effect on the secondary peak. As for the depth error less than 2 , their secondary peaks are all less than 3 . The modulations are safe for downstream optical elements. The inserted diffraction pattern describes the light intensity distribution caused by the mitigation pit with $\Delta d = 1\ \mu\text{m}$ at the position corresponding to the secondary peak. The maximum light intensity is located on the off-axis ring caustic. The off-axis ring caustic is mainly due to the arc contour around the mitigation pit, which produces the effects like a convex lens [32,33]. According to the theoretical analysis (Fig. 2(a)) in the Section 2, the depth error would generate curved steps at the

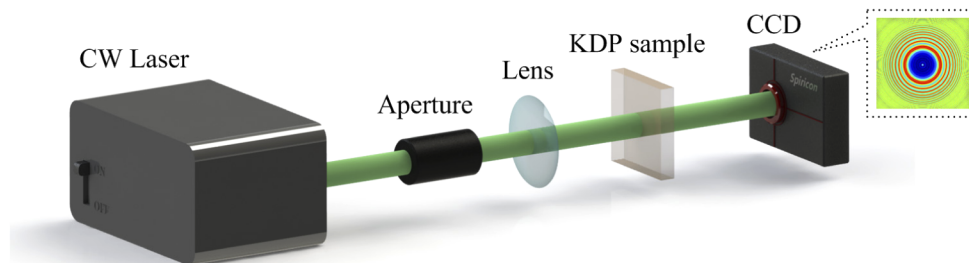
Fig. 3. Light path for detecting the distribution of downstream light field at different locations.

Subsequently, the distributions of downstream light field at different locations behind the mitigated KDP surface were detected with the light path in Fig. 3. The laser outputted a continuous laser beam with a wavelength of 527nm. Then, the laser was spatially filtered and collimated by using the aperture and lens. The laser spot diameter that applied to irradiate the mitigated KDP crystal was ~ 5 mm. The Gaussian mitigation pit on the KDP surface was able to be completely covered by the laser spot. After the laser passing through the mitigated KDP sample, the diffraction patterns induced by the laser light perturbation would be imaged onto a digital CCD camera.

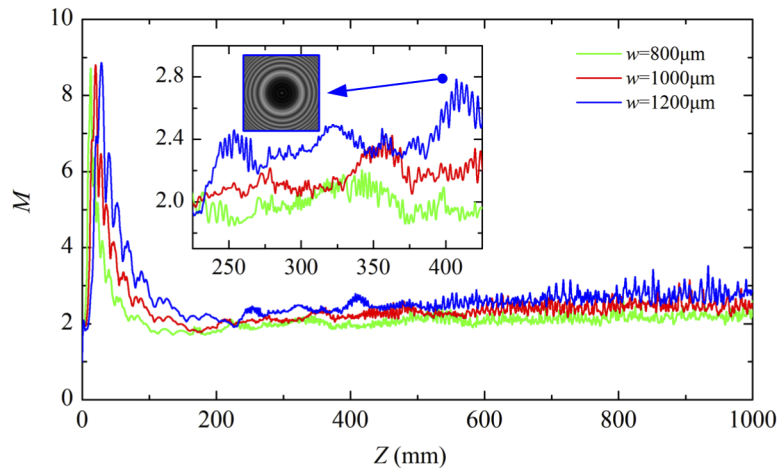
Fig. 4. Modulation curves of downstream light field modulation with respect to propagation distance caused by the Gaussian mitigation pits with depth of 10 μm and widths of 800 μm , 1000 μm and 1200 μm , respectively. The inset is a partial enlargement of the modulation curves near the secondary peak, wherein the inserted diffraction pattern describes the light intensity distribution caused by the mitigation pit with the width of 1200 μm and depth of 10 μm at the position corresponding to the secondary peak.

The scalar diffraction theory was used to calculate the downstream light field modulation behind rear KDP surface with the Gaussian mitigation pits. Figure 4 shows the curves of downstream light field modulation with respect to laser propagation distance caused by the Gaussian mitigation pits with the depth of 10 μm and width of 800 μm , 1000 μm and 1200 μm , respectively. The three curves are almost parallel. As the propagation distance from the rear surface increases, the light field modulation increases sharply first, and then decreases to a stable value. When the curve of downstream light field modulation tends to be stable, the secondary peak appears. The inset is a partial enlargement of the modulation curves near the secondary peak. When the width of the repaired contour increases, the secondary peak of the modulation curve increases slightly. As for the mitigation pits with the width of 800 μm and 1200 μm , they are ~ 2.2 and

~ 2.8 , respectively. The modulation increases by 27%, which is not so big compared to the 50% increment in width. The diffraction pattern shown in the inset of Fig. 4 describes the light intensity distribution caused by the mitigation pit with the width of 1200 μm and depth of 10 μm at the position where the downstream secondary peak modulation is. Light intensifications are caused by on-axis hot spot and off-axis ring caustic in the diffracted field [24,32], which are clear in this pattern. The maximum light intensity is at the center of the diffraction pattern. This indicates that the repair width increment results in the enhancement of the on-axis hot spot at the far position of the diffraction. Previous studies have also suggested that the on-axis hot spot is related to the overall contour of the repaired area [32]. Thus, it can be believed that the secondary peak due to the width increase is related to the on-axis hot spot that generated by diffraction. Besides, the modulations of the secondary peaks are too small to cause laser damage. It could not be paid more attention in the optics installation.

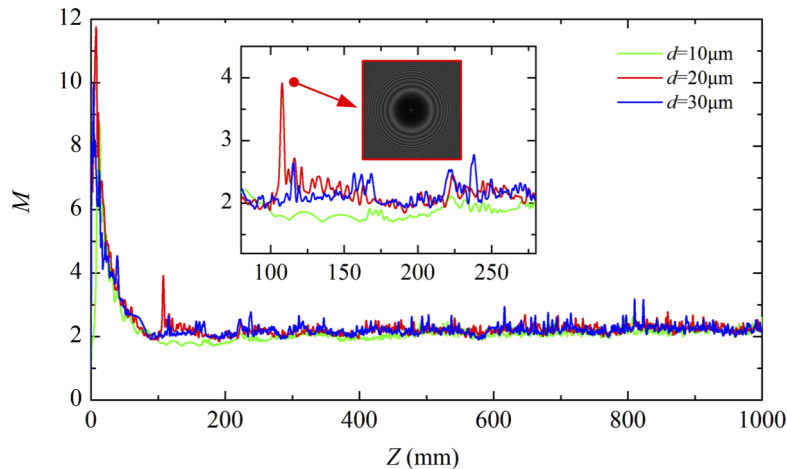
Fig. 5. Modulation curves of downstream light field with respect to laser propagation distance caused by the Gaussian mitigation pits with the width of $800\ \mu\text{m}$ and depths of $10\ \mu\text{m}$, $20\ \mu\text{m}$ and $30\ \mu\text{m}$, respectively. The inset is a partial enlargement of the modulation curves near the secondary peak, wherein the inserted diffraction pattern describes the light intensity distribution caused by the mitigation pit with width of $800\ \mu\text{m}$ and depth of $20\ \mu\text{m}$ at the position corresponding to the secondary peak.

In order to determine the effect of the repair depth on the secondary peak, we calculated the downstream light field modulation caused by the Gaussian mitigation pits with the width of 800 μm and depths of 10 μm , 20 μm and 30 μm , respectively. Figure 5 is the curves of downstream light field modulation with respect to laser propagation distance. Different from the effect of the width variation of Gaussian mitigation pit on the rear KDP surface on the downstream light field modulation, the modulation degree is more sensitive to the depth variation of the Gaussian mitigation pit. The inset is a partial enlargement of the modulation curves near the secondary peak. The secondary peaks of the downstream light field modulation generated by the Gaussian mitigation pits with widths of 10 μm , 20 μm and 30 μm are ~ 2.2 , ~ 4 and ~ 2.6 , respectively. The modulation degree of light field increases firstly and then decreases with the increase of the repairing depth. Its growth is nonlinear. From the secondary peak values of the light field modulation, they increase significantly as the depths of mitigation pits increase. The repair depth doubles from 10 μm to 20 μm . Then, the secondary peak gets 82% higher. Thus, the depth variation has more influence on the secondary peak than the width variation. The cross section of

light intensity distribution at the position corresponding to the secondary peak of the modulation curve for the Gaussian mitigation pit with the width of $800\ \mu\text{m}$ and depth of $20\ \mu\text{m}$ is shown in the inserted diffraction pattern in Fig. 5. As can be clearly seen from the pattern, the on-axis hot spot dominates with the largest light intensity. The light intensity contrast is even more obvious than that in the diffraction pattern of Fig. 4. The increase of the repair depth introduces more phase components, which contributed to the enhancement of diffraction. However, for some special damage points, deep mitigation contours should be designed for damage material removal. Thus, for deeper Gaussian mitigation pits, it is important to reasonably avoid the secondary peak of the downstream light intensification.

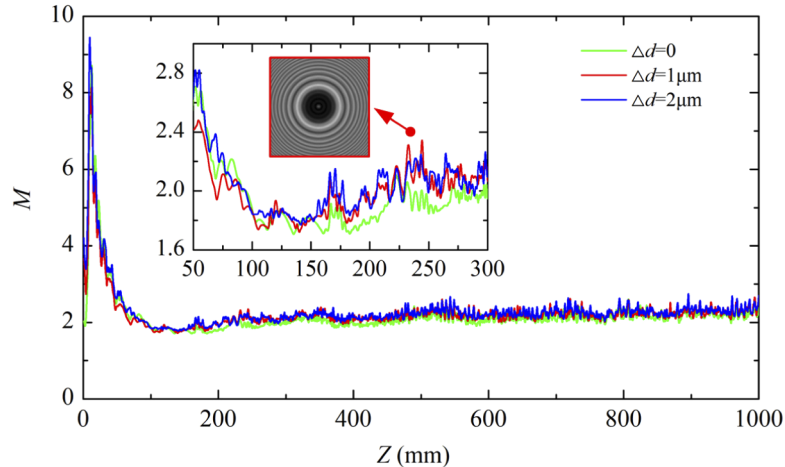
Fig. 6. Modulation curves of downstream light field with respect to laser propagation distance caused by the Gaussian mitigation pits with the depth error Δd of 0, $1\ \mu\text{m}$ and $2\ \mu\text{m}$, respectively. The inset is a partial enlargement of the modulation curves near the secondary peak, wherein the inserted diffraction pattern describes the light intensity distribution caused by the mitigation pit with $\Delta d = 1\ \mu\text{m}$ at the position corresponding to the secondary peak.

edge of the repaired contour. This is the reason why the secondary peak rise with the depth error added. Due to the lower enhancement of the secondary peak, depth errors less than $2\ \mu\text{m}$ caused by the deviation on tool setting point are acceptable in the actual micro-milling process.

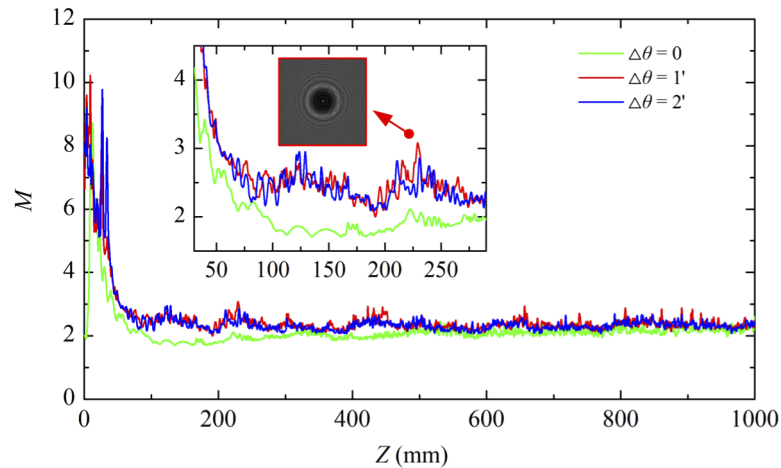
Fig. 7. Modulation curves of downstream light field with respect to laser propagation distance caused by the Gaussian mitigation pits with the tilt error $\Delta\theta$ of 0, 1' and 2', respectively. The inset is a partial enlargement of the modulation curves near the secondary peak, wherein the inserted diffraction pattern describes the light intensity distribution caused by the mitigation pit with depth error $\Delta\theta = 1'$ at the position corresponding to the secondary peak.

The modulation curves of downstream light field with respect to laser propagation distance are exhibited in Fig. 7. These three curves correspond to the Gaussian mitigation pits with the tilt error $\Delta\theta$ of 0, $1'$ and $2'$, respectively. In general, as the tilt error of the mitigation pit increases, the tendencies of other modulation curves are nearly the same with the modulation over that of $\Delta\theta = 0$. And these two curves fluctuate strongly. When $\Delta\theta = 1'$, the curve increases the most and the secondary peak is greater than 3. The curve of $\Delta\theta = 2'$ almost overlaps with the curve of $\Delta\theta = 1'$, with the secondary peak a little bit smaller. The results suggest that the small variation of tilt error would have great influence on the modulation. It is because that the tilt error results in a great change in the geometry of the mitigated contour. As shown in Fig. 2(b), the contour of perfect spatial symmetry is broken. When a light beam passes through the surface, it is easier to generate diffraction points with high light intensity. The inserted diffraction pattern is the light intensity distribution caused by the mitigation pit with $\Delta\theta = 1'$ at the position corresponding to the secondary peak. Due to the tilt of the repaired profile, the bright rings are slightly offset to one side, and not perfect concentric. The on-axis hot spot is also off the center with the largest light intensity. The modulation degree exceeds 3, which would cause ionization breakdown or high-temperature ablation for the downstream optics, resulting in irreversible material damage. Thus, the tilt error should be controlled within $1'$.
