# Smart Patch for Structural Health Monitoring of Composite Repair

**Abstract:** The bondline integrity of a repair patch to the parent composite laminate is considered the most important factor in the repair design. A smart repair patch is proposed here to allow for real-time ultrasonic guided wave monitoring of repaired composites. A diagnostic film with lead zirconate titanate (PZT) transducers and inkjet-printed wires is embedded into the repair patch using a cut-out method. The electro-mechanical impedance (EMI) method is used to verify the integrity of the embedded PZT transducers. The performance of the smart repair patch is assessed on the external panel with artificial bondline delamination and surface-mounted artificial damage. The damage index correlation coefficient and delay-and-sum (DAS) algorithm are used for damage detection and localization. The results show that the developed repair patch can successfully detect and locate damages.

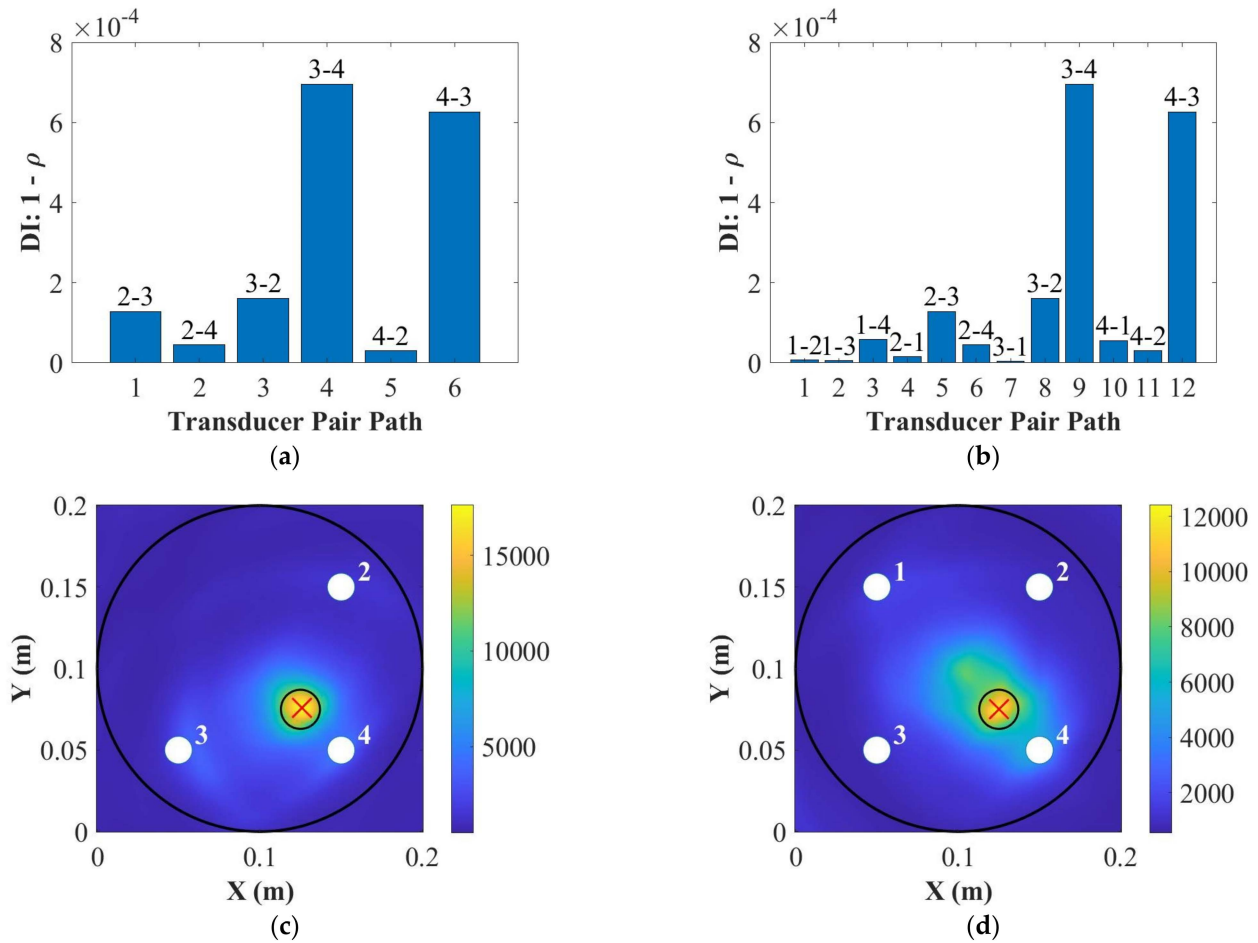
**Figure 8.** Detection of surface-mounted artificial damage on the surface of the repair patch using (a) three PZT transducers and (b) four PZT transducers, and localization using (c) three PZT transducers and (d) four PZT transducers at 250 kHz for the position 2 (where the “○” is the position for real damage and the “×” is the position for predicted damage).

To simulate the repair patch suffering surface damage, a weighted blue tack was attached on the surface of the repair patch. Figures 7 and 8 show the results of damage detection and localization for the surface-mounted artificial damage attached on the surface of the repair patch. As can be seen in Figures 7 and 8, using both three and four PZT transducers can detect and locate the damage accurately. In this situation, the blue tack was removed from the surface of the repair patch only, so the using of contact gel would not become the factor affecting the accuracy of the localization results.

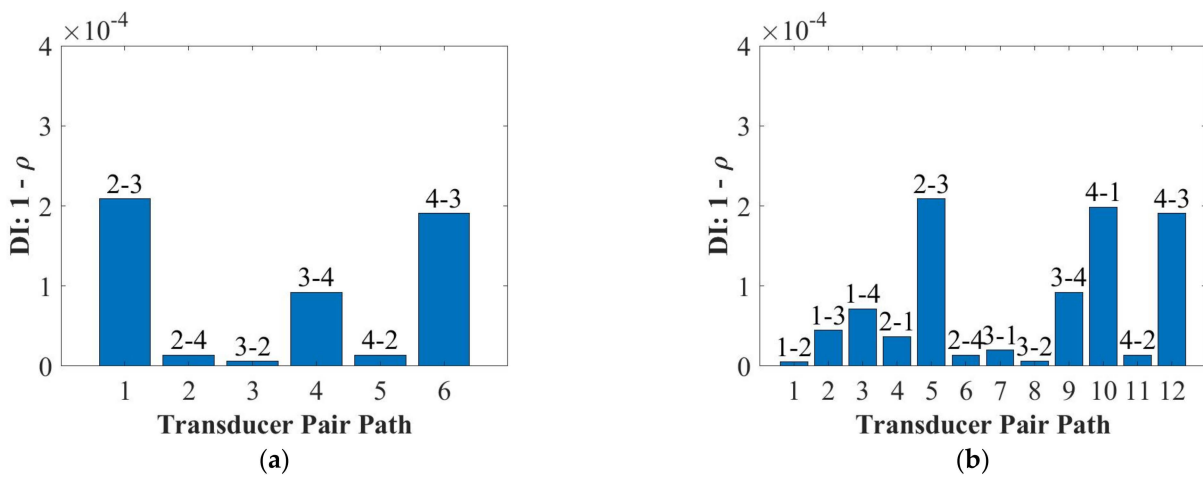
**Figure 10.** Cont.

**Figure 10.** Detection of surface-mounted artificial damage on the bottom of the host structure using (a) three PZT transducers and (b) four PZT transducers, and localization using (c) three PZT transducers and (d) four PZT transducers at 250 kHz for the position 2 (where the “○” is the position for real damage and the “×” is the position for predicted damage).

To simulate the host structure suffering damage, a weighted blue tack was attached on the bottom of the host structure, which was the surface of the opposite side of the repair patch. Figures 9 and 10 show the damage detection and localization for the surface-mounted artificial damage attached on the bottom of the host structure. As can be seen in Figures 9 and 10, using both three and four PZT transducers can detect the damage. However, the DAS algorithm can locate the damage more accurately using three PZT transducers than using four PZT transducers. The reason why five PZT transducers were not used for damage localization is that the repair patch is relatively small and having more sensors installed generate more noise in the signals. This can be seen with the results from three and four PZT transducers that the noise in the signal was high enough to mask the scattering from the damage.
