Conference Paper, Published Version

**Hsu, Sheng T.**

## **Renovation of Existing Reservoir in Taiwan for Sustainability**

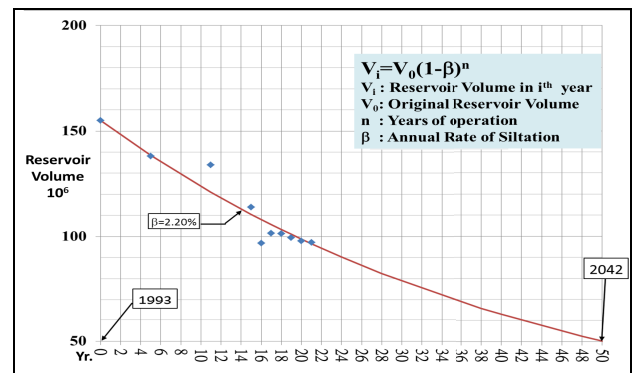
Fig. 1 Rate of Siltation in Nanhua Reservoir

The reservoir began initial filling in Nov. 1993. Due to young geology, intense rainfall during typhoon and lack of large capacity bottom outlets, sediments from extensive landslide and surface erosion in the drainage basin accumulated in the reservoir. Fig. 1 depicts the changes of the reservoir volume with time. The reduction in reservoir volume can be expressed by the following:

Where  $V_i$ : volume at nth year after filling;  $V_0$ : initial volume;  $\beta$ : amount of annual reservoir volume reduction. It is seen that the reservoir experienced about 2.2% volume reduction annually. The average annual sediment deposited in the reservoir is estimated to be about  $3.50 \times 10^6$  tons or about  $3.0 \times 10^6 \text{m}^3$ . Thus the annual depth of erosion in the drainage basin is 27.7 mm. An analysis was made on the effect of water-supply capability if the reservoir siltation is left unchecked. Fig. 2 shows that the water supply capability can be expected to decrease almost linearly with decreasing reservoir volume. By yr. 2042, 50 years after initial filling, the volume of the reservoir could be only  $50 \times 10^6 \text{m}^3$  and the corresponding water supply capability would be only  $0.42 \times 10^6$  CMD. It is thus evident that the biggest threat to the sustainability of the reservoir is the loss of volume due to sedimentation.

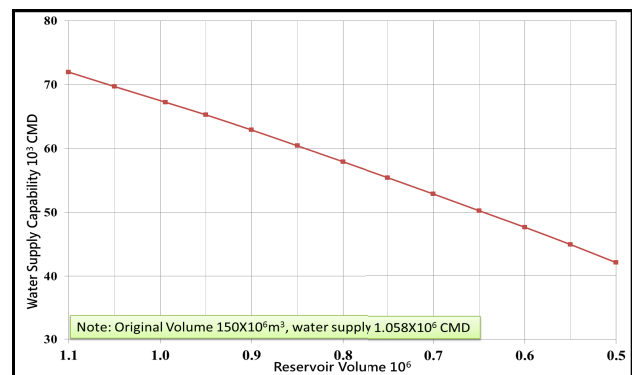
Fig. 2 Effect of Siltation on Water Supply Capability
