**Assessment model for vernacular limestone
buildings using Microsoft Excel®: the case of
Serra de Santo António**

Dissertação para obtenção do Grau de Mestre em
Engenharia Civil
(mestrado integrado)

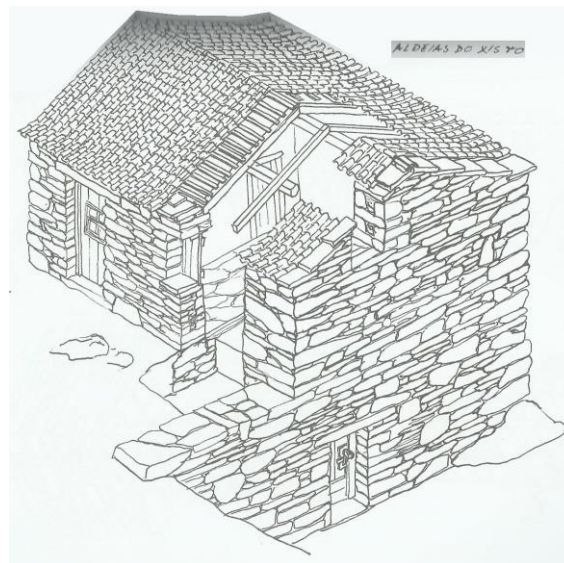
According to the same reference, in 2001 there were about 3.160.043 buildings in Portugal, and 11,15% of those are adobe, rammed soil or stone masonry (INE, I. P., 2002). Masonry can be found all over Portugal, *Aldeias do Xisto* are one of the best well-known examples, their constructive typology is shown in picture 1.

Picture 1 – Building at Aldeias de Xisto in Portugal(in Mascarenhas, J., 2015: 119)

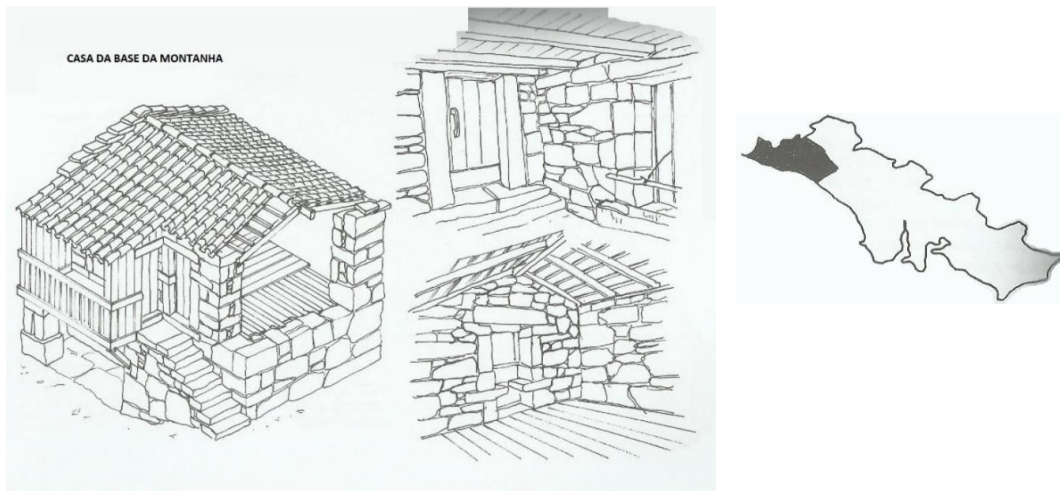
Aldeias de Xisto is not the only example of stone buildings in Portugal. They can also be found from the north of the country (Picture 2), located in Alto Minho the northernmost region of the country.

Picture 2 - Mountain base house in Alto Minho, Portugal (in Mascarenhas, J.,2015: 85)

These previously referred characteristics match some of the ones found in the case study village of Serra de Santo António. Like the two slopes roof, the stairs (Picture 2) are also similar to ones later found (Picture 14), the case of one house (Picture 3) is the one that is geographically closer to the study area. And so, it is the one with more similarities from the stone fence wall, the doorsills, windowsills, and the corners of the walls. Another construction (Picture 4) also has doorsills, windowsills, and corners of the walls similar to the ones found in the village of Serra de Santo António.

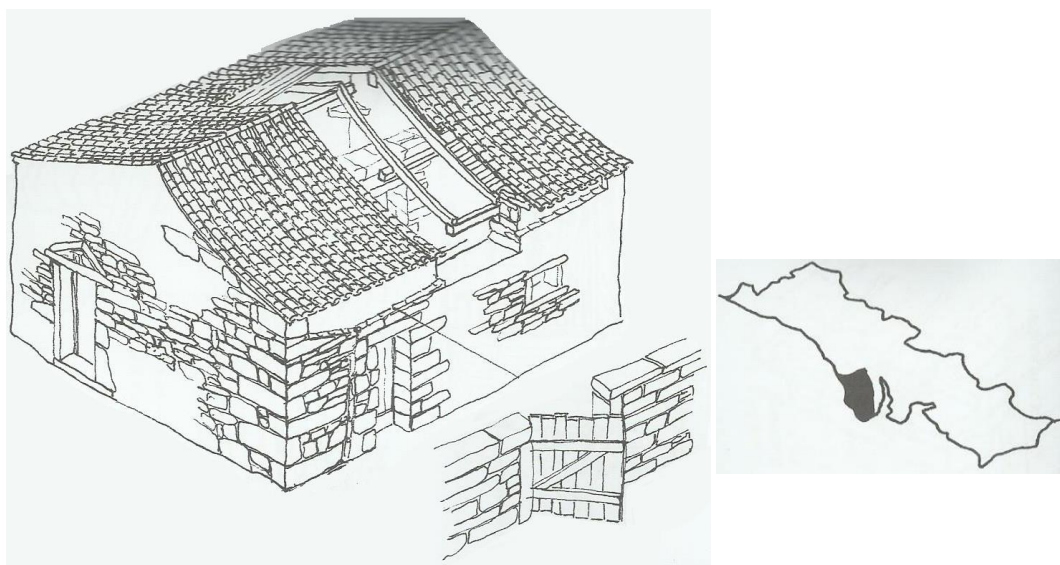
As well as in Estremadura region, in the central part of Portugal (picture 3) there are these kinds of buildings.

Picture 3 - House in Estremadura, Portugal (in Mascarenhas, J., 2015: 137)

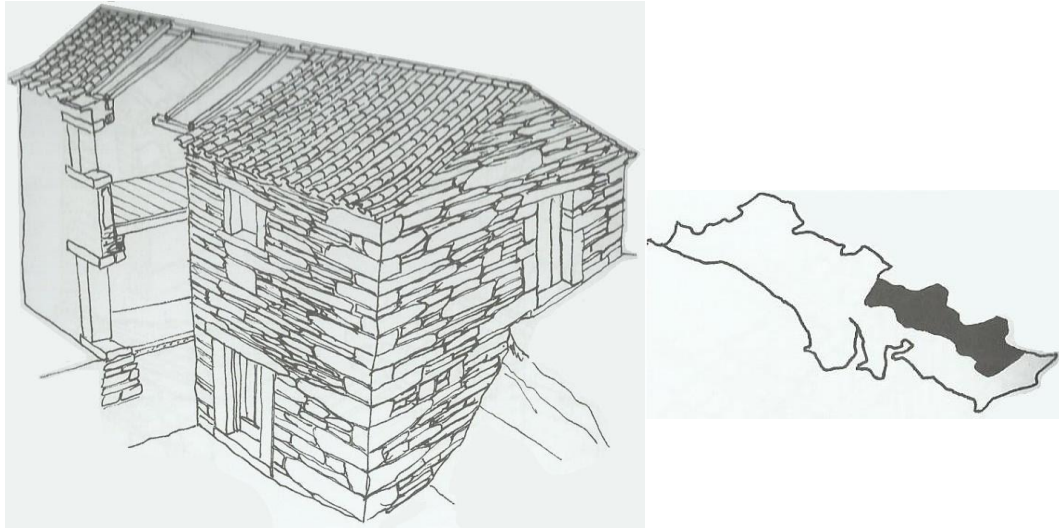
And all the way to Alentejo Interior, to the interior and south of Portugal, is possible to find the presence of these buildings (picture 4).

Picture 4 - House in Alentejo Interior , Portugal – (Mascarenhas, J., 2015: 176)

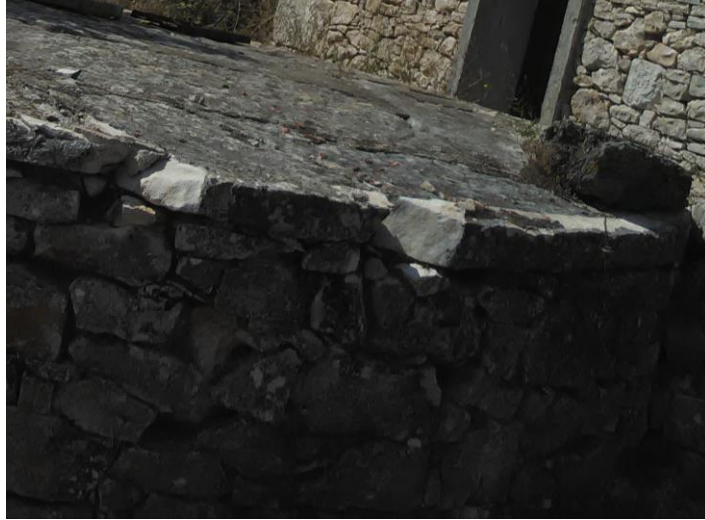
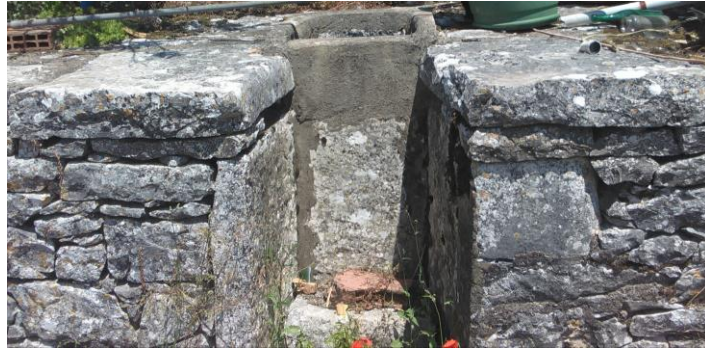
Even though there are underground water deposits. The closest surface water course is Olhos de Água of Alviela river near to Louriceira about 12 km distance from Serra de Santo António, which naturally led to the construction of wells (Pictures 8 and 9). They

Pictures 8 - 9 – Pictures of limestone wells in Serra de Santo António.

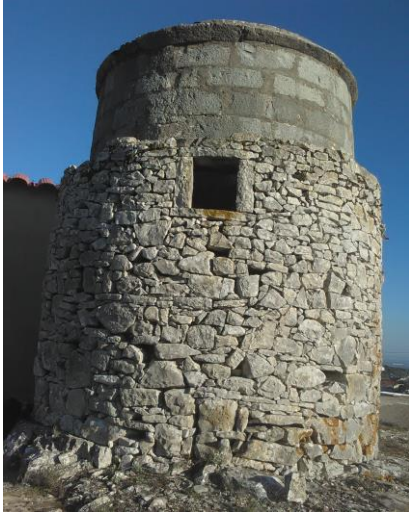
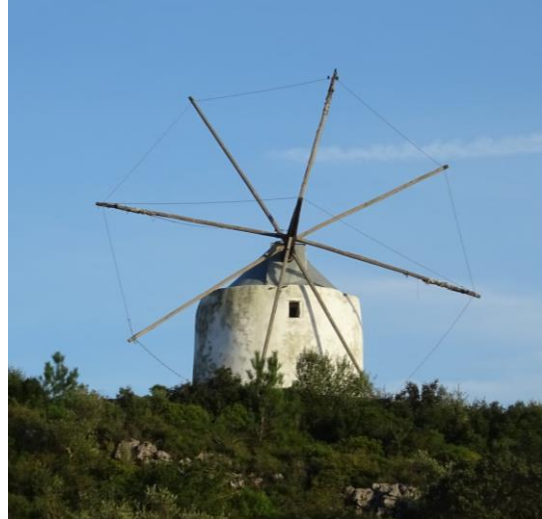
Since agriculture was one of the main occupations of local community, and the altitude of about 360m provides windy days, it should come as no surprise that windmills exist on the village (Pictures 10 and 11). To use the windmills grain was needed, in order, to dry, thresh and sieve the grain threshing floors were used and some can still be found (Picture 12).

Pictures 10 - 11 – Limestone windmills in Serra de Santo António.

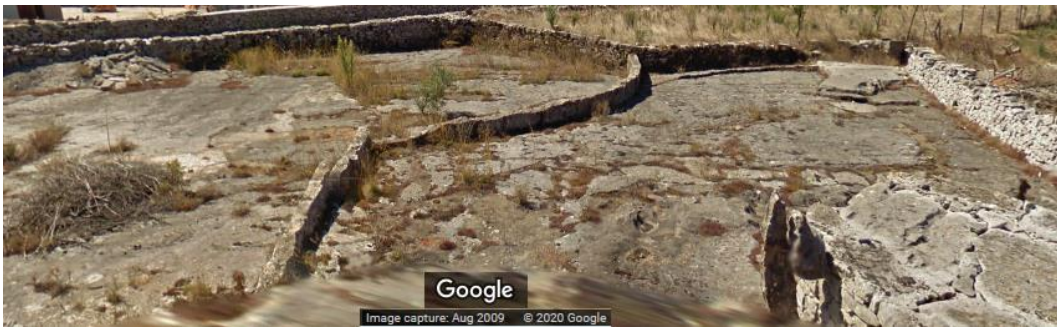
Picture 12 – Limestone threshing floor (Google).

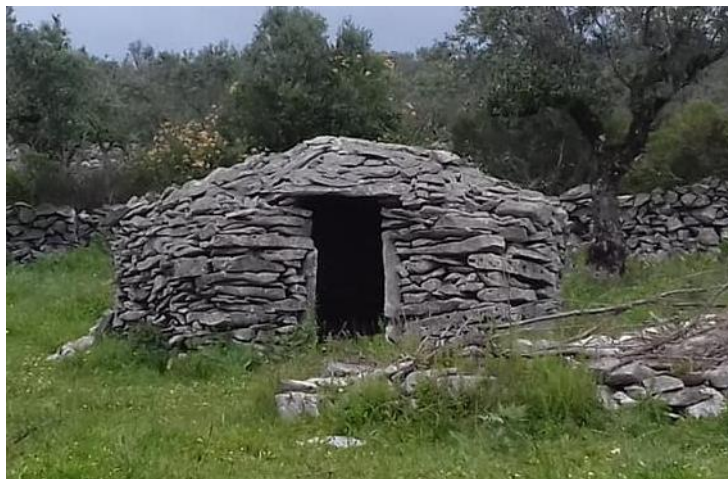
Another main occupation was cattle raising, which gave way to casinas buildings that were used to shelter shepherds from harsh weather (picture 13).

Picture 13 – Casina made of limestone in Serra de Santo António.

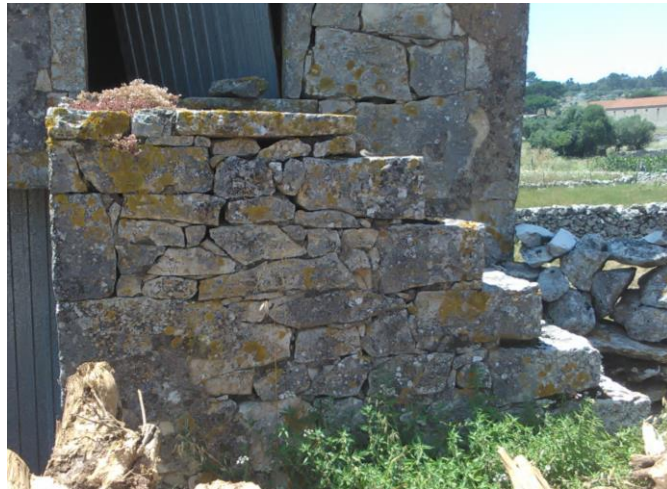
While not very common, it is possible to find some buildings with limestone stairs (picture 14).

Picture 14 – Limestone stairs on the outside of building in Serra de Santo António

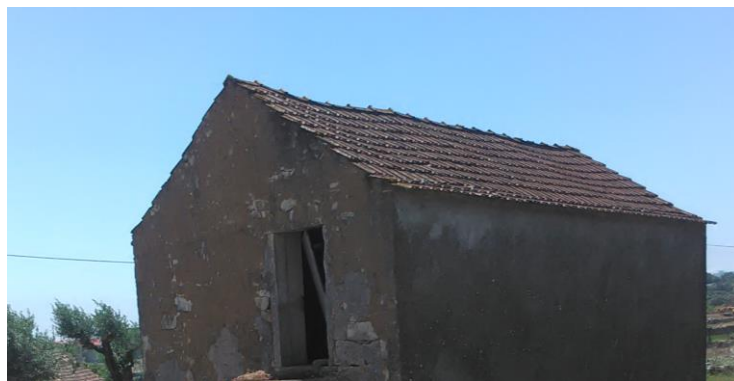
Besides houses there are also isolated barns/granaries (picture 15), it is possible to differentiate from houses due to the lack of windows.

Picture 15 – Isolated barn/granary in Serra de Santo António.

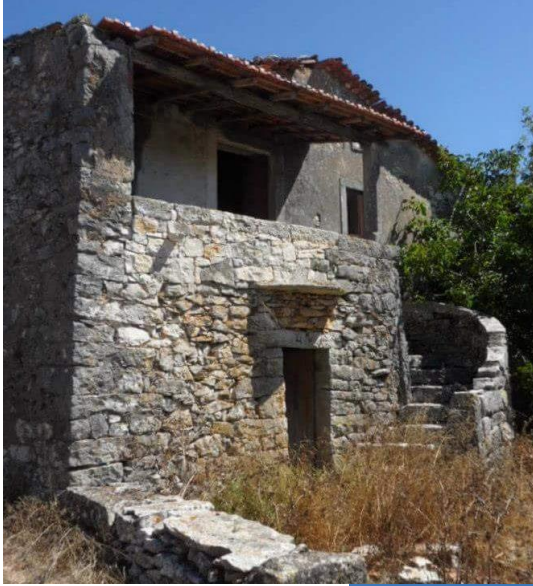
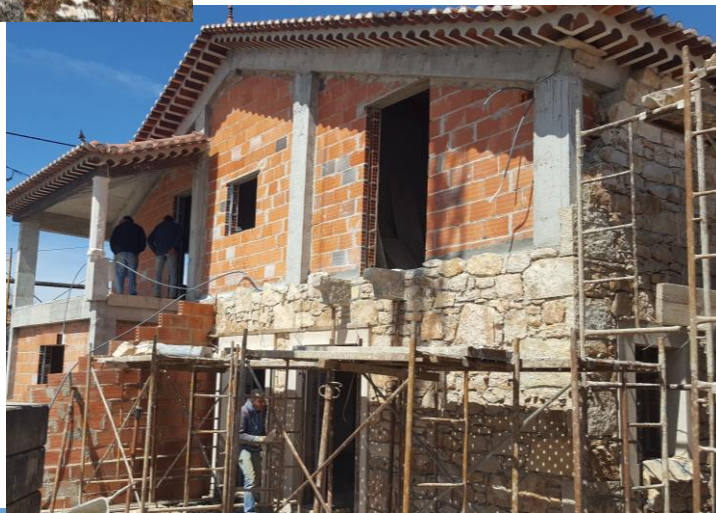
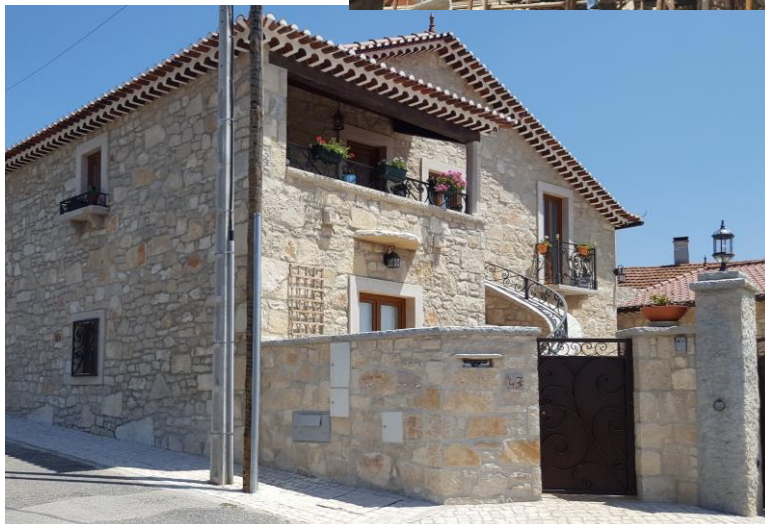
While most constructions have limestone walls with a structural function, there is at least one very curious limestone house, known as house Maria do Bento. It was disassembled, the interior walls were built using modern methods and then the exterior walls were reassembled, so the exterior limestone walls are not structural in this case (pictures 16, 17 and 18).

**Picture 16 – House Maria do Bento
before the restorations in Serra de
Santo António**

**Picture 17 - House
Maria do Bento during
the restorations in
Serra de Santo António**

**Picture 18 – House
Maria do Bento
after the
restorations in
Serra de Santo
António**

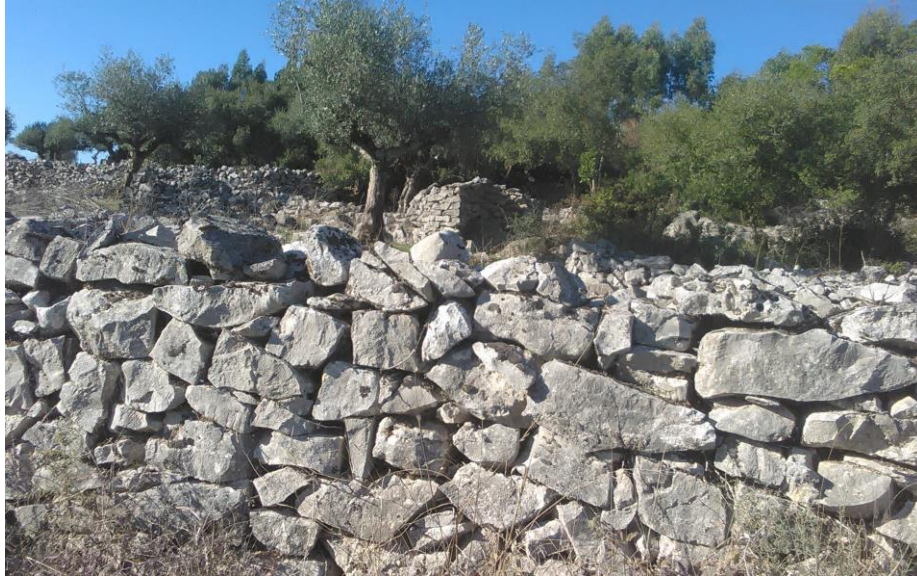
Finally, the most widespread of limestone structures are fence walls (picture 19), which can be found even in plots of land without any other structures. They were important in shaping the landscape and have become a trademark of the Nature Park of das Serras de Aire e Candeeiros (PNSAC).

Picture 2 – Limestone fence wall – Serra de Santo António

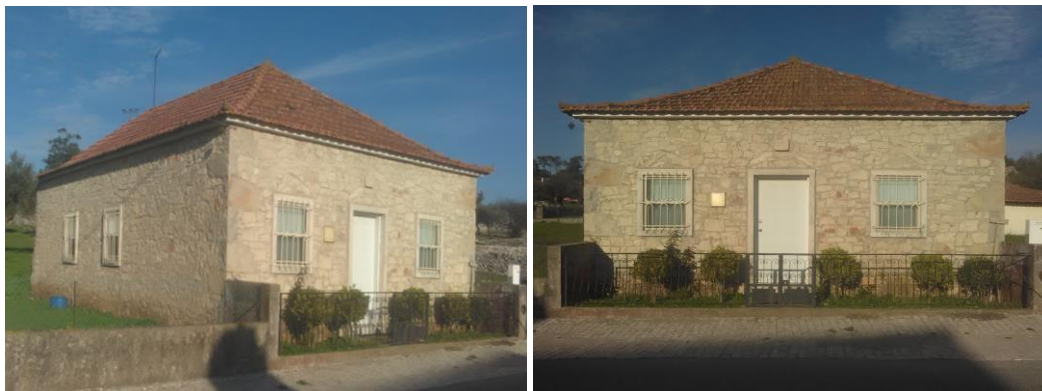
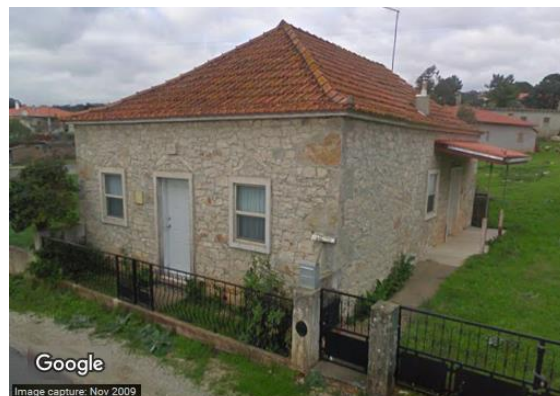
Building 1 is located at Rua António Galveias Dias (picture 25), it is an isolated one-story building, with no annexes, the limestone of the walls is showing (pictures 26, 27 and 28), it has no added area and adjacent free space. Some of its general features are a three slopes roof, a metal fence, wood doors and windows, the rest are listed in tables 1, 2 and 3.

Picture 26-27 – Pictures of building 1 – Serra de Santo António

Picture 28 - Picture of building 1 in 2009 (Google)

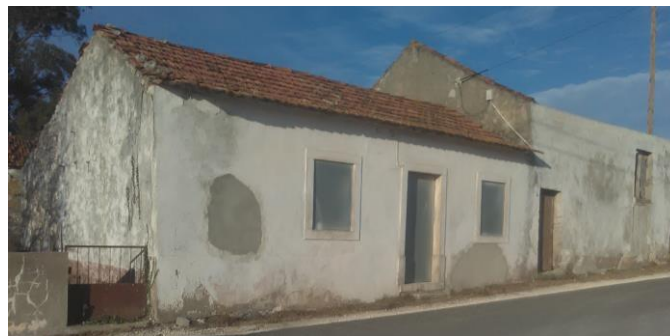
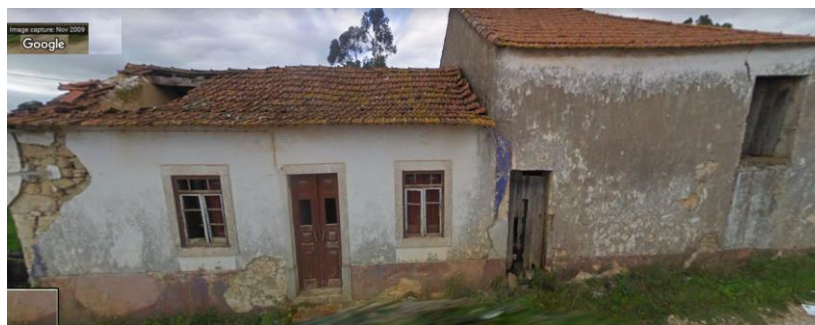
Building 2 is located at Rua António Galveias Dias (picture 29). It is an isolated one-story building, with a barn/granary annex, the limestone of the walls is covered by mortar (pictures 30 and 31), it has no added area and no adjacent free space. Some of its general features are a two slopes roof, Marseille roof tile, doorsills and windowsills made with brushed limestone, the rest are listed in tables 4, 5 and 6.

Picture 30 - Picture of building 2 – Serra de Santo António

Picture 31 - Picture of building 2 in 2009 (Google)

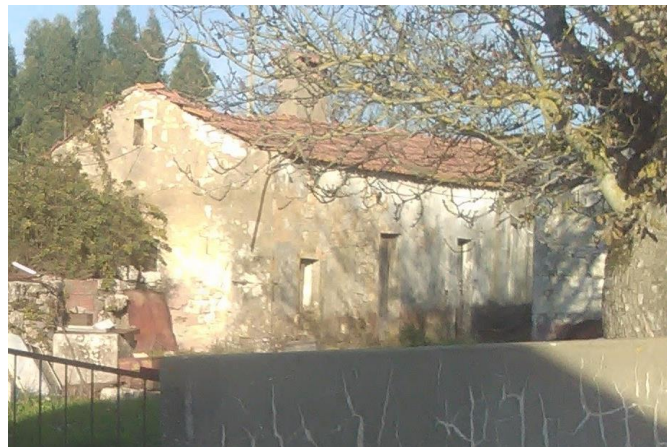
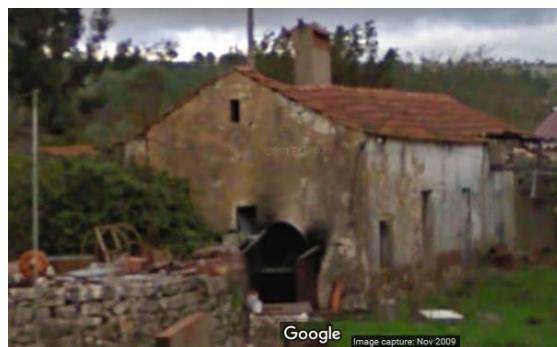
Building 3, is located at Rua António Galveias Dias (picture 32). It is an isolated one-story building, with no annexes, the limestone of the walls is covered (pictures 33 and 34), it has no added area and adjacent free space. Some of its general features include a brickwall fence, and a limestone water tank or well, the rest are listed in tables 7; 8 and 9.

Picture 3 - Picture of building 3 – Serra de Santo António

Picture 4 - Picture of building 3 in 2009 (Google)

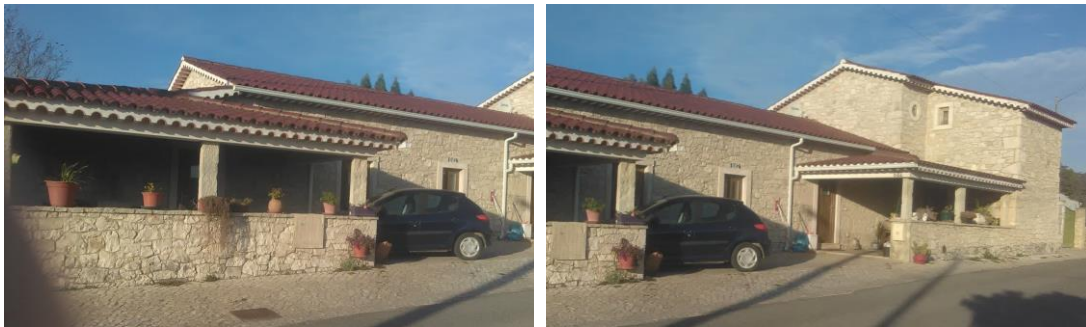
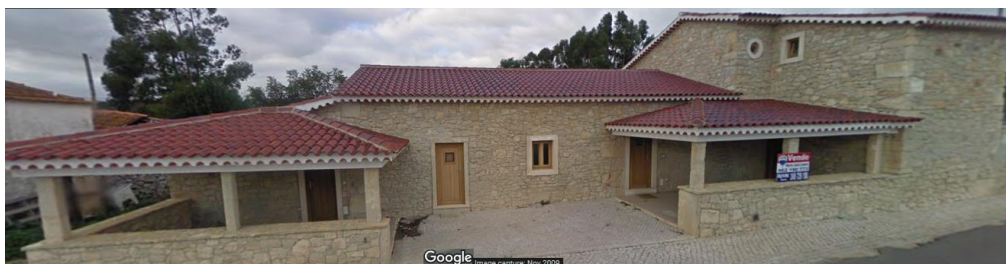
Building 4, is located at Rua António Galveias Dias (picture 35). It is an isolated two-story building, with no annexes, the limestone of the walls is showing (pictures 36, 37 and 38), it has no added area and adjacent free space. Some of its general features are portuguese roof tile, doorsills and windowsills made with brushed limestone, and wood doors, others are listed in tables 10; 11 and 12.

Picture 6;37 - Pictures of building 4– Serra de Santo António

Picture 38 - Pictures of building 4 in 2009 (Google)

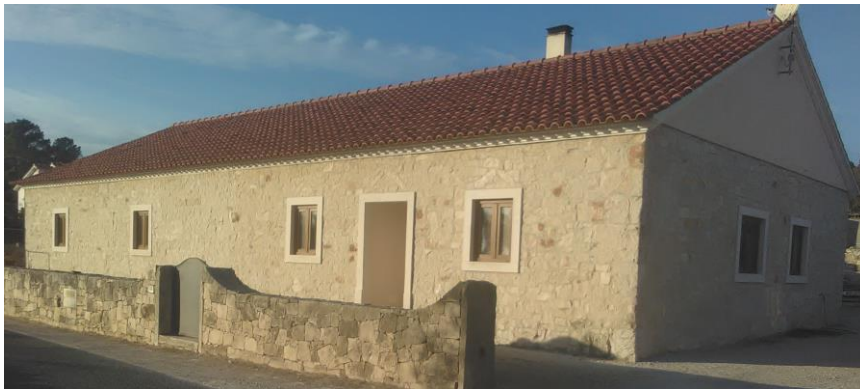
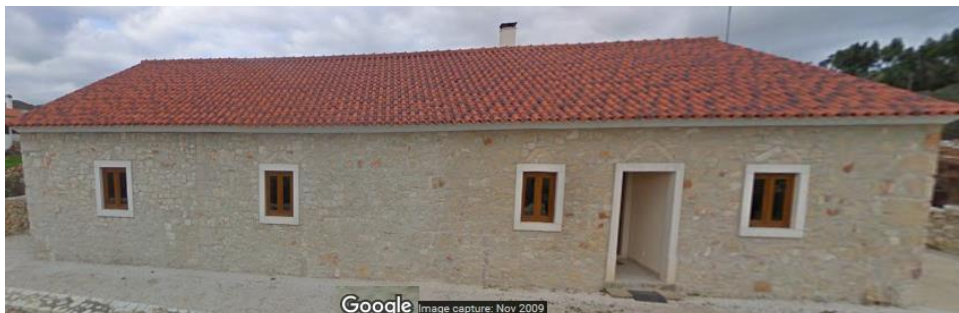
Building 5, is located at Rua António Galveias Dias (picture 39), it is an isolated one-story building with no annex, the limestone of the walls is showing (pictures 40 and 41), it has no added area and adjacent free space. Some of its general features include a brick chimney, doors and windows made of wood and limestone fence wall, the remaining ones are listed in tables 13; 14 and 15.

Picture 40 - Pictures of building 5 (google)

Picture 41 - Pictures of building 5 in 2009 (Google)

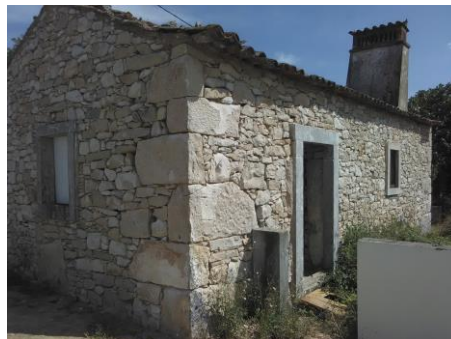
Pictures 43;44;45 - Pictures of building 6 – Serra de Santo António

Building 6, is located at Rua Padre Joaquim Dias (picture 42), it is an isolated one-story building with no annex, the limestone of the walls is showing (pictures 43, 44 and 45), it has adjacent free space and no added area. Some of its general features include a two slopes roof, mission roof tile and a chicken coop, the rest are listed in tables 16; 17 and 18.

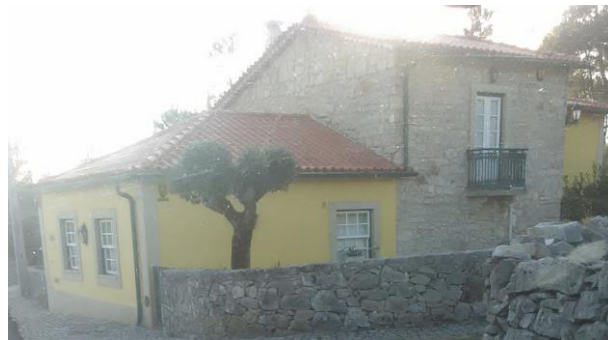
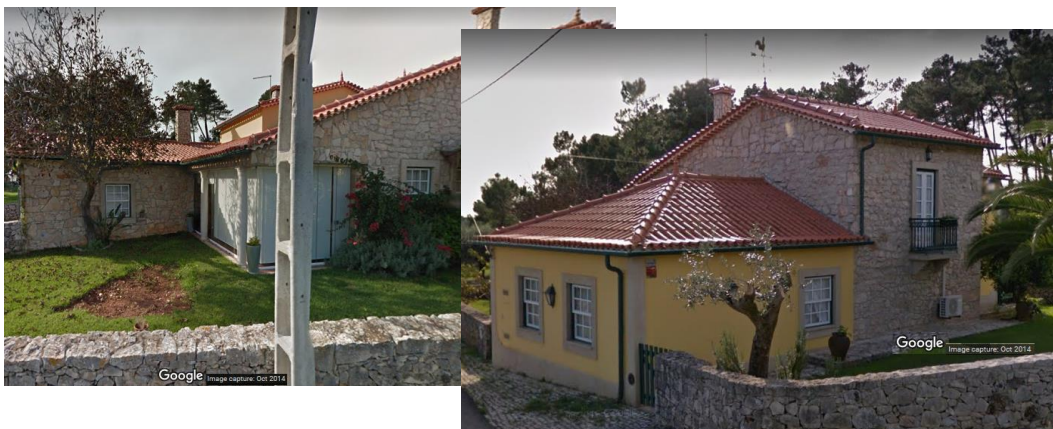
Building 7, is located at Rua Várzea (picture 46), it is an isolated two-story building with no annex, the limestone of the walls is showing (pictures 47,48 and 49), it has added area and adjacent free space. Some of its general features include added area to the side (that led to deductions due to architectural changes), and limestone fence wall, the remaining ones are listed in tables 19; 20 and 21.

Picture 47 - Picture of building 7 – Serra de Santo António

Picture 48;49 - Pictures of building 7 in 2014 (Google)

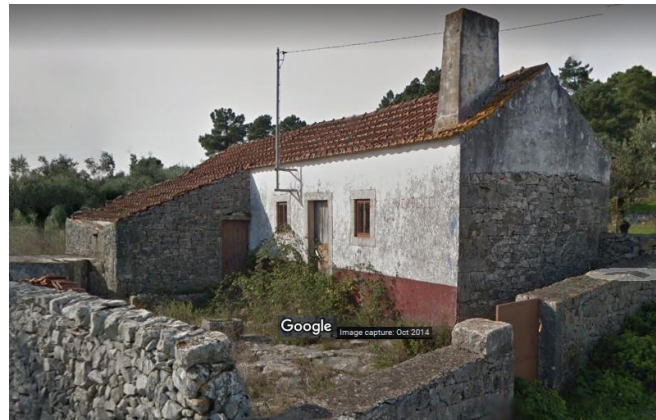
Building 8, is located at Rua Várzea (picture 50), it is an isolated one-story building, with one annex, the limestone of the walls is partially showing (pictures 51 and 52), it has no added area and adjacent free space. Some of its general features are a two slopes roof, a limestone wall fence, and a water tank or well, the rest are listed in tables 22; 23 and 24.

Picture 51 - Picture of building 8 in 2014 (Google)

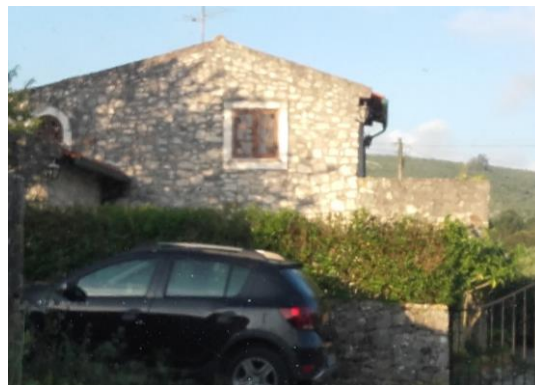
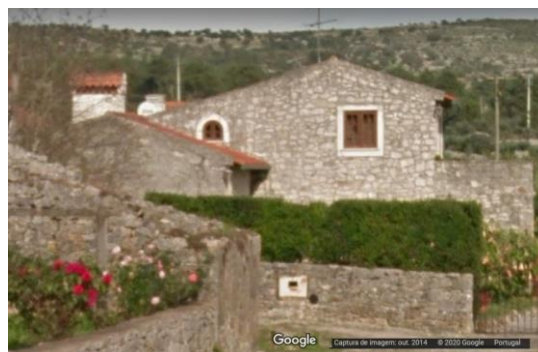
Building 9, is located at Rua Várzea (picture 53), it is an isolated two-story building with annexes, the limestone of the walls is showing (pictures 54 and 55), it has added area and adjacent free space. Some of its general features include added area to the side and an extra floor (that led to deductions due to architectural changes), and limestone fence wall, the remaining ones are listed in tables 25; 26 and 27.

Picture 53 - Picture of building 9 – Serra de Santo António

Picture 54- Picture of building 7 in 2014 (Google)

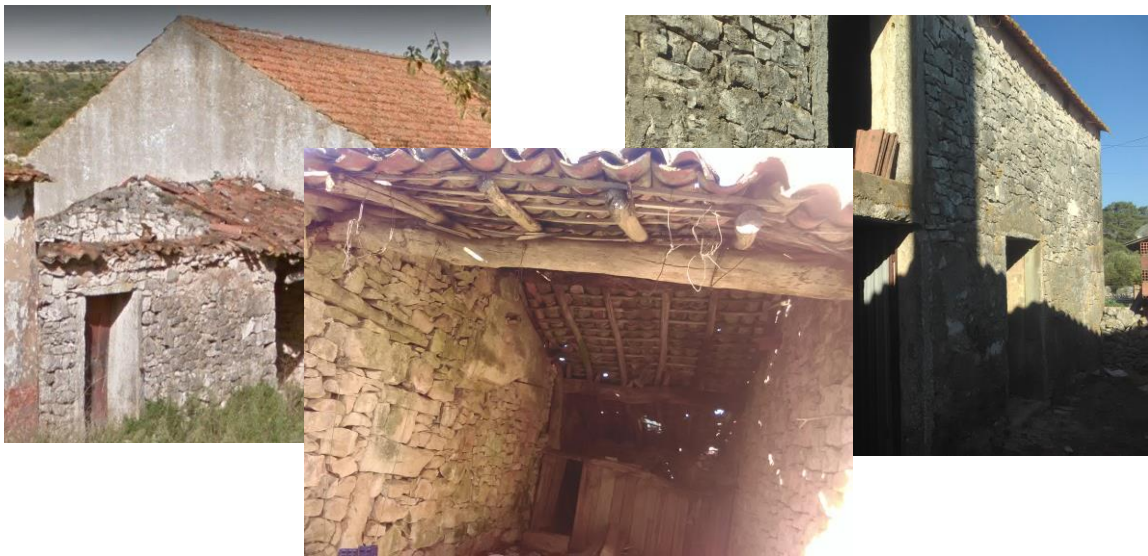
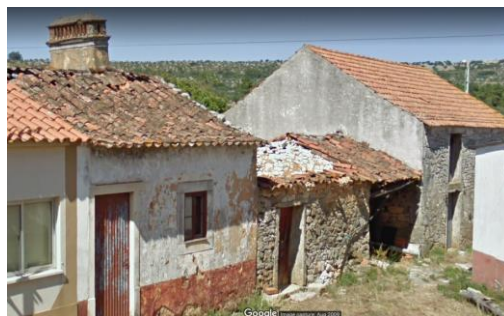
Building 10, is located at Rua Joaquim Maria Batista (picture 56), it is a one-story building with annexes, the limestone of the walls is partially showing (pictures 57, 58 and 59), it has added area and no adjacent free space. Some of its general features include a two slope roof, and Marseille roof tile, the rest are listed in tables 28; 29 and 30.

Picture 56-58 – Picture of building 10 – Serra de Santo António

Picture 59 - Picture of building in 2009 (Google)

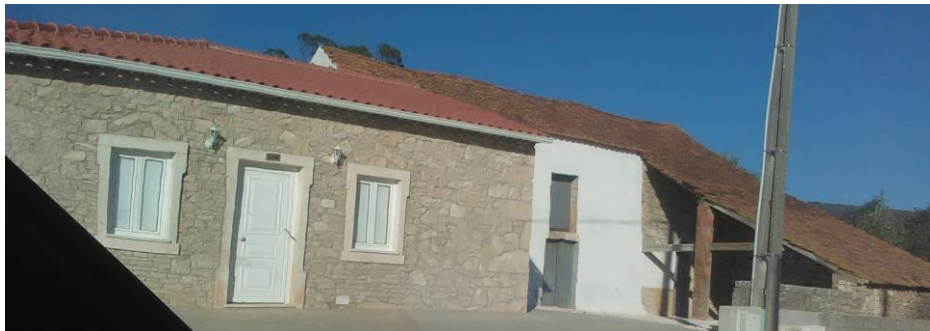
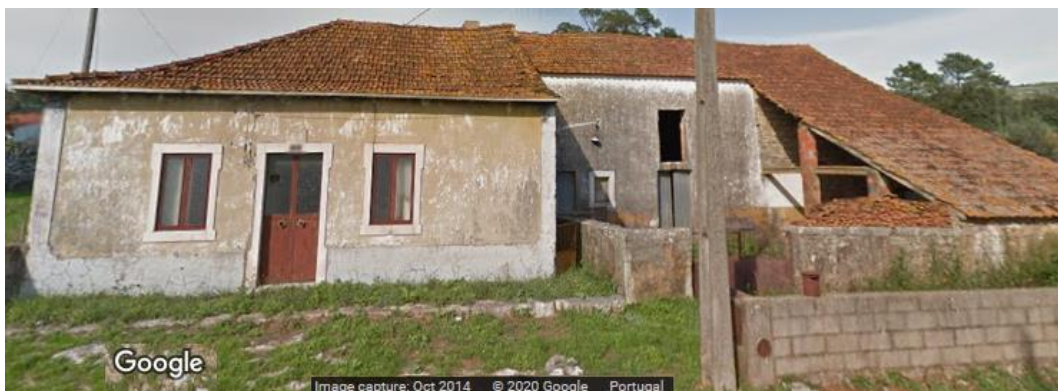
Building 11 is located at Rua Joaquim Maria Batista (picture 60), it is an isolated one-story building with annexes, the limestone of the walls is showing (pictures 61 and 62), it has no added area and adjacent free space. Some of its general features are a three slopes roof, Marseille roof tile, and aluminum doors, the rest are listed in tables 31; 32 and 33.

Picture 61 - Picture of building 11 – Serra de Santo António

Picture 62 - Picture of building 11 in 2014 (google)

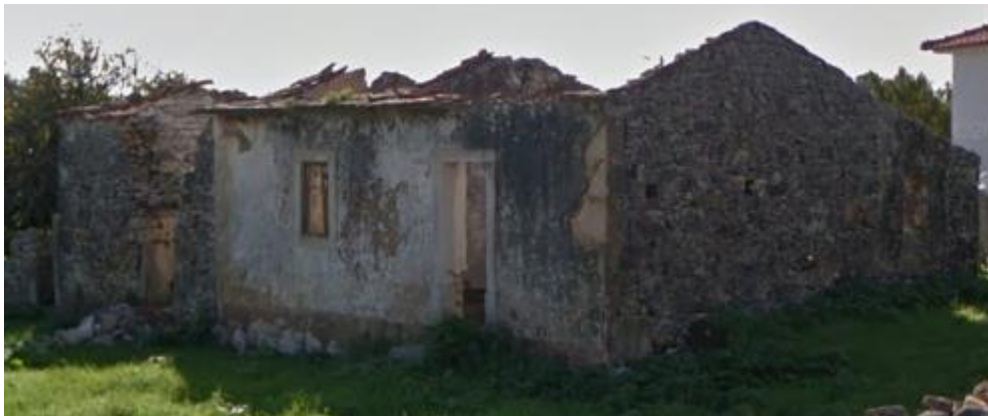
Building 12, is located at Rua Joaquim Maria Batista (picture 63), it is an isolated one-story building with annexes, the limestone of the walls is partially showing (picture 64), it has no added area and adjacent free space. Some of its general features include a two slopes roof, and windowsills made with brushed limestone, and wood doors, the rest are listed in tables 34; 35 and 36.

Picture 64 - Picture of building 12 – Serra de Santo António

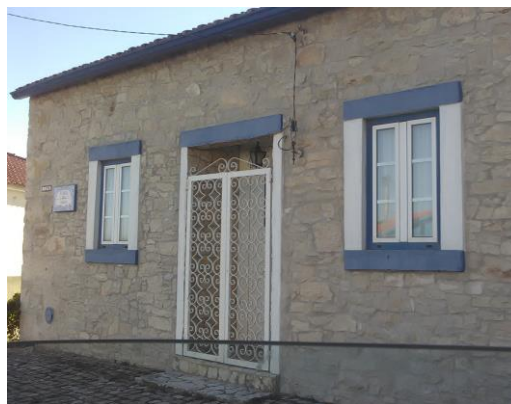
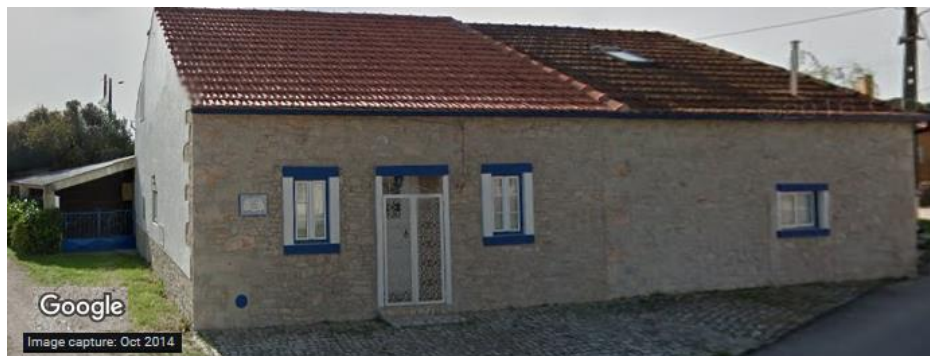
Building 13 is located at Rua Joaquim Maria Batista (picture 65), it is an isolated one-story building with no annexes, the limestone of the walls is showing (pictures 66 and 67), it has adjacent free space and no added area. Some of its general features are a two slopes roof, doorsills and windowsills made with brushed limestone, others are listed in tables 37; 38 and 39.

Picture 66 – Picture of building 13 – Serra de Santo António

Picture 77 – Picture of building 13 in 2014 (Google)

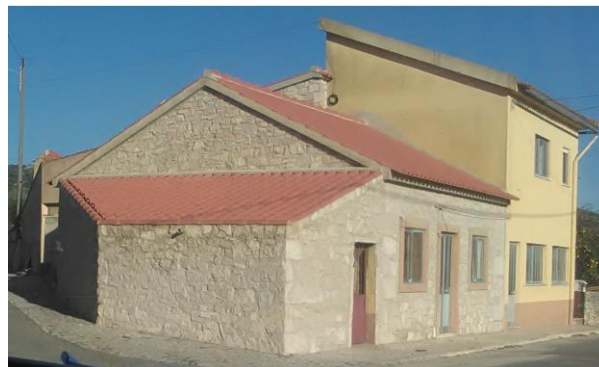
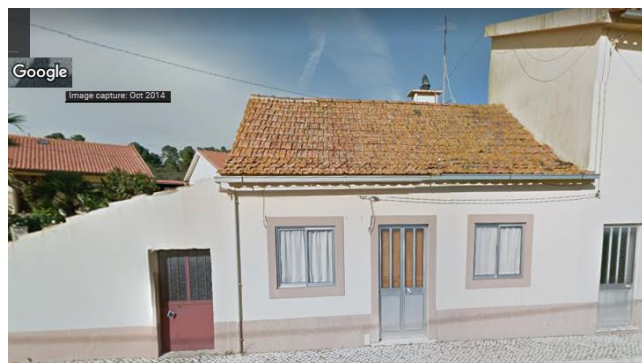
Building 14, is located at Rua Joaquim Maria Batista (picture 68), it is a one-story building, with no annexes, the limestone of the walls is showing (pictures 69 and 70), it has added area and no adjacent free space. Some of its general features include a two slopes roof, portuguese roof tile, and aluminum doors, the rest are listed in tables 40; 41 and 42.

Picture 69 – Picture of building 14 – Serra de Santo António

Picture 70 – Picture of building 14 in 2014 (Google)

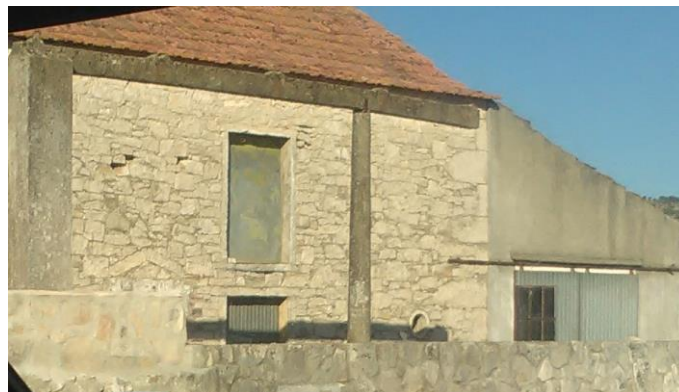
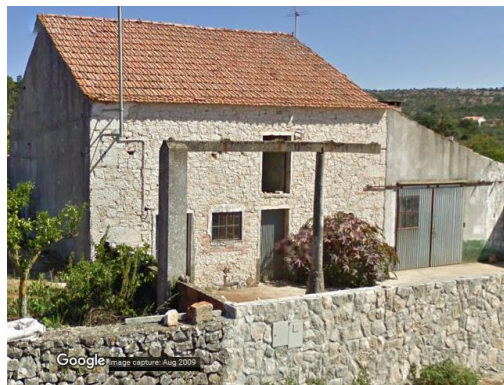
Building 15 is located at Rua Joaquim Maria Batista (picture 71), it is an isolated two-story building, with one annex, the limestone of the walls is showing (pictures 72 and 73), it has adjacent free space and no added area. Some of its general features include a two slopes roof, and marseille roof tile, the rest are listed in tables 43; 44 and 45.

Picture 72 - Picture of building 15 – Serra de Santo António

Picture 73 – Picture of building 15 in 2009 (google)

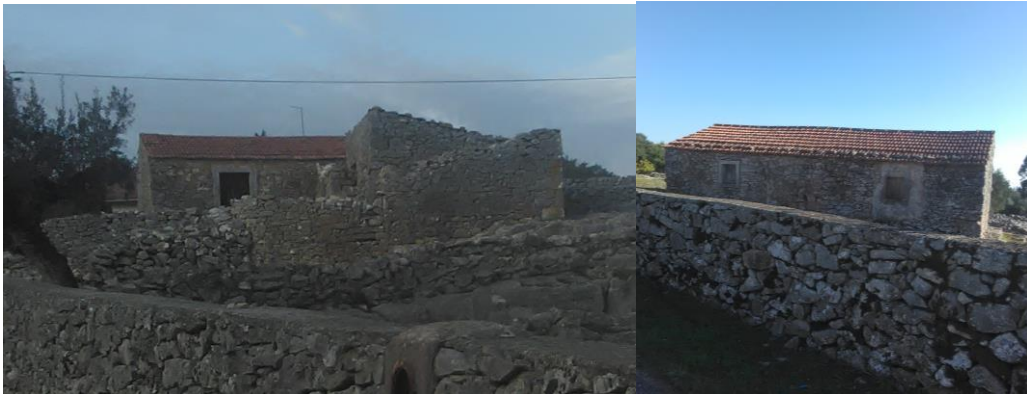
Building 16, is located at Rua Joaquim Maria Batista (picture 74), it is an isolated one-story building with one annex, the limestone of the walls is showing (Picture 75 and 76), it has adjacent free space and no added area. Some of its general features include a two slopes roof, and marseille roof tile, the rest are listed in tables 46; 47 and 48.

Pictures 75 and 76 - Pictures of building 16– Serra de Santo António

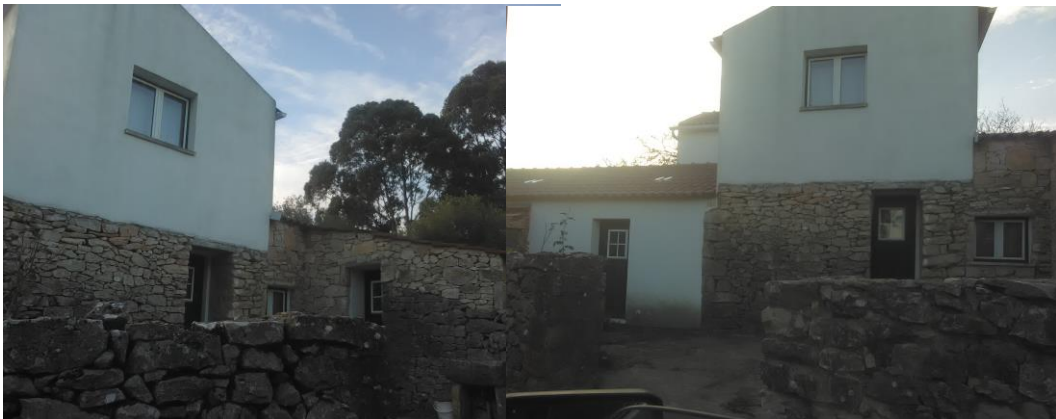
Building 17, is located at Rua Covinhas (picture 77), it is an isolated two-story building, with annexes, the limestone of the walls is showing (pictures 78 and 79), it has added area and adjacent free space. include added area to the side (that led to deductions due to architectural changes), and limestone fence wall, the remaining ones are listed in tables 49; 50 and 51.

Picture 78;79 - Picture of building 17– Serra de Santo António

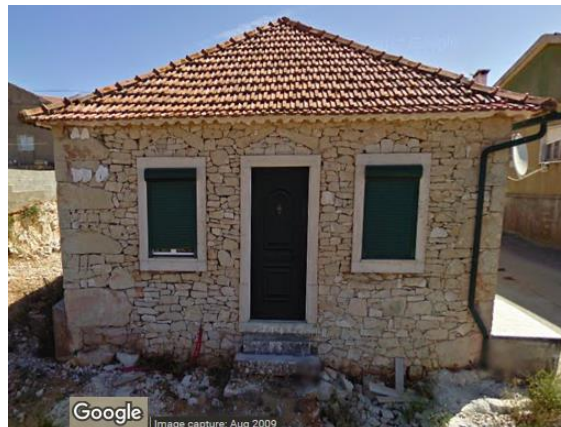
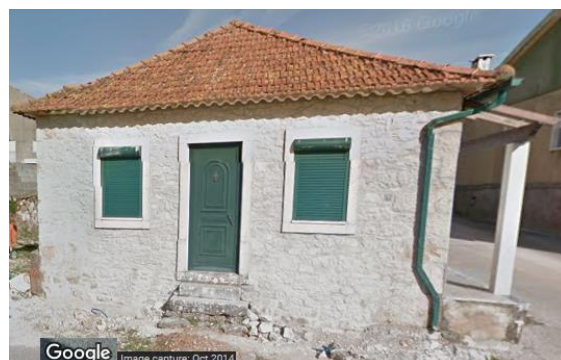
Building 18, is located Rua Joaquim Maria Batista (picture 80), it is an isolated one-story building with no annex, the limestone of the walls is showing (pictures 81 and 82), it has no added area and adjacent free space. Some of its general features include a four slopes roof, marseille roof tile, and a metal chimney, the rest are listed in tables 52; 53 and 54.

Picture 81– Picture of building 18 in 2009 (google)

Picture 82 – Picture of building 18 in 2014 (google)

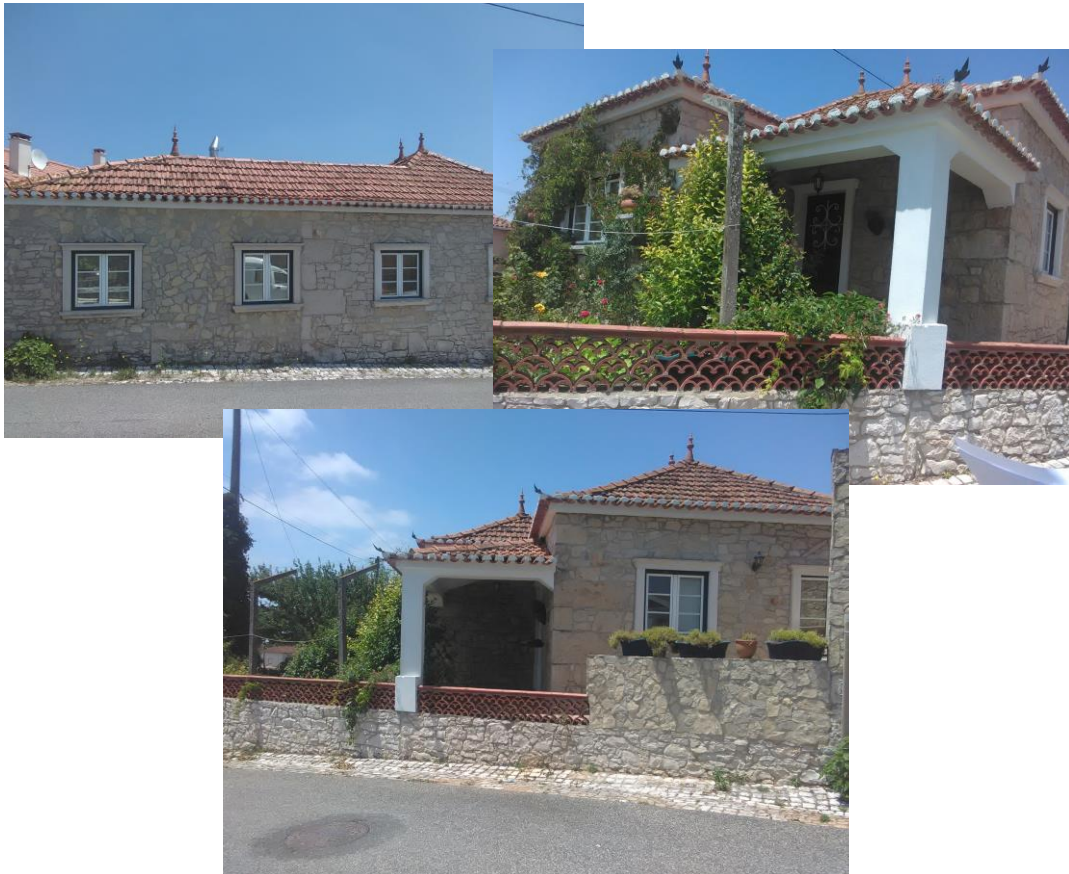
Building 19, is located Rua Luís Vaz de Camões (picture 83), it is an isolated one-story building with no annex, the limestone of the walls is showing (pictures 84; 85 and 86), it has added area and adjacent free space. Some of its general features include a four slopes roof, and marseille roof tile, the rest are listed in tables 55; 56 and 57.

Pictures 84;85;86 - Pictures of building 19 – Serra de Santo António

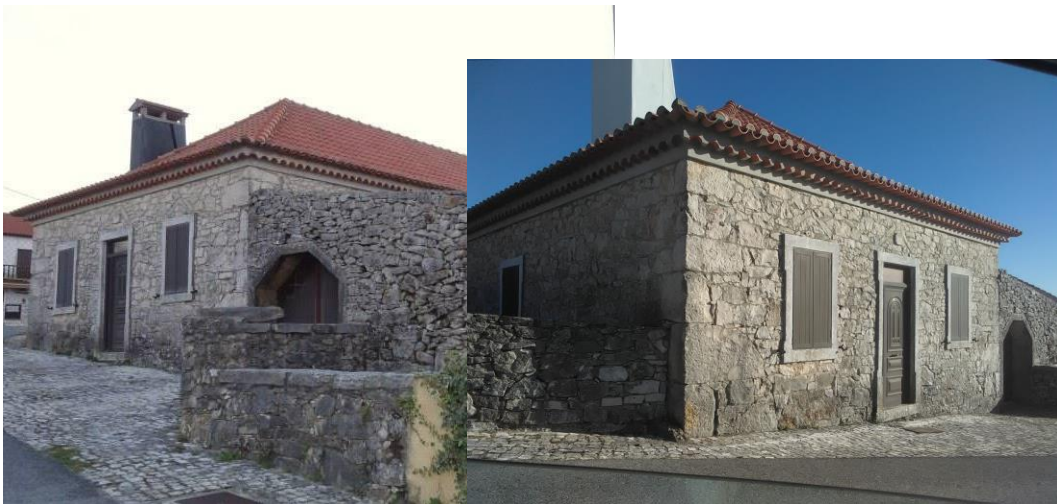
Building 20, is located Rua Ezequiel Arriaga F. Galo (picture 87), it is an isolated one-story building with annexes, the limestone of the walls is showing (pictures 88 and 89), it has adjacent free space and no added area. Some of its general features include a four slopes roof, portuguese roof tile, and brown aluminum doors and windows, the remaining features are listed in tables 58; 59 and 60.

Pictures 88; 89 - Pictures of building 20– Serra de Santo António

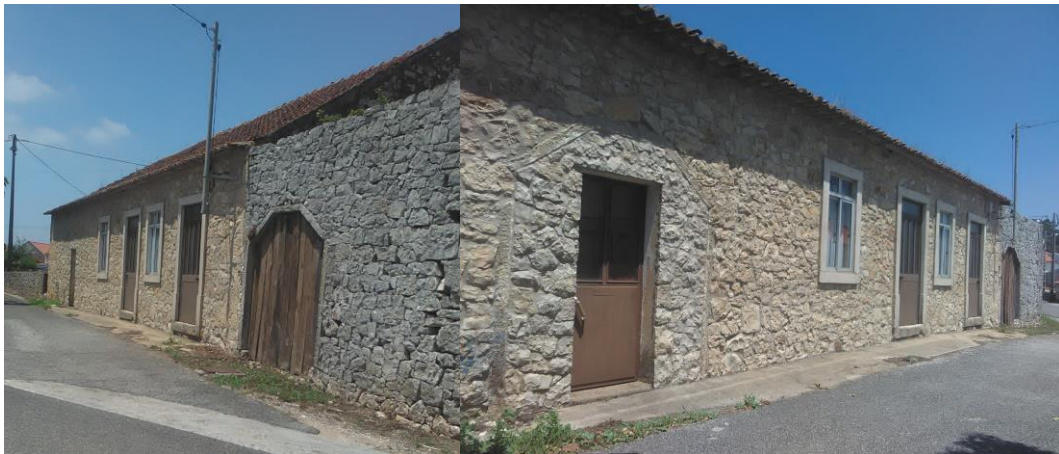
Building 21, is located Travessa João Velez Salvador Pinheiro (picture 90), it is an isolated one-story building, with annexes, the limestone of the walls is showing (pictures 91 and 92), it has no added area and adjacent free space. Some of its general features include a two slopes roof, marseille roof tile, and brown aluminum doors and windows, the rest of the features are listed in tables 61; 62 and 63.

Pictures 91 and 92 – Pictures of building 21 – Serra de Santo António

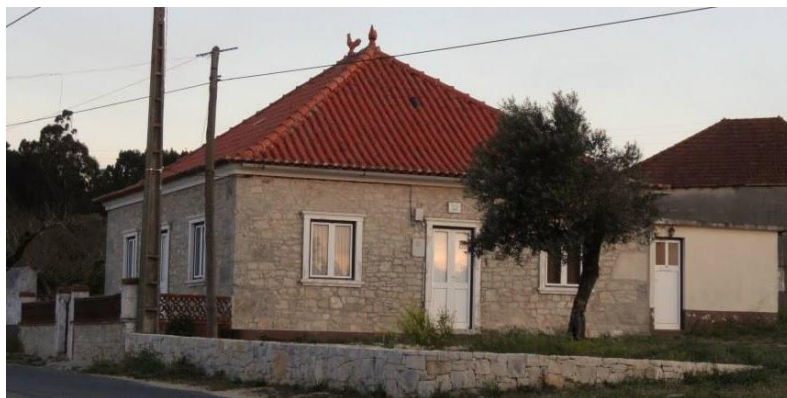
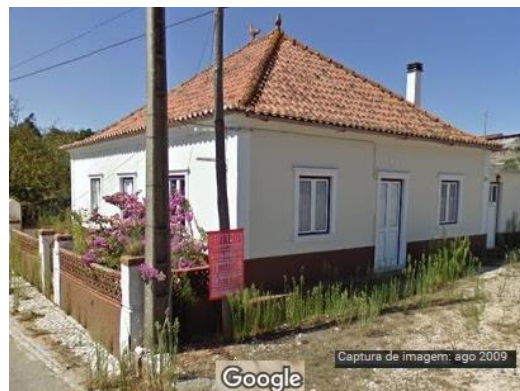
Picture 94 – Picture of building 22 – Serra de Santo António

Picture 95 – Picture of building 22 in 2009 (Google)

Building 22, is located Rua Luís Vaz de Camões (picture 93), it is an isolated one-story building, with annexes, the limestone of the walls is showing (pictures 94 and 95), it has no added area and adjacent free space. Some of its general features include a four slopes roof, portuguese roof tile, and aluminum doors and windows, the rest of the features are listed in tables 64; 65 and 66.

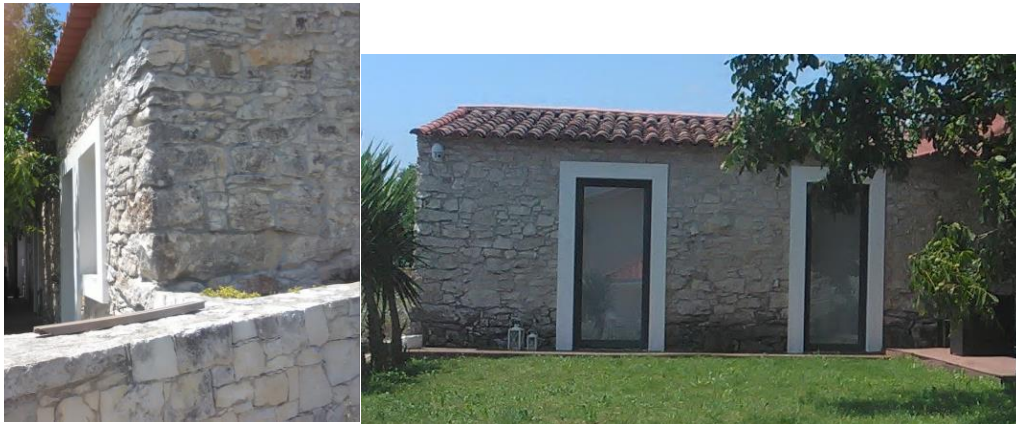
Pictures 97 and 98; - Pictures of building 23– Serra de Santo António

Building 23, is located at Rua do Seminário (picture 96), it is an isolated one-story building, with annexes, the limestone of the walls is showing (picture 97 and 98), it has no added area and adjacent free space. This building was previously a Jesuit school (many years ago) and there is even a model of it (picture 99). Some of its general features include a two slopes roof, mission roof tile, and aluminum doors and windows, the rest of the features are listed in tables 67; 68 and 69.

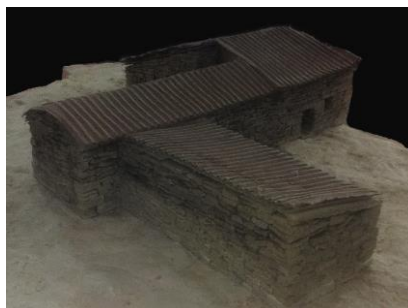
Picture 99 - Picture of a model of building 23– Serra de Santo António
