**Assessment model for vernacular limestone
buildings using Microsoft Excel®: the case of
Serra de Santo António**

Dissertação para obtenção do Grau de Mestre em
Engenharia Civil
(mestrado integrado)

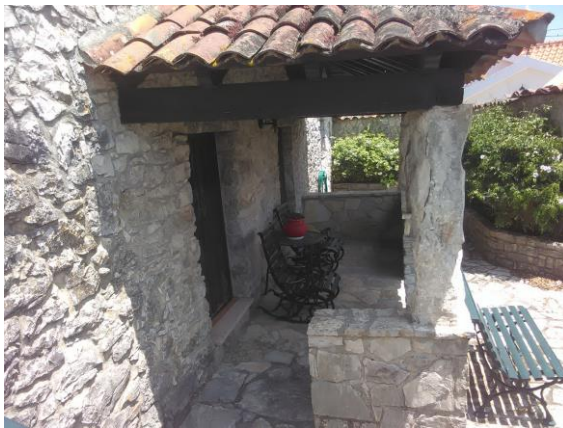
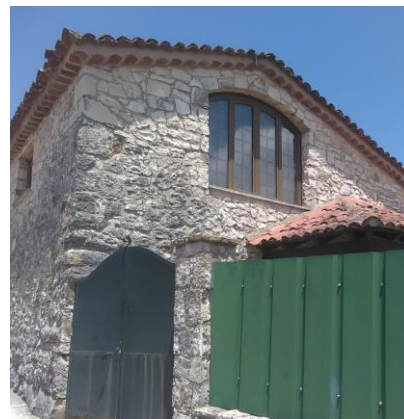
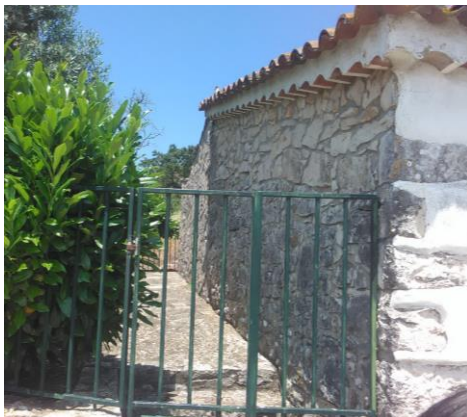
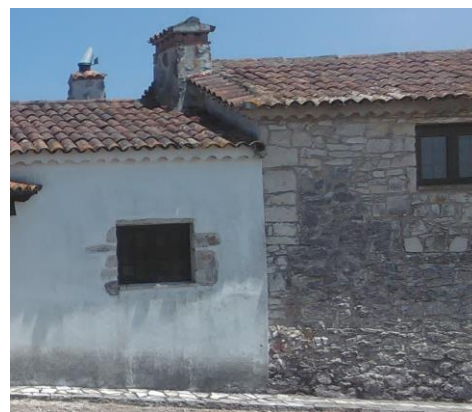
Pictures 101 - 104 - Pictures of building 24– Serra de Santo António

Building 24, is located Rua do Seminário (picture 100), it is an isolated two-story building, with annexes, the limestone of the walls is showing (Pictures 101;102;103;104), it has no added area and adjacent free space. Some of its general features include a two slopes roof, mission roof tile, and brown aluminum windows, the rest of the features are listed in tables 70; 71 and 69.

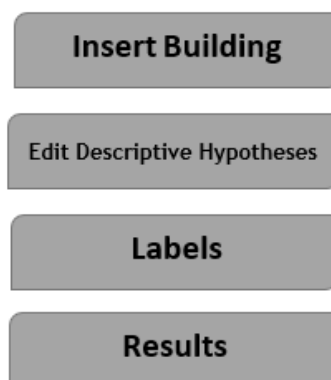
Picture 10 – menu of the model

The first part of the Model is the menu (picture 105), the menu has 4 buttons.

The first button, *Insert Building*, allows the user to add new buildings to the program.
