Detecting Critical Defects: Towards Standards for Conducting NDE on Cast Iron Trunk Mains

**Department of Mechanical Engineering Sciences
University of Surrey**

**A thesis submitted in fulfilment of the degree of
Doctor of Engineering**

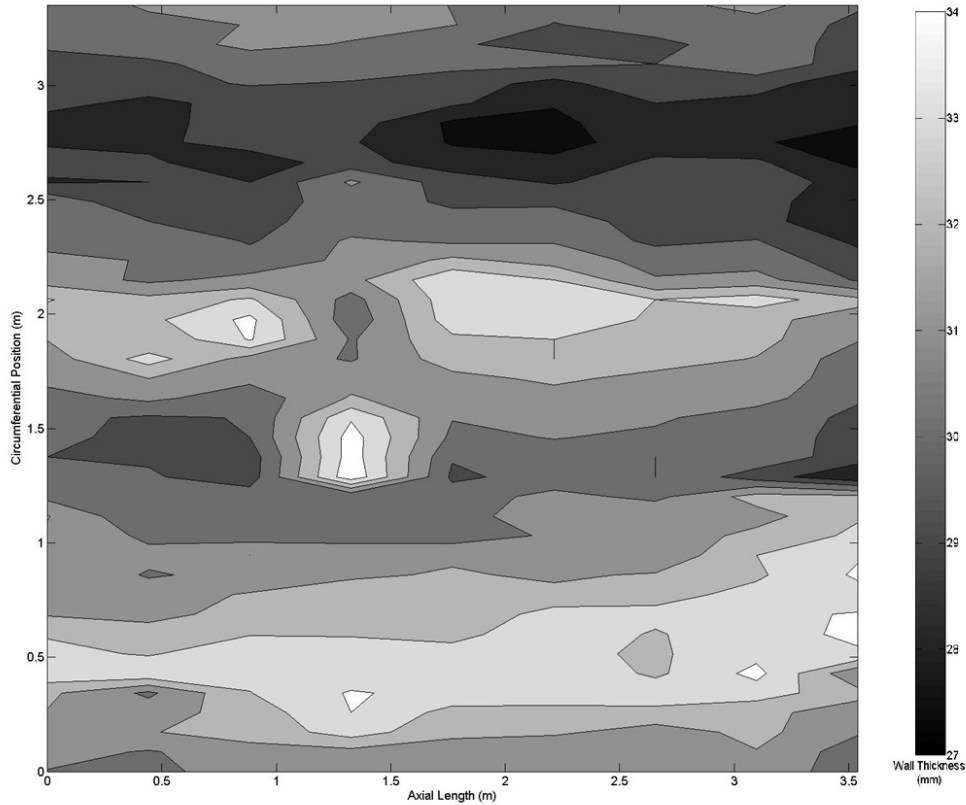
Figure 2.4 - A wall thickness map showing the variation in wall thickness in mm from manual point measurements, taken with a calliper, around the circumference of a 3.54 m length of 42" diameter vertical pit cast trunk main sectioned into rings and each ring into quarters. The darkest point represents the thinnest point and the lightest the thickest. The wall thickness varies by ± 4 mm around a mean of 31 mm. After Rainer *et al.* (2017).

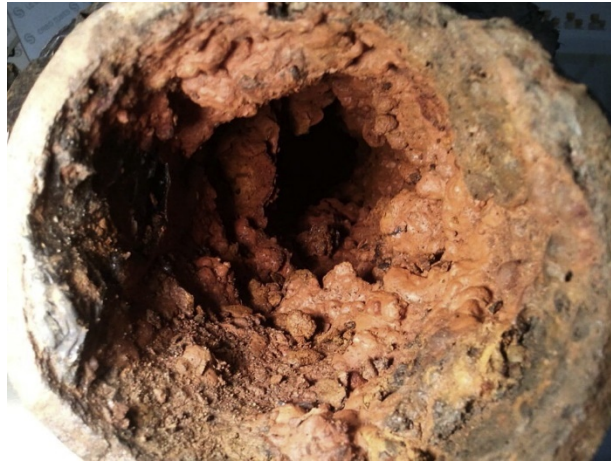
Figure 2.5 - A view of the inner surface of a water main showing significant tuberculation bubbles lining the whole inner surface of the pipe. After Świetlik *et al.* (2012).

Figure 2.5. Tubercles are the result of bacterial corrosion and produce a bubbles of iron oxide on the pipe wall which can vary in strength and structure dependent on the water flowing over them (Gerke *et al.*, 2008).

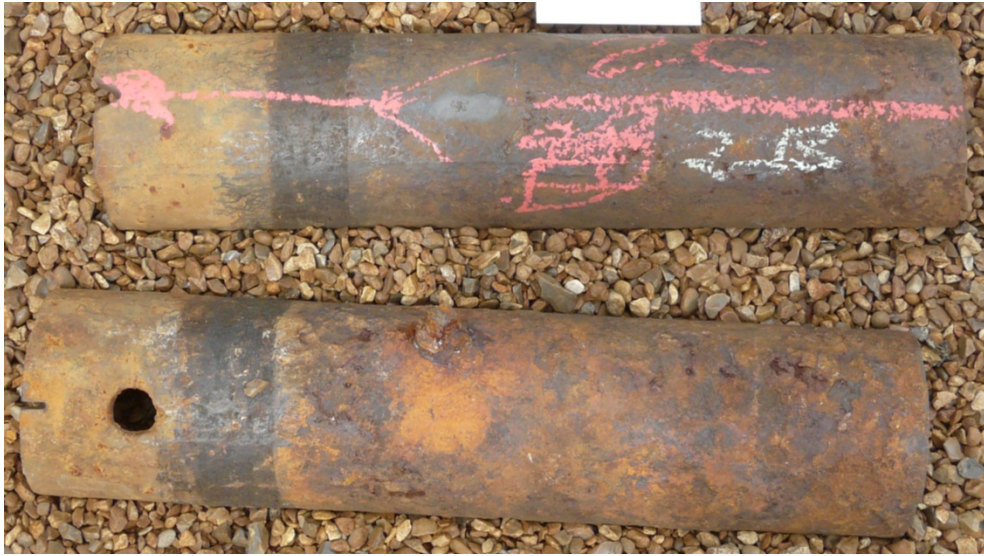
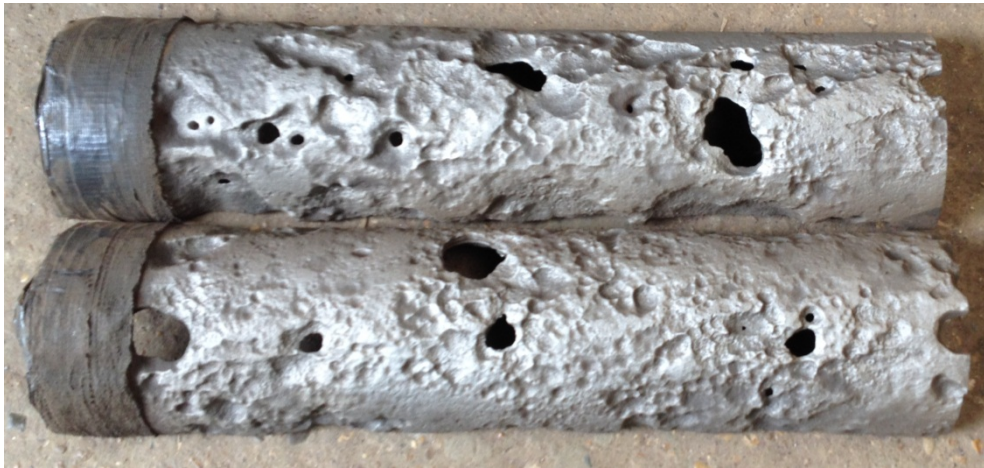
Figure 2.8 - Split section of 4" diameter distribution main illustrating the spread of corrosion and the amount of metal that can be lost to the graphitic corrosion process: (a) before shot-blasting and (b) after shot blasting. After Rainer et al. (2017).

In smaller diameter distribution mains, graphitic corrosion has been shown to have a significant impact on the strength of the pipe and to be in competition with defects that have originated during manufacture (*'a priori'*) and installation (*'ab initio'*). Further, because of the combination of the size of the pipe and its interaction with the local environment, it is possible to comment upon the behaviour of the main a significant distance (multiple casting lengths or 'sticks' of pipe, typically 3 – 5 m in length) either side of a sampling point (Belmonte *et al.*, 2007; 2008; 2009). The size and spread of graphitic corrosion in distribution mains can be seen in Figure 2.8.

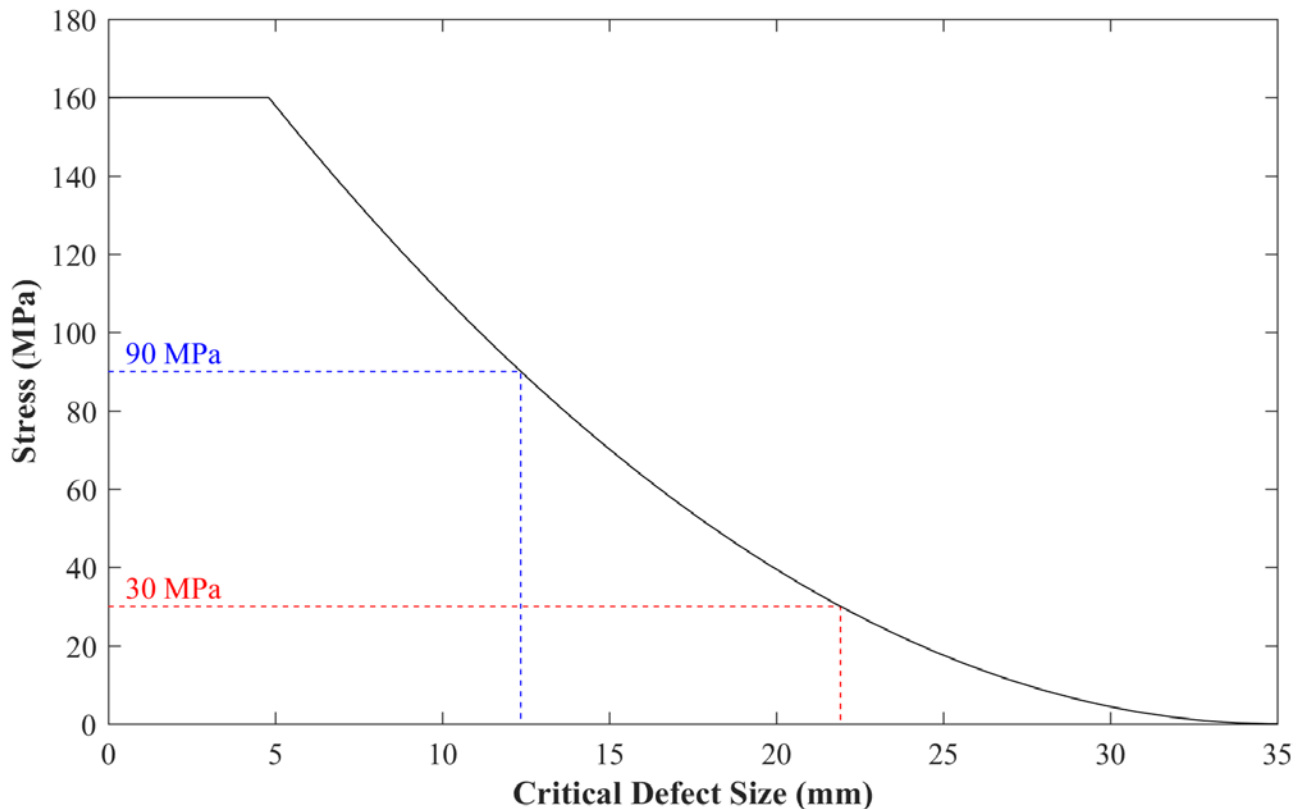
Figure 3.2 - A graph showing the critical defect size tolerable at the stress limits given by Marshall (2001) and Rajani and Abdel-Akher (2013b) for a pipe with an original wall thickness, d , of 35 mm as calculated by the “Loss of Section” approach.

A diagrammatic representation of this loss of section can be seen in Figure 3.1. In this approach, a yield stress of 160 MPa is assumed for cast iron as an upper boundary to the working stress that the cast iron can experience. Equation 3.1 has been plotted in Figure 3.2 and shows the maximum stress that can be supported for a given loss of section. It can be seen that a defect must grow to about 5 mm before any degradation in pipe strength will occur. From this graph it is also possible to determine the critical stresses for the loss of section approach for a given working stress. However, the working stress that the pipe is exposed to must be known. Each pipe in the network is different and it is very unlikely that any two pipes will experience the exact same working stress. To overcome this problem, two different values for the nominal operating stress have been

The two working stresses of 30 and 90 MPa have also been plotted to determine the critical defect size at these stresses. These critical defect sizes are also given in Table 3.1 and it can be seen that a defect less than 12 mm or 22 mm can be supported at stresses of 30 MPa or 90 MPa respectively. Further material loss would result in failure.

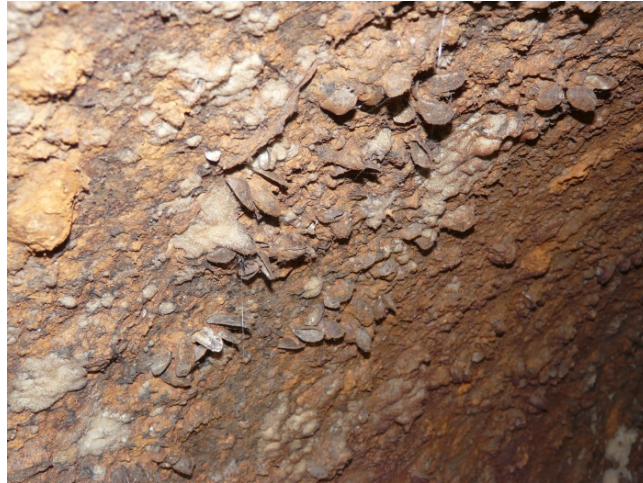
Figure 4.1 - Example of tuberculation build-up on the inner surface of a cast iron trunk main.

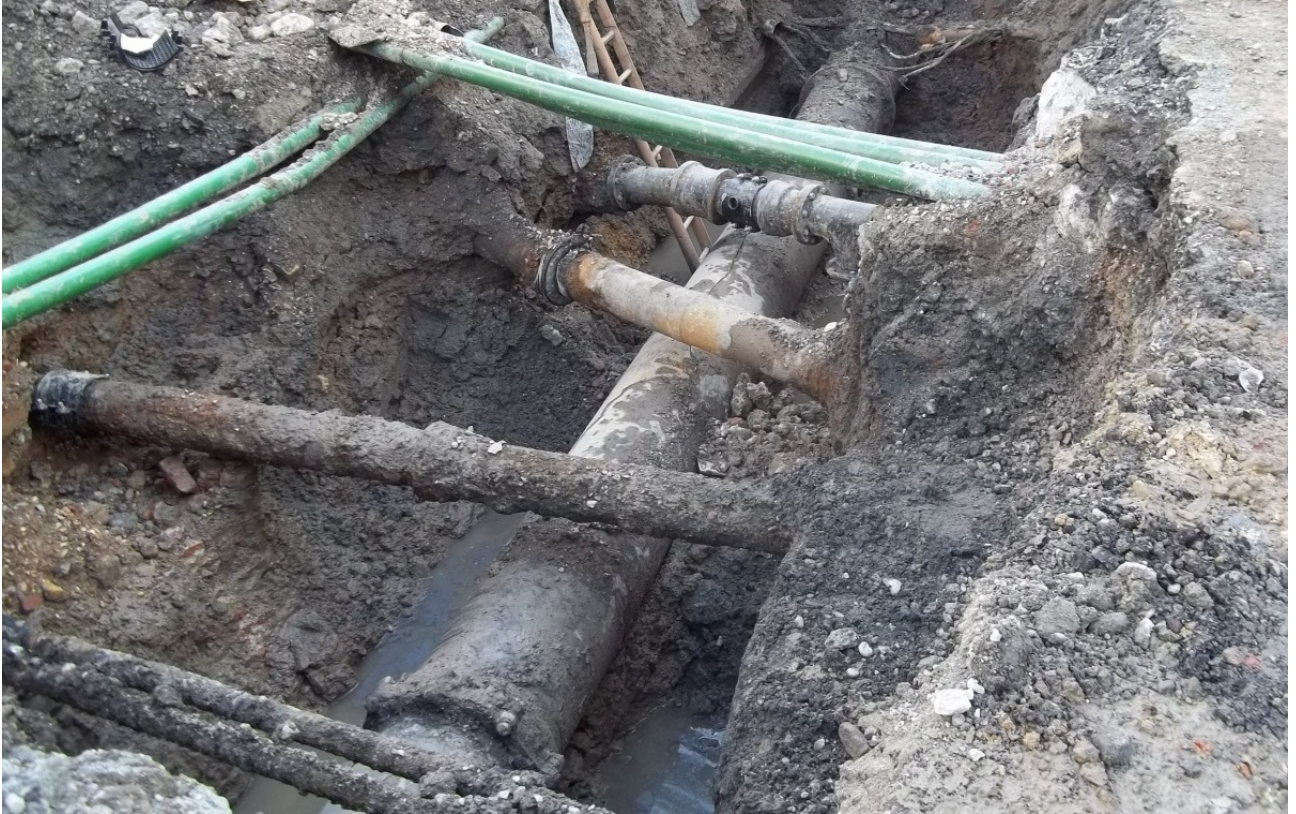
Figure 4.2 - Exposed 20" trunk main in situ at Regent Street in central London with several other pipes and services crossing it showing the restricted space available around a main.

As a consequence, conducting NDE from the outer surface of the pipe is currently preferable, even if it means that the pipe must be excavated for NDE to be conducted. Very often mains are exposed for routine work, which may present sufficient opportunity to assess the main's condition whilst the excavation is still open. However, this is still not without challenge. An excavation creates a muddy trench and may only expose a small section of main, (approximately 1 m in length), which is not significantly wider than the pipe's diameter. This can leave limited access to the surface of the pipe, particularly underneath the pipe, Figure 4.2. Any NDE method will need to be capable of operating within the clearance around the pipe afforded by the excavation and the neighbouring utilities.

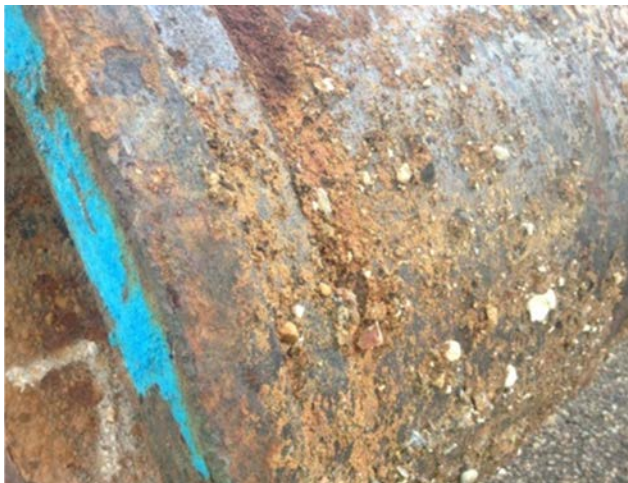
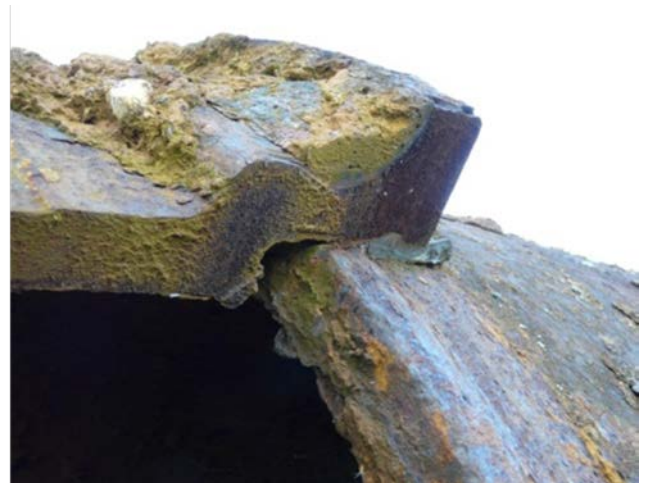
Figure 4. 3 - Barriers to NDE on cast iron trunk main: (a) surface encrustation and (b) variable geometry.

Any technique must be capable of dealing with an outer surface which is often hidden by a well adhered layer of surface encrustation which is formed from the soil and aggregates around the pipe and, in some circumstances, iron leached from the pipe may react with the soil and the aggregates to form a binder, increasing the tenacity of the encrustation to cling to the surface, Figure 4. 3(a). Whilst this encrustation can be removed, it must be done carefully so that the pipe is not compromised or the rate of degradation accelerated. Even once removed, the surface can be seen to be heavily pitted. This is a long way from the typically smooth surfaces seen in the aerospace industry where NDE techniques are routinely used. Finally, NDE must be capable of penetrating thick sections of cast iron, of the order of 30 - 40 mm. This is further complicated as cast iron pipes have a heterogeneous microstructure and so can be difficult to inspect with many established techniques. The graphitic corrosion product, that forms over time, can also be very difficult to inspect as it is also heterogeneous and can greatly attenuate any signals being put into it (Logan *et al.*, 2014). Not all of these

surfaces are of simple geometry. The pipe joints also limit the use of NDE as they can have varying geometry of which the inner profile is not always known, Figure 4. 3(b). Consequently, it may be difficult to distinguish between a geometrical variation and a genuine defect. It also makes accessing the spigot very complex as it is hidden by the pipe bell. Effective NDE will cover the whole pipe section including the pipe joint where the geometry can become significantly more complicated.

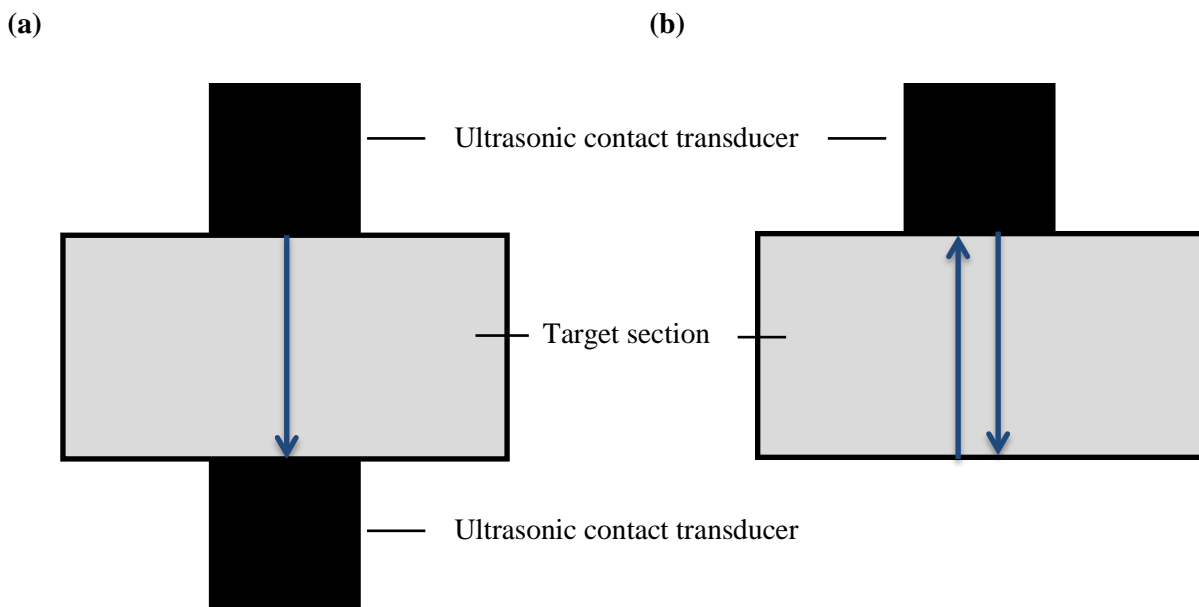
Figure 5.1 - Diagrammatic illustration of contact ultrasonic inspection: (a) through-transmission testing and (b) pulse-echo testing.

The two simplest methods of conducting ultrasonic inspection use one or two contact transducers in the pulse-echo or through-transmission configurations as illustrated in Figure 5.1. Pulse-echo testing is often used when it is difficult to access the opposite side of the material being examined. It uses a single ultrasonic transducer to emit the ultrasonic pulse and to detect the returned pulse. Through-transmission testing can be used when it is easy to access both sides of a material section. It uses two ultrasonic transducers to conduct inspection. One transducer introduces the ultrasound into the material and the other detects the ultrasound pulse on the other side of the material. For accurate results these transducers must be lined up and well coupled to the material surface.

In both cases the elapsed time between the sound leaving the transmitter and arriving at the receiver can be related to material thickness by equation Equation 5.1, where d is the material thickness, t is the time between transmission and reception and v is the velocity of sound in the material.

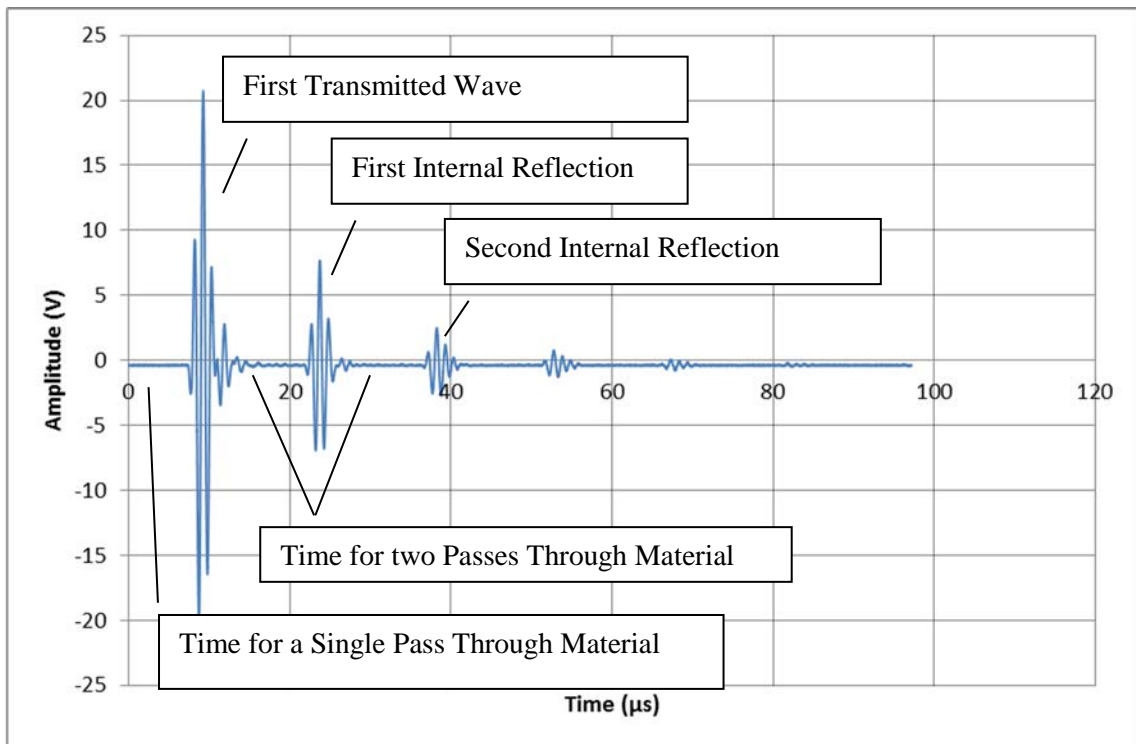
Figure 5.5 - An example contact through-transmission ultrasonic waveform for the Test Block.

An example of a waveform captured for through-transmission testing of the Test Block is presented in Figure 5.5. In through-transmission, the first pulse received is the wave that travels through the material in a single pass. The wave then reflects internally and produces further internal reflections which make two passes each. The time between subsequent reflections can be used to determine material properties. In this example, the time between internal reflections can be seen to be $14.5 \pm 0.2 \mu\text{s}$ which is similar to the value obtained through contact pulse-echo testing.

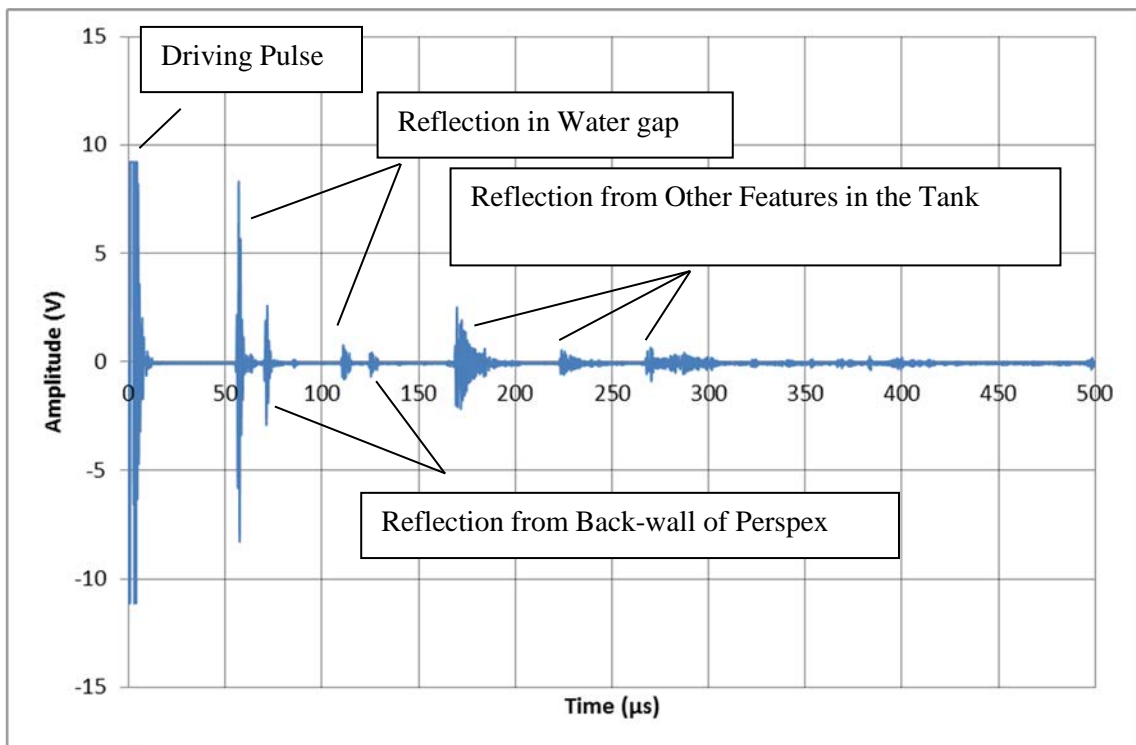
Figure 5.6 - An example immersion pulse-echo ultrasonic waveform for the Test Block.

Figure 5.6 shows the waveform received for pulse-echo immersion testing of the Test Block. It illustrates the locations of the extra waveforms that were not present during contact testing. It also indicates the extra features detected due to reflections inside the tank and other water gap reflections interfering. The time taken for an

speed of sound to Perspex, graphitic corrosion can be seen to attenuate the pulse reflections significantly more than Perspex, Figure 5.6.

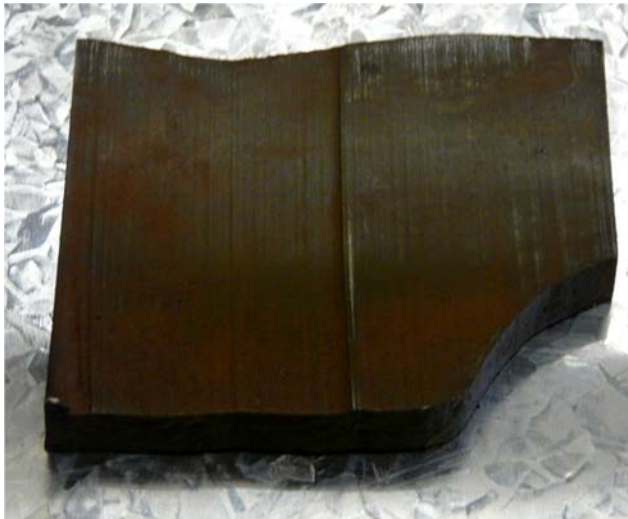
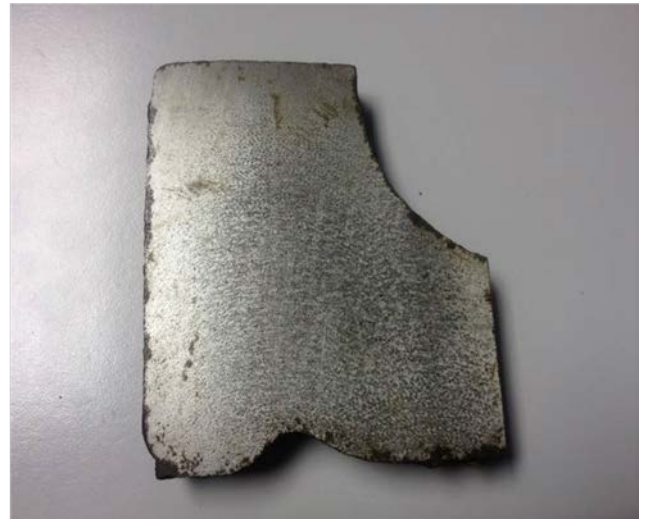
Figure 5.9 - Samples taken from cast iron flange: (a) water-jet cutting finish and (b) as machined surface

In order to obtain cast iron samples with known geometry, a selection of blocks were cut from the pipe flange of a trunk main as it contained the largest amount of material. Samples of cast iron of nominal thickness 20 mm, were cut from the flanges of 4 different cast iron pipes of different ages. Initial cutting was trialled using a water-jet cutter to ensure that there was minimal heat transferred to the material as a result of the cutting. However, the water jet cutter proved to be too slow with a cutting speed of approximately 4 mm min^{-1} for large sections. It also did not give a smooth enough cut finish which would allow a transducer to be coupled to it. The striations created in this fashion can be seen in Figure 5.9(a). Further samples were cut using a reciprocating saw which proved to be quicker at cutting whilst giving a slightly smoother surface. These blocks were machined to set thicknesses to ensure that they were parallel and had a good surface finish. An example of a finished block can also be seen in Figure 5.9(b).

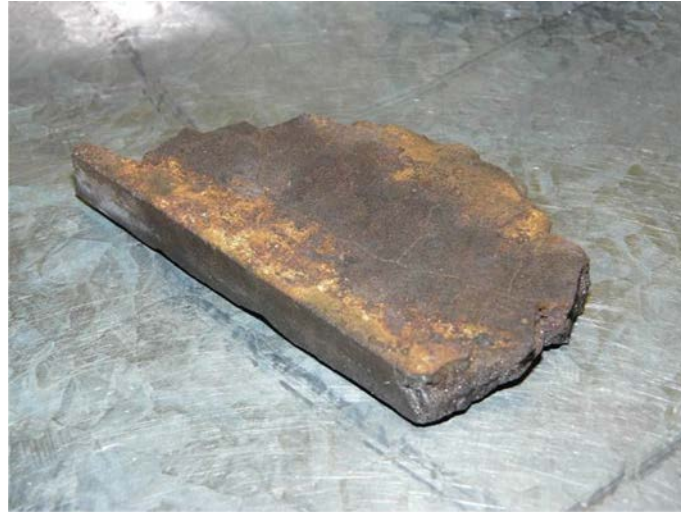
Figure 5.10 - Sample of graphitisation removed from a corroded main

Graphitisation is also a key material to investigate, although, it is difficult to obtain as it is brittle and breaks when being removed from iron sections. However, a thick section of graphitisation was removed successfully from a corroded pipe as shown in Figure 5.10. The sample was gently sanded on both surfaces to give parallel flat sides to enhance the chances of allowing ultrasound to pass through the material. It was not possible to sand both sides to a perfectly smooth layer as one side was heavily pitted and would result in large amounts of graphitisation being removed. The final sample had an approximate nominal thickness of 13 mm.

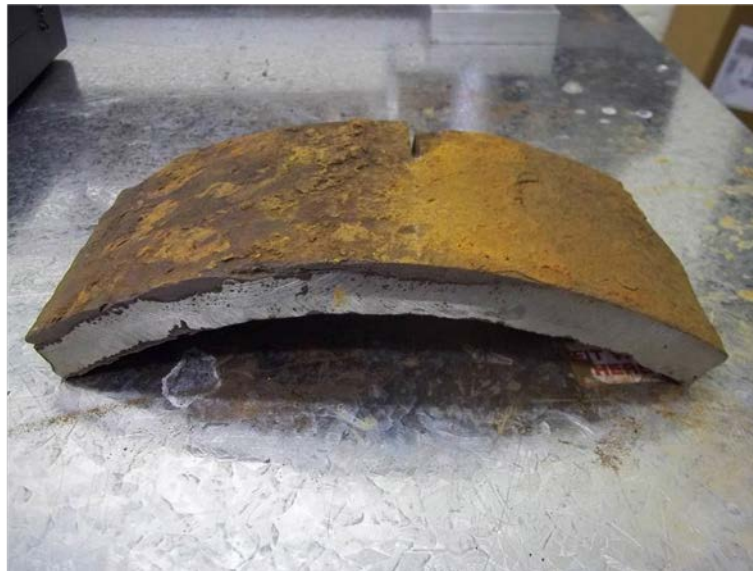
Figure 5.11 - Sample of cast iron trunk main with graphitised layer

Aside from clean samples, a selection of other samples with layers of graphitisation and tubercles were cut from the barrel of the available cast iron trunk main stock. Figure 5.11 shows an example of a section of iron with a layer of surface graphitisation that was used for testing.

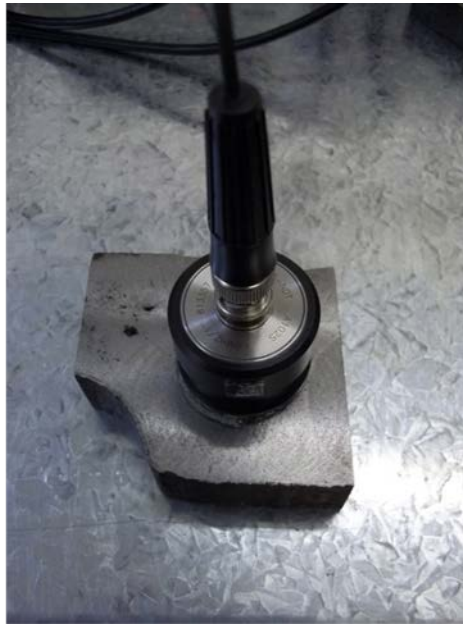
Figure 5.12 - Contact ultrasonic transducer being used to measure the velocity of sound in a machined section of cast iron

Contact testing was used whenever the surface permitted it as it minimised the energy losses through coupling and also simplified the analysis of the signals. However, the machined surfaces were the only surfaces suitable for contact testing. Low frequency⁴ large diameter 1" transducers were used to maximise the ultrasonic signal transmitted to the iron and were arranged in a single-sided pulse-echo configuration or through-transmission configuration as required. A range of Olympus transducers were used in these configurations, however, a single Olympus A102s 1 MHz 1" Accuscan contact transducer in a pulse-echo configuration gave adequate results. This was driven by an Olympus PR 5077 square wave pulser/receiver and Tektronix MSO2014 oscilloscope. The devices were connected together to achieve a pulse-echo format. The pulser/receiver was set to 100 V transducer voltage, 100 Hz pulse repetition frequency (PRF) and pulse-echo mode with minimal damping. Ultrasonic couplant was applied to the surface of the iron and the transducer was pressed down in the centre of the sample, ensuring that it was sufficient distance away from the edges to minimise edge effects as seen in Figure 5.12. The pulser/receiver was switched on and the pulser gain was adjusted such that the signal shown on the oscilloscope was not being clipped by the internal pulser amplifier. The signal was then adjusted on the oscilloscope such that the first back-wall echo was vertically spread across the screen to ensure that there was sufficient level for digitisation. The signal was recorded by a computer linked to the oscilloscope running National Instruments Signal Express v3.0. The raw waveform was captured using a time averaging method of 32 samples to remove any shot noise from the signal.

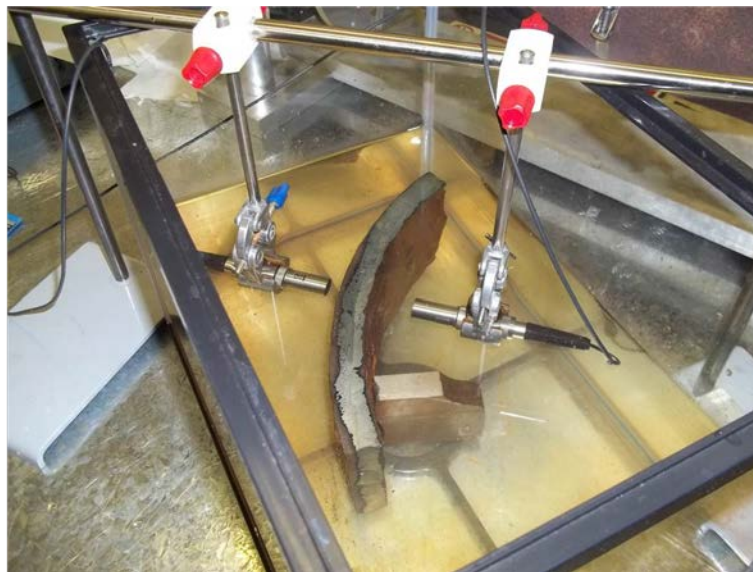
Figure 5.13 - Ultrasonic pulse-echo testing carried out in immersion on a section of graphitised cast iron.

Because contact transducers can only be used on relatively smooth surfaces, immersion testing was used where surfaces were much rougher and could not support a contact transducer. This arrangement was used for inspecting the sample of corrosion products and when investigating the effects of surface geometry. The sample being inspected was placed in an ultrasonic immersion tank (41 x 25 x 25 cm) and stood upright on its side to allow the probe to inspect the surface in question whilst ensuring there was sufficient water cover. The probe was arranged in a pulse-echo format shown in Figure 5.13. An Olympus A303S 1 MHz 0.5" Accuscan immersion transducer was used to inspect the iron in combination with an Olympus PR 5077 square wave pulser/receiver and Tektronix MSO2014 oscilloscope. The devices were connected together to achieve a pulse-echo format. The pulser/receiver was set to 100 V transducer voltage, 100 Hz PRF and pulse-echo mode

with minimal damping. The transducer was positioned over the site of interest and held in position by a stand, ensuring that it was not close to an edge of the sample. The pulser/receiver was switched on and the pulser gain was adjusted such that the signal shown on the oscilloscope was not being clipped by the internal amplifier. The signal was then adjusted on the oscilloscope such that the first back-wall echo was vertically spread across the screen to ensure that there was a sufficient level for digitisation. The signal was recorded by a computer linked to the oscilloscope running National Instruments Signal Express v3.0. The raw waveform was captured using a time averaging method of 32 samples to remove any shot noise from the signal.

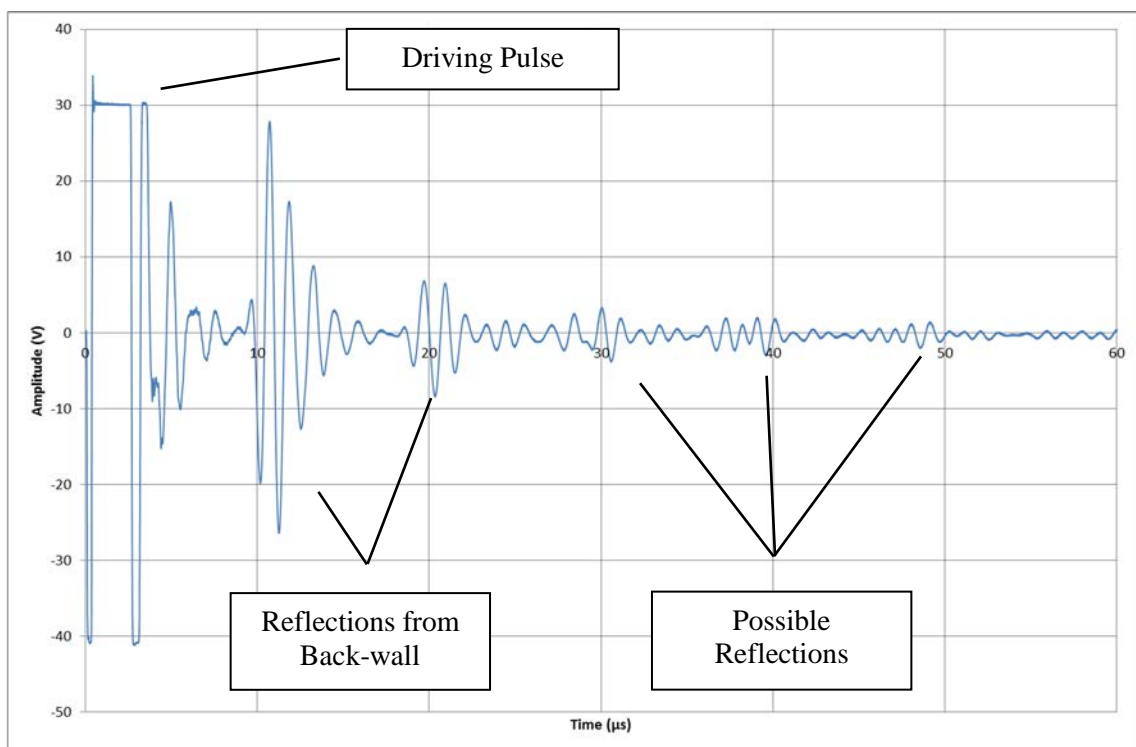
Figure 5.14 - An ultrasonic waveform captured from a clean piece of cast iron

Figure 5.14 illustrates a typical waveform captured from pulse-echo testing of a section of clean cast iron. The waveform shows that the two strong reflections can be seen from the back wall of the iron. The time difference between these reflections is $9.5 \pm 0.2 \mu\text{s}$ and indicates the time taken for a wave to reflect from the opposite side. Given that the material had a nominal thickness of 20 mm, this suggests a velocity of sound in the cast iron of approximately $4210 \pm 90 \text{ m}\cdot\text{s}^{-1}$.

When compared to a similar wave captured on a Perspex Test Block of similar thickness, Figure 5.4, the signal can be seen to attenuate strongly after the first two reflections. Further, the noise in the signal, between the reflections is significantly greater. It is possible to see locations where a reflection would be expected, albeit that the signal is less clear than the previous reflection. These waves are likely to have been attenuated by the microstructure, in particular the graphite flake structure, and other defects within the iron. The pulse distortion seen on the later reflections is also due to the waves being scattered within the iron and causing destructive interference.

Figure 5.14 showed a wave trace of ultrasound being passed through a machined sample of cast iron. This allowed a simple velocity measurement to be taken based on the time for the wave to travel and the material thickness. When carrying out ultrasonic inspection, it is crucial to have accurate material constants as these will affect the results when post-processing the raw data. Current literature shows that the speed of sound in

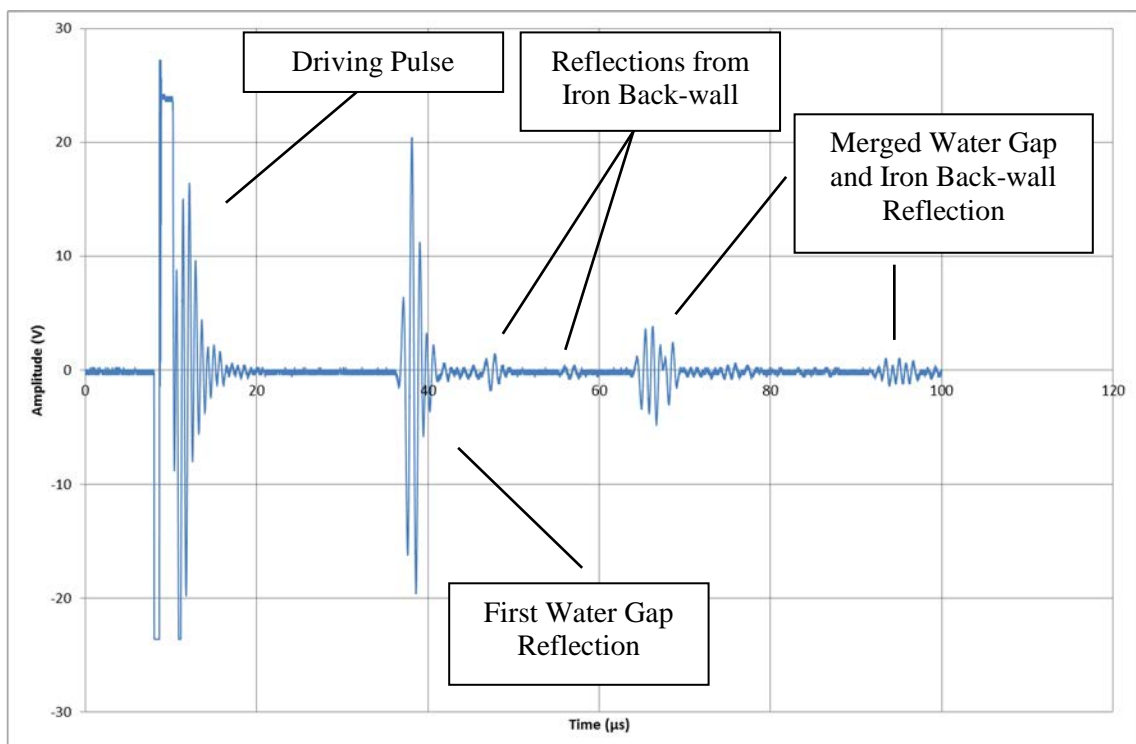
Figure 5.15 - An ultrasonic waveform captured from a pulse-echo test of a non-graphitised piece of cast iron trunk main

An example waveform from this test is shown in Figure 5.15 and shows that reflections from the back wall of the iron can be seen. The iron had a nominal thickness of 20 mm and the time for the back-wall reflection can be seen to be $9.5 \pm 0.2 \mu\text{s}$ which means that the speed of ultrasound in the materials is approximately

$4210 \pm 90 \text{ m.s}^{-1}$. This is consistent with the other values obtained for cast iron shown in Table 5.1 and confirms that the reflection is being obtained from the back wall of the iron.

The reflections seen are greatly reduced in amplitude compared to the initial waves seen in the water gap. Part of this reduction is due to the attenuation processes in the cast iron. The majority of this may be due to the graphite flake structure. However, the curved geometry of the pipe sample adds further complications. This curved back wall increases the ultrasonic beam spreading and reduces the amplitude of the wave returning to the transducer. Also, the phase of the wave may change and result in a delayed arrival at the transducer. This shows why the pulses become less clean and have a ringing⁵ nature.

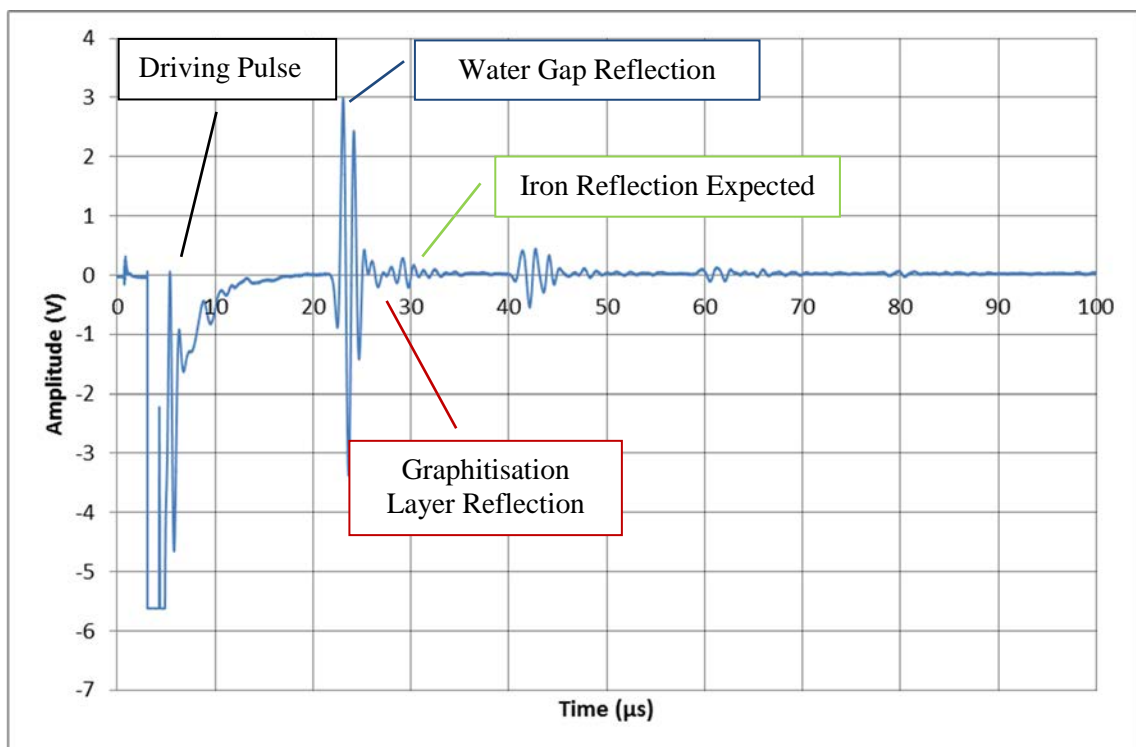
Figure 5.18 - An ultrasonic waveform showing the interaction with a graphitised section from the outside of cast iron trunk main in pulse-echo immersion

The graphitised layer had a nominal thickness of 8 mm and the remaining iron had a nominal thickness of 13 mm. This would result in the graphitised layer producing a reflection at a time of approximately 5 μs and the iron would produce a reflection time of approximately 6 μs . Consequently, a reflection should be seen 5 μs after the first arrival of the water gap reflection and then a reflection for the iron should be seen 11 μs after the first arrival of the water gap reflection. The wave form captured during this testing is given in Figure 5.18 and it shows a clear first reflection for the water gap. However, the signal for the graphitisation and cast iron are not clear. A distortion to the signal train could indicate the presence of the graphitisation, however, it is not

sufficiently distinct to allow an acceptable assessment. Here the reflection from the iron cannot be seen. It is likely that the attenuation of the graphitisation attenuates the signal sufficiently that any signal becomes too weak to be seen.

This test allowed the graphitisation thickness to be seen, however, it did not show the residual iron thickness to be seen. This test was repeated from the internal side of the pipe to see whether a better signal could be obtained. The order of the reflections seen would be slightly different from before, as illustrated in Figure 5.19, whilst an example waveform for this test is given in Figure 5.20. It shows a strong water gap reflection and one further, less distinct reflection that overlaps. It is now possible to establish the thickness the iron from the

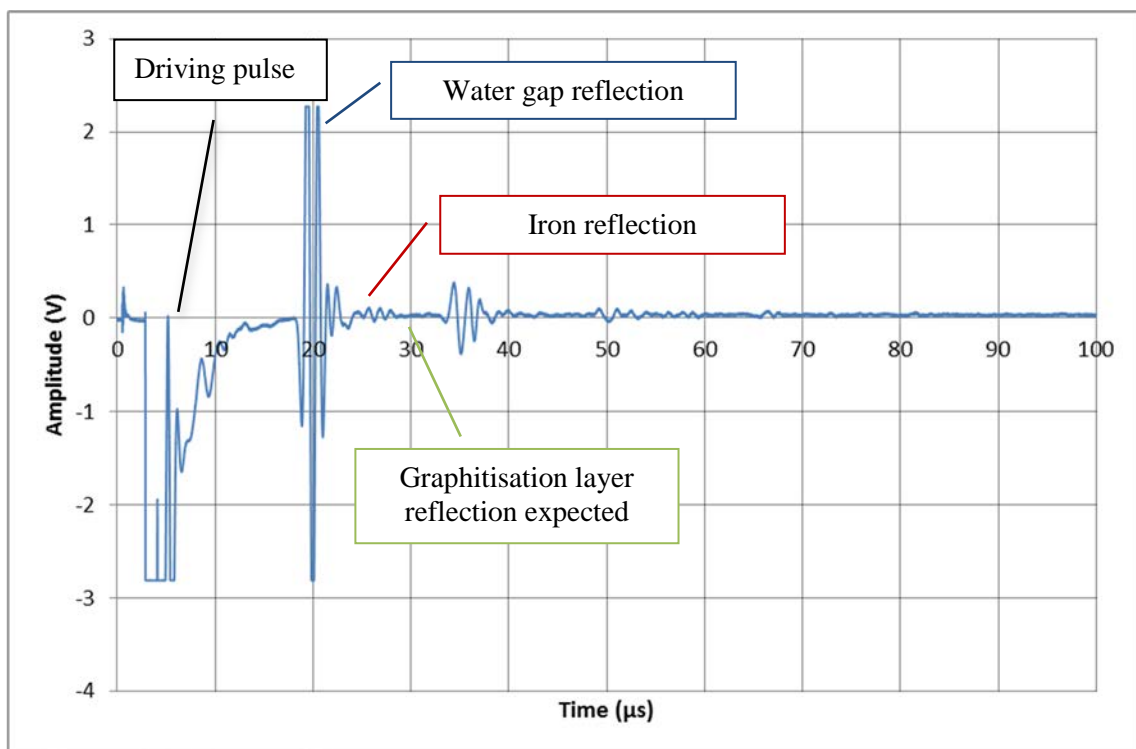
Figure 5.20 - An ultrasonic waveform showing the interaction with a graphitised section from the inside of a cast iron trunk main in pulse-echo immersion

inside, provided there are no corrosion products that would inhibit the progress of the ultrasound. However, a third reflection was not visible and as a result it is not possible to detect the graphitisation that is present.

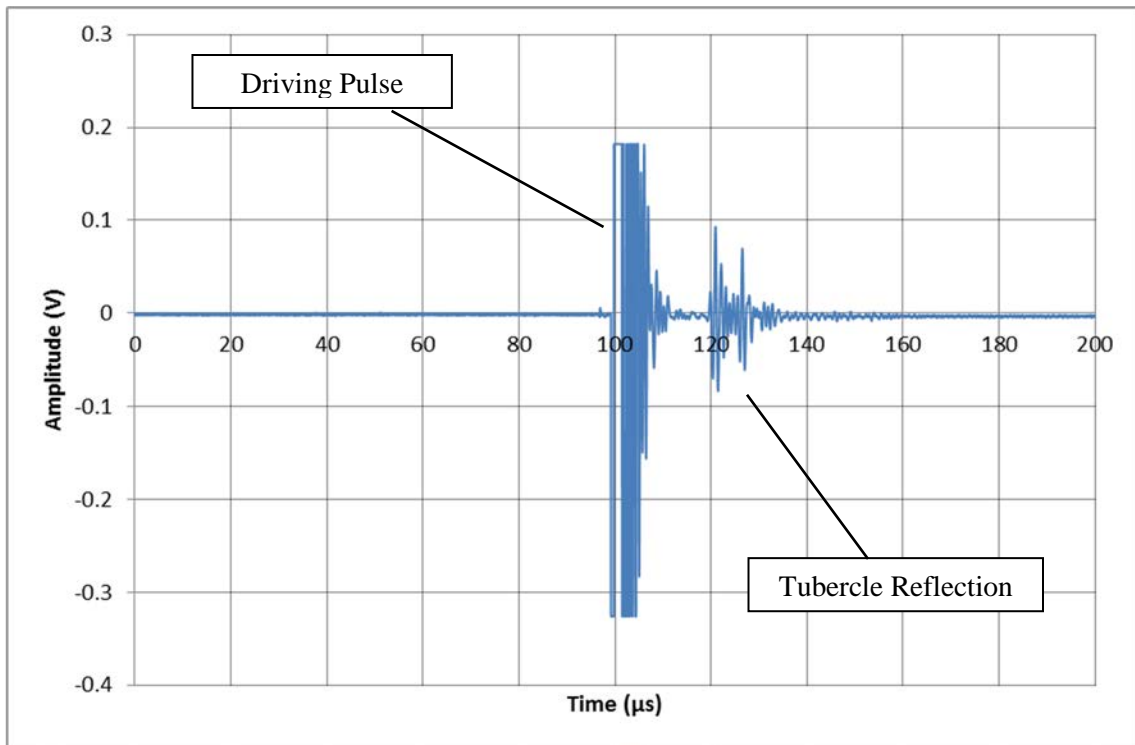
Figure 5.21 - An ultrasonic waveform captured from a pulse-echo test of a tubercle in immersion

and are very noisy. It is possible to see the reflection from the front of the tubercle in the water gap, however, it is not possible to see any further reflections inside the tubercle as these reflections are not sufficiently separated and overlap with the first reflection. The geometry of the tubercle is also likely to cause problems as the rounded shape of the tubercle will cause the ultrasonic beam to spread resulting in many staggered reflection arrivals at the transducer. Consequently, these effects cause an overlap of signals and a distinct reflection cannot be identified. The presence of tubercles on the internal surface of a cast iron pipe would make internal ultrasonic inspection difficult and further work is needed to better understand their effects and if they can be overcome.

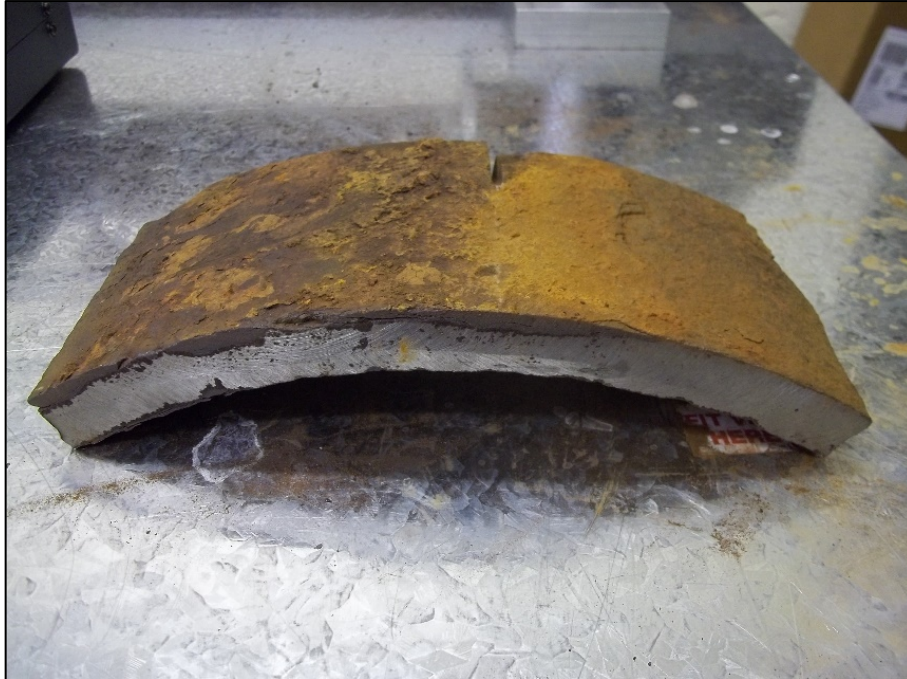
Figure 6.2 - Sample A, which was used for feasibility testing the magnetic force testing principle.

Samples of cast iron were obtained from two different cast iron pipes. Sample A is a section of cast iron trunk main with a uniform layer of external graphitic corrosion that could be seen to vary in thickness between 0 - 12 mm. The origin of this sample is unknown, Figure 6.2.

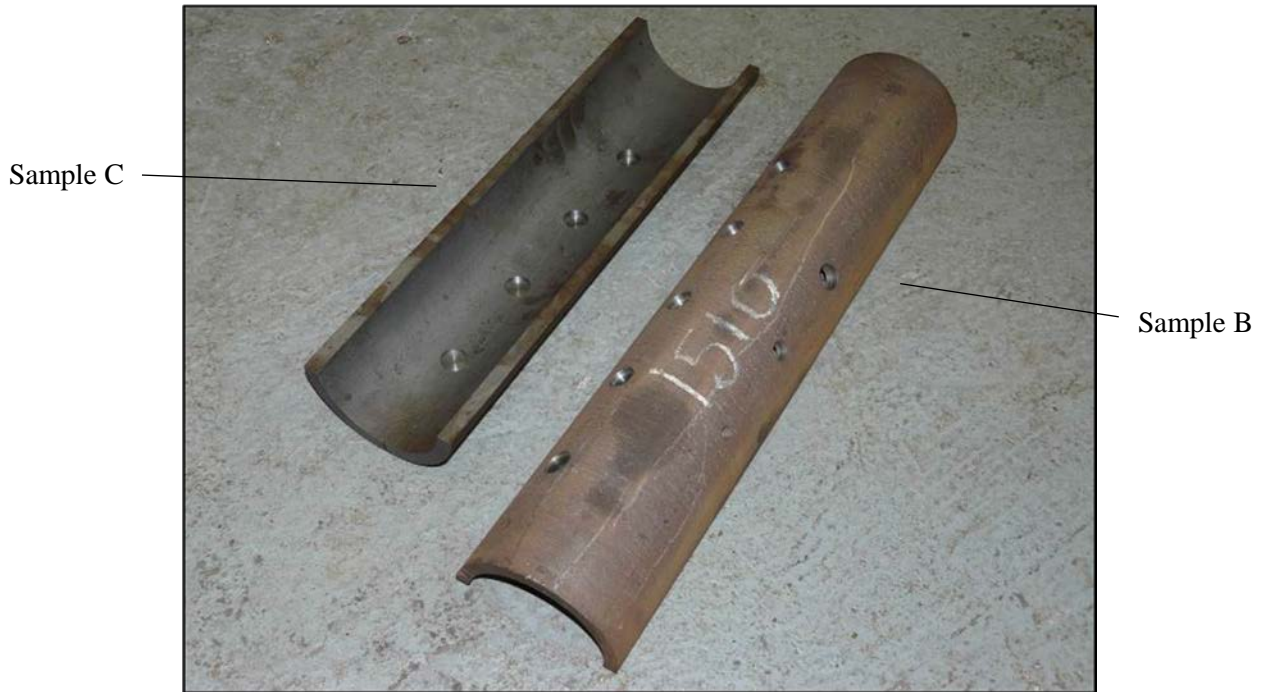
Figure 6.3 - Samples B and C after preparation for magnetic inspection showing internal and external machined defects.

Two further samples were taken from a of cast iron distribution main obtained from the TWUL pipe and soil technical archive (PASTA). This pipe was chosen as it displayed minimal corrosion, twist and eccentricity. This main had previously been split into two halves longitudinally. Each half was prepared differently, Figure 6.3:

- Sample B had two different sets of mechanical defects machined into it. On one side, a selection of five equally spaced external 20 mm flat-bottomed holes of various depths, ranging from 2 mm deep to through wall in 2 mm increments, were machined into it. On the other side, four holes of various diameters, ranging from 5 mm to 20 mm in 5 mm increments, were drilled into it.
- Sample C had a selection of equally spaced internal 20 mm flat-bottomed holes of various depths, ranging from 2 mm deep to through wall in 2 mm increments, machined into it

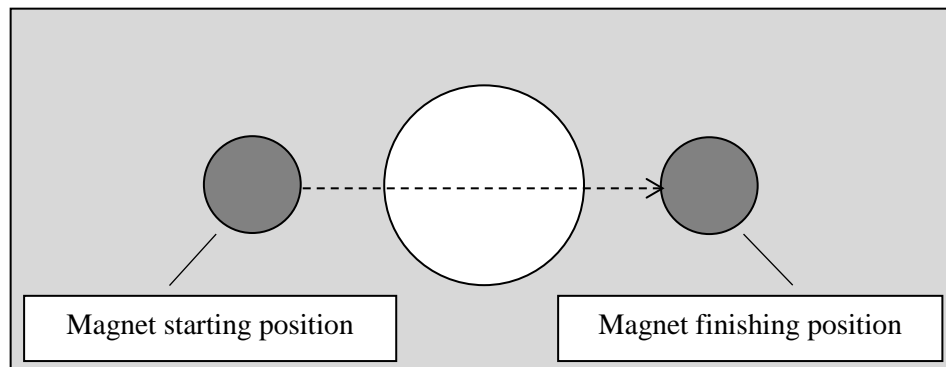
Figure 6.5 - Diagrammatic representation of a linescan conducted across a machined hole

the load cell and an initial force reading was taken from the load cell to mark the zero reading. Sample B was positioned such that the magnet was directly over the centre of a site of interest. The magnet was then moved longitudinally 30 mm away from the defect centre. The magnet was lowered into contact with the sample until the force read by the load cell began to decrease due to the contact force with the magnet compressing the load cell. The magnet was then moved away from the surface very slowly, until the force reading peaked. At that point, the magnet was no longer in direct contact with the sample and the peak load reading was recorded. After the recording was captured, the magnet was moved longitudinally 1 mm closer to the defect centre. This process was repeated until the magnet was 30 mm past the defect centre to create a linescan over a machined defect, Figure 6.5. Once the linescan was complete, the magnet could be changed and the process repeated to determine the effect of each magnet. This testing process was repeated for each of the machined defects in Sample B. When Sample B was complete, it was removed from the rig and replaced with Sample C. The measurement process was then repeated for that pipe section.
