Detecting Critical Defects: Towards Standards for Conducting NDE on Cast Iron Trunk Mains

**Department of Mechanical Engineering Sciences
University of Surrey**

**A thesis submitted in fulfilment of the degree of
Doctor of Engineering**

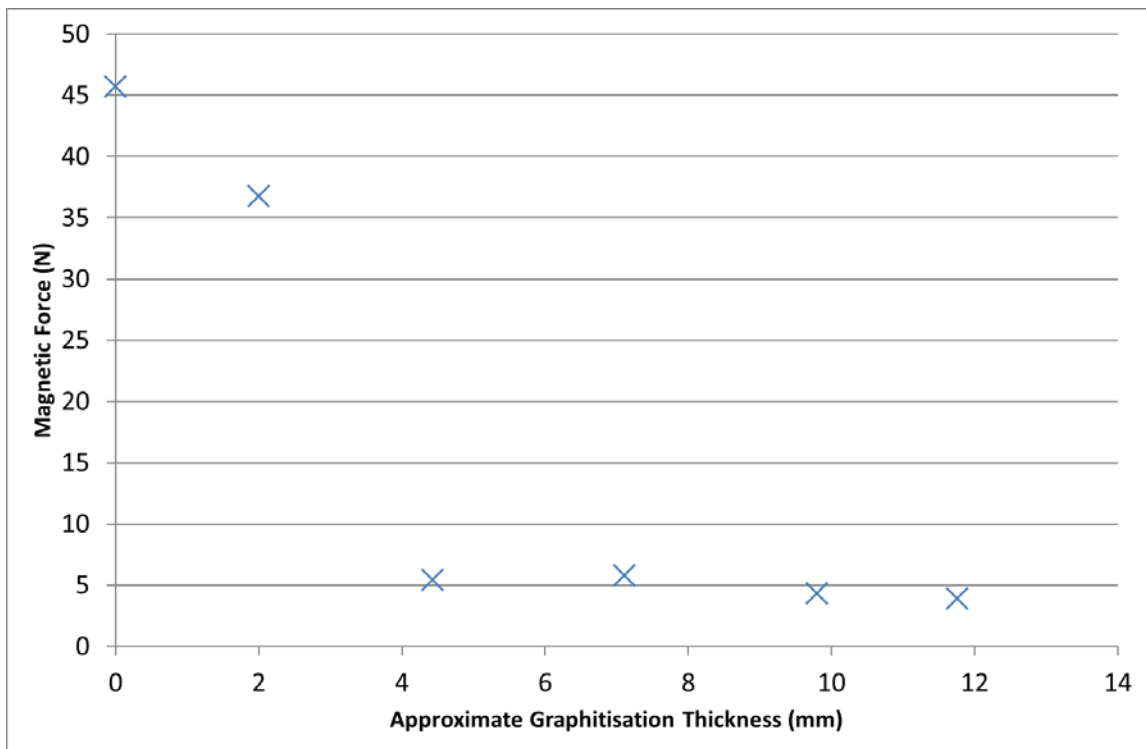
Figure 6.6 - Strength of the magnetic force for the 20 mm magnet compared to the thickness of the graphitisation layer captured during the initial feasibility testing.

Anecdotal evidence suggests that magnets have been used for some time to locate patches of graphitisation on the external surface of metallic pipes. However, they do not appear to have been used to characterise the thickness of the corroded layer. This is likely to be due to the need for a calibrated system rather than a simple “good judgment”. A sample of graphitised cast iron was examined at various locations of differing graphitic corrosion thickness to determine the simple variation in magnetic force compared to graphitic corrosion thickness. The results obtained from this testing show a correlation between reducing corrosion thickness and increasing magnetic force, Figure 6.6. It can be observed that there is a sharp change in the magnetic force of attraction between 2 and 4 mm of graphitic corrosion. Corrosion of a thickness between these values was not available for testing. Consequently, further testing would be beneficial to provide further data points that reduce the spacing between such data points. However, the initial feasibility testing suggests that this concept could possibly provide a useful NDE technique.

When comparing the results given in Figure 6.7 with those given in Figure 6.6, similar trends regarding separation thickness or corrosion thickness and the magnetic force measured can be observed. The results indicate that air would make a suitable substitution material in place of graphitic corrosion.

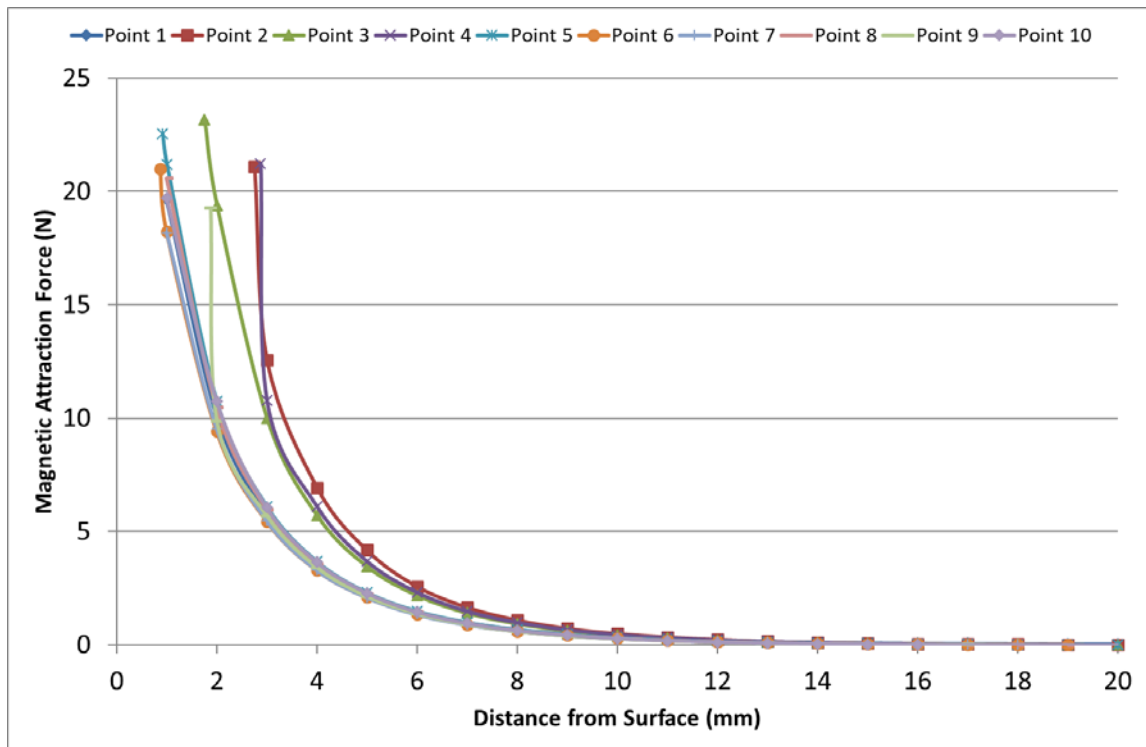
Figure 6.7 - Results of the separation testing carried out with 20 mm magnet

Initially the effect of an air gap between the magnet and a smooth iron surface was investigated. This testing was initially carried out to determine the effect of a change in separation and its effect upon the magnetic force of attraction. A graph showing the magnetic force measured at each separation for each point can be seen in Figure 6.7. It shows that, as expected, there is a non-linear relationship between force of attraction and separation. It indicates that the technique may be able to detect graphitisation layers up to 7 – 8 mm in depth, provided that the magnet could be sufficiently close to the surface of the pipe. The change in force beyond 10 mm deep appears to be very small and may not be significant enough to measure confidently. In order to achieve the highest range of magnetic force, the magnet would need to be able to get within a millimetre of the pipe surface. Good surface preparation would therefore be needed to allow this to happen.

Figure 6.7 shows two trends similar in shape, although offset in the distance from the surface. This change is unlikely to be a variation in material as the pipe was of approximately uniform dimensions throughout. This offset is likely to be due to inaccuracy in the method of measuring the distance above the surface of the pipe. If improved, it is likely that the offset would disappear and the curves would be in closer agreement.

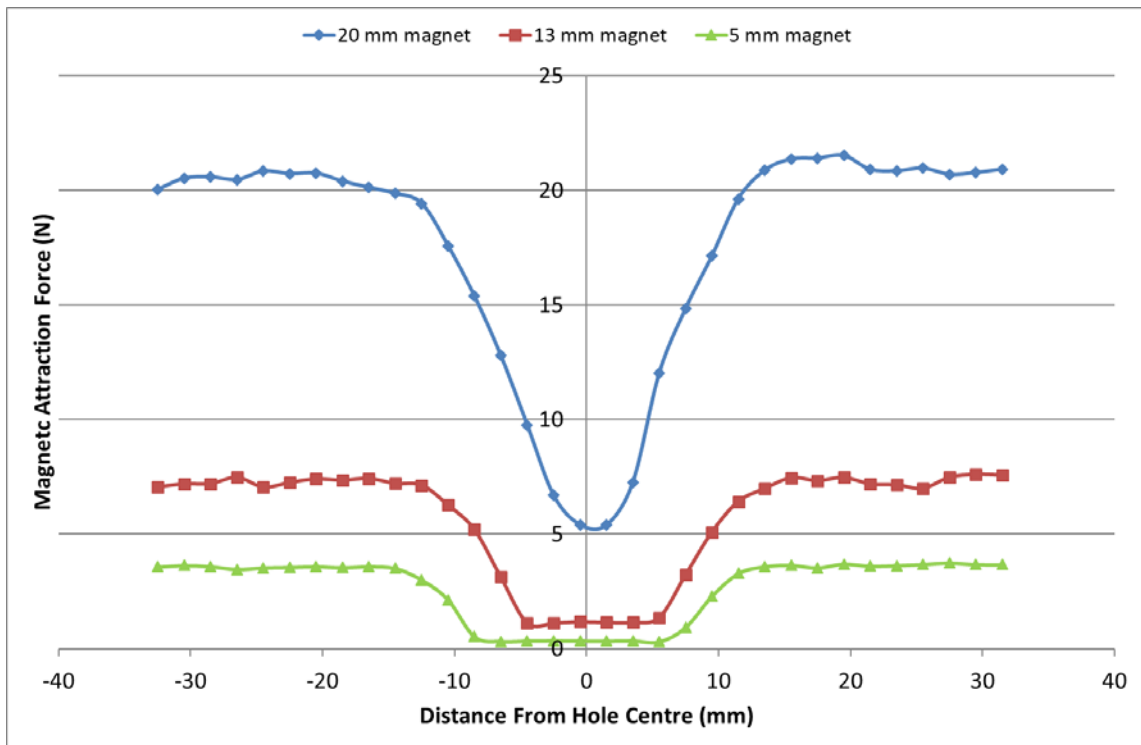
Figure 6.8 - Linescans showing the magnetic force of attraction against the distance of magnet centre from hole centre for the three magnet diameters for a 20 mm diameter flat bottom hole 2 mm deep

The initial separation testing showed that the maximum corrosion thickness that could be investigated was 7 - 8 mm; beyond this the magnetic force of attraction becomes too small to measure and accurately distinguish. Further testing was carried out to see whether defects in a cast iron pipe could be detected as deep. In this test, a sample of cast iron distribution main with flat-bottomed holes machined in to the outside of it was used. Here the air gap in the hole represented the graphitisation. Figure 6.8 - Figure 6.10 illustrate the results obtained when performing a longitudinal linescan over the flat-bottomed holes of varying depths. In each figure, it can be seen that the magnetic force of attraction drops off dramatically for each magnet as it passes over the hole. The force of attraction levels out once the magnet is at the centre of the hole. It then rises sharply as the magnet begins to move away from the hole. This is in agreement with the results in Section 6.4.2 which show a sharp decay as the distance between the magnet and the iron is increased.

On further comparison of the graphs, it can be seen that the shape of the curves is different. It is suggested that the magnetic field around the 5 mm and 13 mm magnets has a smaller diameter than the 20 mm holes. Consequently, the field lines do not expand enough radially to cut through any iron when it is over the centre of the flat bottomed holes, whereas the magnetic field of the 20 mm magnet is likely to have a larger diameter than the 20 mm holes. Consequently, the magnetic field lines for such a magnet expand enough radially and

The results show that the magnetic force of attraction for the 5 mm, 13 mm and 20 mm magnet is greatly reduced by an air gap of 2 mm, 4 mm and 6 mm respectively. It is unlikely that significant magnetic force, capable of distinguishing further layer thickness, would be produced for larger air gaps. Hence, the maximum thickness that would be able to be classified with the current magnets would be 6 mm.

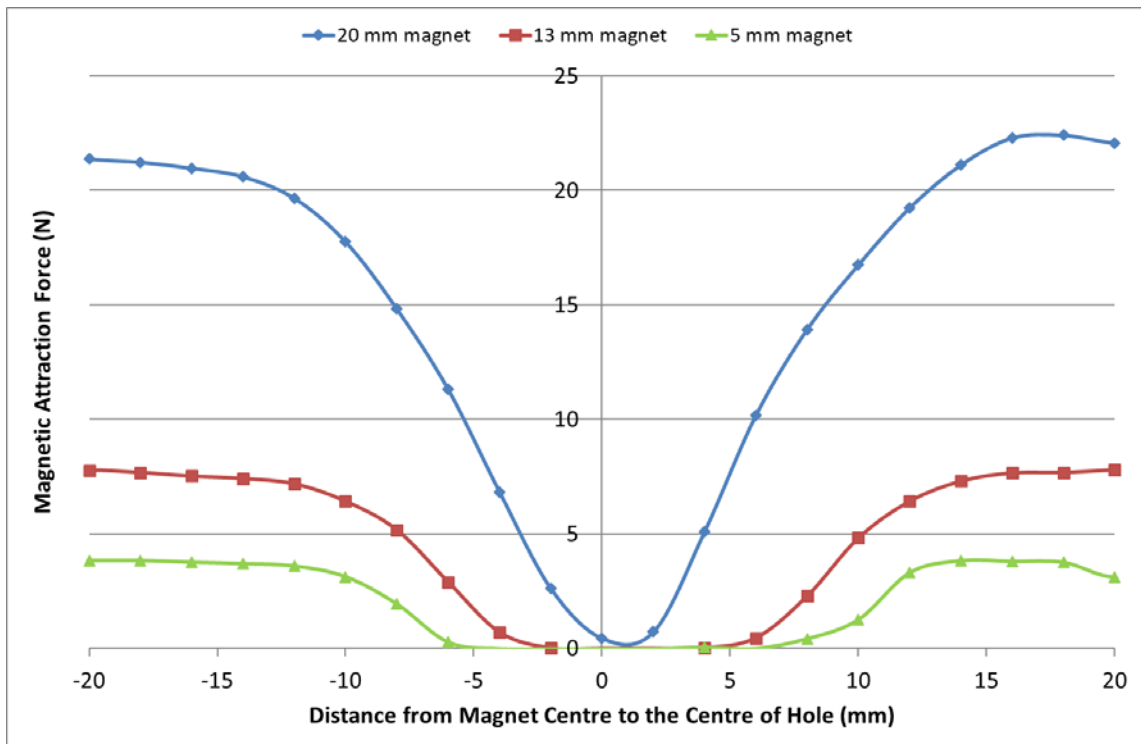
Figure 6.14 – Linescans showing the magnetic force of attraction against the distance of magnet centre from hole centre for the three magnet diameters for a 20 mm diameter through-wall hole

In the last linescan, Figure 6.14, both the 13 mm and 5 mm magnet have lost all magnetic force when they are over the hole. However, the 20 mm magnet has a small amount of residual force left. Given that the 13 mm

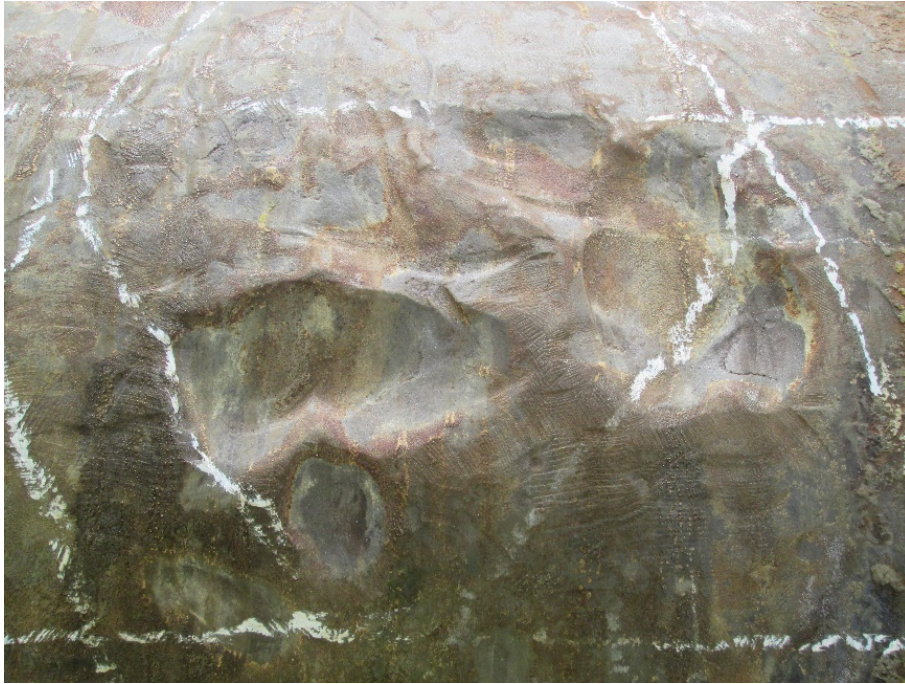
Figure 7.3 - Corrosion pit after the graphitic corrosion has been partially removed during surface preparation.

Finally, it is recognised that many of the NDE techniques employed require smooth surfaces to operate properly. All contractors are allowed to conduct surface preparation to enable effective NDE, however, it has been observed that the surface preparation of some contractors can be overly aggressive leading to graphitic corrosion being eroded from the pipe surface, Figure 7.3. This can lead to underestimation of the corrosion thickness measured. The current method of evaluating an NDE contractor can be seen to have problems which prevent information detailing their performance being gathered. Consequently, an improved method of destructive analysis is needed that can provide the internal and external corrosion thickness, and any loss during surface preparation, as well as the remaining wall thickness.

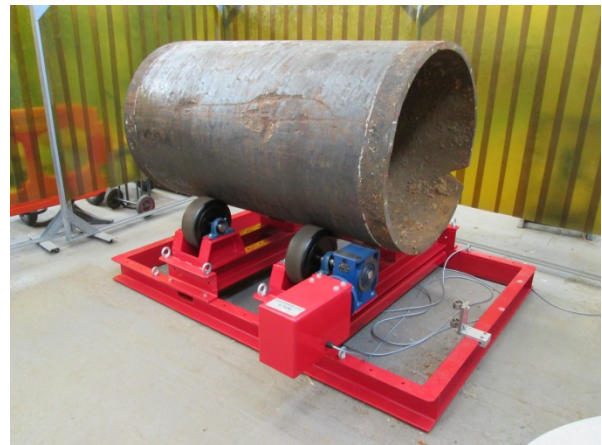
Figure 7.4 - Equipment used to conduct the pipe scanning: (a) the Artec Eva structured white light scanner (Artec, 2016) and (b) the specialised pipe rotator used to manipulate the sections of trunk main loaded with a section of 42” main.

trunk main sections, of the order of 1 – 2 tonnes in mass, required much more careful handling and sufficient space in which to do it. A bespoke pipe rotator was manufactured by Spectrum Welding Supplies (Chesterfield) to allow large sections of pipe to be rotated safely for scanning. The rotator comprised a standard five tonne capacity motor driven rotator pair on a bespoke frame that could be repositioned using a forklift truck. This rig enabled sections of trunk main, up to one complete pipe ‘stick’ long, i.e. 5 m in length including the bell and spigot, to be safely positioned and manipulated for 3D scanning, Figure 7.4(b). This is believed to be a unique facility.

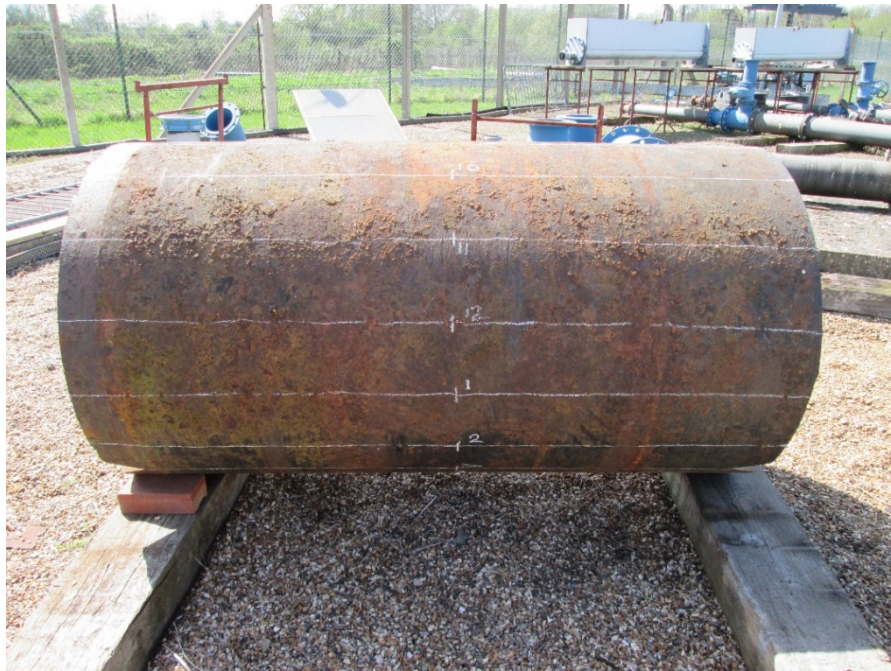
Figure 7.19 - Specimen Three.

A further section of trunk main was obtained to verify that the updated method, demonstrated on the section of distribution main, was capable of functioning on a full-sized trunk main section. This section was cut from a much longer section of 42" trunk main that had been exhumed from the Olympic Park during the pipe replacement project. This sample is referred to as Specimen Three. The specimen was cut to 1.8 m long using a petrol disc cutter, Figure 7.19. A crownline was marked along the specimen to give a reference vector from which measurements can be made.

In the case of a live comparison exercise, it is beneficial if this is the actual crownline, marked when the pipe is exhumed, as this can help to reference the position of the corrosion captured in the 3D scans. Two v-notches were cut into the Specimen Three: one at each end of the crown line. The geometry of these notches is not prescriptive, however, the notch must not encroach into the specimen more than 100 mm. It is also advised that the angle of this v-notch is greater than 90 degrees to ensure that the 3D scanner can fully illuminate the wall cross-section. Failure to do this can result in the notch geometry being poorly resolved in each 3D model and ultimately the alignment between each scan becomes poorer.

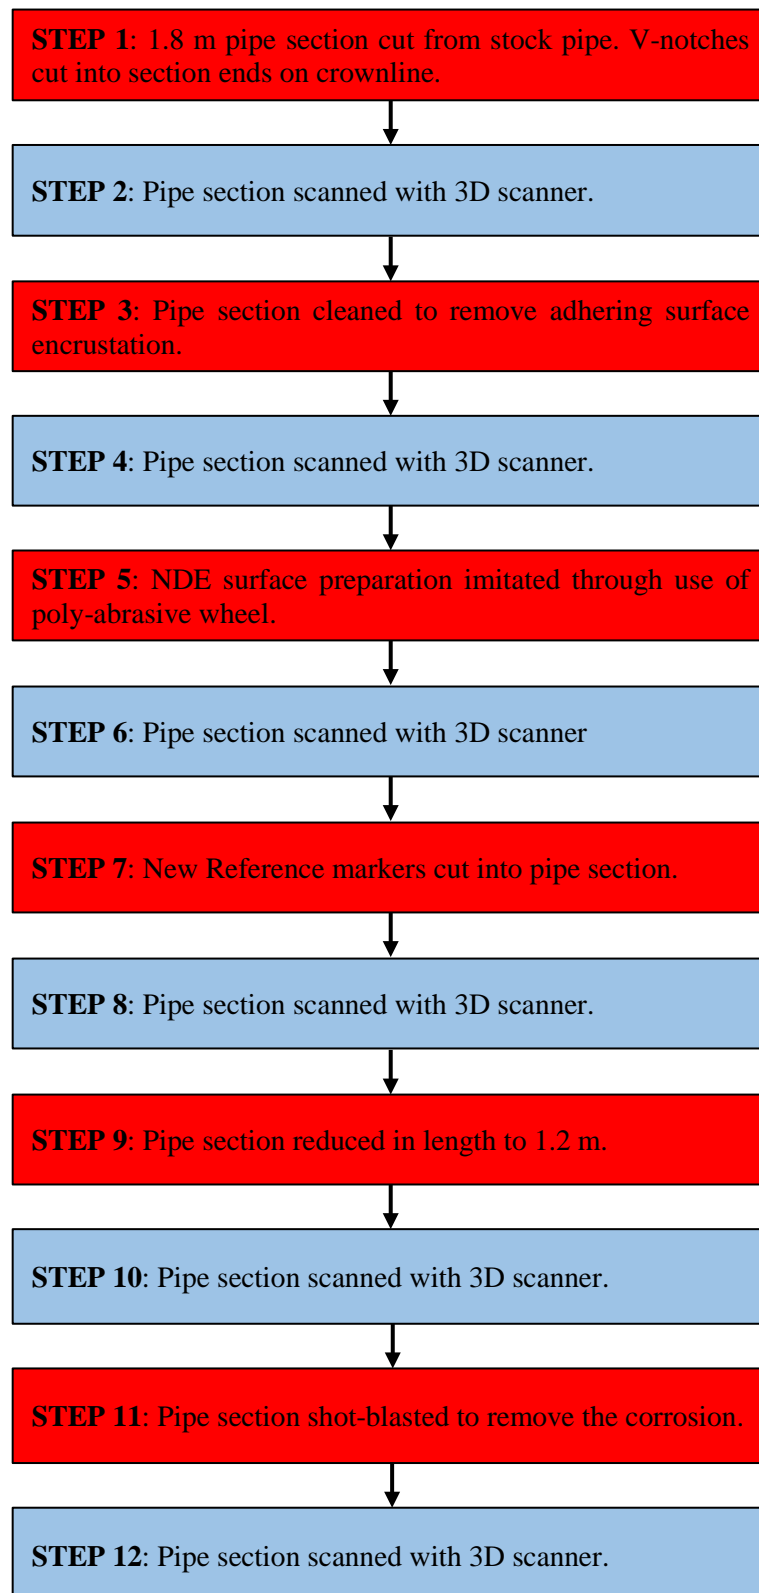
Figure 7.20 - Diagrammatic representation of the steps taken to conduct a trial of the initial methodology for capturing the real pipe condition on a large section of trunk main. The red boxes indicate steps where changes to the pipes geometry are made and the blue boxes indicate steps where the pipe section is scanned.

two scans were needed, the methodology developed for use on a trunk main section requires several further steps. Whilst several of these steps provide further insight into specific pipe condition, such as the remaining wall thickness present across a pipe section, other steps have been added to allow any changes in geometry, due to the pipe reduction, to be recorded. This ensures that changes made to the pipe do not result in all of the common geometry between scans being removed such that 3D models created from consecutive stages of the exercise cannot be aligned to the common coordinate system. A diagrammatic representation of the main stages of the methodology are given in Figure 7.20.

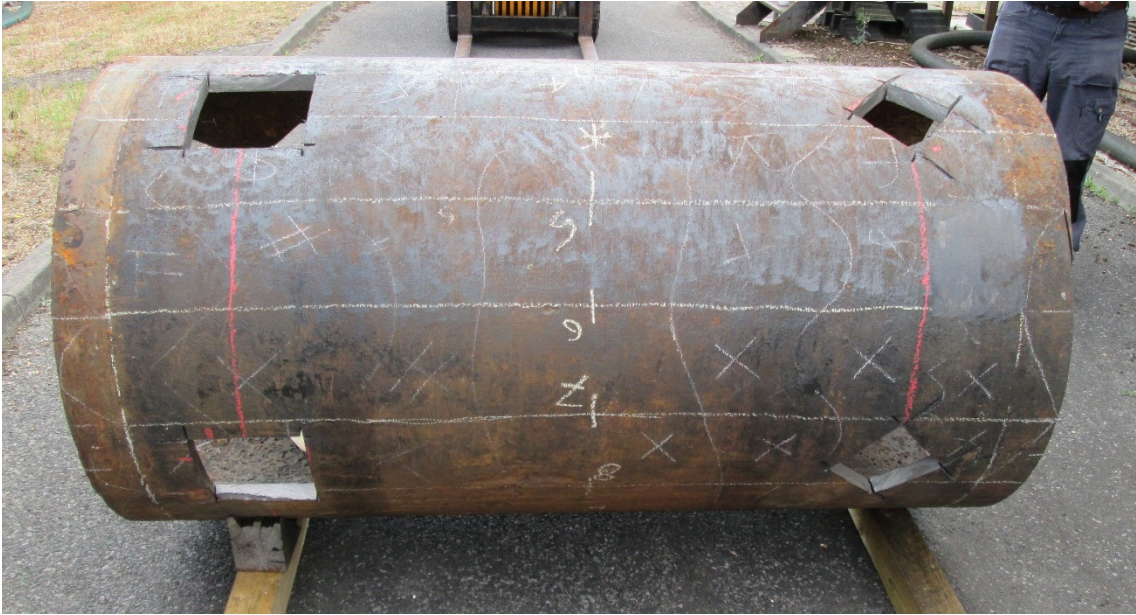
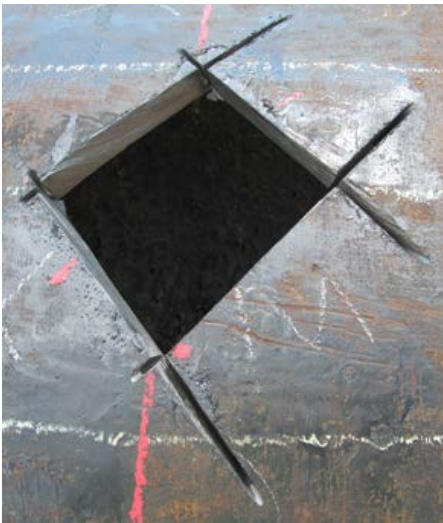
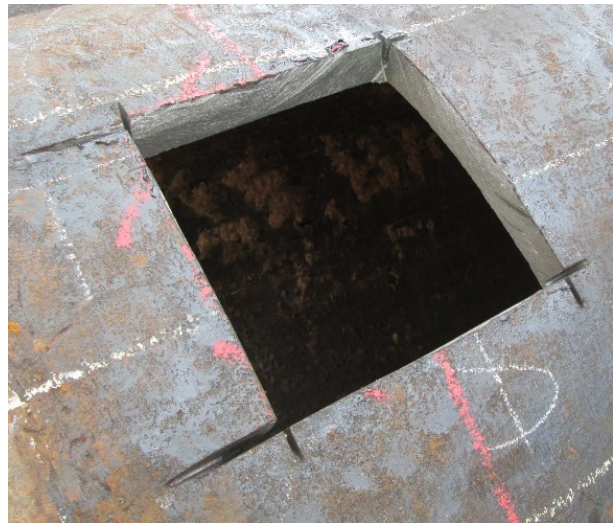
Figure 7.21 - Additional reference markers cut into Specimen Three: (a) the complete pipe section with reference markers, (b) a close-up of a diamond marker and (c) a close-up of a square marker.

Following NDE, the pipe section was cut down to a manageable length before being sent for shot-blasting. In doing this, the original v-notch markers and external untouched end rings were removed leaving no common geometry which can be used to align further 3D models. As a consequence, further markers were cut into the pipe section which align axially with the original v-notches, Figure 7.21(a). A selection of diamonds, Figure 7.21(b), and squares, Figure 7.21(c), nominally 200 mm axially by 200 mm circumferentially in size, were cut into the pipe section with their centres 300 mm in from each end. A total of four markers were cut into the pipe at angles 0, 90, 180 and 270 degrees to the crownline at each end of the pipe.

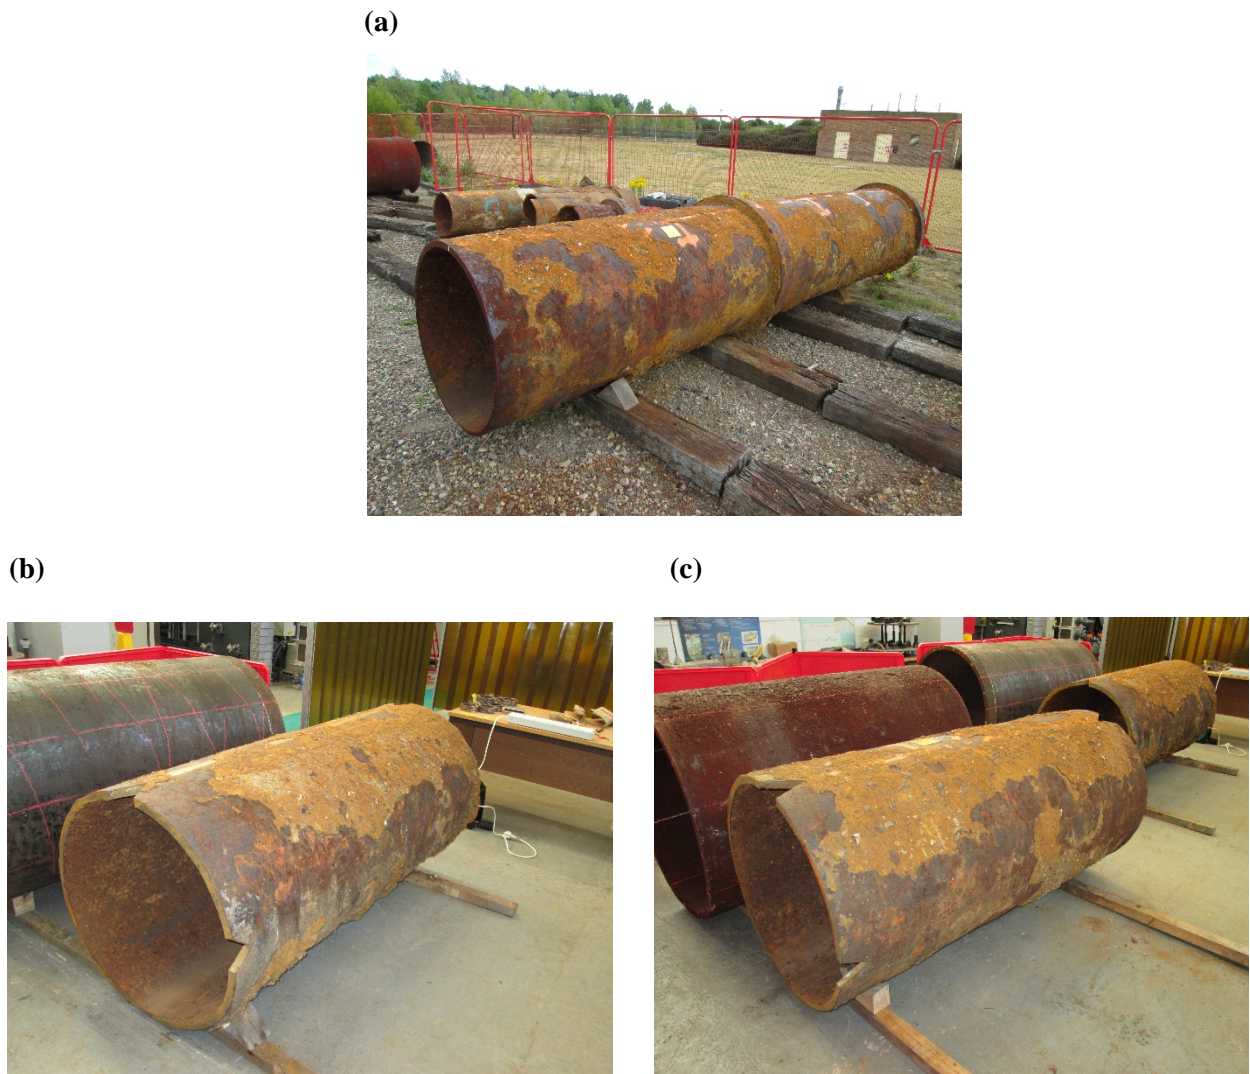
Figure 8.2 - Jointed pipe cut-out before and after it was cut into smaller sections: (a) complete pipe cut out, (b) Pipe 1 and (c) Pipe 2

Two sections of cast iron trunk main, nominally 1.8 m long were cut from an intact jointed section of pipe that had been cut out as part of a repair job on a burst main at Hogsmill sewage treatment works in Surbiton, Figure 8.2(a). The two samples are referred to as “Pipe 1” and “Pipe 2”. Pipe 1 and 2 were cut and prepared according

In addition to the cuts described in the methodology given in the previous section, a further v-notch was cut into the pipe at the end approximately 90 degrees further round the pipe from the crownline to identify the spigot end, Figure 8.2(b) and Figure 8.2(c). This allows the original orientation of each section to be identified at a later date, if needed, but also provides a further point of geometry that does not change during the exercise and can be used to align the scans taken at each stage. Once the v-notches had been cut and the raw sections had been 3D scanned for the first time, the pipe sections underwent cleaning to remove the surface encrustation.

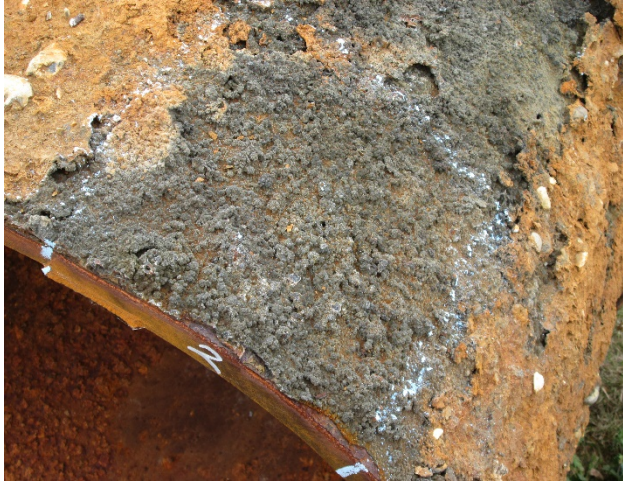
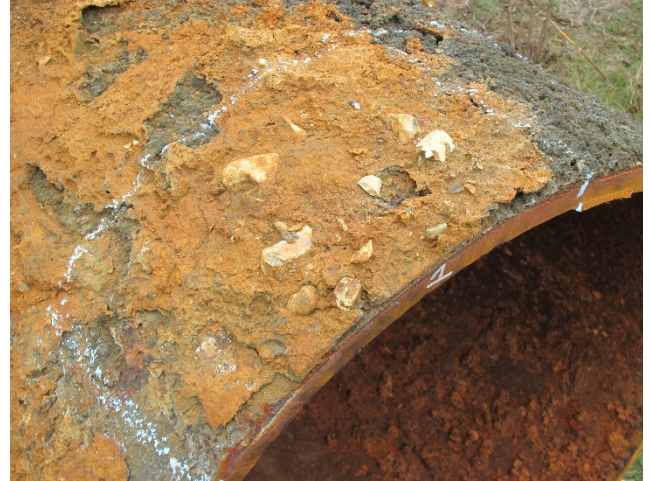
Figure 8.3 - Different types of surface encrustation found across the surface of both pipes: (a) a very hard pointed encrustation formation and (b) a softer encrustation formation including stones from the surrounding soil.

the encrustation present on Pipe 1 and Pipe 2 was significantly thicker and a great deal better bonded to the outer pipe surface, Figure 8.3(a) and Figure 8.3(b). The adhering encrustation was removed from the outer surface of both pipes using a hammer drill fitted with a wide chisel. In some places, the encrustation was extremely adherent and a chisel was not sufficient to remove it. Instead an angle grinder fitted with a tungsten carbide coated grinding disc was used to remove any further protrusions and leave the surface of the pipe nominally smooth. Care was taken to ensure that any corrosion penetrative into the wall was not removed or damaged.

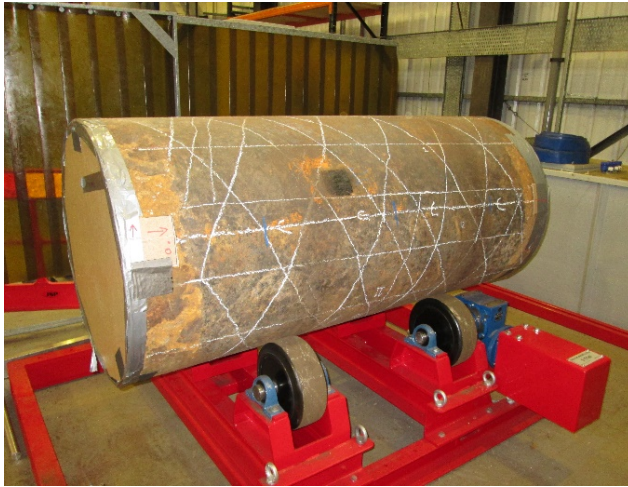
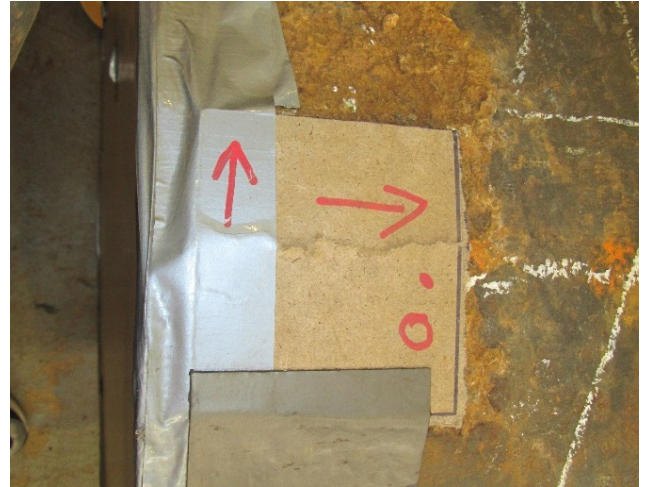
Figure 8.4 - Detail of the end caps that covered each end of the pipes and the caps covering each v-notch: (a) Pipe 2 with its end caps in place and (b) A cap covering a v-notch on Pipe 2 with the positive measurements directions and measurement origin drawn on.

Once the surface preparation was completed, the pipe sections were prepared to be inspected. The perimeter of each end of each pipe section was traced on to 3 mm thick hardboard and then cut out using a jig-saw. These boards were fastened on to the ends using cloth tape to cap each pipe end, Figure 8.4(a). Further square caps were also cut to cover the v-notches that were cut into each pipe, Figure 8.4(b). The end caps prevented either contractor gaining an unfair advantage by seeing and being able to measure the wall thickness so as to influence their NDE results.

An origin was marked on the pipe for all the contractor measurements to be taken, including the positive directions around the circumference and along the length. This origin was positioned over the apex of the v-notch on the crownline at the spigot end of the pipe, Figure 8.4(b).

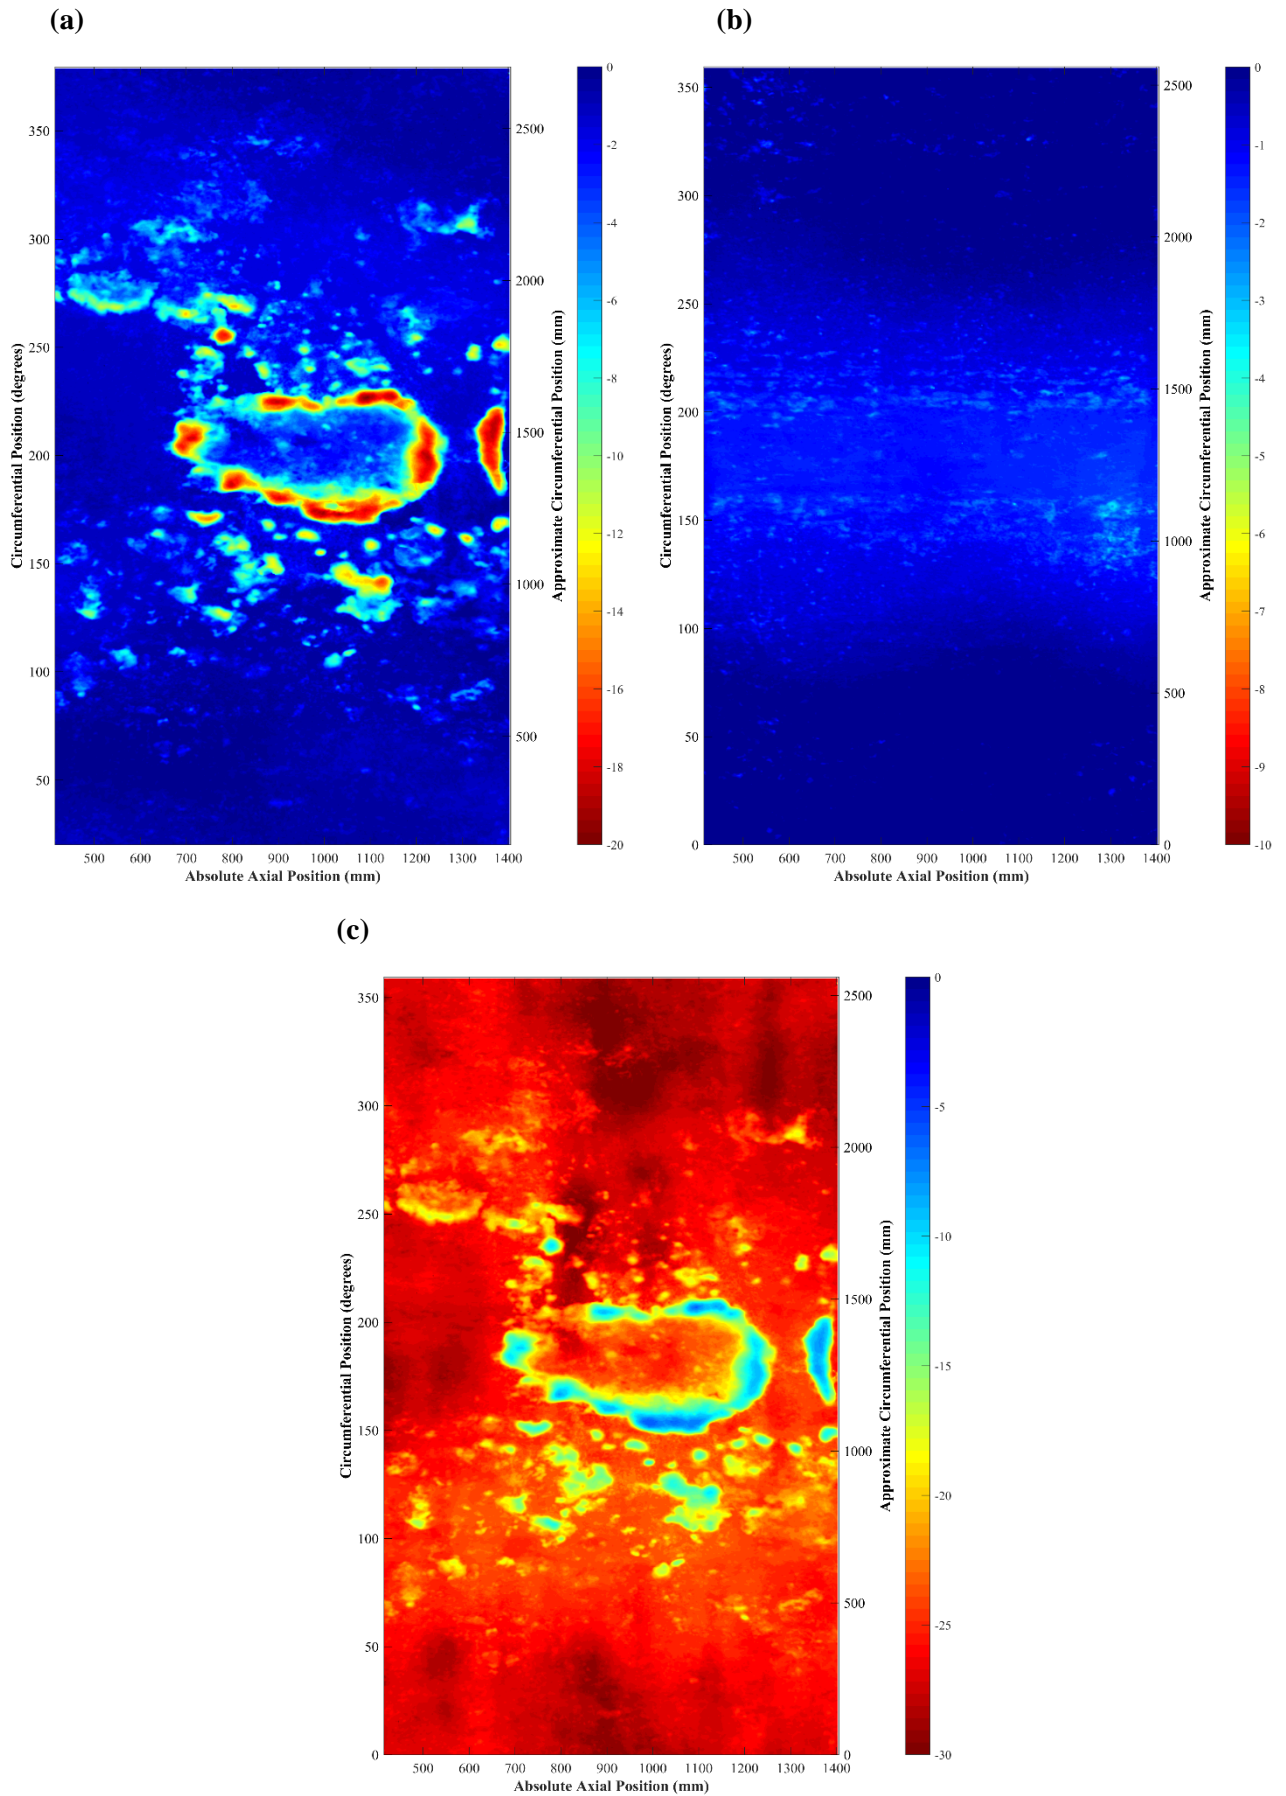
Figure 8.7 - Contour plots showing the condition of Pipe 2, as measured by the 3D scanner: (a) External corrosion, (b) Internal corrosion and (c) Remaining wall thickness.

Figure 8.6 and Figure 8.7 detail the pipe condition as measured by the 3D scanner for Pipe 1 and Pipe 2. In Figure 8.6(a) and Figure 8.7(a), it is possible to see the external corrosion measured for Pipe 1 and 2 respectively. Both sections are covered with extensive corrosion and have a maximum external corrosion thicknesses of 17.2 mm and 19.7 mm. Given that the nominal pipe wall thickness for these pipes was 25 mm thick, this equates to 68% and 76% of the pipe wall being lost to external corrosion only. Further, the corrosion appears to be located at similar circumferential positions on both pipe samples.

Pipe 2 is of particular interest, due to the shape of the corrosion, Figure 8.7(a). This corrosion geometry came as a great surprise. As Pipe 2 did not undergo any surface preparation, no clues were given as to the level of corrosion present during the trial. It is clear that this pipe section was in a very poor state of health and may have soon failed at this point if it had been left in service.

In Figure 8.6(b) and Figure 8.7(b), it is possible to see the internal corrosion present in each section. Both sections show significant coverage across the whole pipe surface and a maximum value of 6.6 mm and 3.8 mm for Pipes 1 and 2 respectively. However, in both sections, there appears to be an absence of corrosion along the pipe invert. It is likely that this pipe may have had sediment which flowed along the invert and ultimately settled on the surface to protect the inner surface of the invert. In order to calculate the internal corrosion measurements, the tuberculation was removed from the pipe surface to leave a smooth cylindrical surface that was representative of the original inner pipe surface at manufacture. Despite the use of a hard, abrasive wheel, the base of many of the tubercles proved to be significantly adherent and it was not always possible to create a smooth surface where the tubercles had been removed. In some cases, a rough surface several millimetres in height was left behind and without significantly more aggressive methods being used, it was not possible to eradicate all traces of tubercles. These surface undulations will be detected by the 3D scanner and will have a bearing on the results reported. Consequently, the results for the level of internal pipe corrosion presented should be treated accordingly and only the larger values for internal corrosion should be used.

Finally, the remaining wall thickness in each pipe section is given in Figure 8.6(c) and Figure 8.7(c). It can be seen that the remaining wall thickness is heavily controlled by the external corrosion. The minimum wall thicknesses were 6.6 mm and 5.9 mm for Pipes 1 and 2 respectively.

These findings are further supported by the results obtained from the 3D scanning, Figure 8.6 and Figure 8.7. It can be seen that the wall thicknesses reported by the Contractor A are not representative of the real pipe geometry. As shown in Chapter 5, the speed of sound in cast iron varies dependent on the graphite flake structure. This also needs to be considered when processing such results.

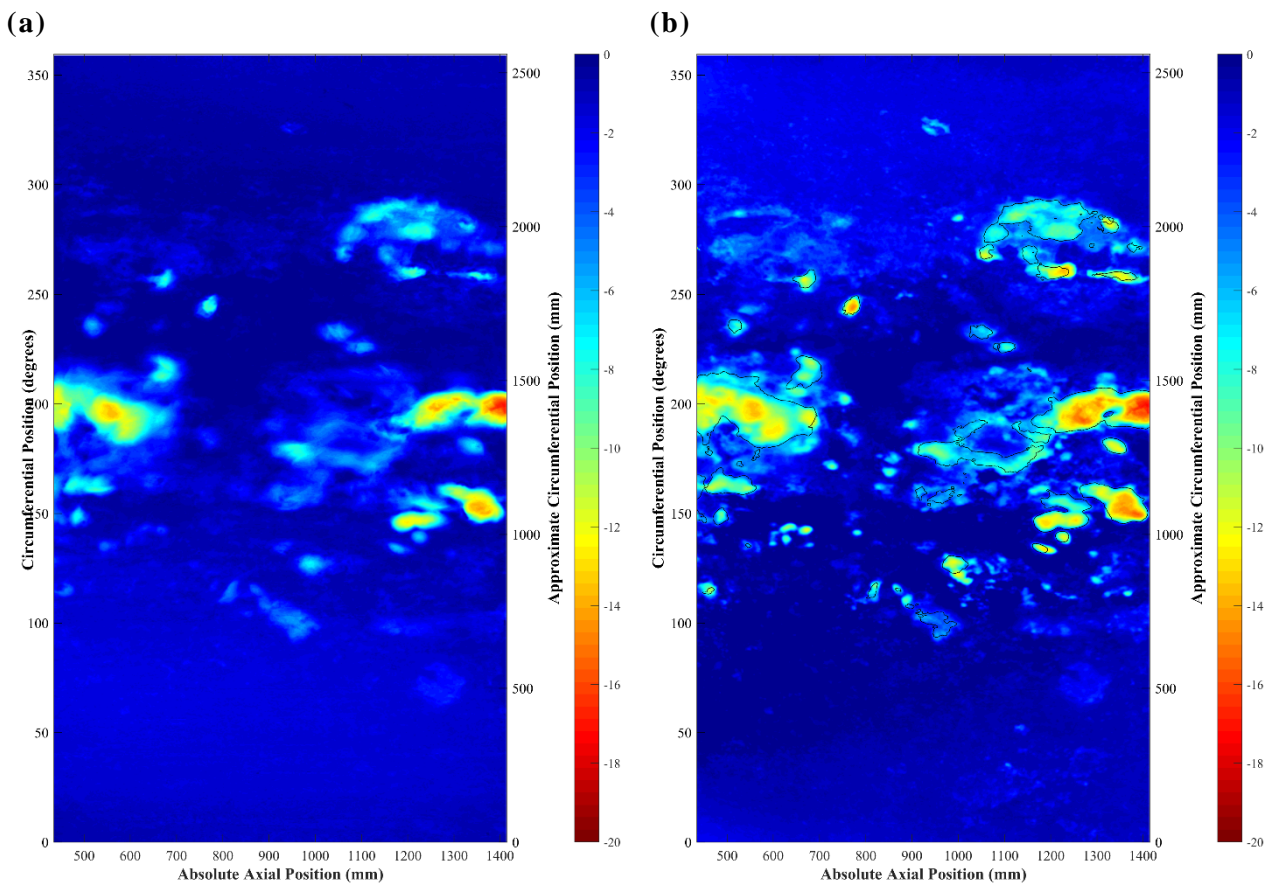
Figure 8.11 - Contour plots detailing the position and level of material removed during the surface preparation conducted by Contractor B: (a) Pipe 1 and (b) The external corrosion present on Pipe 1 with the outline of the areas where over 4 mm of material has been removed during the surface preparation.

Figure 8.11(b) is a duplicate of the contour plot presented in Figure 8.11(a) except that a black line tracing the areas of surface preparation deeper than 4 mm has been overlaid. It is clear, when looking at this figure, that the surface preparation has been applied across the whole surface of the pipe and focuses heavily on the graphitic corrosion where significant material was removed. This significant removal of material is not isolated to a handful of pits where the operator may have initially been overzealous but it appears across the whole pipe and each pit has been abraded in a similar fashion. Only the small isolated patches have avoided abrasion. In such cases, it is likely that it was not possible to excavate any corrosion from these patches as they were not large enough to be able to get the abrasive wheel into.

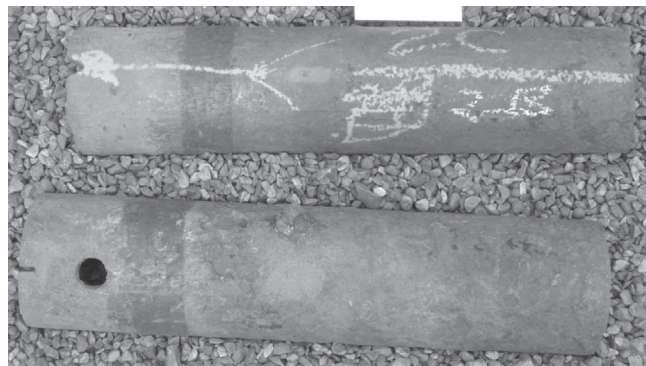
(a)

(b)

Figure 4. Digital photographs of a split section of 4 in. (102 mm) dia. distribution main illustrating the spread of corrosion and the amount of metal that can be lost to the graphitic corrosion process: (a) before shot blasting and (b) after shot blasting

In smaller-diameter distribution mains, graphitic corrosion has been shown to have a significant impact on the strength of the pipe and to be in competition with defects that have originated during manufacture (formed beforehand) and installation (formed at the beginning). Further, because of the combination of the size of the pipe and its interaction with the local environment, it is possible to comment on the behaviour of the main a significant distance (multiple casting lengths or ‘sticks’ of pipe, typically 3–5 m long) either side of a sampling point (Belmonte *et al.*, 2007, 2008, 2009). The size and spread of graphitic corrosion in distribution mains can be seen in Figure 4.

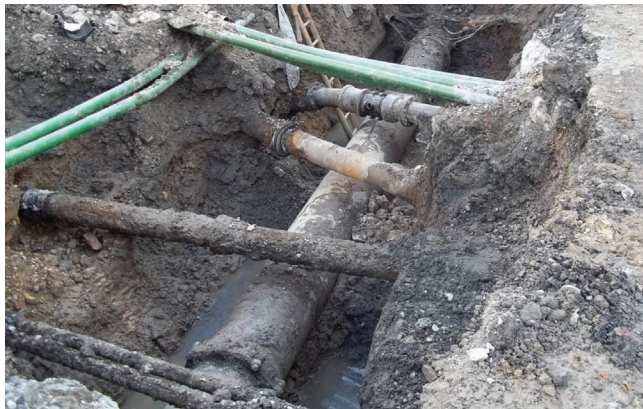
Figure 7. An exposed 20 in. (0.508 m) trunk main in situ at Regent Street in central London with several other pipes and services crossing it, showing the restricted space available around a main

Hence, conducting NDE from the outer surface of the pipe is currently preferable, even if it means that the pipe must be excavated for NDE to be conducted. Very often mains are exposed for routine work, which may present sufficient opportunity to assess the mains condition while the excavation is still open. However, this is still not without challenge. An excavation creates a muddy trench and may expose only a small section of main (approximately 1 m long), which is not significantly longer than the pipe’s diameter. This can leave limited access to the surface of the pipe, particularly underneath the pipe (Figure 7). Any NDE method will need to be capable of operating within the clearance around the pipe afforded by the excavation and the neighbouring utilities.
