THE PRESERVATION OF PRE-WORLD WAR TWO  
COAST GUARD ARCHITECTURE IN OREGON

A THESIS

Presented to the Interdisciplinary Studies Program:  
Historic Preservation  
and the Graduate School of the University of Oregon  
in partial fulfillment of the requirements  
for the degree of  
Master of Science

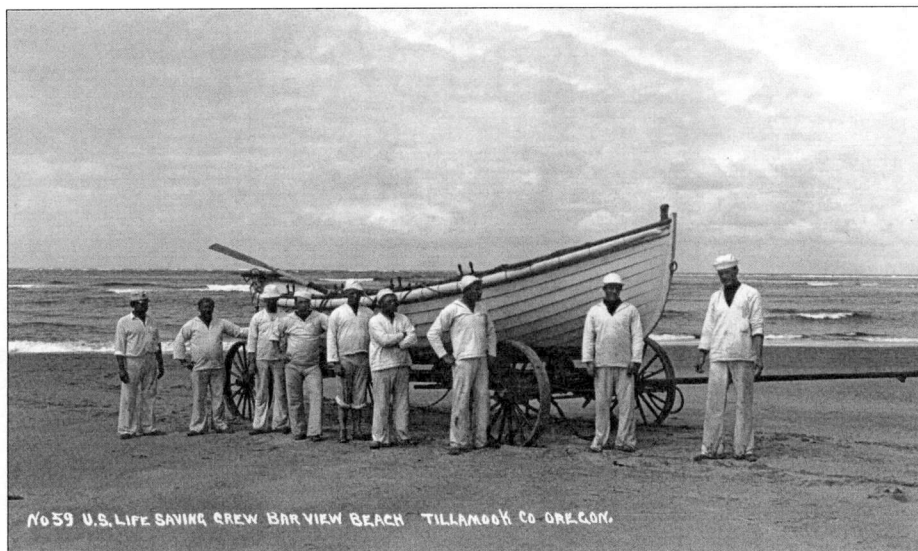
Figure 13. Tillamook Bay Life-Saving Station Crew with Surfboat, Circa 1910. Source: Author's Collection.

There were three principal types of surfboats used in Oregon: the Beebe, the Beebe-McLellan, and the Monomoy. They measured 25' to 27' long and weighed 700 to 1,100 pounds. Surfboats were relatively light-weight so that they could be pulled along the beach on a carriage (Figure 13) and then launched directly into the surf (Figure 14). Six crewmen were needed to row the surfboats with the keeper manning a long steering oar at the stern. They were highly maneuverable and excellent for short distances when only a few people were imperiled. Surfboats were ideal for work on the Eastern Seaboard. None of the surfboats were self-righting, but the Beebe-McLellan was self-bailing.

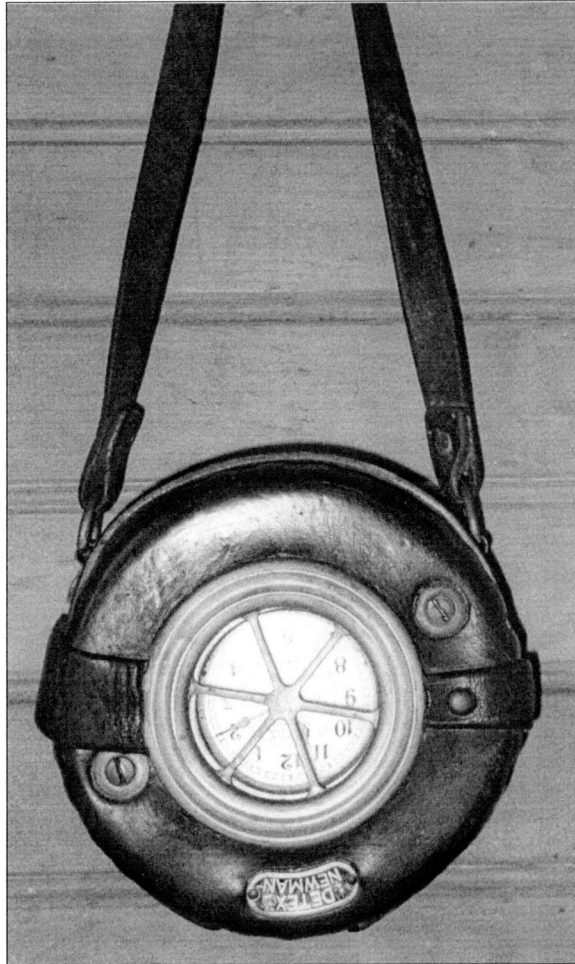
Figure 22. Patrol Clock, Point Allerton, Massachusetts. Source: Author.

patrol and exchange tokens to show that they had completed their assigned “beat.”<sup>41</sup> On the Oregon Coast, since the stations were so isolated, a life-saver would walk until he reached the end of his beat where there would be a post with a key attached. He would insert the key into a patrol clock that he carried (Figure 22), marking the time in which he reached the end of his patrol. If a crewman spotted a ship either too close to shore or aground, he would burn a red Coston flare to either ward off the ship or to signal the ship that help was on the way.

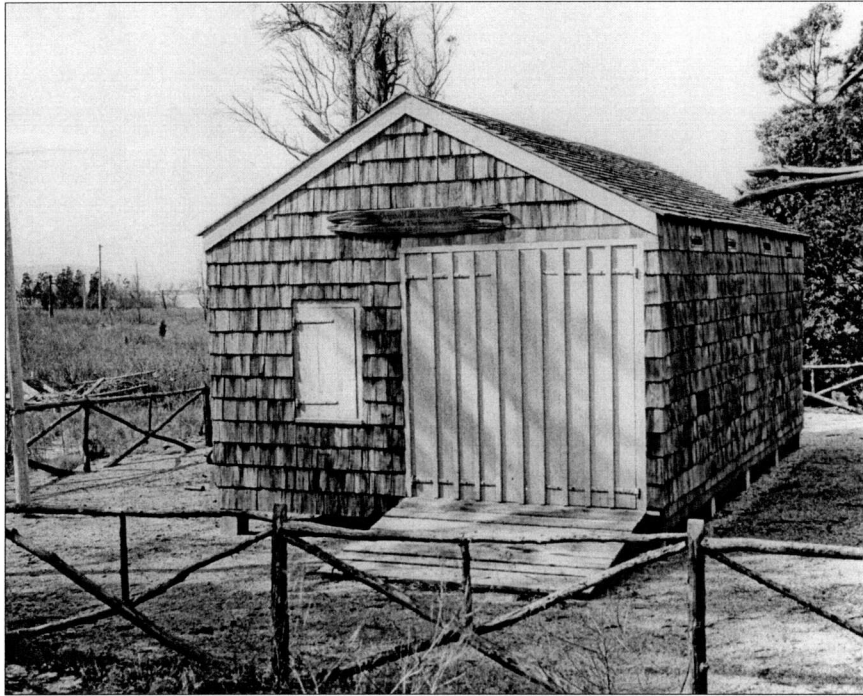
Figure 32. Spermaceti Cove, New Jersey, Boathouse (1848) in 1926. Source: U.S. Coast Guard Headquarters (Life-Saving Service: Stations and Architecture File).

The first federally-funded stations were constructed in 1848 when Congress appropriated \$10,000 for eight boathouses along the New Jersey shore. These unmanned and unkept stations were simple, one-story, gabled boathouses, 16' wide by 28' deep (Figure 32). They were surfaced in shingles and were probably very similar to the lifeboat stations built by the Massachusetts Humane Society.

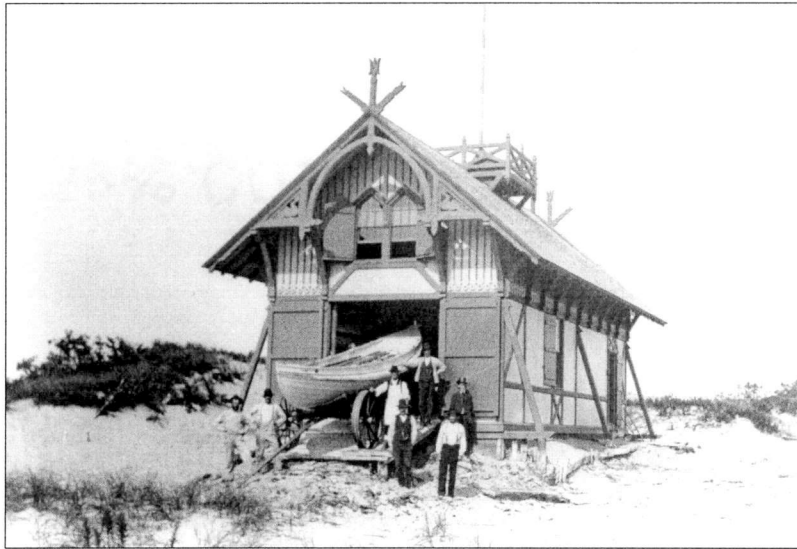
Figure 33. Plum Island Life-Saving Station (Chandler, 1873-74), Massachusetts, an 1874-Type Station. Source: U.S. Coast Guard Headquarters (Life-Saving Service: Stations and Architecture File).

With the Congressional appropriation of \$100,000 in 1873, a new design was developed for the stations. Twenty-three of what have become known as 1874-type stations were built. These were the first stations to employ a recognizable architectural style (Figure 33). The stations were designed in the mode of the Carpenter Gothic and

the Stick Style. Influences from the outdated Carpenter Gothic can be seen in the beaded vertical siding and intricate scroll work in the gable. From the Stick Style came the station's gable stick work, brackets and half-timbering to represent the structural elements of the building. Disregarding the detailing, the station design was much the same as the Red House stations from 1871 in size and layout. A lookout platform was added to the roof with an internal ladder to reach it.

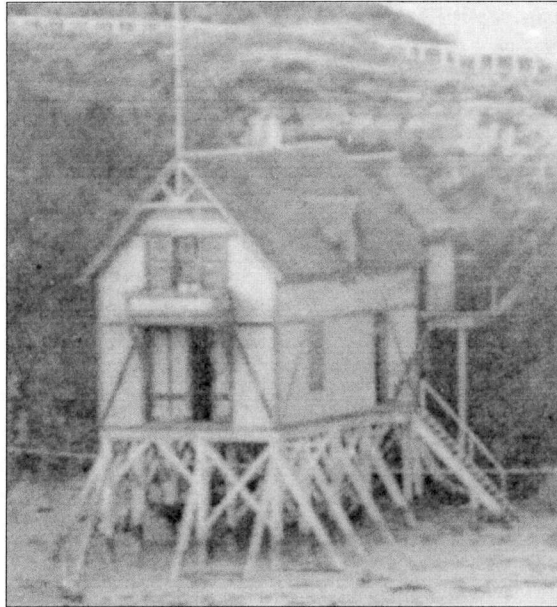
Figure 34. Cape Arago Life-Saving Station (Chandler, 1878), a Modified 1875-Type Station. Source: U.S. Coast Guard Headquarters (Life-Saving Service Photos: Personnel File).

second floor was divided into a large room at the front, a store room at the middle, and two bedrooms in the back. At least 16 of the 1875-type stations were built on the Atlantic and Great Lake coasts. For Oregon, Washington, and California, a modified version was drawn which altered some of the detailing, eliminated the lookout tower, and added dormers. This is the version that was built at Coos Bay, Oregon, for the Cape Arago Life-Saving Station (Figure 34).<sup>70</sup>

Arago station did not have a lookout tower or platform on its roof but instead substituted a balcony above the boatroom doors. This balcony can be found on the 1875-type clipped gable stations, but the Cape Arago Station did not have a clipped gable. The Cape Arago Life-Saving Station is discussed in detail in Chapter IV.

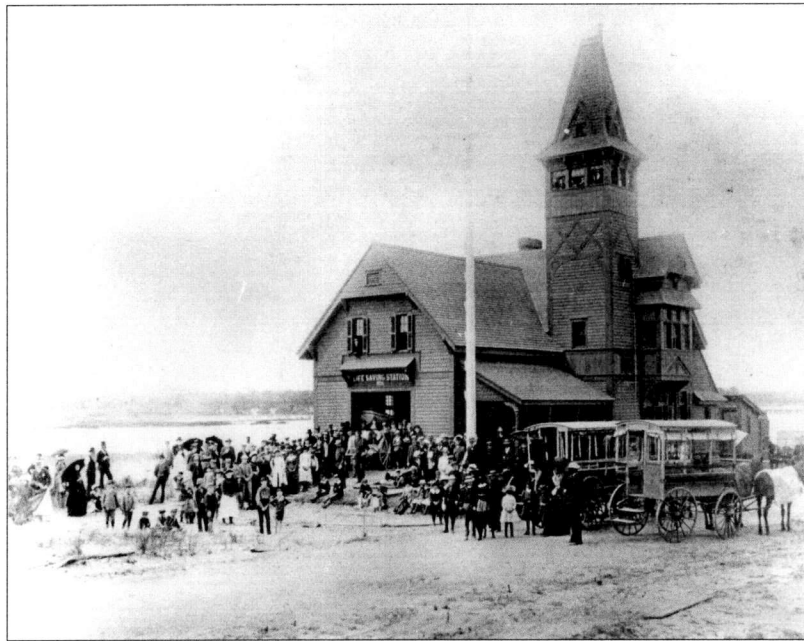
Figure 35. Deal Life-Saving Station (Pelz, 1882-83) in New Jersey. Source: U.S. Coast Guard Headquarters (Life-Saving Service: Stations and Architecture File).

Several high-style stations were designed on commission after the 1882-type station by prominent, independent architects. Paul J. Pelz designed what in 1885 can be only described as passé High Victorian Gothic meets Queen Anne at Deal, New Jersey (Figure 35). This design can be considered the pinnacle of ornateness in Life-Saving Service architecture. Its sister station at Bay Head was featured in the 15 September 1885 issue of *American Architecture and Building News*.<sup>75</sup>

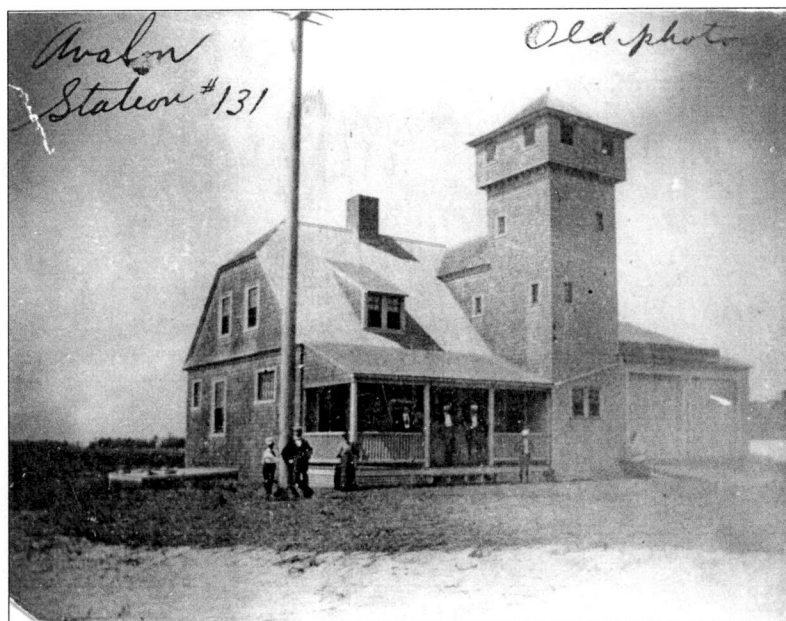
Figure 40. Avalon Life-Saving Station (Tolman, 1894) in New Jersey. Source: U.S. Coast Guard Headquarters (Life-Saving Service: Stations and Architecture File).

Tolman continued to design in the Shingle style, producing two more designs, the Niagara-type and the Duluth-type, and a sole one-of-a-kind station. The Niagara was similar to the Quonochontaug, but the Duluth departed from the norm and provided a large lookout tower (Figure 40). At least 54 of Tolman's station designs were built, plus a modified version of his Quonochontaug plan was constructed for the World's Columbian Exposition at Chicago in 1893.

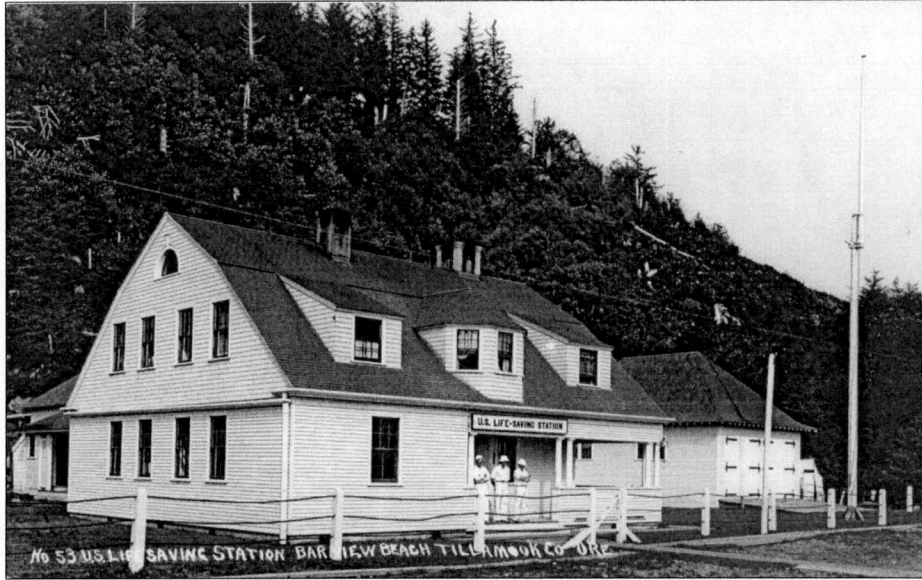
Figure 41. Tillamook Bay Life-Saving Station (Mendleheff, 1908) at Barview, Oregon, Circa 1913. Source: Author's Collection.

for the Service the longest.<sup>77</sup> Mendleheff started out by designing the Petersons Point-type station, one of which was built on Tillamook Bay, Oregon, at Barview. The station was a gambrel-roof structure, like the Fort Point-type station, but it was much squatter and less symmetrical with an integral porch (Figure 41). It had three dormers, again like the Fort Point-type, but the center one was three-sided to form a diminutive lookout tower. The 1-1/2 story station was sheathed in shingles. Detailing was Colonial Revival with Tuscan columns and lunette windows in the gables. The boathouse was detached. Chapter IX describes the Tillamook Bay Life-Saving Station in detail.

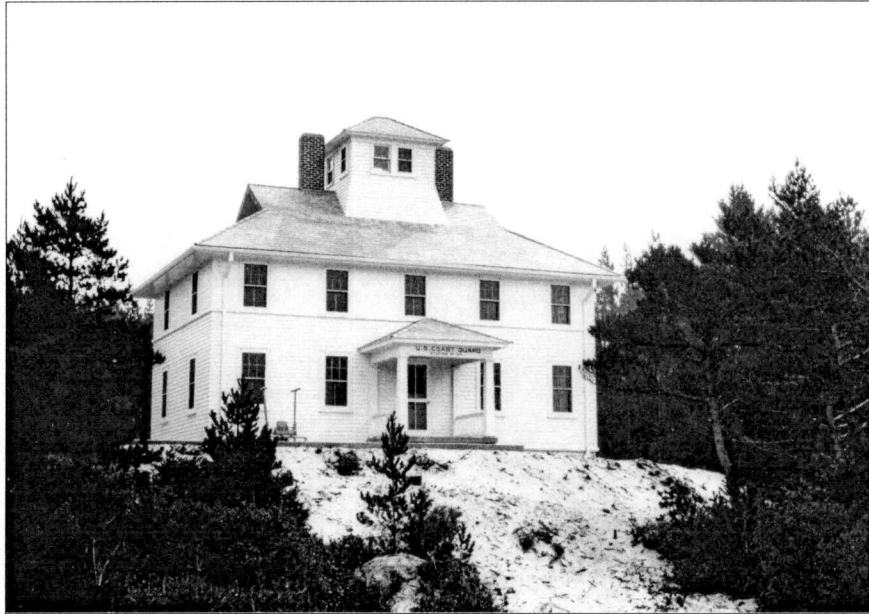
Figure 42. Siuslaw River Lifeboat Station (Mendleheff, 1917) at Florence, Oregon. Source: U.S. Coast Guard Headquarters (Siuslaw River File).

At least 30 of the Chatham-type stations were built, one of which was the Siuslaw River Lifeboat Station (1917) at Florence, Oregon. The station house was symmetrical, 44' wide and 24' deep, clad in shingles, with a hipped gable roof (Figure 42). The roof was frequently surmounted by an integrated lookout tower harkening back to the designs of Chandler in the mid-1870s. The boathouse was detached and enlarged to accommodate the evolution to the larger motor lifeboats and their associated equipment. The Siuslaw River Lifeboat Station is described thoroughly in Chapter X.

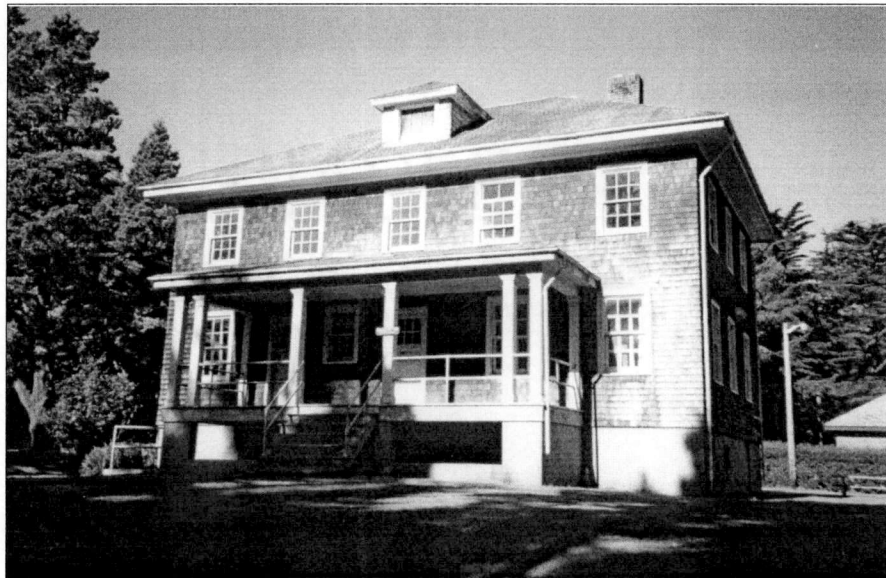
Figure 43. Port Orford Lifeboat Station (1934), Station House, in 1996. Source: Author.

On 28 January 1915, the Life-Saving Service merged with the Revenue Cutter Service to form the Coast Guard. An all-time high of 279 stations were active at the changeover. It is believed that Mendleheff continued on as architect through the transition period to the Coast Guard.<sup>78</sup> Variations on the Chatham-type station continued to be built through the 1930s.<sup>79</sup> In 1936, the Port Orford Lifeboat Station was built on a variant of the Chatham plans (Figure 43). The station featured a simpler hipped roof, no cupola, and a dormer on the front and back of the building. It also featured a wider front porch. The Port Orford Lifeboat Station is described in detail in Chapter XI.

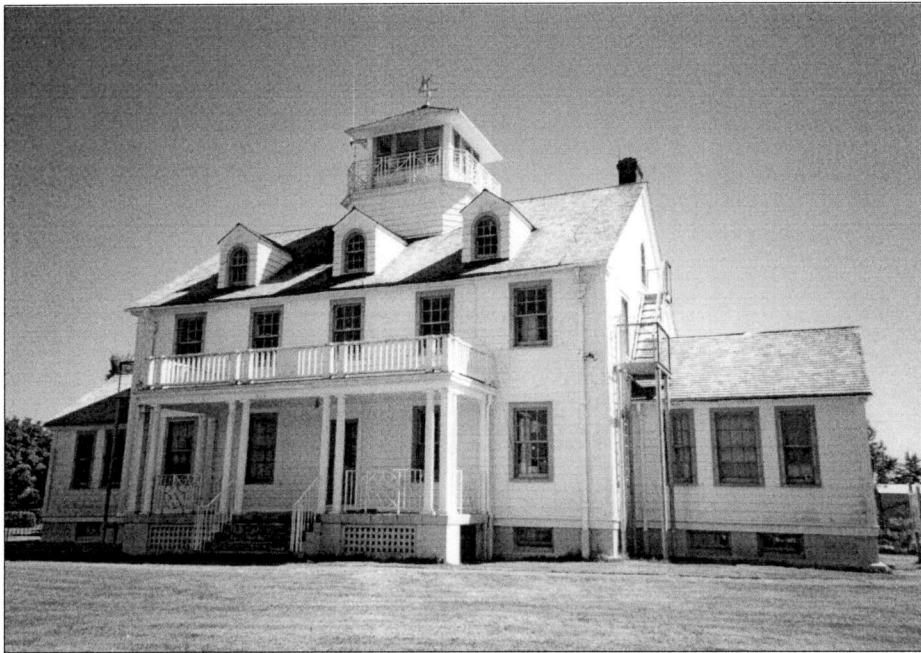
Figure 44. Point Adams Lifeboat Station (1939), Station House, in 1997. Source: Author.

A total of four Roosevelt-type stations were built in Oregon, making it as prolific in Oregon as the Marquette-type of the Life-Saving Service era. At Point Adams, Oregon, there is an early Roosevelt-type station from 1938 (Figure 44). Generally, the construction dates for the Roosevelt-type stations fall within the Franklin Roosevelt's presidency (1933-45). However, at Yaquina Bay, Oregon, the station was built in 1949. The Yaquina Bay Lifeboat Station is considered one of the last Roosevelt-type stations in the nation.<sup>81</sup>

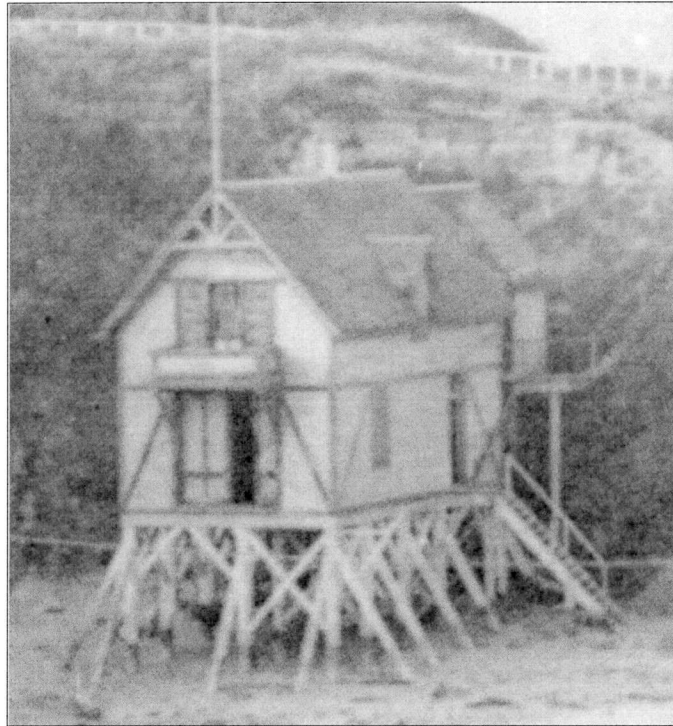
Figure 48. Detail of Cape Arago Station, 1885.  
 Source: U.S. Coast Guard Headquarters (Life-Saving Service Photos: Personnel File).

As mentioned previously, the Cape Arago Station was a modified version of the 1875-type. In fact it had modifications unseen at any other life-saving station (Figure 48). The Life-Saving Service did build from a standard set of plans, but it was not unusual for builders to make alterations to suit the local materials and conditions. Cape Arago did not have a lookout tower or platform on its roof but instead substituted a

balcony above the boathroom doors. This balcony can be found on the 1875-type clipped gable stations, but the Cape Arago Station did not have a clipped gable. To access the balcony, there was a door flanked by two windows. The 1875-type stations had the window but no door; the 1875-type clipped gable had the door but no windows; the Cape Arago Station had both the windows and the door.

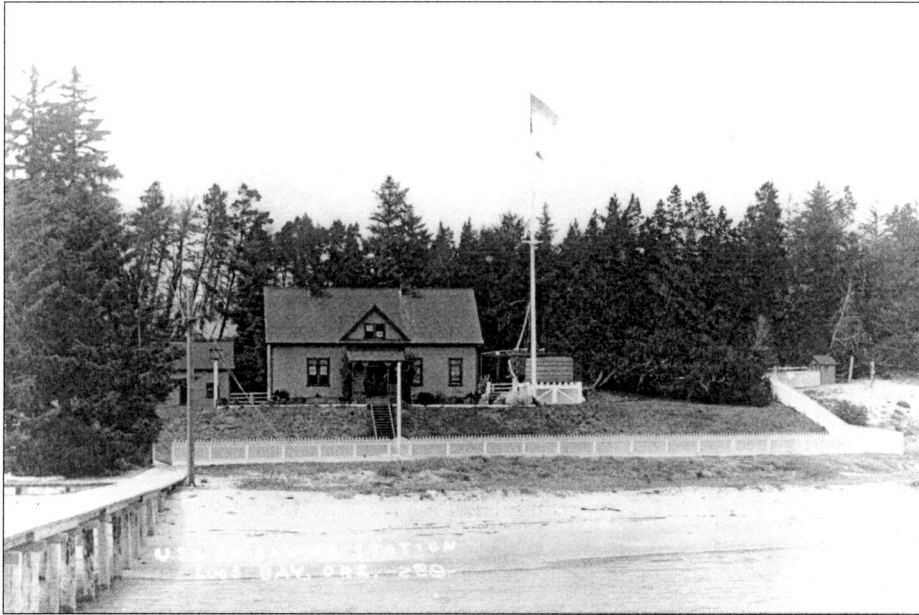
Figure 54. Coos Bay Life-Saving Station at North Spit, circa 1910.  
Source: Oregon Historical Society (OrHi #0028P207-006940).

Even though the new station at North Spit was even further away from the land form known as Cape Arago (Figure 52), the station retained the original Cape Arago name and continued to be documented as the Cape Arago Life-Saving Station until mid-1902 when it became known as the Coos Bay Life-Saving Station.<sup>98</sup> Keeper Hodgson helped in siting the station approximately two miles from the entrance to Coos Bay on the north edge of the bay (Figure 53). The station house was placed on a small rise just off Hungryman Cove (Figure 54).

A pair of water towers were built adjacent to the station house to capture runoff from the roof of the station house. In Figure 54, a washhouse can be seen to the left of the station house. A washhouse was necessary since the station house had no plumbing other than the hand pump to the kitchen sink. In 1892, the crew built a wharf in front of the station constructed of planks found on the beach.<sup>104</sup> During September 1893, the crew built a woodshed.<sup>105</sup> The wreck pole is visible to the left of the group in Figure 55. A tall flag pole rises over the station yard. A post topped by a bell box appears to the left of the station house. During June 1892, the crew built a handsome picket fence around the property.<sup>106</sup>

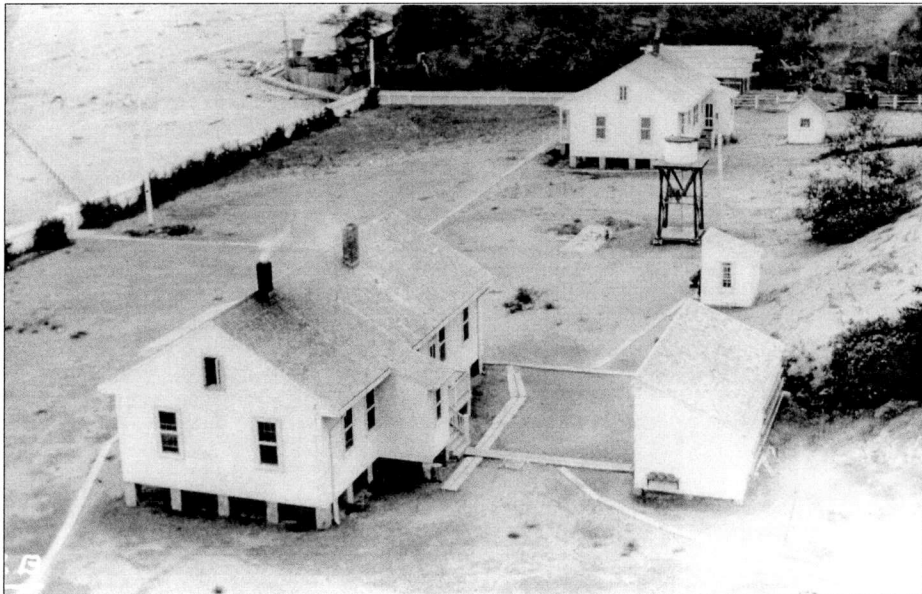
Figure 60. Coos Bay Lifeboat Station, 1923. Source: U.S. Coast Guard Headquarters (Coos Bay File).

left, and one is visible under construction in 1923 in Figure 60. These dwellings have been lost over time, though they may have been moved and recycled elsewhere.

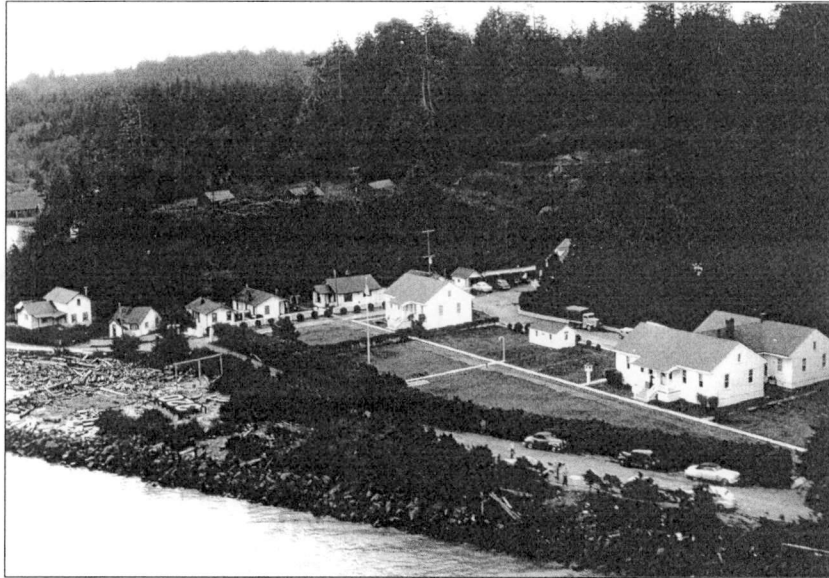
Figure 63. Coos Bay Lifeboat Station, 1954. Source: National Archives (RG 26-CGS, Box 2, Folder Coos Bay).

The crew's dwelling received a substantial addition sometime between 1923 and 1939, according to photographs. During that period, a building approximately identical to the crew's dwelling was built behind and parallel to the crew's dwelling and then connected at the center by a hyphen to create a H-shaped plan (Figure 63). This new "addition" became "the dorm" and the old crew's dwelling became "the office."<sup>111</sup>

It was common practice at stations for married crew members to build houses close to the stations. These small, one-story, gable roof structures are purely vernacular, built with local materials by local carpenters. Five are recognizable in Figure 63 to the

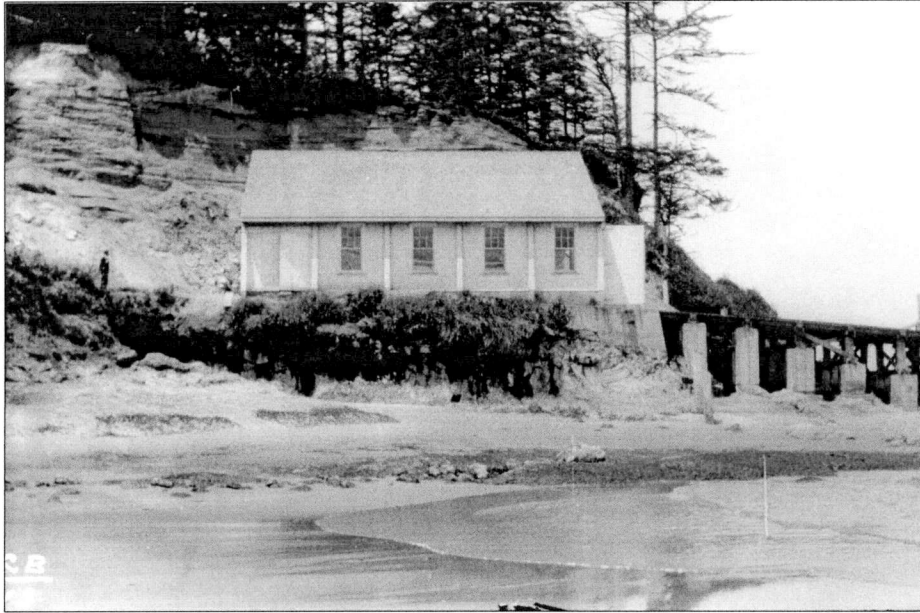
Figure 64. Coos Bay Lifeboat Station, Boathouse, 1923. Source: U.S. Coast Guard Headquarters (Coos Bay File).

The boathouse was as unique as the dwellings for the keeper and crew (Figure 64). The Coos Bay Lifeboat Station boathouse is believed to be the only one built from the plans drawn. The building measured 40' wide by 50' deep and was three-bays wide and five-bays deep (Figure 65). In 1915, the bays stored one 34' motor lifeboat, one Dobbins lifeboat, one Monomoy surfboat, and one Beebe-McLellan surfboat.<sup>112</sup> Its distinctive features are the six buttresses on each side of the building, recalling the 1874-type stations with their side buttresses. Like the dwellings for the keeper and crew, the roof and walls of the boathouse were covered in shingles, 4-1/2" to

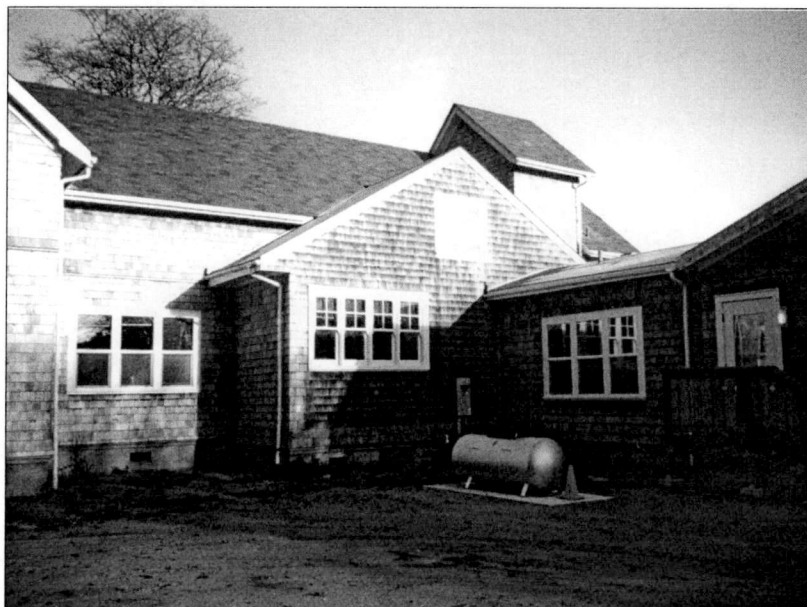
Figure 71. Former Keeper's Dwelling (1915), Coos Bay Lifeboat Station, 1999. Source: Author.

The keeper’s dwelling has been served an even worse life sentence than the crew’s dwelling. It has been enveloped by a just-completed, two-story library complex (Figure 71). Only through photo comparison can the exterior of the former keeper’s dwelling be distinguished. The new building does not differentiate the keeper’s dwelling in any way on the interior. A plaque on the interior denoting what the building once was is the only means left to present the history of the former Coast Guard building.

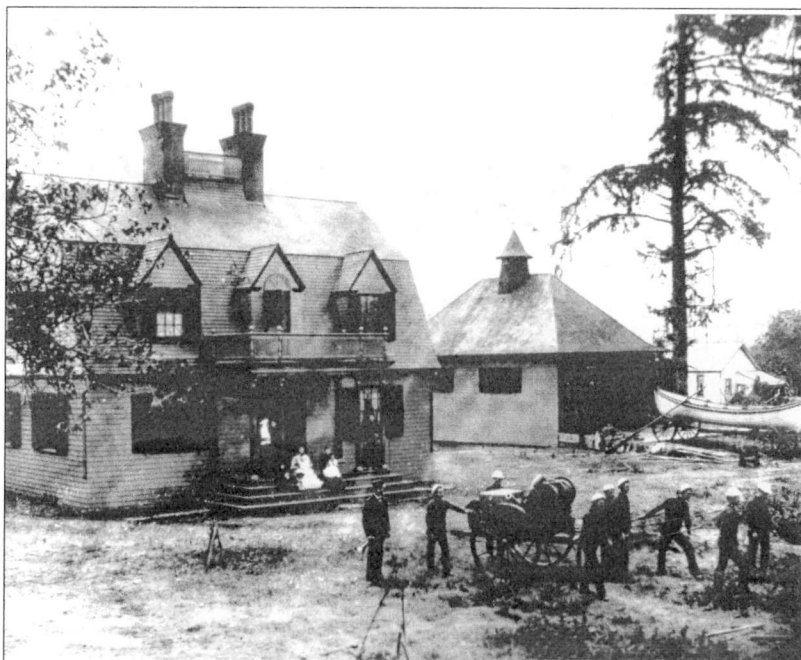
Figure 74. Point Adams Life-Saving Station, Circa 1900.  
Source: U.S. Coast Guard Headquarters (Point Adams File).

first station to emphasize the living quarters over the boatroom. For Point Adams two years later, he went one step further and detached the boatroom entirely from the dwelling (Figure 74). The evolution allowed the boathouse to be placed in a location convenient to launching a boat while the living quarters could be placed in a more protected location. Having the rescue apparatus in its own building also allowed for increased ventilation to dry out the equipment. Only three of what has become known as the Fort Point-type stations were built, but all were constructed on the Pacific Coast.

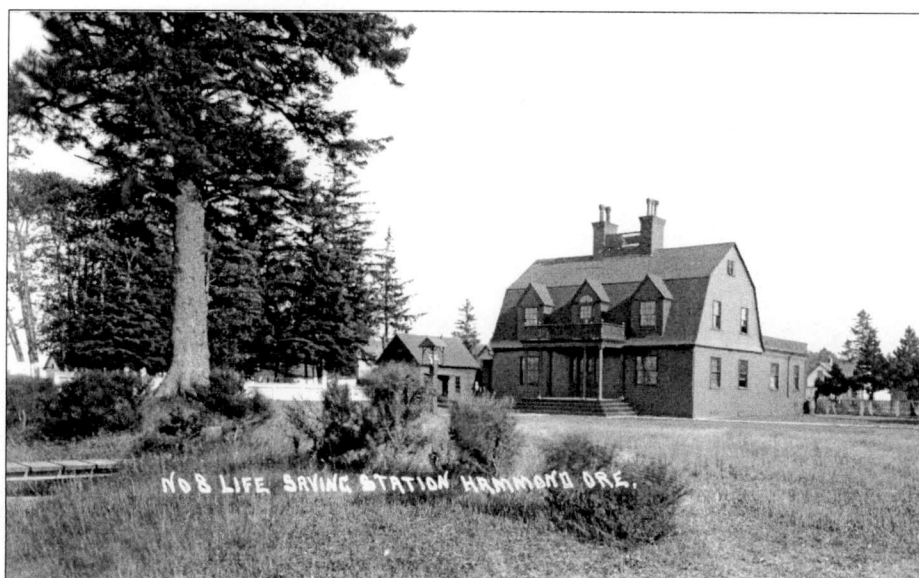
Figure 75. Point Adams Life-Saving Station, Circa 1910. Source:  
Oregon Historical Society (OrHi #654-A 10541).

The Point Adams station house was a symmetrically-planned, gambrel-roofed structure with three prominent dormers (Figure 75). In its symmetry, gambrel roof and front door detailing, the style is nodding to the Colonial Revival. The one sheet shown in Figure 76 is the only drawing that could be found for the three stations built. The design was short-lived, as all three stations were built in 1889, and no more would come from the plans. The Fort Point Life-Saving Station on San Francisco Bay was the prototype, followed by the Point Reyes Life-Saving Station just north of San Francisco Bay, and finally the Point Adams Life-Saving Station. The Fort Point Life-Saving Station is the only one that still stands, and it was the last U.S. Life-Saving Service station still in use in the nation when it was decommissioned in 1990. Today, it is part of the Golden Gate National Recreation Area.

operable shutters, eight-over-eight windows at the first floor, and an entry porch with steps off of all sides. As was typical among Oregon life-saving stations, the plan is symmetrical with a central entry and stair hall. Colonial detailing abounds, such as multi-pane windows with shutters, sidelights at the entry, classical porch columns, a lunette in the central dormer, and eave returns on the dormers. The entire building was sheathed in shingles.

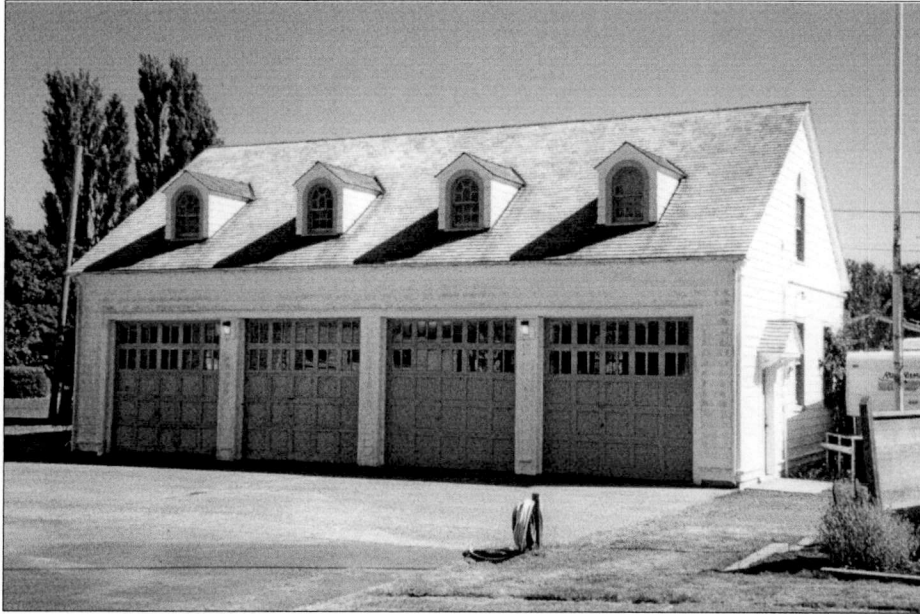
Figure 81. Equipment Building (1939) at Point Adams Lifeboat Station, 1997. Source: Author.

A standard, four-bay equipment building was built in 1939 to the south of the station (Figure 81). Stations starting in the 1930s all had what were called equipment buildings, which served as garages for vehicles and small boats, plus had storage space for equipment in the attic. The plan of the building was approximately 50' wide by 30' deep and built on a concrete foundation. The equipment building continued the Colonial

Revival theme of the station house with its arched, multi-light windows in the dormers, eave returns at the gable ends, a lunette over the gable windows, and water table with cap. Each dormer was centered over a garage door that contained 10 lights over 15 panels. On the back side, there were four more dormers. On the west elevation was an entrance door sheltered by a small gable hood supported by elegant brackets. The building was clad in shingles and finished with classical corner boards.

The exterior of the equipment building (1939) is in excellent shape. The attic space has been adapted into a meeting space. The other four-bay, Roosevelt-type equipment buildings in Oregon are at Siuslaw River and Coos Bay and are identical to the one at Point Adams. The Coast Guard still uses the Siuslaw River and Coos Bay equipment buildings and have altered their exteriors significantly to meet their current needs. In contrast, the Point Adams equipment building has excellent integrity. The National Marine Fisheries Service should continue to maintain the building in its current state, its exterior should not be altered, and its interior not be changed any further. The same applies to the c.1925 shop building. It is in good condition, and it should continue to be used and maintained.

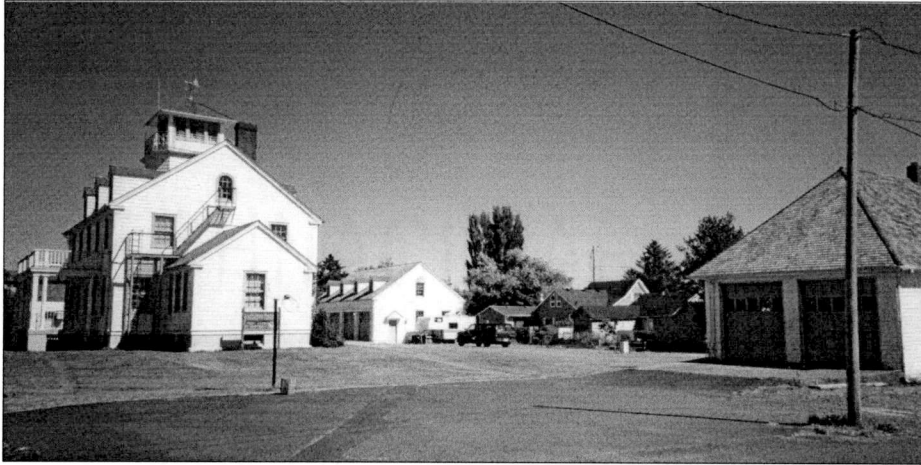
Figure 82. Decommissioned Point Adams Lifeboat Station Complex, 1997. Source: Author.

The Point Adams station complex is remarkably intact (Figure 82). The station was decommissioned c.1963 and was used for a brief time by the Clatsop Community College. In 1969, the National Marine Fisheries Service bought the station complex and its 5.8 acres from the Coast Guard to use as a research station. At the time, the National Marine Fisheries Service was well aware of the historic importance of the station and have done their best to preserve what remains over the past 30 years.<sup>133</sup> The Point Adams 1889 station house, the c.1915 boathouse, and the 1939 boathouse are all gone, but the 1889 boathouse, c.1925 shop building, and the 1939 station house and equipment building all survive.

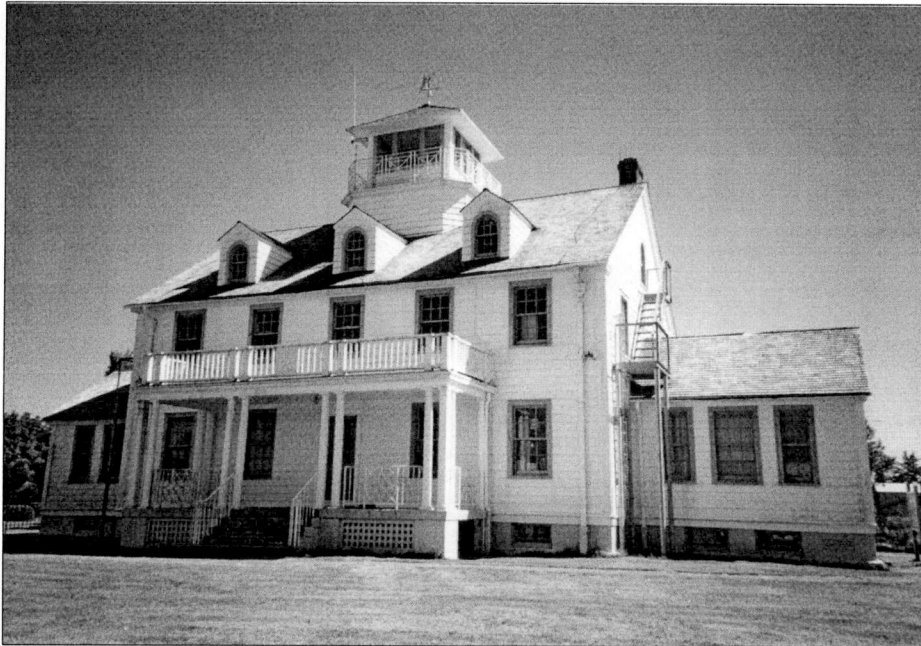
Figure 83. Station House (1939) at Point Adams Lifeboat Station, 1997. Source: Author.

The 1939 station house is the most intact building on the site (Figure 83). It retains its original exterior appearance with only the addition of a non-integral, metal fire

escape on either side of the building to serve the second floor and attic. The shutters have been removed, but they are in on-site storage. On the interior, the National Marine Fisheries Service has not altered the spatial arrangement, only the use of the rooms. All decorative features have been retained. Much of the original signage, cabinetry, closets, and hardware remains. Unfortunately, most of the light fixtures have been replaced over the years; however, in the entry hall there is an original 1939 light fixture. The National Marine Fisheries Service has even continued to use the same shades of paint, such as pale yellow and pale gray, on the interior. The station house is a good model of adaptive reuse.

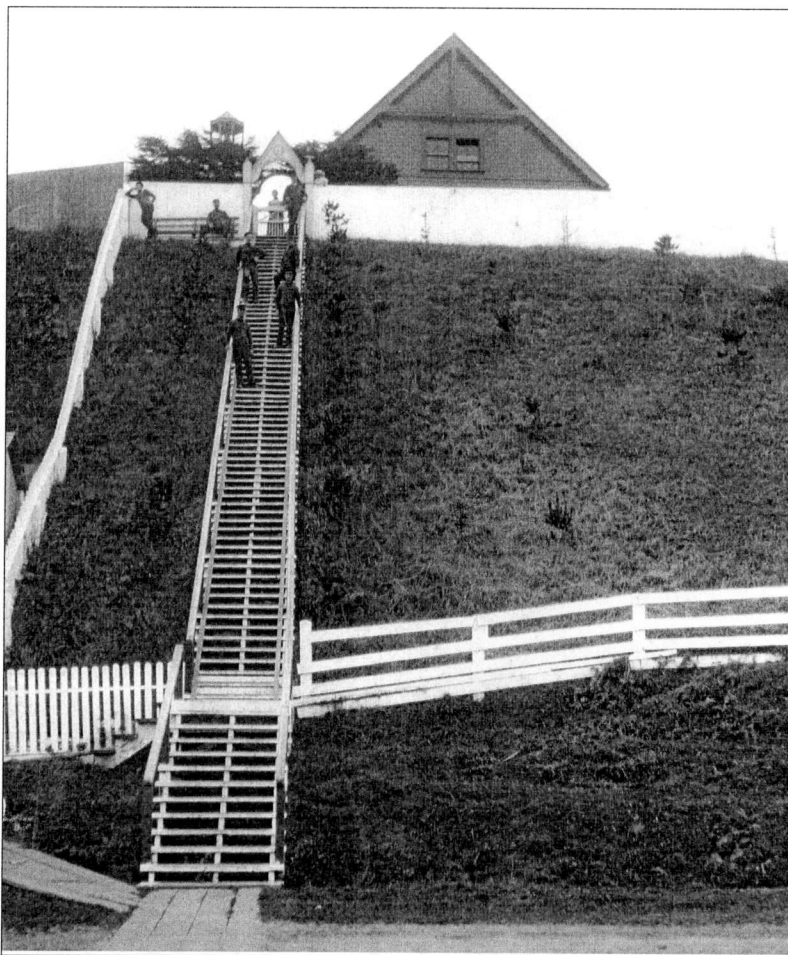
Figure 89. Coquille River Life-Saving Station Staircase to Station House, Circa 1910. Source: Bandon Historical Society (BHS #1559).

In late-1916, a concrete sidewalk and retaining wall were poured at the base of the station bluff. At the stair to the station, the retaining wall opened in two places to create two, eight-step flights that rejoined into one before going up the hill. Between 1923 and 1936, the upper portion of the launchway was replaced with a concrete ramp and bulkhead.

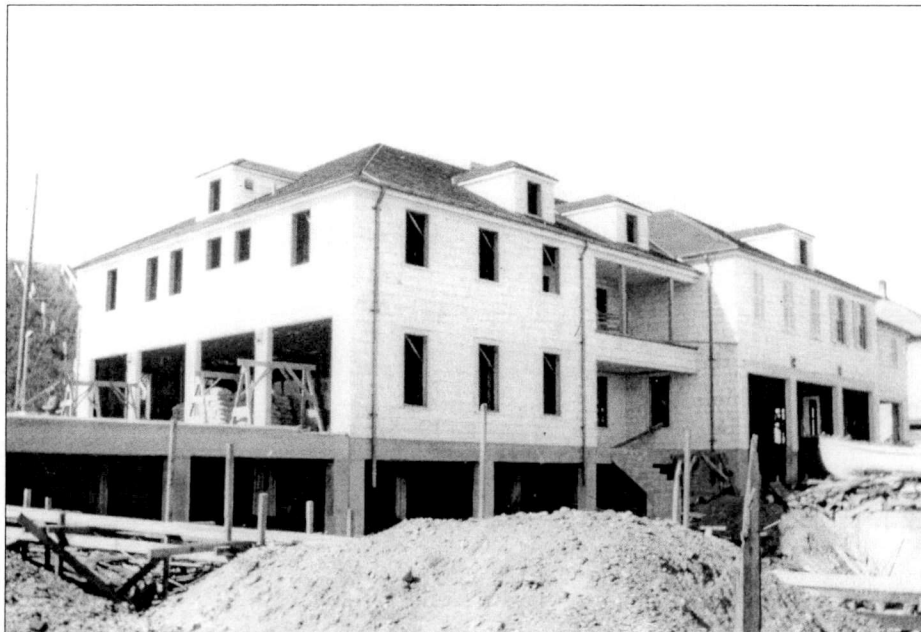
Figure 96. Coquille River Lifeboat Station Under Construction, 1939. Source: U.S. Coast Guard Headquarters (Coquille River File).

*World* newspaper in 1940.<sup>140</sup> Quinn Construction Company of Portland was the general contractor for the building; however, local subcontractors were used on the job. Working drawings were completed by the Coast Guard on 23 December 1938, and construction started in February 1939 (Figure 96). It was decided to consolidate all of the Coast Guard operations into one building on the waterfront, similar to the one on Yaquina Bay's waterfront, though larger. The structure cost approximately \$80,000, but equipping the station drove the cost up to \$125,000. This was by far the most expensive of the pre-WWII stations built in Oregon. The station was built on the site of the old

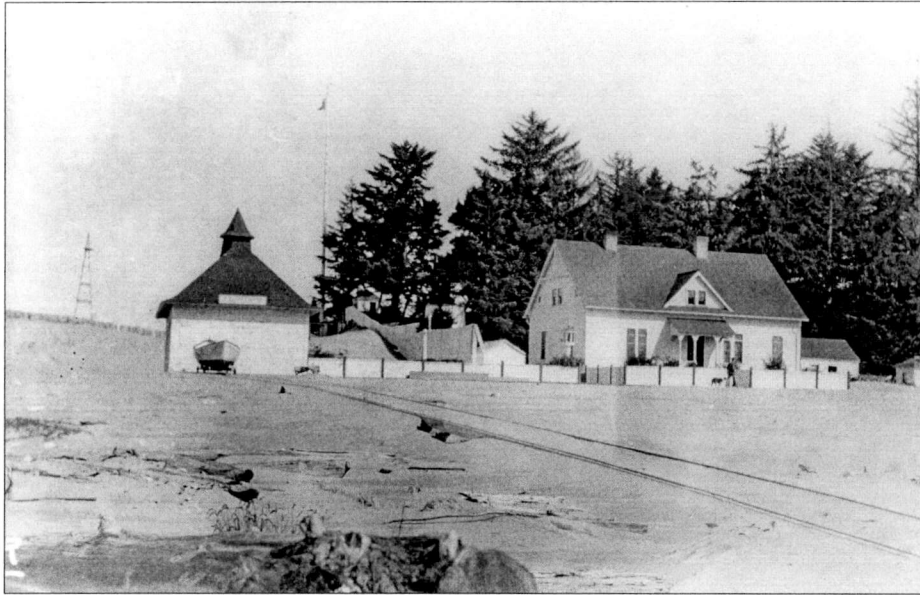
Figure 105. Umpqua River Life-Saving Station, 1923. Source: U.S. Coast Guard Headquarters (Umpqua River File).

the standard Marquette plan with a Fort Point-type boathouse (Figure 105) as described in Chapter III. The station complex was located on a small area of stable soil, 1800' southwest of the base of Army Hill, adjacent to the river beach. In general, the 50' by 30' house was divided by a central hallway and stair with the right half reserved for the keeper and the left half for the crew. On the main floor, the keeper's living room, office, kitchen and pantry were to the right. On the left was the crew's living room and quarters. Upstairs, the right half contained bedrooms for the keeper and his family. On the left was the crew's locker room.

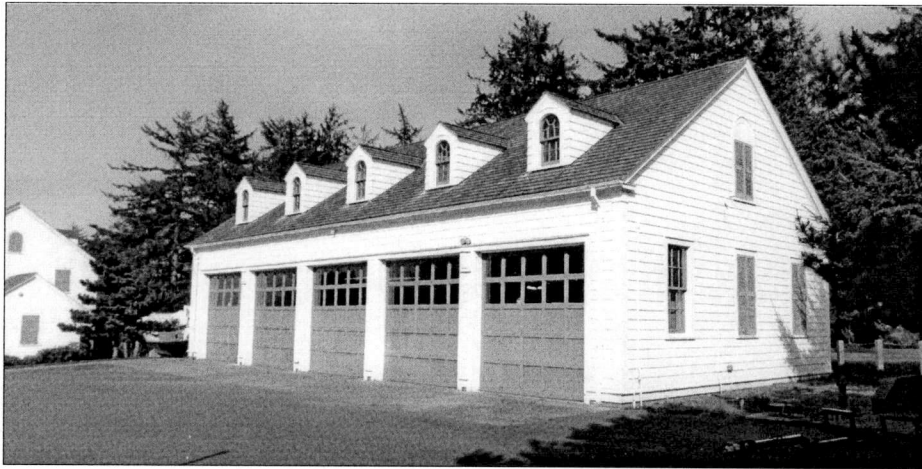
Figure 113. Equipment Building at Umpqua River Lifeboat Station, 1991. Source: Oregon State Historic Preservation Office (Umpqua River Coast Guard Station File).

A standard, five-bay equipment building was also built in 1939 to the north of the station (Figure 113). Stations starting in the 1930s all had what were called equipment buildings, which served as garages for vehicles and small boats, plus had storage space for equipment in the attic. The plan of the building was approximately 62' wide by 30' deep and built on a concrete foundation. The equipment building continued the Colonial Revival theme of the station house with its arched, multi-light windows in the dormers, eave returns at the gable ends, a lunette over the gable windows, and water table with cap. Each dormer was centered over a garage door that contained 10 lights over 15

panels. On the back side, there were five more dormers. The attic was divided into two dormitory rooms and a bathroom during WWII to house beach patrolmen.<sup>162</sup> On the south elevation was an entrance door sheltered by a small gable hood supported by elegant brackets. The building was clad in shingles and finished with classical corner boards. It was painted in the same color scheme as the station house.

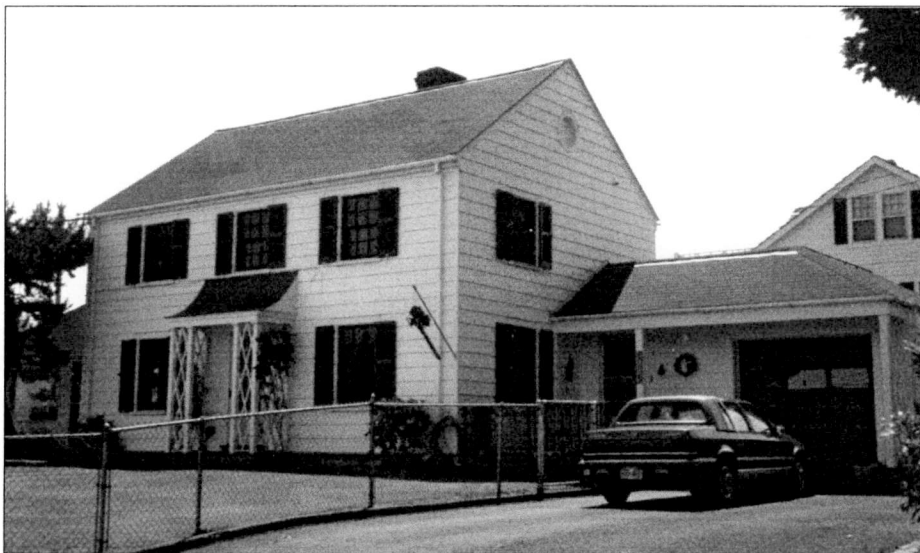
Figure 156. Officer-in-Charge's House (1942), Tillamook Bay Lifeboat Station, 1997. Source: Author.

windows with operable shutters. Bull's-eye windows light the attic. The front porch is covered by a flared, shed roof supported by slender columns connected by thin, diagonal spacers. Like the station house, the OIC house has flanking, one-story wings. The south wing was originally an open porch and has since been glazed in. The north wing was an attached garage, which has now been converted into living space.<sup>224</sup>

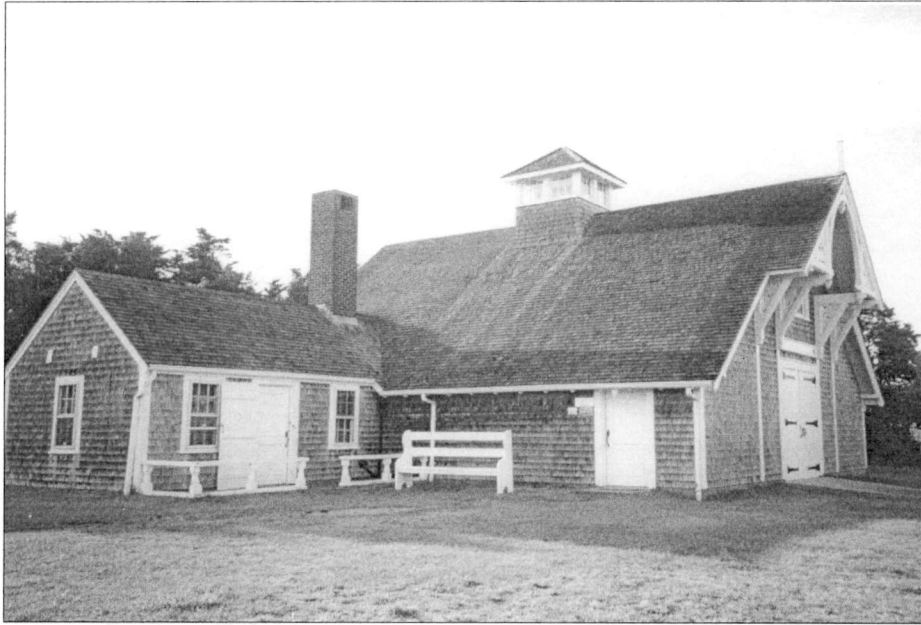
Figure 185. Nantucket Life Saving Museum, Nantucket Island, Massachusetts, 1997. Source: Author.

Several Oregon station sites would receive interpretive benefits from reconstructions, such as the lookout tower at Port Orford, the old lookout at Coquille Point, and the boathouse at Port Orford, just to name a few. It would be spectacular to see the old Cape Arago Life-Saving Station rebuilt on Lighthouse Island. However, reconstructions are expensive and take a lot of desire on the part of the supporters. There have been several reconstructions on the East Coast. The Nantucket Island Life-Saving Museum is in a recreation of a 1874-type station with “later” additions (Figure 185).

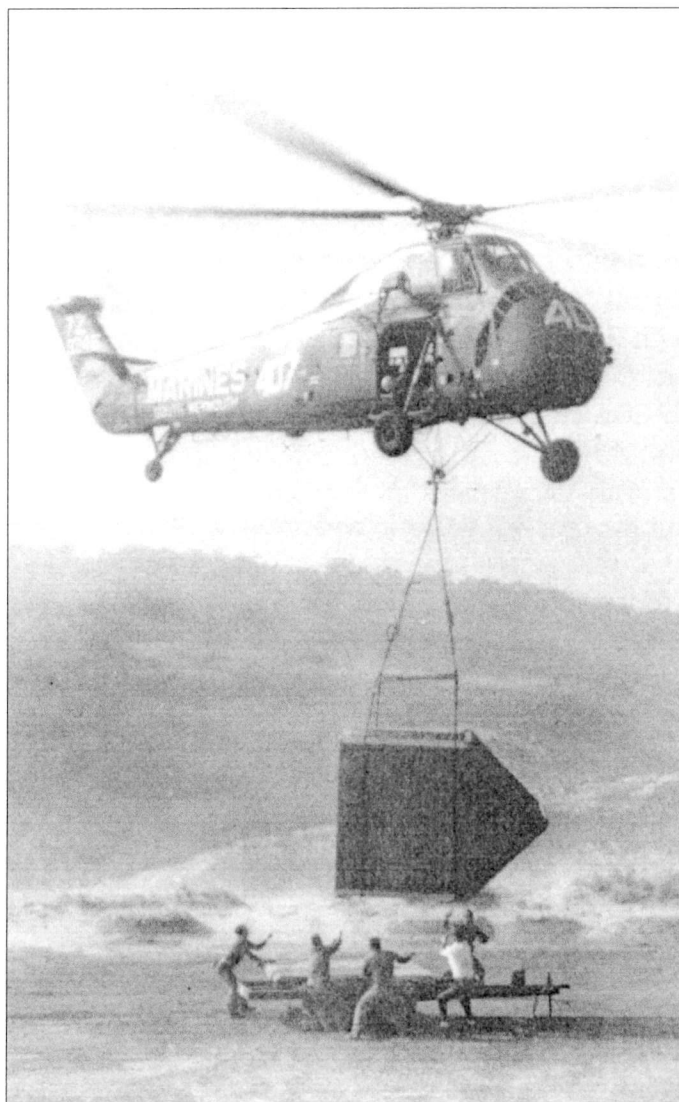
Figure 186. Marine Helicopter Moving Halfway House at Mystic Seaport in 1968. Source: Curtis, *Moving Historic Buildings*.

In recent decades, stations have been moved in an effort to preserve them (Figure 186). Once a station is considered surplus by the Coast Guard, it is either mothballed, demolished, sold, given to other government agencies, or donated to nonprofit groups. Often the Coast Guard simply wants the land on which the old station rests for a new purpose. This is a legitimate need, and nonprofit groups should take advantage of it.
