THE PRESERVATION OF PRE-WORLD WAR TWO  
COAST GUARD ARCHITECTURE IN OREGON

A THESIS

Presented to the Interdisciplinary Studies Program:  
Historic Preservation  
and the Graduate School of the University of Oregon  
in partial fulfillment of the requirements  
for the degree of  
Master of Science

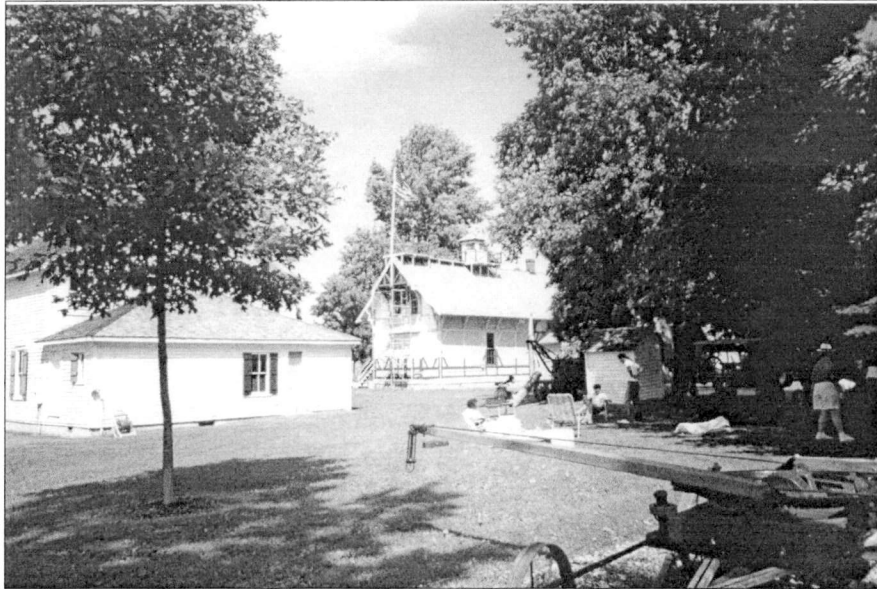
Figure 187. Pointe Aux Barques Life-Saving Station (1875-76) in New Context at Huron City Museum, Huron City, Michigan, 1997. Source: Author.

Loss of context is a serious issue to a moved structure (Figure 187). With early life-saving stations, context is less of an issue since they were built to move. As long as the station is near a beach with appropriate water access on a properly sized plot of land, the life-saving station will "feel" appropriate. Even life-saving stations not meant to move can be moved without too much turmoil. For example, the Old Harbor Life-Saving Station was barged from one end of Cape Cod to the other without much loss in site character (Figure 188).

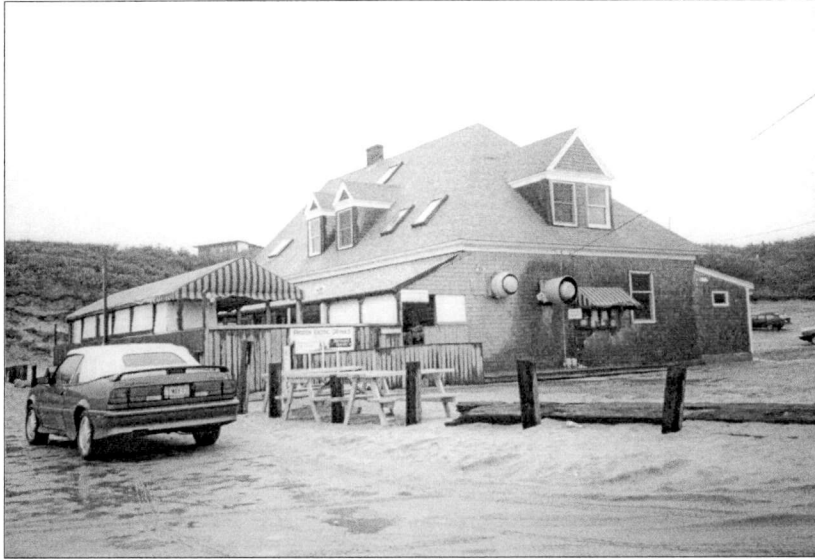
Figure 189. Cahoons Hollow Life-Saving Station (1894) Rehabilitation, Cahoons Hollow, Massachusetts, 1997. Source: Author.

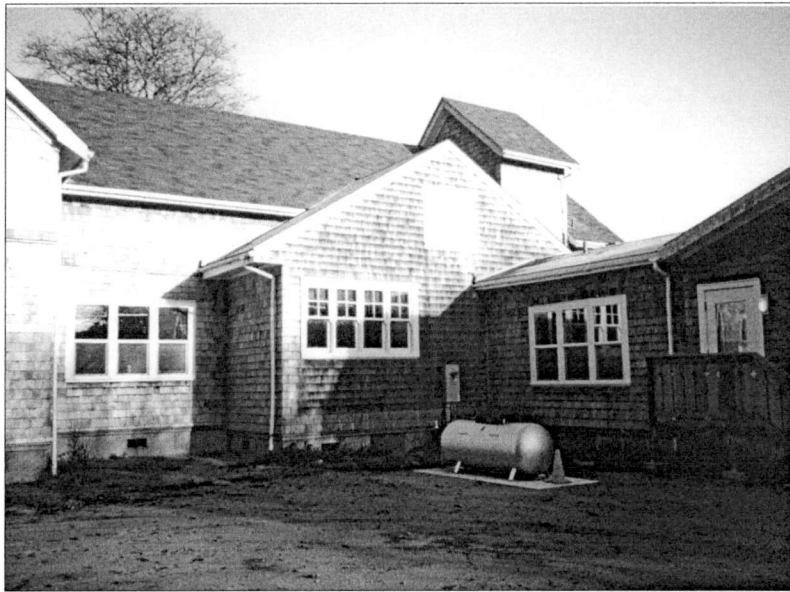
Figure 190. Keeper's Dwelling (1915) Enveloped, Coos Bay Lifeboat Station, 1999. Source: Author.

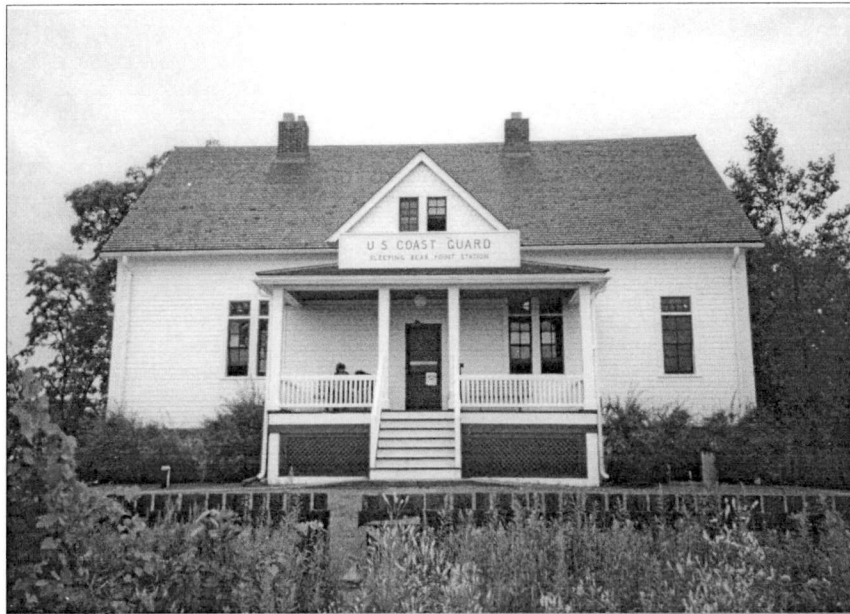
Figure 192. Sleeping Bear Point Life-Saving Station (1901), 1997. Source: Author.

type Life-Saving Service stations built in Oregon that are no longer standing (Figure 192). The station house is set up with non-permanent, interpretive displays on the first floor (Figure 193). Existing cabinetry is used to display life-saving items (Figure 194). The second floor is set up as a house museum to give the visitor an idea of what it was like to be a surfman (Figure 195). The Fort Point-type boathouse stands nearby (Figure 196). The station has been moved to its present location though it still retains its original orientation and relationship with Lake Michigan. Inside the boathouse are a surfboat, lifeboat, lifecar, and beach apparatus cart just as they would have been housed 100 years earlier (Figure 197). Items are displayed in proper fashion, though not in quantities that would have originally occupied the boathouse. The displays are interpreted by trained docents rather than signage.

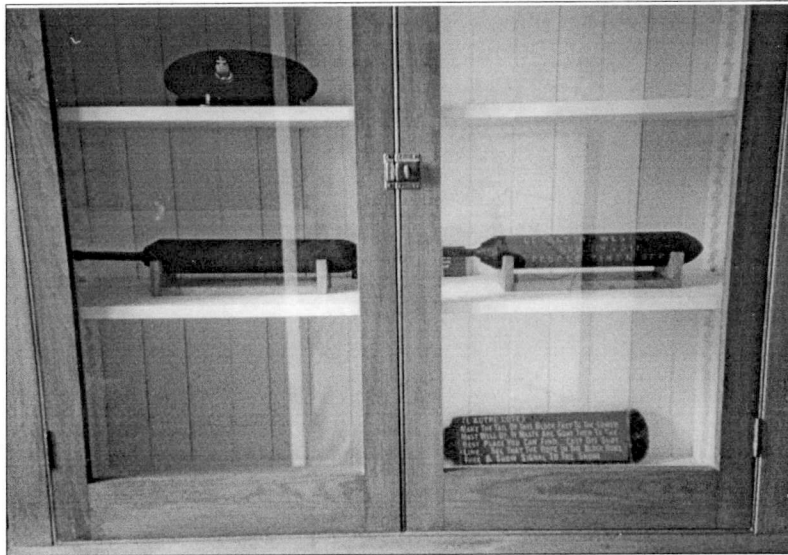
Figure 194. Kitchen Cabinet Interpretation, Sleeping Bear Point Life-Saving Station, 1997. Source: Author.

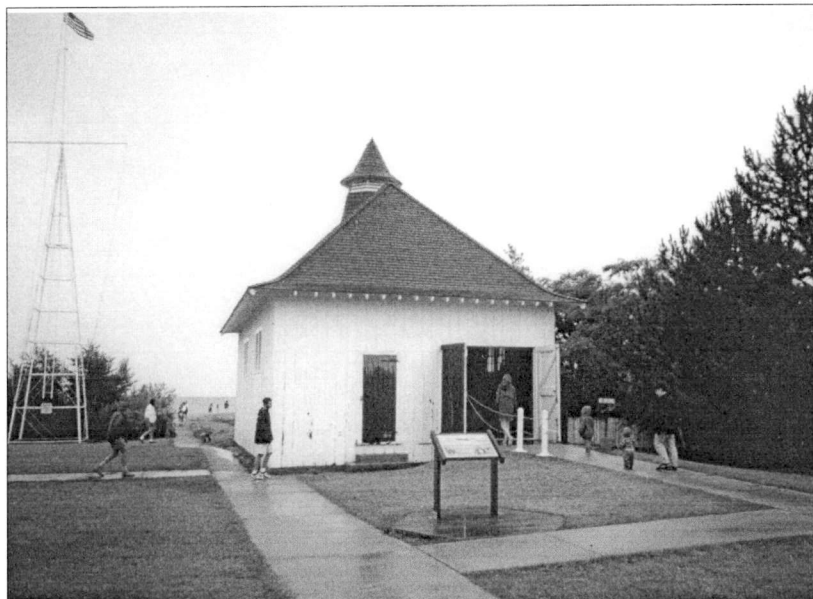
Figure 196. Boathouse (1901), Sleeping Bear Point Life-Saving Station, 1997. Source: Author.
