A study on curing processes and environmental effects for rapid composite repair

Abstract

This article focuses on scarf joint comprised of vacuum-precured, vacuum-cocured, autoclave-precured, and autoclave-cocured composite patches bonded to autoclave- and vacuum-precured parent laminates. Autoclave- and vacuum-cured parent laminates and scarf joints were prepared and exposed to the same temperature and moisture environment for comparison. All specimens were loaded in tension at three temperatures. Interlaminar shear strength (ILSS) tests were also carried out for the parent materials. As noted, the tensile strength and ILSS decrease when the material has been exposed to moisture and tested at elevated temperature. But, no significant difference was reported for either tensile strength or ILSS between autoclave- and vacuum-cured materials. The room temperature repair efficiencies are reported for single-scarf repairs comprised of vacuum-cocured and vacuum-precured patches. These vacuum-cured repair efficiencies were found to be similar to the efficiency of the autoclave-precured patch repair. This result supports the feasibility of scarf joint repairs with precured or cocured pat

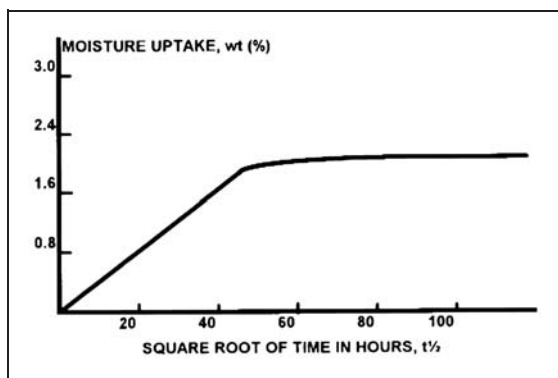
Figure 3. Typical moisture uptake vs. square root of time.

transient storage box until they cooled to the ambient temperature, then they were weighed to the nearest 10^{-3} g. After weighing, the specimens were returned immediately to the vessel. This weighing process was repeated until the equilibrium values of moisture uptake in the specimens were obtained. The weight gains were recorded as a function of time and the moisture uptake, determined as percent weight gain, was plotted vs. the square root of time (Figure 3).

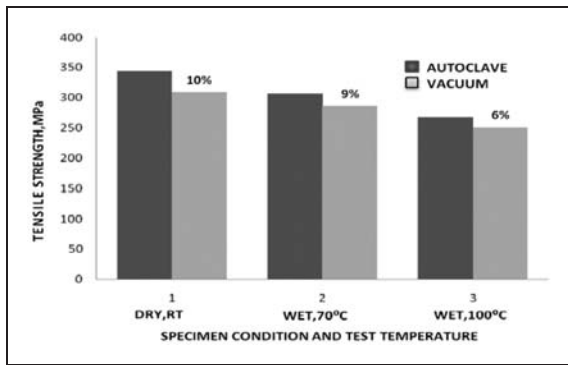
Figure 4. Effect of curing process on tensile strength.

Considering the data obtained from the static tests of parent material performed at RT, 70°C, and 100°C on dry and conditioned specimens for both autoclave and vacuum cure cycles, it can be seen that the average ultimate tensile strength (UTS; 343 MPa) of dry specimens at RT for the autoclave cure is 10% higher than the strength (309 MPa) of dry specimens at RT for the vacuum cure. The wet specimens had differences in tensile strength between the autoclave and vacuum cures of 9% and 6% at 70°C and 100°C, respectively (Figure 4). These differences were considered insignificant and they indicated that vacuum-cured patches could be an alternative to autoclave-cured patches for repair in the field-level maintenance facility.

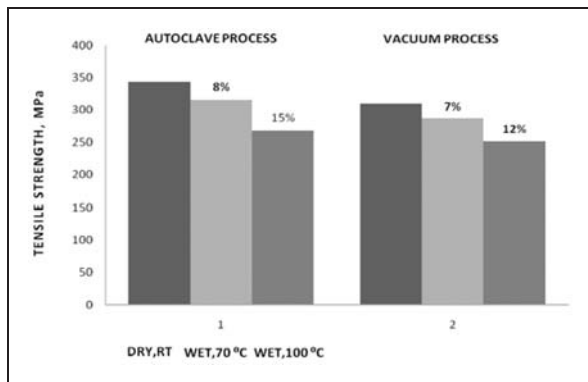
Figure 5. Effect of moisture and temperature on tensile strength.

It was also noted that moisture (wet) conditioned specimens showed a decrease in tensile strength of up to 8% (from 343 to 316 MPa) at a test temperature of 70°C and up to 23% (from 343 to 268 MPa) at 100°C for autoclave-cured material. Similar results were also obtained for vacuum-cured specimens. The maximum decrease in strength was about 23%, which came from the effect of combining moisture, temperature, and curing process (Figure 5). Therefore, it is important in
