PREVENTION OF EROSION IN HOOPER BAY, ALASKA

Civil Engineering

University of Alaska Anchorage

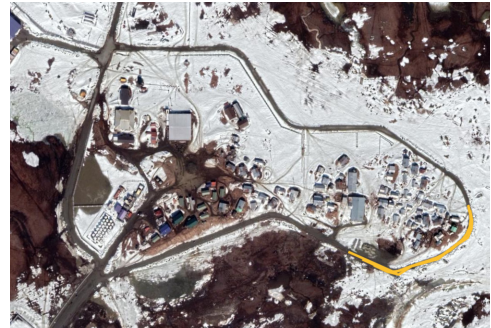
Figure 5: Image of a portion of Hooper Bay from Google Earth, accessed 4/18/22

Because that section of road is part of a loop, all of the structures near that section of the road could be reached by an alternative route. There also exists space in the surrounding area for

another alternate route if greater ease of access to those structures is required. A second consideration is that, even looking at the worst of the projections, the structures near that section of the road will not be exposed to erosion until after the year 2075. The third consideration is community efforts. The ability of these rural communities to enact their own erosion mitigation measures, even if sometimes short term, is often overlooked.

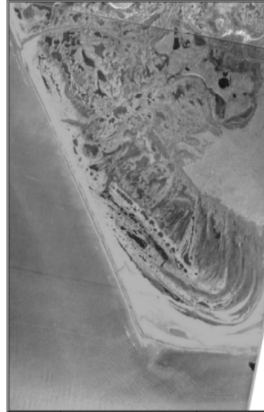
Figure A.1: Salient position in 1951, Drawn from (Jones 2011)

The most interesting question encountered during this project was the salient. The salient was only mentioned in one of the reports used as sources for this paper, the Coastline Engineering report (Jones 2011). The writers of that report did not have the resources or time to ascertain the cause of the salient's formation nor the mechanisms behind its northward movement. The Hooper Bay salient could prove to be an interesting topic of study not only due to its importance to the ongoing runway erosion mitigation efforts but also because the salient is, in and of itself, an intriguing coastal phenomenon.
