Conference Paper, Published Version

OBSERVATION ON BEHAVIOR OF FLOWING DRIFTWOODS AROUND BRIDGE PIER

Yasuharu Watanabe , Hiroyasu Yasuda and Hiroaki Shirai

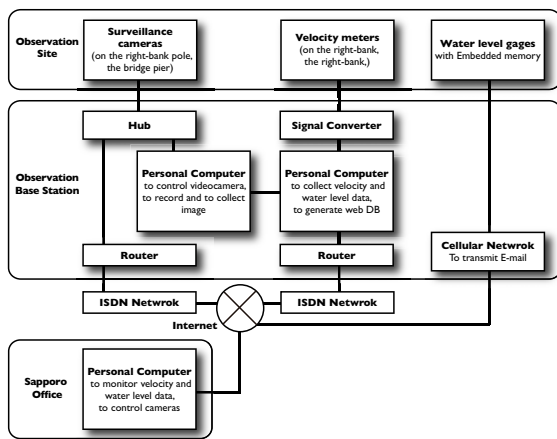
Fig-3 Communication line structure of the system for monitoring driftwood around the bridge pier

As shown in Fig-3, monitoring data were transmitted through the LAN cable from the monitoring devices to PCs, which were installed at the on-site observation station to manage video images, control surveillance cameras, compute velocity data and create web databases. These PCs were connected to the Internet through an NTT ISDN line. The data for the normal water gauge was sent directly to a web database via e-mail. A system was developed to monitor the on-site conditions from the Sapporo observation station by viewing web databases that showed static images and hydrological data from the monitoring site every 10 minutes. Operation of the on-site surveillance cameras and checking of the live images were conducted via

the Internet using special software. These cameras were remote-controlled both from the on-site station using PCs for image control and from the Sapporo station using monitoring PCs. The surveillance camera images were stored on expanded PC hard discs at the on-site station due to the limited capacity of the communications lines.

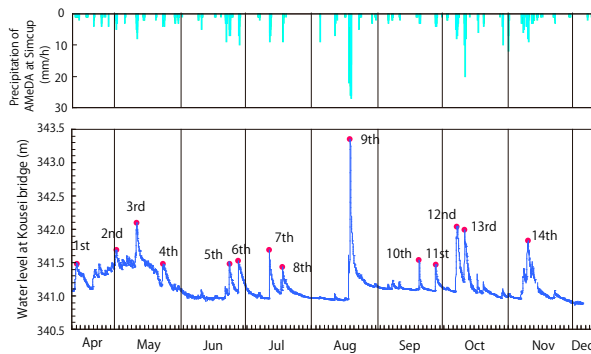
Fig-4 Rainfall and water level conditions observed in 2006

Fig-4 shows the hourly changes in rainfall in Shimukappu based on the Meteorological Agency's AMeDAS (Automated Meteorologi-

cal Data Acquisition System), while Table 1 lists the factors of actual flooding events. During the snowmelt season from mid-April to late May, the water level gradually rose and became higher at times of rainfall, causing four floods of different scales. From summer to autumn, flood occurred approximately 10 times due to rainfall. The flood from August 18 to the early morning of the next day was caused by heavy rain due to a stationary front. According to AMeDAS data from

the Shimukappu station, the accumulated rainfall and maximum hourly rainfall were 201 mm and 27 mm respectively. At 4:00 a.m. on August 19, a water-level high of 343.35 meters was recorded at the monitoring site of the rehabilitated bridge. In addition to this flood, between one and three others occurred monthly during the monitoring period of 2006, and the driftwood conditions during floods of varying scales were observed.

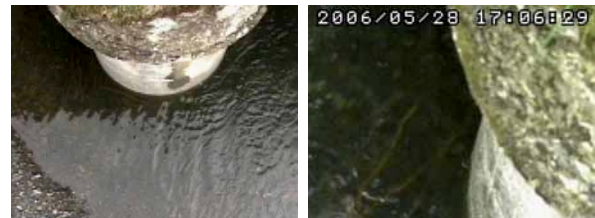
Fig-6 Trees observed around the bridge pier after flood due to snowmelt (right: an image observed at the Sapporo station; left: a close-up of the image)

In this research, driftwood that accumulated around the lower part of the bridge pier due to flood was observed when the water level fell after the event. The driftwood shown in **Fig-6** was observed at the end of May after a flood caused by snowmelt. Around five sunken trees of approximately 1.5 meters in length were observed, and were washed away at the time of flooding in mid-August. During a survey on the amount of sediment on September 15, a willow of approximately 8 meters in length was found in addition to old trees. As shown in **Fig-7** and **-8** and Table-2, these trees were drifting around the bridge pier with their roots pointing upstream. They were also washed away during an flood in October. No images recorded during flooding events showed driftwood stagnating and gradually accumulating around the bridge pier. However, a temporary accumulation of driftwood, as shown in **Fig-9**, was observed from 11:41 a.m. to 00:01 p.m. on August 19. Images (1) to (4) in this figure were picked out from among those recorded frame by frame, and show driftwood situations at four different stages: (1) drifting to the bridge pier, (2) captured by the bridge pier, (3) floating in a balanced state around the bridge pier, and (4) becoming unstable around the bridge pier due to drag caused by the flowing water. After hovering around the pier in such an unstable condition for 80 minutes, the driftwood finally left the pier and flowed downstream.

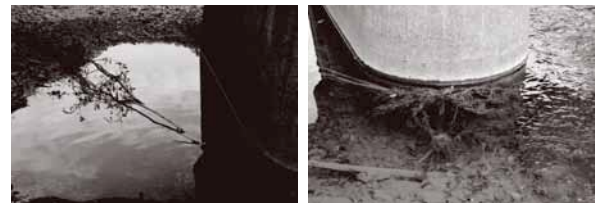
Fig-7 Accumulation of driftwood after flood in August

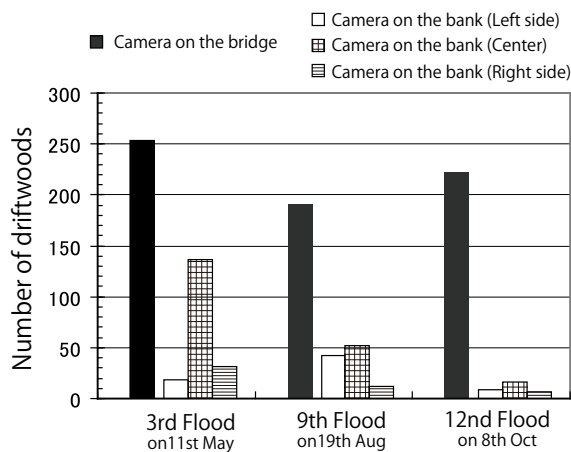
Fig-10 Number of driftwood in three flood events

Table–3 also shows the numbers of trees that accumulated by separating them into those before and after the peak water level to examine differences, and **Fig–10** graphs the result. Of the three floods, the number of pieces of driftwood counted on August 19, the day of the year’s largest flood in the river, was significantly lower than that for the other two flooding events.

This may be explained by the fact that higher water levels brought the water surface closer to the on-bridge camera, thus narrowing the shooting range. This, in addition to the strong splashing that accompanied it, made it difficult to distinguish driftwood. Since the flood on August 19 peaked at night, the lighting range may have been narrow, resulting in undercounting of driftwood. Likewise, the counts based on images from the camera on the right-bank side may have been smaller than the actual figures due to the limited lighting capacity. The significant differences in the total for the October 8 flood between the two cameras may also have been caused by the light-

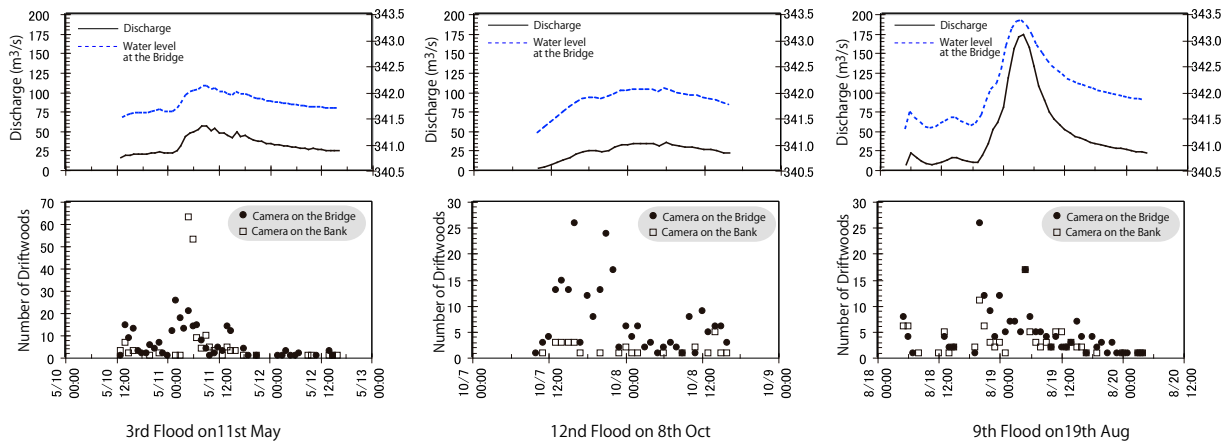
Fig–11 Chronological change in flow rate, number of trees drifting downstream and water level

Fig–11 shows the chronological changes in the number of trees drifting downstream, the flow rate and the water level at the time of the three flooding events outlined above to enable examination of the relationships between them.

The chronological changes in the number of drifting trees shown in the images from the on-bridge camera, whose total was larger than that of the right-side camera, were examined. In each flood, the driftwood flowed down at an hourly density of approximately 30 trees before both the water level and the flow rate peaked, after which the number of drifting trees gradually decreased. **Fig–12** shows the relationships between the number of drifting trees and the water level/flow rate by dividing that number into the values before and after the peak. In each flood-

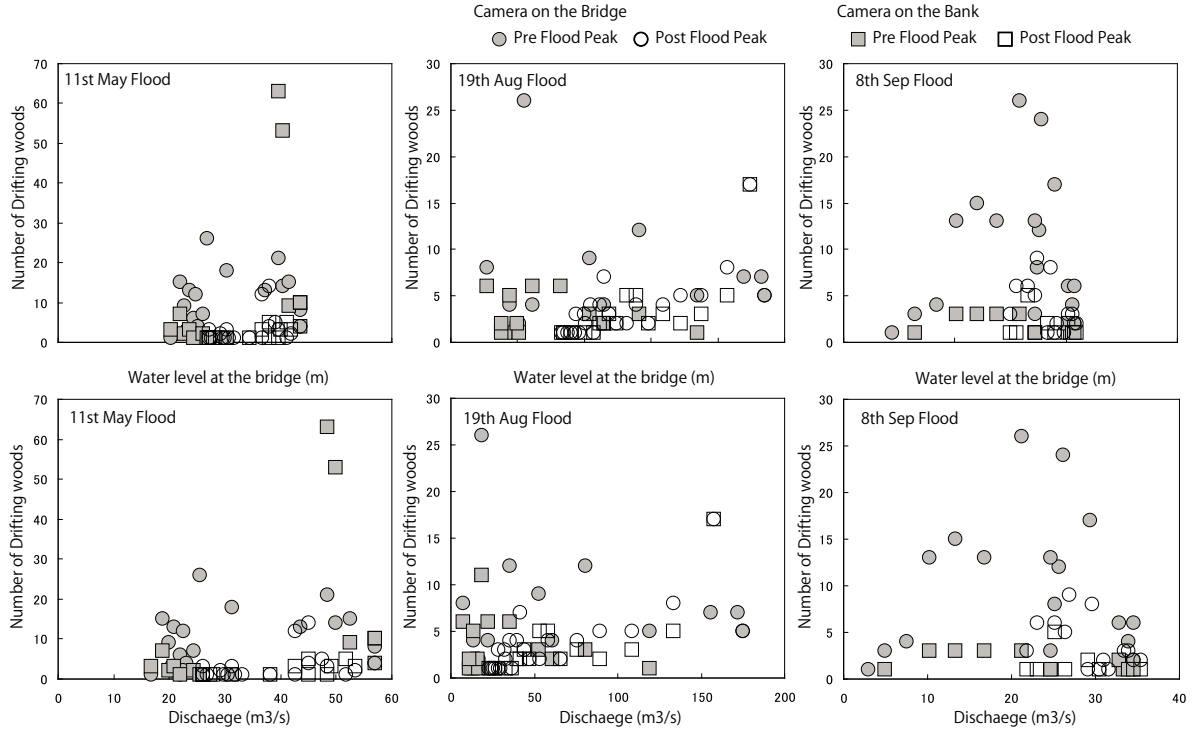
Fig–12 Relationships between the number of trees drifting downstream and the water level and flow rate before and after the peak

ing event, the number of drifting trees before the peak outnumbered that after the peak. Although some positive correlations were observed before the peak between the water level or flow rate and the number of drifting trees, any clear relationships disappeared after the peak. The same applies to comparing the number of drifting trees per unit time before and after the peak. According to Table 3, the number before the peak was 1.7 to 5 times higher than that after the peak. This comparison, based on the images from the on-bridge camera, indicates that the number of trees drifting downstream may increase before the peak of the water level and flow rate.
