Deformation Process of Sandbar and Interaction between Vegetation and Sandbar in Meandering Channel of Shibetsu River

DEFORMATION PROCESS OF SANDBAR AND INTERACTION BETWEEN VEGETATION AND SANDBAR IN MEANDERING CHANNEL OF SHIBETSU RIVER

Hiroyasu Yasuda and Yasuharu Watanabe

Key Words : Shibetsu river, re-meandering, restoration

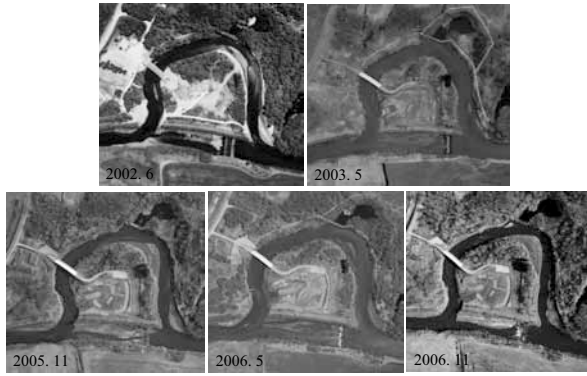
Fig-6 Conditions of the experimental section

Vertical aerial photographs at the experimental section had been taken five times. The first is in June 2002, three months after water flow commenced. The second is in May, 2003, 14 months after water flow commenced. The third is in November, 2005 and the fourth is in May 2006. The newest is November 2006, after the largest flood in the observed period. These photographs show in **Figure-6**. From the photograph of June 2002 in **Figure-6**, the formation of sandbars can be seen on the inner bank side of the former

river channel (meander channel) section and the present river channel (straight channel) section at a point in time three months after water flow commenced. Moreover, although the shape of the sandbars cannot be confirmed clearly in May 2003, because the water level when the photograph was taken was about 30 cm higher than in June 2002, the sandbars were confirmed by

survey to have nearly the same shape as those in June 2002. When comparing the pictures in June 2002 and in May 2003, there are no large differences in the shape of the sandbars, but in May 2003 it is possible to discern that the right and left river banks in the area upstream of the sheet pile and the river bank on the left bank of the inflow area near the present river channel (straight channel) have been eroded substantially. This shows the sandbars were almost entirely formed by the first snowmelt floods, and that river bank erosion caused by the accompanying deviation of the flow is advancing with successive floods. Furthermore, because the river bank on the left bank side of the inflow area had been eroded by as much as nearly 12m by October 2002, there was a danger the weir built in the present river channel (straight channel) might be destroyed if the erosion progressed further. Therefore, to maintain the test flow, from December 2002 to March 2003 a revetment (cobblestones packed in netlike nylon bags) was constructed extending 70m from the tip of the inflow area. The changes in the river bank line of the former river channel (meander channel) section from March 18, 2002 immediately prior to the test flow as determined from cross sectioning are shown in **Figure-7**. After May 2003, the heavy bank erosion had not been occurred. The remarkable river bank erosion of the river channel section that was newly excavated to connect the former river channel (meander channel) section and the present river channel (straight channel) section is clearly shown in **Figure-7**. The results of the site reconnaissance are summarized and shown in **Figure-8**. In addition to the river bank erosion on the left bank side of the inflow area that Sato et al (2002). pointed out based on indoor hydraulics experiments, river bank erosion believed to result from the water flow occurred in multiple locations along the newly excavated river channel section. The river bank erosion that occurred in the vicinity of SP280 on the left bank side, which is the inner bank side of the curve section, and at SP400 on the right side, were noted after snowmelt periods or the comparatively large-scale flood period that occurred in October 2002. Such erosion of the inner bank side is believed to have occurred because the main current line of the flow forms a free vortex flow near the inner bank side. On the other hand, the river bank erosion in the vicinity of SP40, SP240, and SP280 on the right bank side and SP420 on the left bank side is on the outer bank side of the curve section. This is because the riverbed on

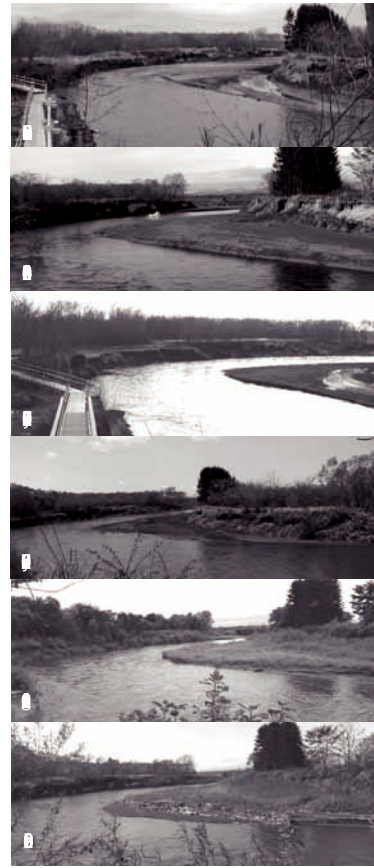
Fig-11 Changing situations of invaded willows on the bar

There is no large flood from September 2003 to September 2006 for about three years at the experimental section (see **Figure-5**). Sandbars in this section were stabilized and emerged. The willow invaded on sandbars. The changing situations of invaded willows on the bar which generated at the inner bank of meandering part of the channel are shown in **Figure-11**. Although the greatest flood in an observation period occurred in October 2006, destruction of the willow trees accompanying deformations of a sandbar was not generated. When growth of a willow continues,
