Line defects in epitaxial silicon films grown at 560°C

We present an investigation of line defects in epitaxially grown silicon layers using Secco defect etching and transmission electron microscopy (TEM). 1 μm thick layers were deposited onto Si (100) wafers at a substrate temperature of 560°C using electron cyclotron resonance chemical vapour deposition (ECRCVD). Defect etching reveals a variety of etch pits related to extended defects. A detailed analysis of the orientations and shapes of etch pits related to line defects is carried out. Using this information it is then possible to assign different types of etch pits to line defects observed by TEM. The investigations show, that one type of defect are extended dislocations parallel to $\langle 112 \rangle$, while the direction of two other types are $\langle 110 \rangle$ as well as $\langle 314 \rangle$, a direction uncommon for line defects in silicon.

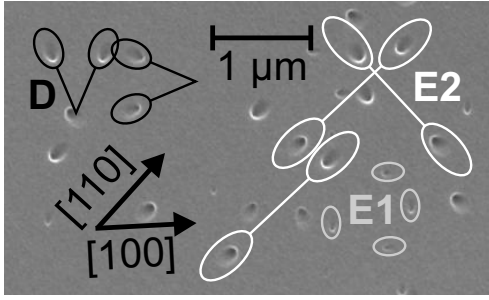
Fig. 1. Topview SEM image showing the different types of elliptical etch pits observed after Secco etching. The lines connecting E2 and D pits indicate defect pairs as discussed in the text.

The elliptical etch pits found in our samples can be put into three categories (E1, E2, D) as indicated in the overview SEM image of a Secco etched surface of an epi-layer shown in Fig. 1. The properties of the different types of etch pits and their correlation to defects observed in TEM images will now be discussed.

E2 are elliptical etch pits whose main axis is approximately 300 nm long and aligned parallel to the <110> directions. This shows that the direction of the underlying defect can be written in the form <11z>. As indicated in Fig. 1 these etch pits are often found in pairs whose two partners lie on a <110> line. The separation of the two partners, r_{E2} , depends on the thickness of the epitaxial layer, d_L , as shown in Fig. 3. Note that the vertical line at each data point represents the spread of r_{E2} observed for each sample. The linear dependence observed in Fig. 3 indicates that the defect pairs start to grow in approximately the same depth below the surface. Assuming that this is the epi-Si/c-Si interface, it is possible to get an estimate for the Z component of the defect orientation. The lines added to the graph give the calculated values of r_{E2} for line defect pairs that start to grow at the epi-Si/c-Si interface into the given directions. It becomes obvious from Fig. 3 that the experimental data are best described assuming a direction of <112>. However, the observed values of r_{E2} lie on or slightly below the predicted behaviour for defects with <112> directions.

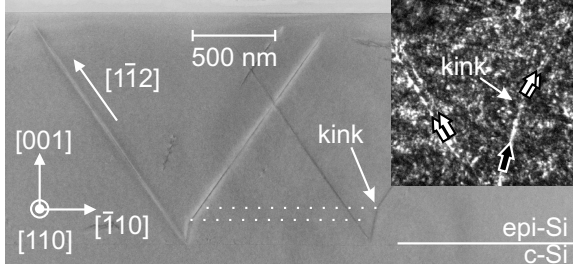
Fig. 4. TEM image of V shaped defects responsible for the E2 etch pits. The line direction of the defects is $\langle 112 \rangle$. The dotted lines indicate the plane parallel to the epi-Si/c-Si interface where the kink is observed for the two defect pairs. The inset shows a more detailed image of the region around the kink.

To get more insight into this behavior, TEM investigations were performed on a sample that exhibits a high E2 density. Fig. 4 shows a TEM image of two defect pairs where both partners lie exactly in <112>

directions. Near the interface the direction of one of the two line defects is tilted towards the surface normal. The distance from the interface where this "kink" occurs is not fixed but varies from pair to pair as indicated by the two dotted lines. The presence of this kink will therefore result in a slightly smaller r_{E2} than expected for a pure $\langle 112 \rangle$ direction. Taking this kink into account, the data in Fig. 3 can be fitted with a linear function (dotted line) from which a mean distance of the kink from the interface of about 230 nm can be estimated. This is in good agreement with what is found in Fig 4. These defects therefore explain the dependence of r_{E2} on d_L and also its variations and can be identified as the origin of the E2 etch pits.

To get more insight into the region around the kink, a more detailed image is shown in the inset of Fig. 4. For this image the sample was slightly tilted, revealing that the defect is a single line in the region between the kink and the interface (black arrow), but a set of two parallel lines in the region, where the direction is $\langle 112 \rangle$ (white arrows). In the region between the kink and the interface the Burgers vector (b) was determined to be perpendicular to the dislocation line

($b = \frac{1}{2} \langle 110 \rangle$) showing that it is a perfect edge dislocation. Above the kink the defect consists of two lines which can therefore be interpreted as two partial dislocations with a stacking fault in between them, known as an extended dislocation [10].
