## A Review on Galvanizing Coating Defects: Causes and Remedies

Jayraj Parmar\*, Daulat Kumar Sharma, Patel Khyati & Patel Sweta

*Metallurgy Engineering Department, Government Engineering College, Gandhinagar, Gujarat Technological University, Gujarat, India*

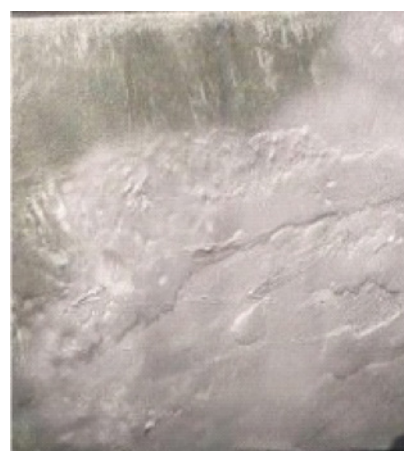
Distortion is a very common defect in galvanizing. It is the undesirable warped that intermittently turn into evident after galvanizing. The galvanizing practice takes place at liquid Zn temperature around 450° C. For treating steel it is lower at end of stress relief temperature. Any other inherent welding and rolling stress in fabrication, which seems to release. It results in a dimensional-based change, like distortion defect (Tang & Goodwin 2001).

FIGURE 2. Distortion (Tang & Goodwin 2001)

Thin plates are many possibilities to distort and it causes due to quick different heating and cooling of products. To control this one should use sections of similar thickness; use

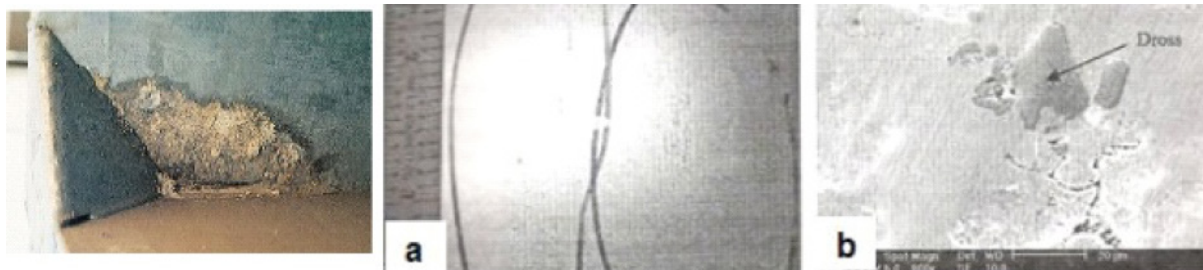
be given the rough look. It is also particles of Fe and Zn alloy produce during the process. Excessive Fe fines carry on incoming strip substrate could easily lead to form a dross particle inner side of the Zn tank. Figure.3 (a) characterize the visual look of dross, which can be simply misguided as coated over a “scratch” defect. Figure.3 (b) characterize the SEM substrate look of dross pick-up after then polishing.

FIGURE 3. Different types of drosses (Khode 2019)

It is uninformed by galvanizer and precipitate in the bottommost. Dross deposits from the lowermost of the Zn bath surrounded the edges of production. The dross is associated with coating, which prevents drainage of the Zn in the middle portion (Khode 2019).

Dross contains a similar Fe-Zn alloy as coating; it will offer the same oxidation resistance as a common hot-dipped galvanizing coating (Tang 1998). The presence of dross addition in the coating is non-harmful to coating performance as corrosion resistance of Zn dross matches with the hot-dipped galvanizing coatings (Tang & Goodwin 2001).

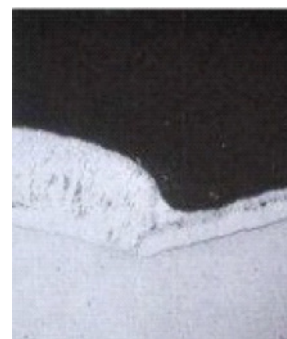
Determinations to raise the galvanized coating depth on minimum reactive steel can be resulting in unfortunately thicker and brittleness coating on much reactive steel. Alteration in the coating depth and its carried by a mixture of one or more reactive Si killed steel and high P results in thick galvanized coating and very less reactive Al killed steel results in galvanized coating depth lower than that requirement in specifications. The thickness of resultant coating on reactive steel may be much thicker, results in an inelastic coating more prone to damage. To prevent it select same steel for fabrication any part. If necessity, agree to take a request by any galvanizer when thin coating is possible (Khode 2019).

FIGURE 12. Non-Reactive and reactive steel welding together (Khode 2019)
