Improving indoor conditions in an Italian historical Church: the case study of Donnaregina Vecchia

Abstract— Preserving the historical and artistic heritage is a topic of central interest, especially in countries that have particularly old heritage such as Italy. This study concerns the monitoring of environmental conditions of an ancient church in the center of Naples, a beautiful example of Italian Gothics, which, besides the absolute value of the architecture, even preserves works of art of special significance. The measurement campaign, performed during two typical winter weeks, was necessary to calibrate a dynamic energy model of the church. Then, a radiant floor was designed, to provide a space heating service for the Choir, used for conferences and events, so that the improvement of microclimatic conditions, in winter, can contribute to preserving artifacts (e.g., too cold conditions can induce cracks of wooden materials) and improve occupants' thermal comfort, without compromising the historical/artistic value of the church. The monitoring revealed that the indoor microclimatic conditions do not satisfy the ideal ranges for the conservation of the artistic heritage, and th

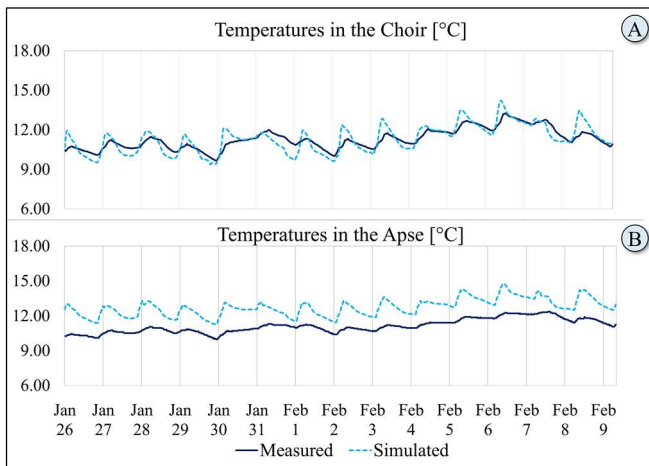
Fig. 5. Measured and simulated indoor temperatures

The MBE values are perfectly in the range suggested by [12][13] for calibrated models. The maximum temperature difference between measured and simulated data is 1.89 °C in the Choir and 2.77 °C in the Apse. The difference of specific humidity that corresponds to the temperatures with the maximum discrepancy between simulated and measured data, is 1.6 g/kg in the Choir. Therefore, based on these considerations, the model was deemed to be calibrated.

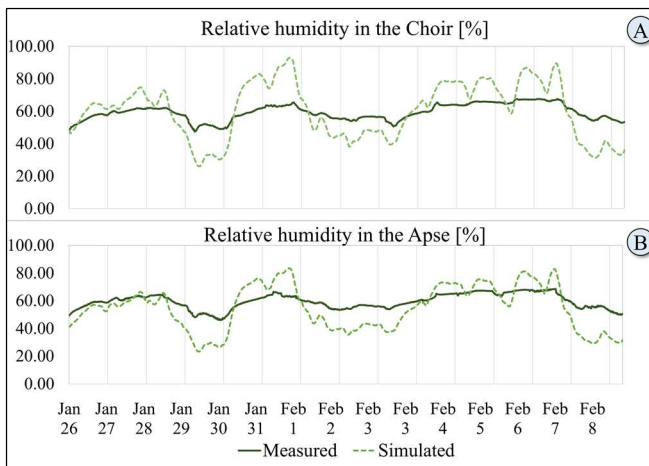
Fig. 6. Measured and simulated indoor RH in the Choir and in the Apse

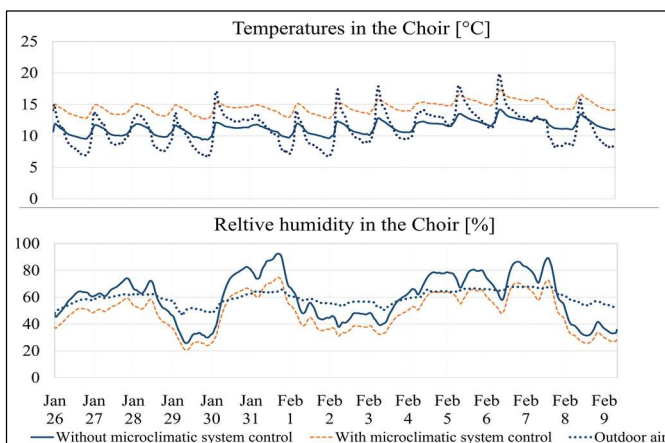
Fig. 8. Temperatures and RH before and after the addition of a radiant floor

height. The system will be installed on the Choir floor, currently not of prestige, so the intervention is not invasive. The dimensions of the radiant surface are 15.1 m in length and 6.7 in width, and it is positioned as represented in Fig. 7. The radiant system is connected to air-to-water heat pump with a power of 12 kW, and a COP of 3, active for the whole day. The limited power of the system is a consequence of the limited surface at disposal, to avoid an invasive design. This concerns even an insulation layer of 4 cm below the radiant surface and a screed of 4 cm above it and before the pavement layer. The results of energy simulation show that, after the installation of the radiant floor, the mean temperature in the Choir has an increment (Fig. 8) during the examined weeks. The mean air temperature in the Choir is not lower than 12.6 °C and not higher than 17.2 °C. The daily maximum temperature excursion is 2.65 °C. By considering the thermal ranges reported in Table II, temperatures perfectly fall in the ranges for a correct conservation of frescos and mural paintings. Regarding RH, the curve undergoes a downward slip, so there is a clear reduction in the RH rate of the environment. The installation of humidification systems is foreseen to raise the level of relative humidity and to keep it in the range suitable for the conservation of both wooden furnishings and frescoes. The addition of a radiant floor system in the Choir, even if mild, involves variations in the microclimatic conditions of the Apse area too, with an increase of minimum mean temperature of about +0.6 °C. Regarding the thermal and hygrometric comfort for occupants, when the temperature reaches its highest value in the Choir, the PMV is -0.9 and the PPD is 22 %. According to the Fanger approach, the environment can be considered “moderate”. An improvement of microclimatic parameters is measured, even if not optimal, mainly in the Apse.

Conversely, the Choir, used for events, obtains thermally comfortable conditions. Finally, the intervention guaranteed an improvement of thermal and hygrometric comfort conditions, even if not optimal, and an improvement of the T and RH values for the correct conservation of the works of art.
