Analysis of sensor disturbances caused by IEMI

Arne Pahl, Faculty of Electrical Engineering, Helmut Schmidt University, Hamburg, Germany
Prof. Dr.-Ing. Stefan Dickmann, Faculty of Electrical Engineering, Helmut Schmidt University, Hamburg, Germany

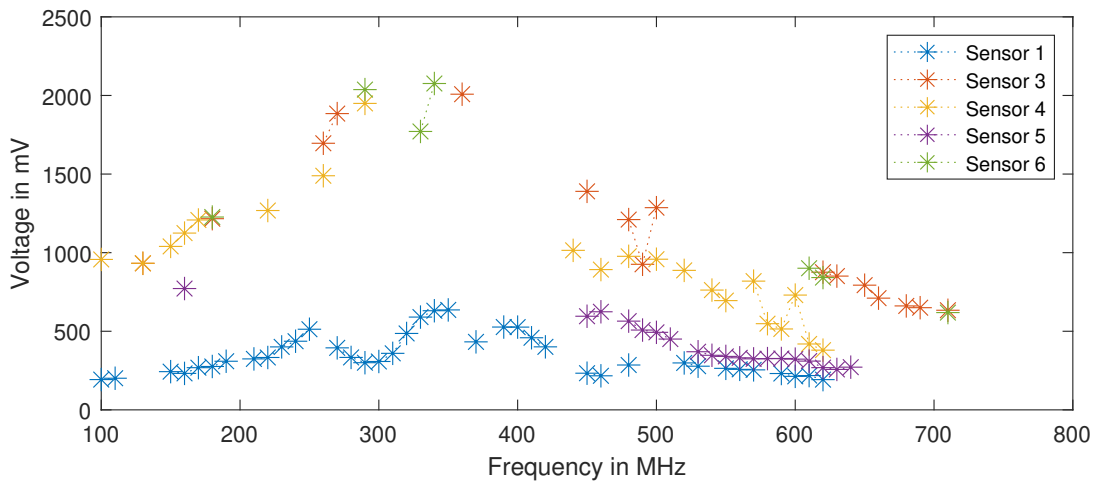
Figure 4: Occurrence of I²C errors

on the sensor type. Figure 4 shows the occurrence of the I²C error as a function of amplitude and frequency of the interference voltage for 5 sensors. The first occurrence of the controller error is shown in Figure 5. With sensor 2, the errors only occur at very high amplitudes and only at 100 MHz and are therefore not shown in this figures.
