Experimental Investigation of Retrofitting Techniques for Steel Bridge Girders Subject to Fatigue Failure

Mirza O*, Milner L and Mashiri F

School of Computing, Engineering and Mathematics, Western Sydney University, Locked Bag 1797, Penrith South DC, NSW 1797, Australia

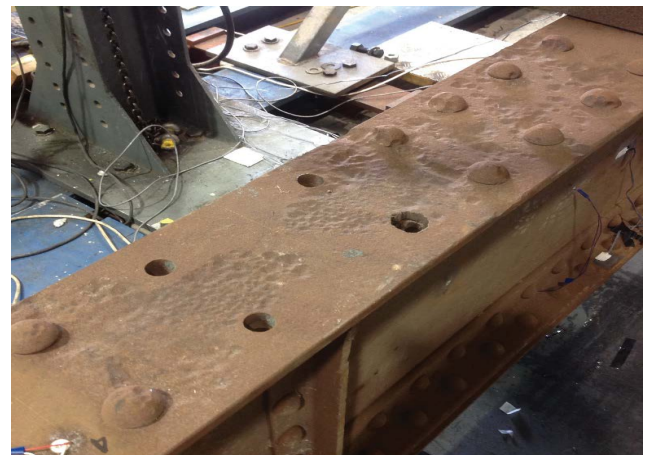
Figure 4: Defects for 120-year-old girder.

present. One defect experienced by the 120-year-old girder is corrosion, as the entire beam is covered in surface rust with some locations experiencing the corrosion more aggressively as the girder has started to pit. Another notable defect for the 120-year-old girder is that it had rivets missing in some locations. The defects for the 120-year-old girder are shown in Figure 4. The new hot-rolled 610UB113 girder has 7.9 mm vertical stiffeners fillet welded in place by EJV engineering to the flange and web. As expected the new equivalent has no defects present.

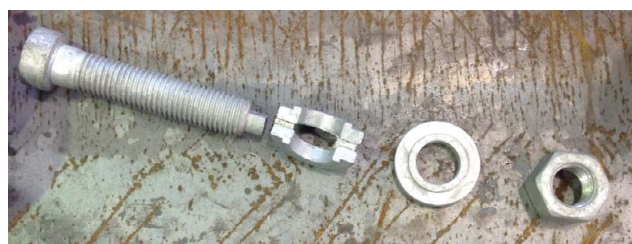
Figure 7: Ajax Oneside fastener.

The retrofitting technique for the girders is a way to combat fatigue that occurs at mid span within the bottom flange. The retrofit was required to be practical as it must be designed so it can be performed within a real-life situation to minimise disruption to bridge services. The retrofit performed was to combat an artificial fatigue crack at mid span within the two girders. The plate to be attached to the girders is 20 mm thick, 1410 mm in length and the width of the girder's flange which is 228 mm for the new girder and 177 mm for the old girder. 350 grade steel plates were found to be the optimum grade as 250 grade was not adequate in design. The plate is attached to the girders using 20 mm diameter Ajax Oneside fasteners which are high strength 8.8/S structural bolts. The Ajax Oneside fasteners are a bolting system that enables the bolt to be tightened with only having access to one side of the bolt. Without the Ajax Oneside fasteners this retrofit would not be practical for some bridge girders. Figure 7 shows the arrangement of the Ajax Oneside fasteners in the order it is installed, which includes a bolt, collapsible washer, flat washer and a nut.

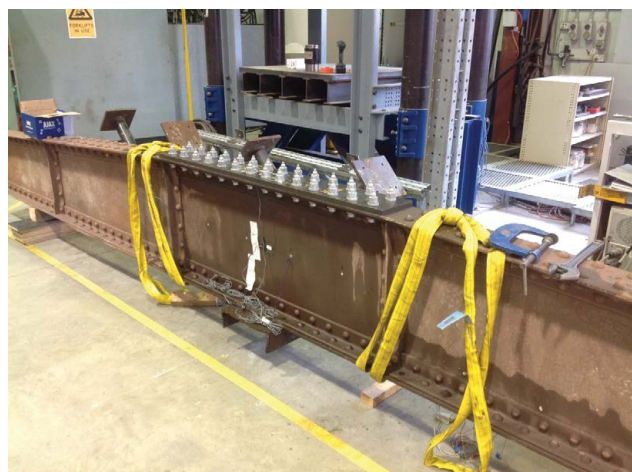
Figure 8: Completed retrofit for RMS 120-year-old girder.

Once all the drilling and rivet removal was complete the Ajax Oneside fasteners completed the retrofit by attaching the plate to the girders. Figure 8 shows the completed retrofit for the RMS 120-year-old girder. Figure 9 shows the completed retrofit for the EJF New equivalent girder.

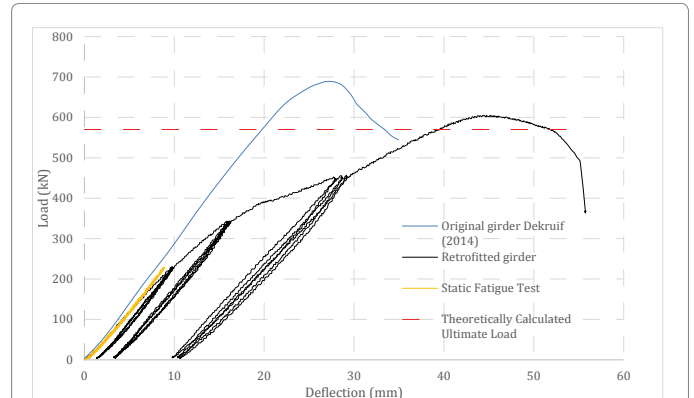
Figure 10: Load versus deflection curve for new equivalent girder experimental results.

New equivalent girder: The new equivalent girder had two experiments performed: before the girder had an artificially induced fatigue crack, and after the girder had an artificially induced fatigue crack that was retrofitted. Figure 10 shows a load versus deflection curve for the static fatigue test for the girder, and static strength test until failure for the retrofitted new equivalent girder. The load versus deflection curve was plotted due to the data obtained from the linear variable displacement transducers (LVDT), along with the known loading rate of 0.1 mm/s for the 1000 kN hydraulic press. Also displayed in Figure 10 is the experimental result from Dekruif [11], which is a static strength test until failure of an identical 610UB113 which is the same length and has vertical stiffeners in the same location; however, no retrofit was performed on the beam.

Figure 10 illustrates that the stiffness of the girder changed after the retrofit was installed on the girder. The girder initially had a stiffness of 26.14 kN/mm. Once the girder had the artificial fatigue crack induced and the retrofitting plate installed, the stiffness decreased to 23.16 kN/mm. The 11.4% decrease in stiffness is due to the artificially induced fatigue crack and the technique of the retrofit. Initially, the girder was a hot rolled uniform cross section with no discontinuities within the bottom flange. Once the artificial fatigue crack was induced in the bottom flange, it compromised the cross section of the girder reducing the stiffness. The connection of the retrofitting plate also affected the stiffness of the girder. The retrofitting plate was connected to the bottom flange using 20 mm diameter Ajax Oneside fasteners which were inserted to fill 22 mm holes within the flange and plate. The 22 mm holes were drilled so that the bolt had 2 mm of clearance. This caused the connection between the girder and the plate to slip as the Ajax Oneside fasteners would not engage with the plate and girder until the girder had deflected and engaged the fasteners with the outside of the holes for both the girder and retrofitting plate. Figure 11 shows the artificially induced fatigue crack propagating into the web of the new equivalent girder. This shows that the clearance of the bolt holes caused a slippage between the girder and retrofitting plate. This ultimately increased the deflection and reduced the stiffness of the girder. The slippage that occurred between the retrofitting plate and the girder is evident as the artificially induced fatigue crack was a 2 mm cut within the bottom flange. Once the testing was complete, the artificially induced fatigue crack had expanded to a 9 mm gap as seen in Figure 11. The result from the static strength test until failure for the retrofitted

new equivalent girder displayed in Figure 10 shows that retrofitting is effective for rehabilitating beams with fatigue failure within the bottom flange. It is seen in Figure 10 that the retrofitted new equivalent girder reached an ultimate applied point load of 604.86 kN. For a 610UB113 with a length of 6477 mm, the theoretically calculated ultimate applied mid span point load was calculated as 568.9 kN. This corresponds to a 6.32% increase in the ultimate applied point load the girder can sustain before failure. This is not a significant improvement although it clearly validates that the retrofit can restore the girder to its original design loading capacity determined according to the Australian standards published by Standards Limited (2012) entitled Steel Structures [11]. Results for the original girder showed that the girder before the retrofit could sustain an ultimate applied load of 681.4 kN. Dekruif [11] showed the girder could sustain 76.54 kN more than the retrofitted girder which corresponds to 12.65% decrease. However, as the results favour the original girder used [11], it can be seen in Figure 10 that the stiffness of the original girder used was greater than the girder used in this experimental study [11]. Original girder displays a higher stiffness and can resist a greater ultimate point load than the retrofitted girder. However, Figure 10 shows that the ductility of the retrofitted girder is greater than the original girder [11]. The greater ductility of the retrofitted girder is displayed, as the retrofitted girder yields and fails earlier than the original girder. Nevertheless, it is not as sudden and drastic as it sustains its ultimate point load for a longer duration.

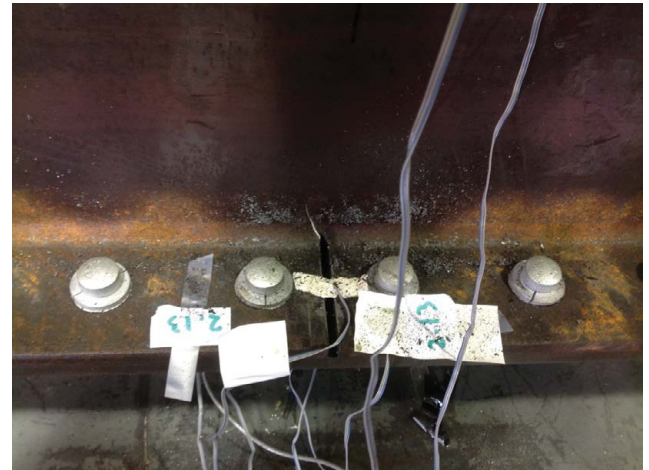
Figure 11: Artificially induced fatigue crack propagating into the web for new equivalent girder.

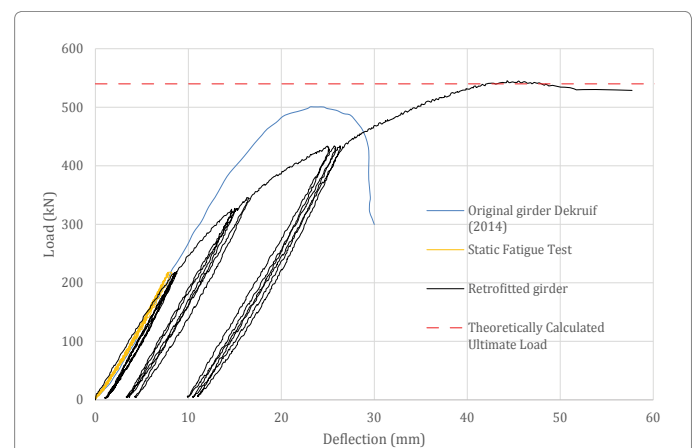
Figure 14: Load versus deflection curve for RMS 120-year-old girder experimental results.

RMS 120-year-old girder: The RMS 120-year-old girder had two experiments performed: before the girder had an artificially induced fatigue crack, and after the girder had an artificially induced fatigue crack that was retrofitted. Figure 14 shows a load versus deflection curve for the experimental results of the static fatigue test for the girder and static strength test until failure for the retrofitted girder. The load versus deflection curve was plotted due to the data obtained from the linear variable displacement transducers (LVDT), along with the 1000 kN hydraulic press known loading rate of 0.1 mm/s. Also, displayed in Figure 14 is the experimental result from Dekruif's [11] experimental study which is a static strength test until failure of an identical 120-year-old girder that has experienced the exact same loading conditions and environment. The identical girder is the same length and has vertical stiffeners in the same location; however, no retrofit was performed on the beam.

From Figure 14 the stiffness can be calculated, showing that the girder used to conduct this experimental study and the original girder used in Dekruif's [11] study had the same stiffness of 27.82 kN/mm. However, once the girder had the artificial fatigue crack induced and the plated retrofit installed, the stiffness decreased to 25.29 kN/mm. The 9.1% decrease in stiffness due to the artificially induced fatigue crack and the connection of the plate to the bottom flange of the girder for the retrofit similar to the new equivalent girder. Figure 15 shows the artificially induced fatigue crack before the girder was tested. Figure 16 shows the artificially induced fatigue crack extending into the web and rivet hole after testing. This shows that the clearance of the bolt holes caused a slippage between the girder and retrofitting plate, ultimately increasing the deflection of the girder, which in turn reduced the stiffness of the girder. The slippage that occurred between the retrofitting plate and the girder is evident as the artificially induced fatigue crack was a 2 mm cut within the bottom flange. Once the testing was complete, the artificially induced fatigue crack had expanded to a 9 mm gap as seen in Figure 16.

The static strength test until failure results in Figure 14 for the retrofitted girder furthermore reinforces that retrofitting is an effective technique for strengthening and rehabilitating girders affected by fatigue cracks within the bottom flange. Figure 14 shows the RMS

retrofitted 120-year-old girder reached an ultimate applied point load of 544.84 kN. The maximum applied point load for the RMS 120-year-old girder was calculated as 540.1 kN. The 0.88% increase in the ultimate applied point load is negligible, however, it is noteworthy as the 120-year-old girder had experienced many years of loading over its service life and had accumulated damage that would negatively affect the ultimate applied point load the girder could sustain. Nonetheless, the retrofit performed upon the 120-year-old girder had rehabilitated the girder to its original design loading capacities, according to the Australian standards published by Standards Limited (2012) entitled *Steel structures*, which further validates the retrofitting technique. The ultimate applied point load was 8.73% higher than Dekruif's [11] experimental study results for the original 120-year-old girder which had an ultimate applied point load of 501.1 kN. This further validates the retrofit and shows the need for retrofitting as Dekruif's [11] original 120-year-old girder did not reach its design load capacity. Another notable observation from the results in Figure 14 of the retrofitted 120-year-old girder is the ductility. The ductility of the girder was significantly increased with the retrofit. The retrofitted girder maintains the ultimate applied load for a longer duration before failing, whilst the original girder reaches its ultimate load and drastically loses its strength and fails. This shows that the retrofitted girder has an improved ductility.

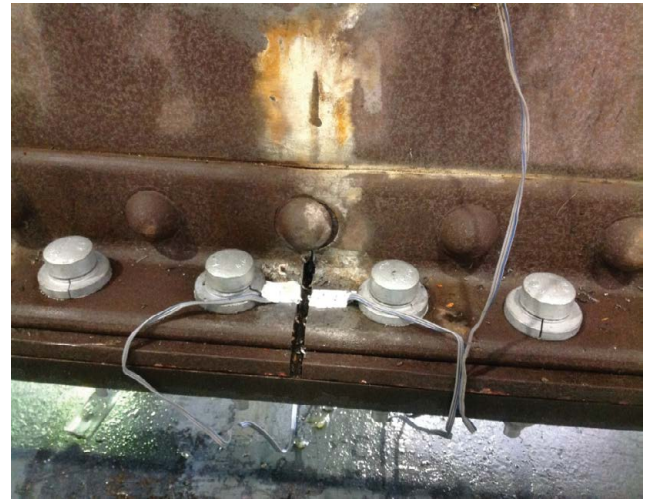
Figure 16: Artificially induced fatigue crack propagating into web of RMS 120-year-old-girder.

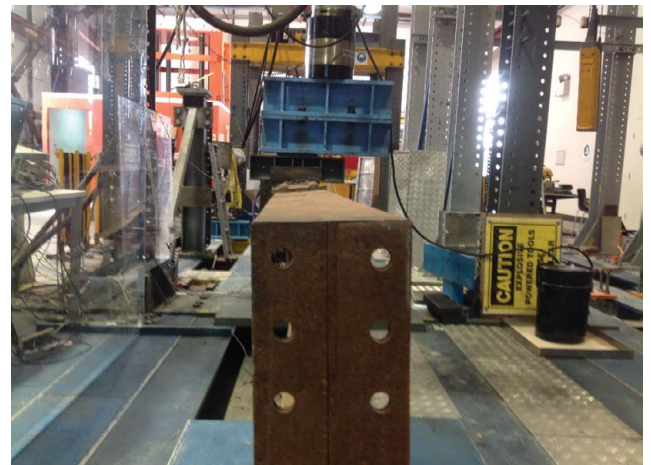
Figure 17: Distortional buckling within flange.

The failure mode of the retrofitted 120-year-old girder was due to distortional buckling within the flange and web of the girder similar to that of the new girder. Figure 17 shows the distortional buckling within the flange, whilst Figure 18 shows the distortional buckling within the web. The plated retrofit did not sustain any form of failure and helped laterally restrain the girder which is evident in Figures 17 and 18.

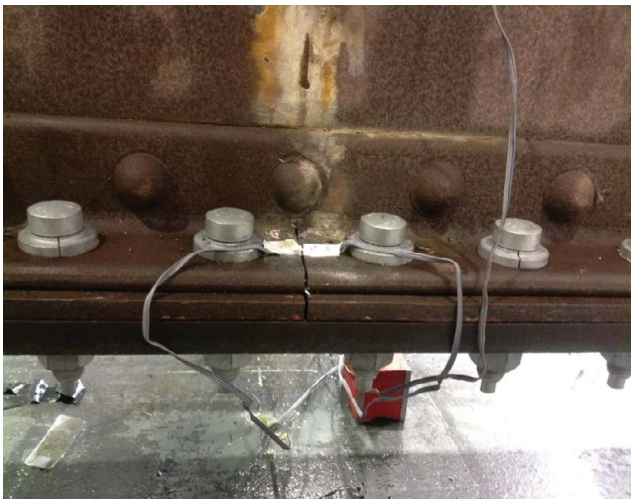
Figure 15: Artificially induced fatigue crack for RMS 120-year-old girder.
