Inspection and Understanding of Sewer Network Condition in Dindaeng District (Thailand)

Hnin Ei Phyu¹, Sutha Khaodhiar^{1,2,*}

Keywords: Sewer pipeline; Assessment of pipe condition; Scoring system; Grading system; Defect types

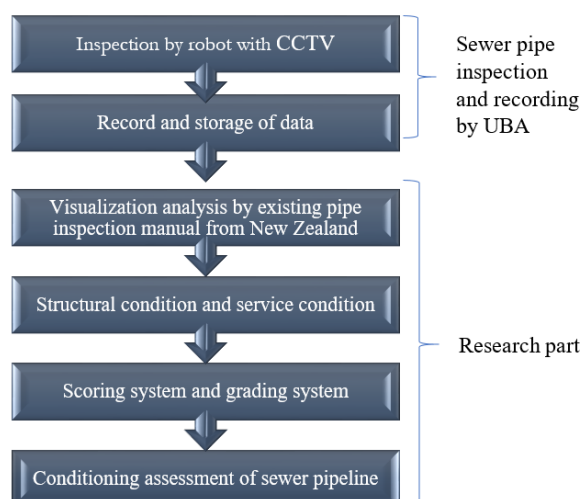
Figure 1 Outline of research work.

This research includes two parts: data collection by a robot with CCTV and data analysis. For the data collection, which was conducted by UBA Company, the condition of the sewer pipes was recorded by a robot mounted with CCTV. The robot ran along the sewer pipelines and recorded videos and images of the condition of the pipes between manholes. The UBA staff monitored and controlled the robot with CCTV at a ground station. The study outline is shown in Figure 1.
