Research Article

Experimental Study on Failure Model of Tailing Dam Overtopping under Heavy Rainfall

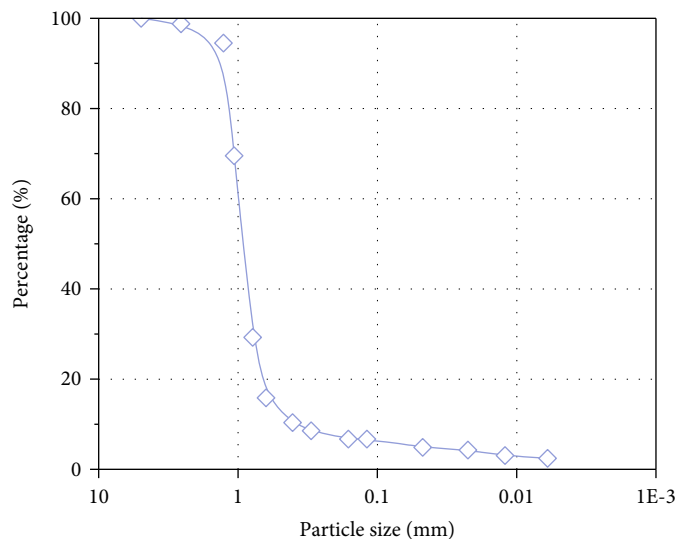
FIGURE 1: Particle size distribution curve of prototype tailing sand.

To ensure the similarity of main mechanical properties between the material used in the experiment and prototype material, as well as the reliability of experimental results, the viscosity of the model sand and the prototype sand must be similar. According to the selection principle of model sand, the physical and mechanical characteristics of the model sand and the prototype sand are far from each other. Therefore, the model materials are all prototype tailing sand, and the particle size distribution curve of prototype tailing sand is shown in Figure 1.

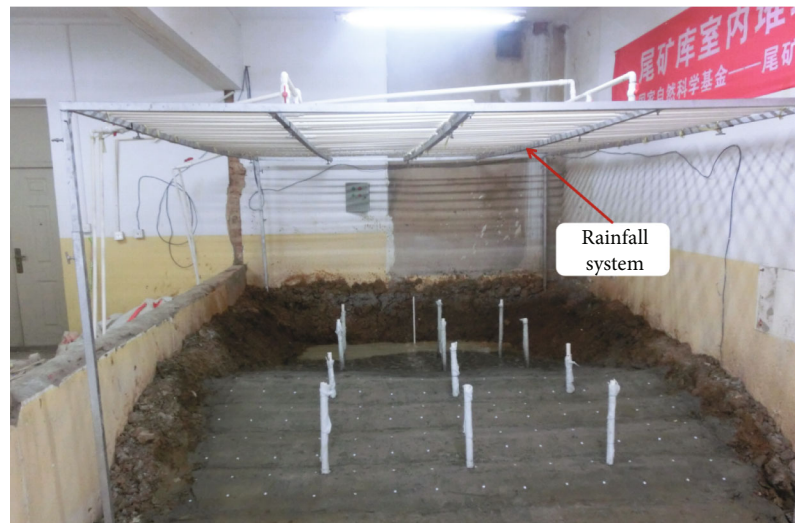
2.3.1. Rainfall System. For this experiment, the tailing dam model is rectangular in size and large in area. If the circular sprinkler covers the whole area, it will inevitably cause rainfall overlap, which will lead to a big difference in rainfall intensity and affect rainfall uniformity. Therefore, in this experiment, the rainfall device adopts spray (pipe network) rainfall mode, as shown in Figure 4, and the rainfall uniformity test is carried out. Eight measuring points were arranged in the rainfall area, and the measuring time of each measuring point was 2 minutes. The received rainwater was poured into a measuring cylinder to measure its volume and

FIGURE 4: Rainfall system.

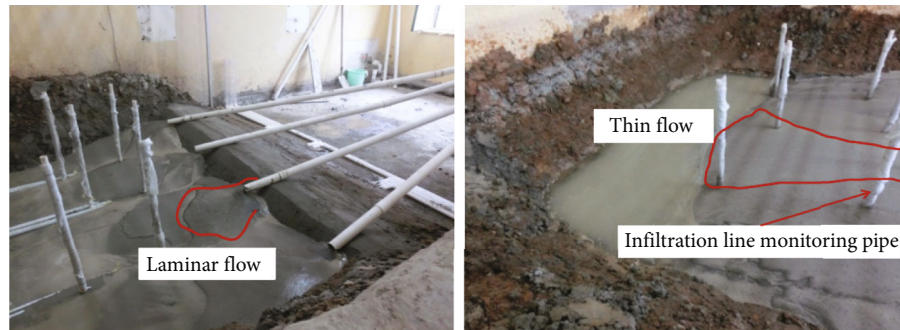
method of discharge tailings was shown in Figure 7(a). It could be seen from Figure 7(b) that the tailings had no obvious sedimentary tailing sand when the tailing slurry flowed into the tailing pond. It was worth noting that the tailing slurry flowed into the tailing pond in the state of “thin flow” and “laminar flow,” forming a clear fan-shaped alluvial beach in the front dam.

FIGURE 7: Particle size distribution of tailings: (a) tailing discharge and (b) particle deposition distribution.

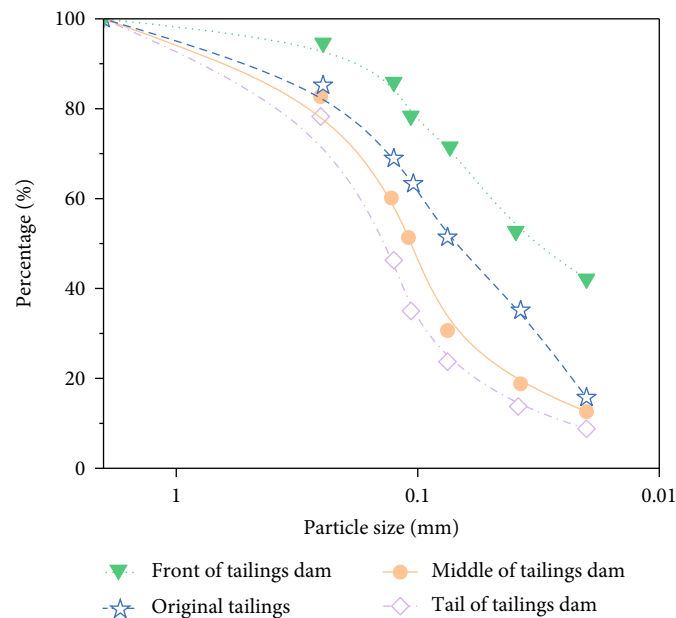
To reflect the deposition law of tailing particle on the dry beach, the front (0.2 m away from the subdam), middle (middle of the dry beach), and tail (0.2 m from the water level) of the tailings of tailing pond were taken along the middle line of the fourth-level subdam after the dam was built. Three groups of tailings were taken for particle size analysis, and the comparison curves of particle size distribution are shown in Figure 8.

It can be clearly drawn that the particle size of the tailings in front of, in, and at the end of the tailing pond is quite different from the experimental analysis. Where the particle size of tailings in front of the tailing pond was $D_{50} = 0.11$ mm, the particle size of tailings in the tailing pond was $D_{50} = 0.051$ mm, and the particle size behind

FIGURE 8: Tailing particle size distribution contrast curve.

the tailing pond was $D_{50} = 0.035$ mm. The tailings with a particle size of less than 0.075 mm accounted for more than 50%, which basically appeared as tailing silt and tailing mud. This deposition law of tailings is mainly related to the selecting effect of water flow. During the flow of tailing slurry on the dry beach, the coarse particles of large size settled down first, and the carrying distance affected by water flow was short. However, the fine particles of small size were carried a long distance by the water flow. Only partial particles were slowly deposited with the water flow, forming tailing silt or tailing mud to accumulate at the tail of the tailing pond. This phenomenon is also consistent with the deposition law of tailings on the dry beach in the actual engineering.

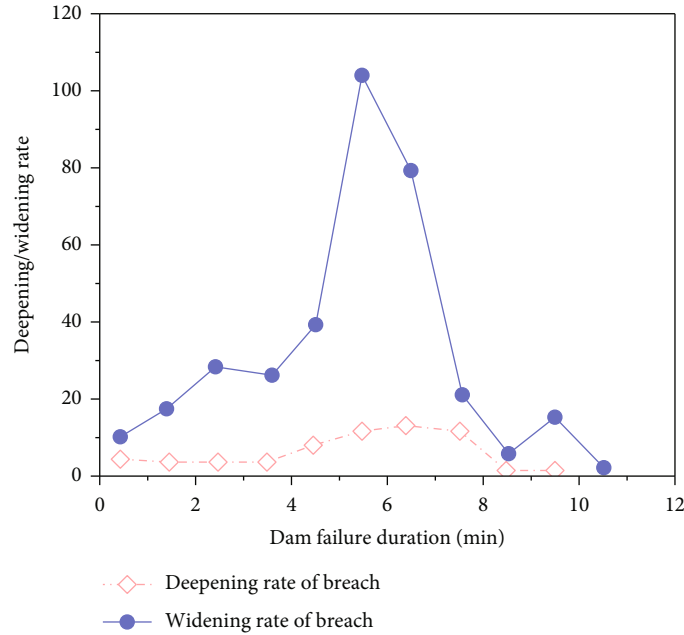
According to the development of the dam failure, the dam failure can be divided into three periods: the early period of dam failure (1~4 min of dam failure), the middle stage of dam failure (4~8 min of dam failure), and the later stage of dam failure (8~11 min of dam failure). It could be seen from Figure 12 that the widening and deepening rates of the breach were different in different periods of dam failure. In the early period, the widening and deepening rates were slow, which were corresponding to Figure 11(b). The overflow erosion was mainly at the breach, and the tailing sand was slightly scoured by the water flow because the water flow velocity was slow. A small quantity of tailing sand was transported downstream of the dam body. With the increase of the width and depth of the breach, the flow rate at the breach constantly increased, and more tailing sand was flushed to the downstream of the dam body. In the

rapid increase of the breach flow. The erosion ability of the water flow reached the maximum, and the widening and deepening rates of the breach reached the maximum when the steep developed upstream of the dam body and approached the bottom of the breach. At this stage, the widening rate of the breach was much larger than the deepening rate, which was about 3-8 times the deepening rate. This was mainly because the widening of the breach was related to not only the tailing migrated by the water flow scouring but also the water flow erosion. The deepening of the breach depth resulted in intermittent instability and collapse of the breach on both sides, and the width of the breach developed rapidly. In the late period of dam failure, the widening and deepening rates of breach gradually decreased to zero (corresponding to Figure 11(e)). After the flood peak at the breach, the flow of the breach gradually decreased, and the water flow erosion to the breach was weakened. When the flow velocity of the flow at the breach was less than the starting velocity of the tailings, the widening and deepening development of the break stopped.

FIGURE 12: The variation of deepening and widening rate with a time of the breach.

It can be seen from Table 2 that the width and depth of the breach were continuously widened laterally and deepened with the increase of the dam breach time in the process of dam failure, and the width variation was much larger than the depth variation of the breach. After dam failure, the breach was 340.58 mm in width and 63.1 mm in depth, and the width was about 5 times the depth. However, the width and deepen variation of the breach was different in different time periods. The depth and width of the breach during the dam failure process were sorted and calculated, respectively, and the variation of widening rate and deepening rate of the breach could be obtained are shown in Figure 12.

middle period of the dam failure, the increase rate of the width and depth increased rapidly (corresponding to Figures 11(c) and 11(d)), which was mainly related to the

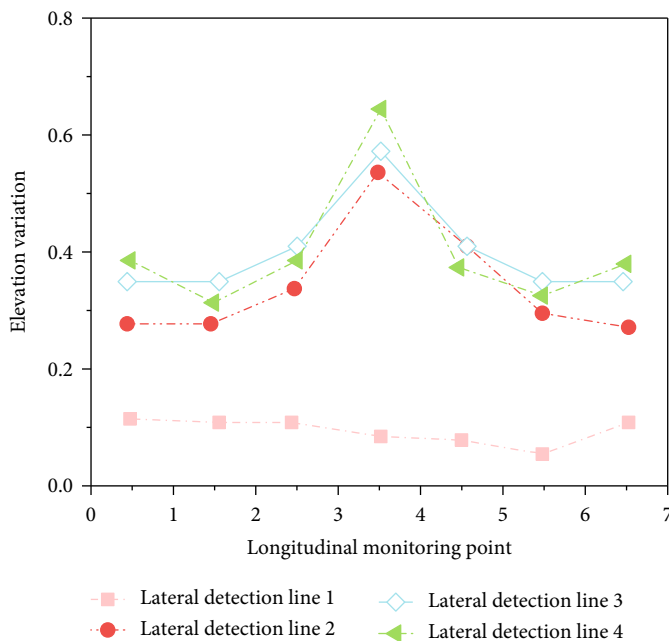
3.3.3. Variation of Dam Body Elevation before and after Dam Failure. After the dam failure, the variation of dam body elevation before and after dam failure was measured by the laser range finder, as shown in Figure 15. The dam failure variation body before and after the dam failure could be obtained from the difference.

- (1) The elevation of the dam body expressed obvious changes before and after the dam collapse, and the dam body elevation change was the smallest at the location of “horizontal monitoring line 1” (the initial dam crest position). However, the dam body elevation changes were obvious at the positions of “horizontal monitoring line 2,” “horizontal monitoring line 3,” and “horizontal monitoring line 4” (between the subdams of the dam body)
- (2) A breach occurred near the middle of the dam crest (that was where the monitoring points 4-1, 4-2, 4-3, and 4-4 were located), and the variation of dam body elevation at the breach reached the maximum. After

FIGURE 15: The height variation of dam break before and after dam failure.

the collapse, the shape of the breach was parabolic, and the maximum value of the parabola was the deepest part of the breach
