FROM DETERIORATION TO REVIVAL

Approaches to the Conservation of Plastic Buildings

Ashal Tyurkay, Uta Pottgiesser

ABSTRACT: The four Futuro case studies (*Futuro No. 000, Corfu-Futuro, Donaldson-Futuro, Munich-Futuro*) presented in this journal document conservation approaches to plastic buildings and elements – in this case, glass-reinforced plastic (GRP) sandwich panels. They contribute to the definition of general conservation approaches, and at the same time reveal the knowledge gaps related to their individual histories and the necessity of a framework for managing interventions that are suited to GRP sandwich panels. The history and physical fabric of the selected Futuros, and the interventions done are compared in this article. The comparative analysis demonstrates how important it is to integrate a framework for adequate research and documentation into the conservation processes, in order to understand each building's significance and plan the interventions accordingly. The arguments deduced from the analyses demonstrate which factors differentiate the conservation solutions of the case studies in order to reframe the Futuros' expected life-span into a managed life-cycle.

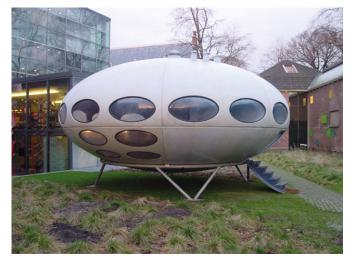
01 Futuro No. 000 (prototype) before conservation in 2003 exhibited outside in the Centraal Museum in Utrecht. © K. Vermaas, 2003

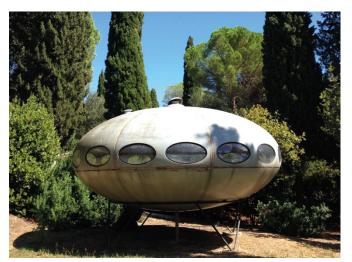
02 The Corfu-Futuro house installed in Limni, Corfu island. © D. Joannou, 2014

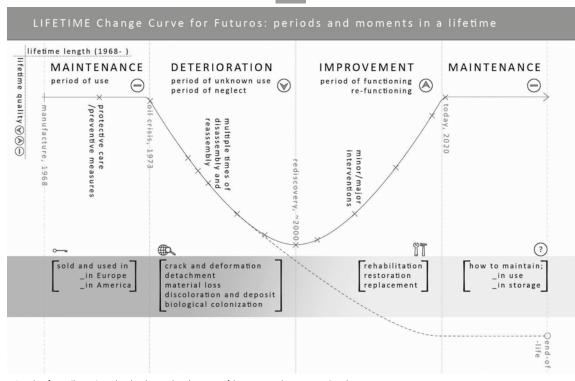
05 The Lifetime Change Curve describes the periods and moments of deterioration and intervention. © Authors

Criteria and processes of conservation could be applied to the lifetime of the Futuros [05]. Taking the manufacture or creation date of the Futuro as the start of its life, the lifetime could be described, including maintenance, deterioration and conservation intervention (improvement).

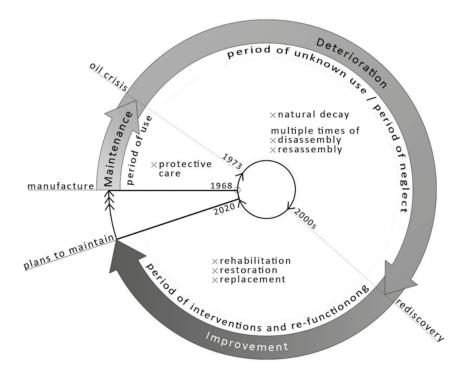
06 The Life-time Change Curve can be transformed into a life-cycle concept through conservation. © Authors
