ELECTRICAL IMPEDANCE TOMOGRAPHY FOR DAMAGE DETECTION AND LOCALIZATION ON CARBON FIBRE REINFORCED POLYMER COMPOSITES

Abstract: *Electrical impedance tomography (EIT) is being developed as promising non-intrusive technology for damage detection in conductive fibre reinforced polymers (FRP) composites. This work assessed EIT and one-step difference Gaussian-Newton algorithm to detect different damages in CFRP laminates, including through-thickness holes and impact damage of different severities. Two layup laminates were studied: quasi-isotropic [0/45/90/-45]s and unbalanced [0/0/45/90/-45]s. Each laminate configuration was subjected to three levels of impact energy. Through-thickness holes with diameters as small as 2 mm were detected. The LVI on unbalanced specimens created elongated shaped damages, which were observed through EIT and ultrasonic C-scan. Differently, the ultrasonic C-scan inspections revealed circular shaped damages on the centre of the quasi-isotropic specimens, while EIT could not reveal a well-defined damage shape. Yet, the presence of damage was observed in the centre of the specimens by EIT. Although EIT overestimated the damaged area, it was highly sensitive to

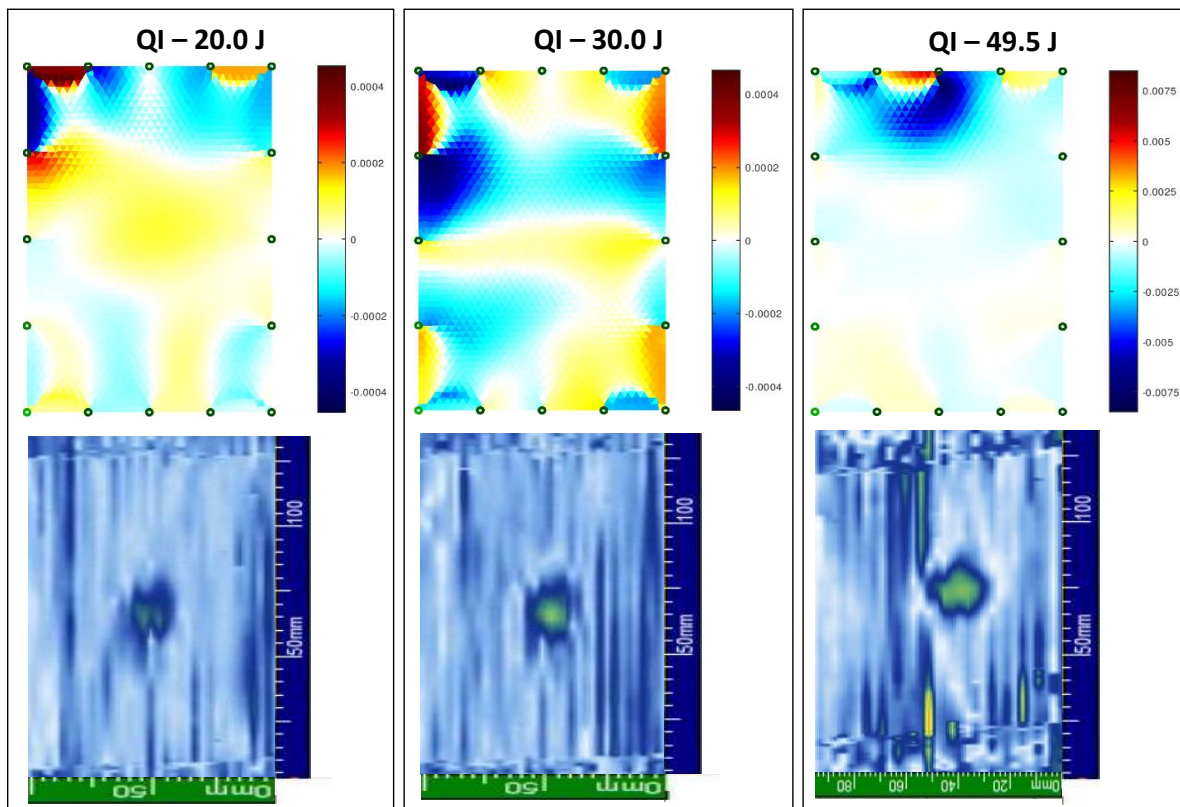
Figure 5. (top) EIT images and (bottom) ultrasonic C-scan inspection images of quasi-isotropic specimens damaged by Impacts of different energies: (left) 20.0J, (middle) 30.0 J, and (right) 49.5 J

The impact events produced different damage shapes on the two laminates of different configuration. Contrary to the expectations, the quasi-isotropic specimens revealed an increase of electrical conductivity in the central region of the specimens, with undefined shape of damage (top of Figure 5). Contrarily, the unbalanced laminates (top of Figure 6) showed elongated “peanut” shaped damages (11), where a decrease of electrical conductivity can be seen. The ultrasonic inspections (bottom of Figure 5 and 6) verified the damage shapes created in the impacted laminates, where the EIT of unbalanced laminates overestimates the delamination areas in about 1.4 to 2 times.

It was expected that EIT would locate damage with improved accuracy in the quasi-isotropic laminate. Yet, the opposite was verified, which might be explained by the higher number of layers at 0°, yielding an improved path for electrical conduction in the unbalanced specimens.
