# Evaluation of The Effect of Rock Joints on the Stability of Underground Tunnels

**Abstract.** To facilitate the water supply to the main cities in Malaysia such as Kuala Lumpur, Putrajaya and Cyberjaya, Pahang Selangor Raw Water Transfer Tunnel project is constructed in 2015. Facility tunnel of 44.6 km length with 5.2 m diameter are being constructed to transfer water from Karak to Hulu Langat. Granitic rock with dominant intrusive zones in various range of I until V were observed in the studied tunnel length. This tunnel has crossed sheared zone that categorized into fair, poor, and very poor rock classes with moderate to heavily jointed rock. At NATM-1, the discontinuities like joints that is close and far from the fault are one of the most important which caused to instability of the tunnel and reduced the performance of tunnel performance. In this paper, the joint orientation, overburden and distributions of discontinuities (joints and faults) into the tunnel were evaluated. These data were then simulated using discrete fracture networks with the direction of tunnelling excavation in the tunnel. Movement of blocks in the tunnel roof and wall is possible due to the creation o

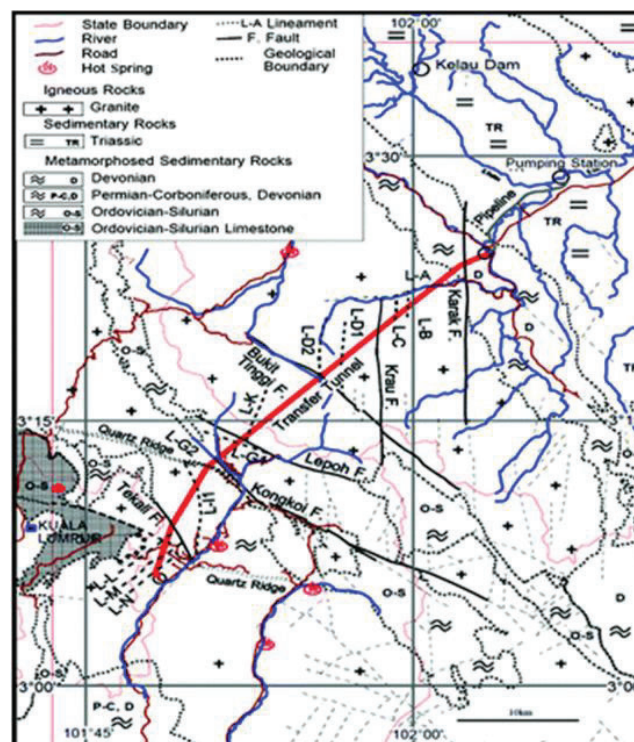
**Figure 3.** Cross section of tunnel with the Lineament (L-) and fault line (F.). Study area is marked by the yellow box.

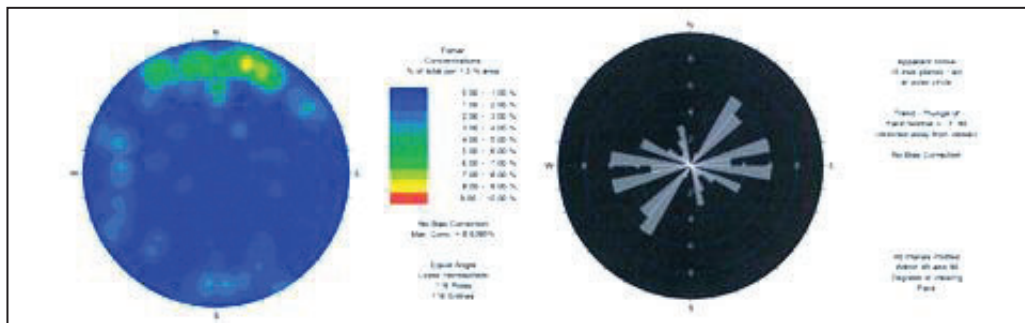
After the raw data has been extracted. The dip will be input into the program, along with its location, for study. The data will be analyzed using the Rocscience Dips tool. Based on plots from the dip and dip direction, this program generates a Fisher Concentration (Figure 5 a) and Rose Diagram (Figure 5 b) based on stereonet in rock mechanics, with the Rose Diagram illustrating the number of joints that go in each direction. By observing the shift in joint pattern along the tunnel, these items can be studied. The joint pattern can change along the tunnel due to factors such as regional faults, overburden height, and climate. The findings of this study will be utilized to identify the source of specific joint pattern behavior and predict the possibility of the joint collapsing. To assess these data, it will take a lot of consultation with the supervisor who has enough knowledge and expertise in this subject. The interpretation process could go awry if there is no consultation, resulting in erroneous outcomes.

**Figure 5.** (a) Joints concentration (b) Direction of joint density (Rose Diagram).

Between TD-550 and TD-654, the Karak River can be found at the top of the overburden. According to the Rose Diagram (Figure 5a and 5b) at the time, the joint's orientation is following the regional fault pattern. The orientation of the joints is unaffected by the river's position on top of the overburden. Regardless, this portion has much too many joints, with 192 joints compared to an average of 60-80 joints in other sections.

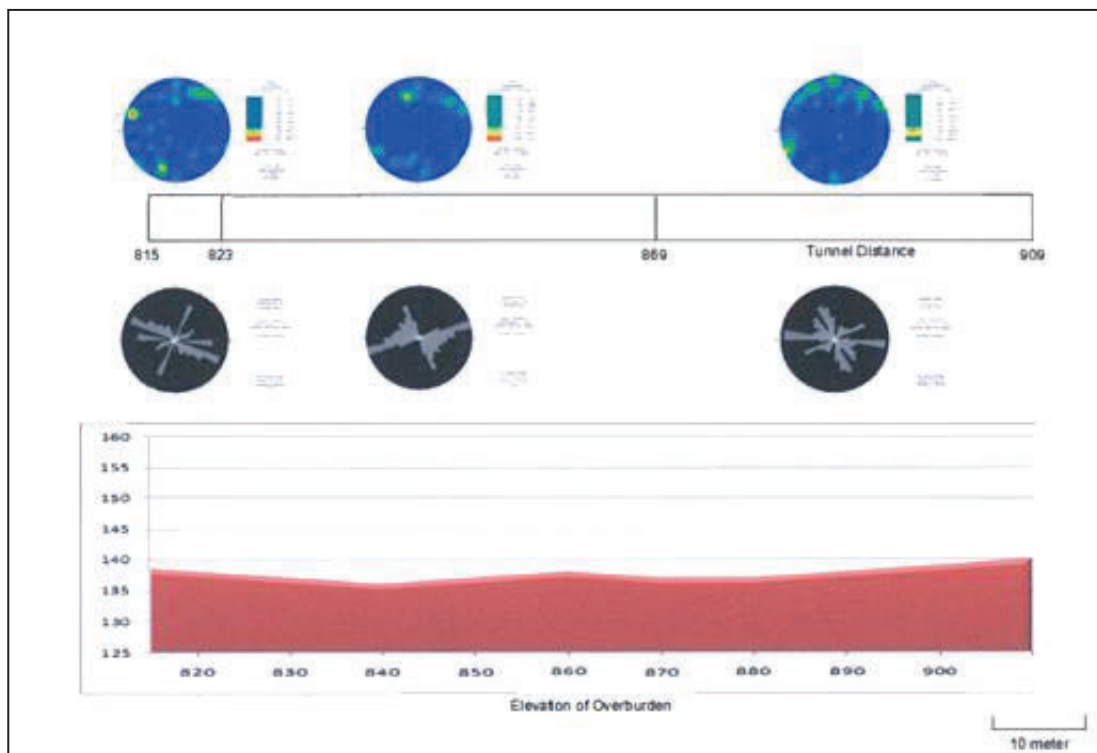
To develop the model, the extracted data was digitalized and entered into software. The pattern changes depending on the environment around the tunnel faces. The patterns begin with TD-0 and end with TD-909. The rock type existing at the tunnel face, the stability of the rock basis as determined by the Rock Mass Classification (Japan Highway Public Corporation; JH), the elevation of overburden, and the groundwater in the vicinity have all been considered. The joint pattern and the overburden can be seen in Figure 6.

**Figure 6.** Joint Pattern of TD-815 to TD-909 with its elevation of overburden.

From Figure 6, no significant relationship can be correlated. The rock stability in the NATM-1 area is threatened by numerous fractures and joints at the shear zone of Karak with the composition of the shale, homfels, phyllite, siltstone, sandstone, and slate as well as clay, breccia, quartzite, and chert were all found too. 1767 joints were recorded from the top of the tunnel face to the bottom. There are 430 faults, 278 smooth planar joints, 94 foliation joints, 9 bedding joints, and 956 random joints among the
