# Hydrogen-related Fatigue Fracture under Various Test Frequencies in Low-carbon Martensitic Steel

Matsumiya, Hisashi; Shibata, Akinobu; Maegawa, Yoshiaki; Okada, Kazuho; Tsuji, Nobuhiro

Matsumiya, Hisashi ...[et al]. Hydrogen-related Fatigue Fracture under Various Test Frequencies in Low-carbon Martensitic Steel. ISIJ International 2022, 62(10): 2089-2094

KEY WORDS: hydrogen embrittlement; fatigue fracture; test frequency; martensitic steel; electron back-scattering diffraction; crystallographic orientation analysis.

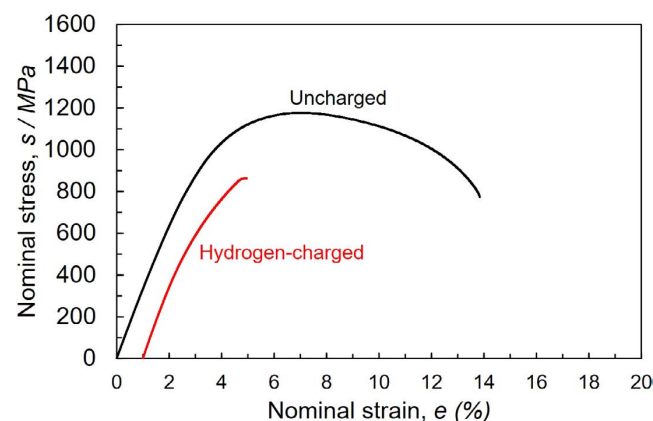
**Fig. 2.** Nominal stress – nominal strain curves of the uncharged specimen (black line) and hydrogen-charged specimen (red line). The data from previous study<sup>20)</sup> was reused here (reproduced with permission from Elsevier). (Online version in color.)

**Figure 1** shows an optical microscopy image of the heat-treated specimen. A typical lath martensite structure composed of several blocks and packets inside each prior austenite grain was observed, and no pro-eutectoid ferrite was confirmed. The mean prior austenite grain size was 47.7 μm. The nominal stress – nominal strain curves of the uncharged and hydrogen-charged specimens were shown in **Fig. 2**. The 0.2% proof stress and tensile strength of the uncharged specimen were 849 MPa and 1 177 MPa, respectively. The total elongation of the hydrogen-charged specimen was 1.5%, and significantly limited compared with that of the uncharged specimen (11.3%).
