# **Identification of Partial Discharges in Cable Terminations using Methods based on Acoustic, Electromagnetic and Electrical Measurements**

**Juhani TAMMI\*<sup>1</sup>, Tuukka SYRJÄNEN<sup>1</sup>, Robert ALBRECHT<sup>2</sup>, Kim BACKMAN<sup>3</sup>,  
Kari LAHTI<sup>4</sup>, Pertti PAKONEN<sup>4</sup>**

**Fingrid<sup>1</sup>, NL Acoustics<sup>2</sup>, Prysmian Group Finland<sup>3</sup>, Tampere University<sup>4</sup>  
Finland**

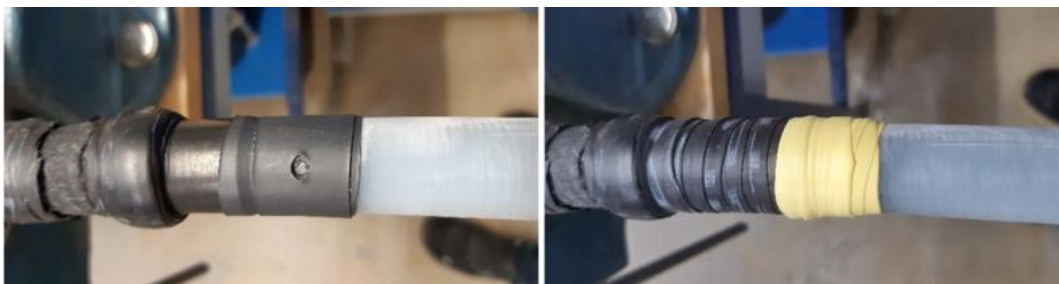
Figure 1 shows the test sample with an internal fault, where a 0.5 mm layer of insulating tube was heat shrunk around the cable to extend the semiconducting layer. This layer of tape was punctured with a hole and another same type of insulating layer was wrapped around it. Another hole was punctured through both insulating tape layers and a layer of semiconducting tape was applied over the insulating tape layers. Finally, some stress controlling tape was applied as the last layer at the end of semiconducting tape layer and everything was sealed under a heat shrink sleeve.

**FIGURE 1: THE TEST SAMPLE WITH AN INTERNAL MV FAULT WITH TWO HOLES IN THE INSULATING TAPE INSERTED BENEATH THE SEMICONDUCTING TAPE LAYER.**

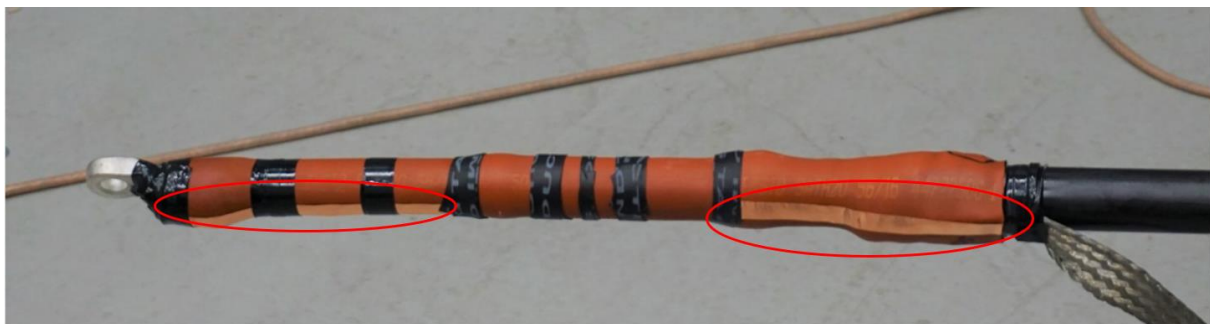
Test termination for the sample with an external MV fault was prepared according to the termination manufacturer's instructions. However, the flashover distance of the termination surface was reduced by applying copper tape and a few rounds of semiconducting tape according to Figure 3. The goal was to simulate dry band type surface discharges. The dry band fault can occur, for example, when a leakage current dries an area on a temporary conducting surface due to pollution and wet conditions. The dried area no longer works as a conductor, which creates favourable conditions for surface discharges over the dried spot.

**FIGURE 3: TEST SAMPLE WITH AN EXTERNAL MV FAULT, WHERE CLEARANCE BETWEEN LIVE AND GROUNDED PART WAS REDUCED BY INSERTING TWO SECTIONS OF COPPER TAPE (HIGHLIGHTED BY RED CIRCLES) AND ROUNDS OF SEMICONDUCTING TAPE.**

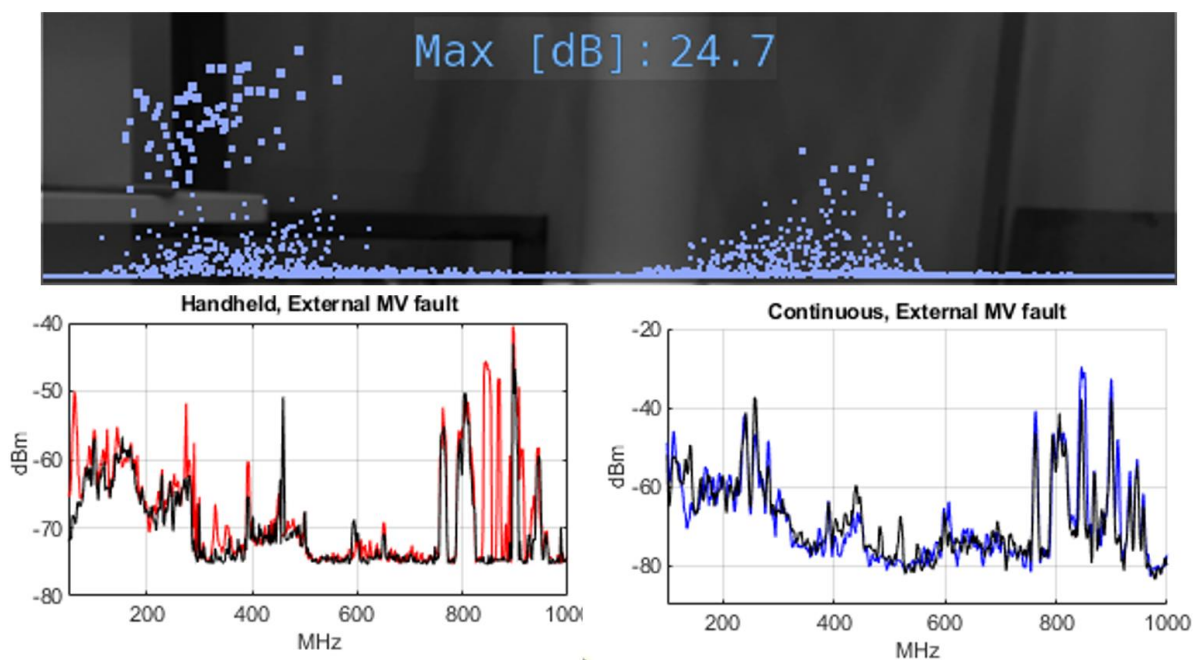
The measurement was performed with RFI surveying tools from a distance of 5 meters and with an acoustic camera from a distance of 1.2 meters. The magnitude of the partial discharges in this measurement was approximately 5.5 nC and the used voltage was 11 kV. The handheld RFI surveying tool recognized the surface discharges right at the beginning of its frequency spectrum at 50–150 MHz. The continuously measuring RFI device did not perform in the recognition that well, which is most likely due to the frequency range of the device, which starts from 100 MHz. The handheld device measured most of the deviations under the frequency of 100 MHz. Nevertheless, small deviations can be noticed at frequency range of 100–115 MHz in the results of the continuously measuring RFI surveying tool. The acoustic camera performed well in the measurements, and it recognized partial discharges clearly from the distance of 5 m, where the highest measured signal level was 13.6 dB. The highest measured signal level was 24.7 dB from a distance of 1.2 meters, which is shown in Figure 4.

**FIGURE 4: THE MEASUREMENT RESULTS OF THE ACOUSTIC CAMERA (ON TOP), THE HANDHELD RFI TOOL (BOTTOM LEFT) AND THE CONTINUOUS RFI TOOL (BOTTOM RIGHT) FROM THE TEST SAMPLE WITH AN EXTERNAL MV FAULT.**

tests were performed from a distance of 3–5 m with RFI surveying tools and 1.2–5 m with an acoustic camera. The second measurement was chosen to represent the results of the RFI and the acoustic measurements of the external MV fault test sample. The results are presented in Figure 4.

Other test samples causing external discharges were also recognized with the RFI devices with the exception of one test sample, which the continuously measuring RFI surveying tool did not recognize. The acoustic camera recognized all the external discharges exceptionally well.

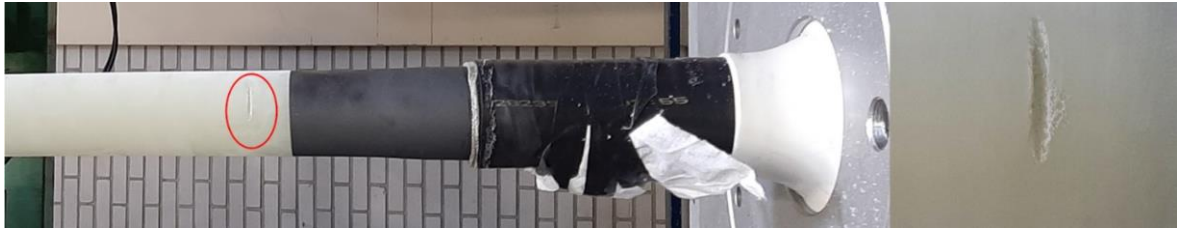
In the test sample with an internal fault, the cable insulation was damaged by using a saw according to Figure 5. The introduced cut remained under the stress cone when termination was assembled. In service, this type of fault would present a coarse and very severe installation error.

**FIGURE 5: TEST SAMPLE WITH AN INTERNAL HV FAULT, WHERE THE INSULATION WAS CUT IN A PART OF THE CABLE BENEATH THE STRESS CONE.**

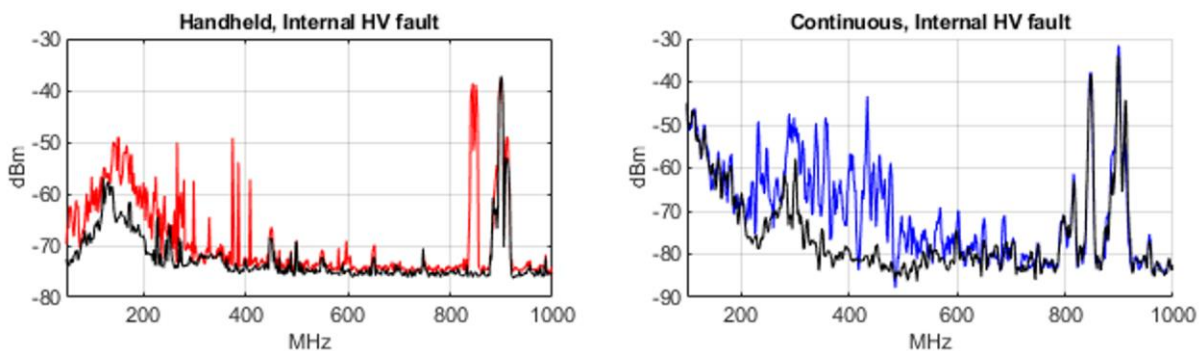
During the measurement, the partial discharge level was momentarily at 300 pC and dropped to 120 pC. The test voltage was 70 kV and the measurement distance with RFI surveying tools was 5 m and with the acoustic camera 3 m. For the handheld tool, clear deviations caused by the partial discharges can be seen clearly at 50–300 MHz and for the continuously measuring tool at 200–500 MHz. The acoustic camera didn't recognize these internal partial discharges.

**FIGURE 6: THE MEASUREMENT RESULTS OF THE HANDHELD RFI (LEFT) AND CONTINUOUSLY MEASURING RFI (RIGHT) TOOLS FROM THE TEST SAMPLE WITH AN INTERNAL HV FAULT.**

A total of seven different tests were performed for the test sample with an internal HV fault with test voltages of 44–110 kV. The tests produced partial discharges with magnitudes of 100–8000 pC. Tests were performed from a distance of 3–5 m with RFI surveying tools and 2.5–3 m with an acoustic camera. The sixth measurement was chosen to represent the results of the RFI measurements of the internal HV fault test sample. The results are presented in Figure 6.

Generally, both RFI tools performed similarly recognizing the partial discharges in this test sample. For each set of measurements, they both either measured or did not measure clear deviations. It can be concluded from the measurements that in this case, the internal partial discharges with the magnitude of 300 pC are visible with the RFI surveying tools whereas 120 pC discharge levels are not clearly visible.

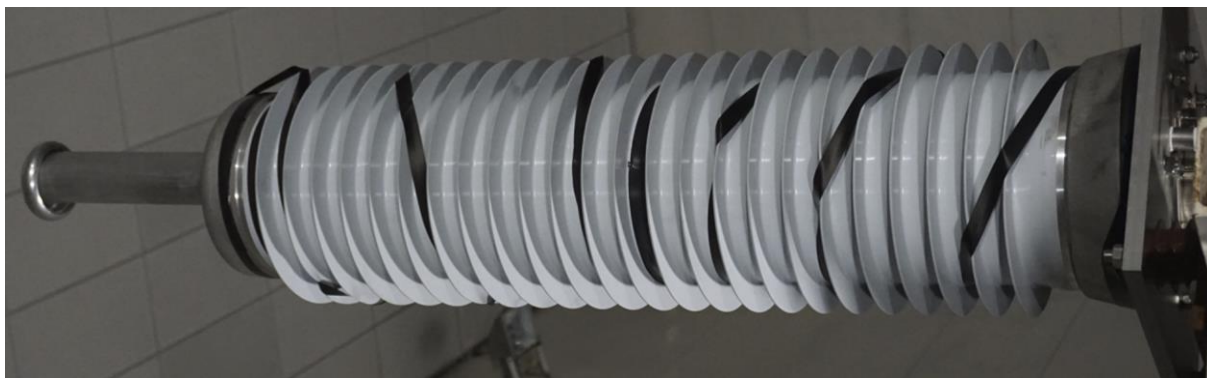
The test sample with an external HV fault was prepared by wrapping semiconducting tape around the termination as shown in Figure 8. The idea was to reduce the creepage distance of the termination by by-passing the silicone sheds and thus creating surface discharges. In this test, only the area between two adjacent sheds was left unwrapped with the tape.

**FIGURE 8: TEST SAMPLE WITH AN EXTERNAL HV FAULT, WHERE SEMICONDUCTING TAPE IS WRAPPED AROUND THE TERMINATION TO REDUCE THE CREEPAGE DISTANCE.**

In the Master's Thesis study, this test was varied, for example, by adjusting the number of unwrapped silicone sheds. In addition, copper wire was used instead of semiconducting tape. However, in terms of partial discharges, all the variations produced similar results.

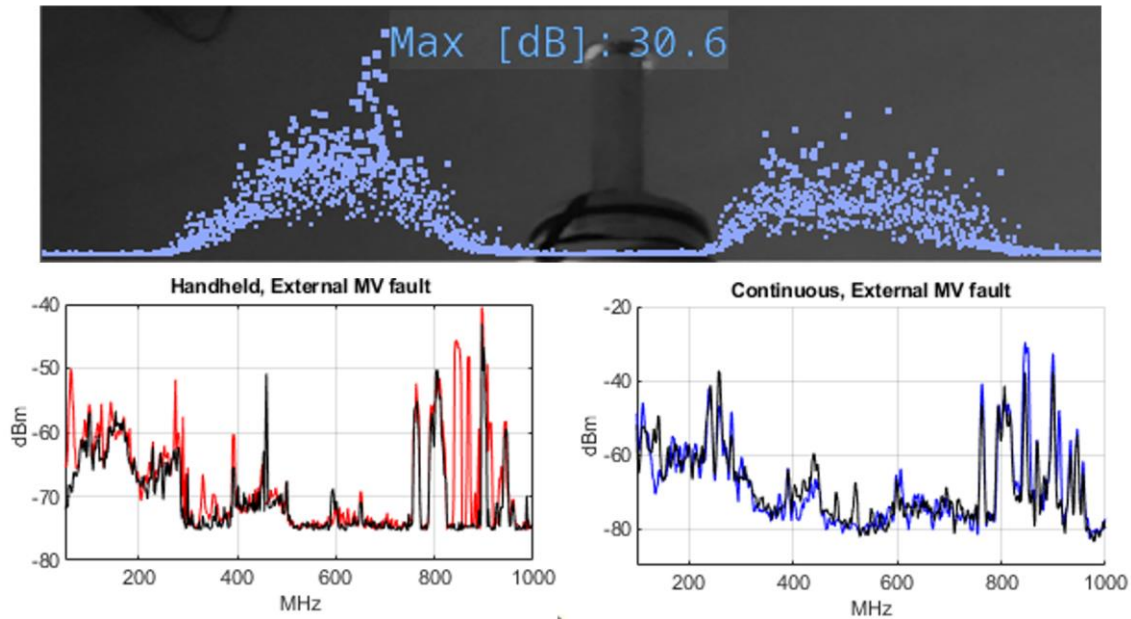
During the measurement, the partial discharge level was momentarily at 300–500 pC, the test voltage was 32 kV and the measurement distance with RFI surveying tools was 3 m. The RFI tools didn't produce any clear deviations apart from a narrow band below 100 MHz and some random spikes with the handheld tool. On the other hand, the acoustic camera performed very well with the highest measured signal level being 30.6 dB. In addition, it produced clear PRPD patterns which correctly indicate surface discharges.

**FIGURE 9: THE MEASUREMENT RESULTS OF THE ACOUSTIC CAMERA (ON TOP), THE HANDHELD RFI TOOL (BOTTOM LEFT) AND THE CONTINUOUS RFI TOOL (BOTTOM RIGHT) FROM THE TEST SAMPLE WITH AN EXTERNAL HV FAULT.**

A total of three different tests were performed for the test sample with an external fault with test voltages of 20–32 kV. The tests produced partial discharges with magnitudes of 70–500 pC. The tests were performed from a distance of 3–5 m with RFI surveying tools and 3.5 m with an acoustic camera. The third measurement was chosen to present the results of the RFI and the acoustic measurements of the external HV fault test sample. The results are presented in Figure 9.

Based on all the test samples and measurements regarding faults producing external partial discharges studied, it seems that the RFI surveying tools cannot recognize external partial discharges that well compared to the recognition capability of internal partial discharges. However, the handheld tool seems to be slightly more sensitive in recognizing them than the continuously measuring tool.
