Conservation of ancient constructions and application to a masonry arch bridge

Paulo B. Lourenço

Daniel V. Oliveira

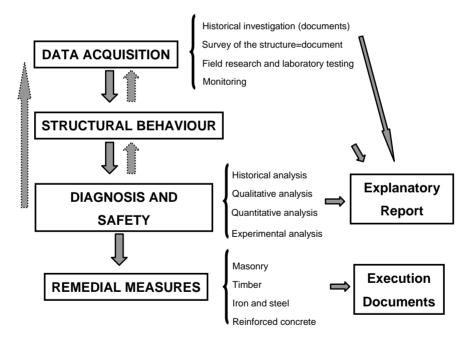
Figure 1: Flowchart with the methodology for structural interventions proposed by ICOMOS [1].

The methodology stresses the importance of an "Explanatory Report", where all the acquired information, the diagnosis, including the safety evaluation, and any decision to intervene should be fully detailed. This is essential for future analysis of continuous processes (such as decay processes or slow soil settlements), phenomena of cyclical nature
