State of the Art: Portugal

Luís Bragança, Manuela Guedes de Almeida, Ricardo Mateus
University of Minho Civil Engineering Department

ABSTRACT: The aim of this paper is to give an overview of housing in Portugal, presenting the building stock characterisation, the related Portuguese legislation and the socio-economic aspects. For this purpose, the main housing building technology used in Portugal is described and the problems related to multi-storey family houses are identified.

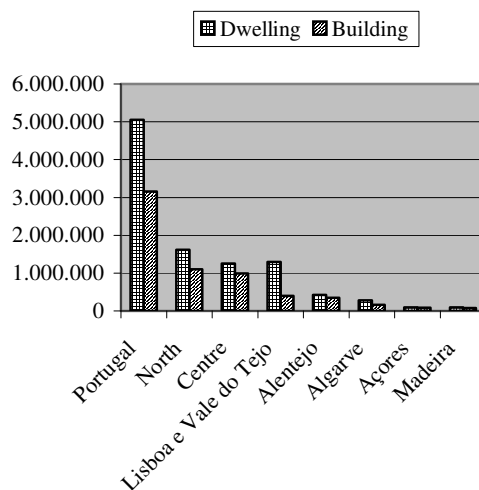
Figure 4: Dwellings and buildings (Census of 2001).

Table 3 and Figure 4 show the distribution of the existing dwellings and buildings by the Portuguese territorial units.

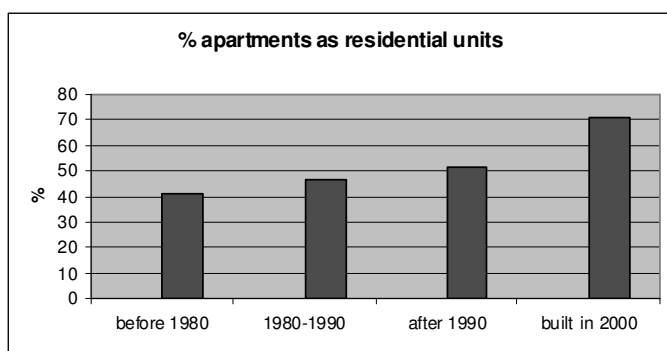
Figure 5: Percentage of apartments as residential units.

In Portugal, 80% of the new residential buildings are single-family buildings. However, the remaining 20% of apartment buildings represent 70% of the total housing units as it can be seen in Figure 5.

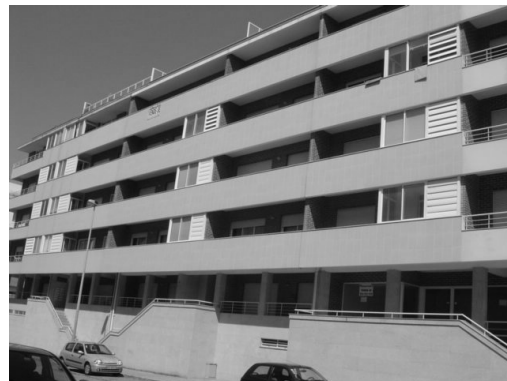
Figure 8: Façade of a typical Portuguese building built from the early 80's up till now.

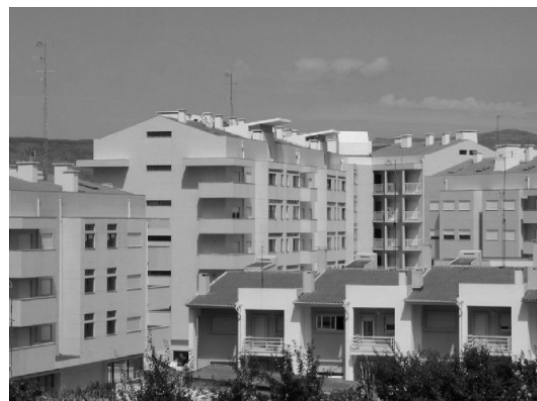
Figure 10: Typical tilted roofs.

At the roof level, the most common protection is carried out by tilted roofs using ceramic tiles as covering. However, in recent buildings the use of flat roofs is becoming more and more popular. In these cases, the protection against moisture is achieved through the use of bituminous sheets.

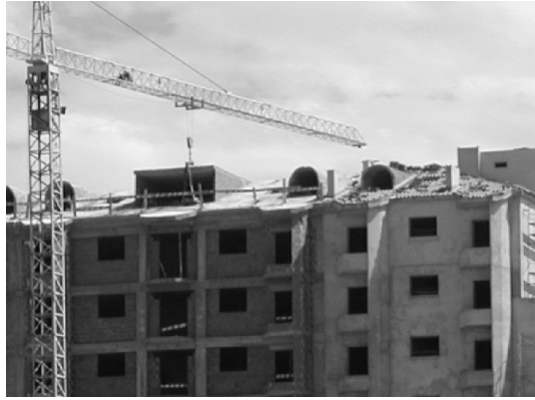
Figure 11 – Covering the roof slab with ceramic tiles.

- Roofs: tilted roofs and/or flat roofs (especially in the south). Usually the pendant of the tilted roof is made of pre-strengthened beams and ceramic molding blocks slab, constituting a non-ventilated attic (Fig. 11);

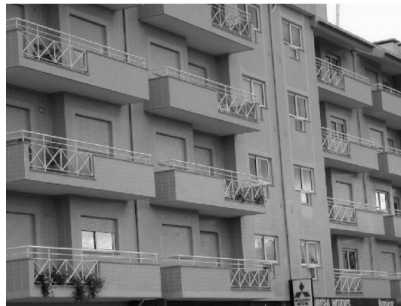
Figure 14 – Balconies and roller shutters used as shading devices.

- Shading devices: due to the intense solar radiation almost all windows are protected with exterior roller shutters mostly made of plastic since the 70's (Fig. 13 and 14).

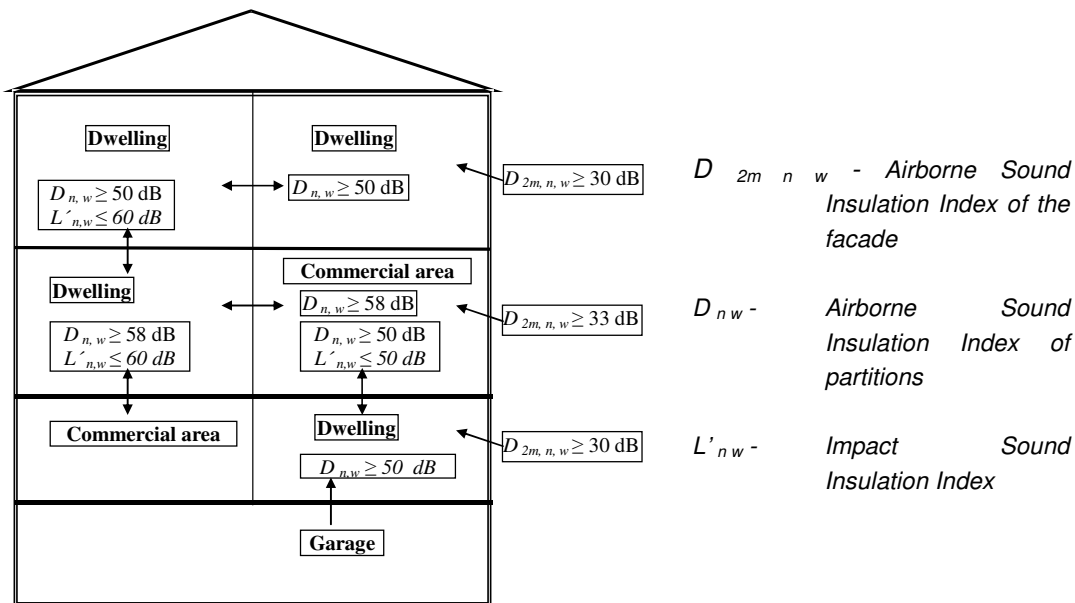
Figure 26: Mandatory sound insulation levels.

According to the Portuguese Building Acoustics Legislation, partition elements must meet some acoustic requirements as shown in Figure 26.

The high mass of the conventional construction systems contributes to the satisfactory sound insulation of the vertical partition elements. The majority of complains is related to the horizontal partition elements, normally between commercial areas and dwellings, due to an insufficient airborne sound insulation level. The low impact sound insulation index observed between dwellings is another cause for complains. Floating slabs and suspended ceilings are the most common solutions used in the horizontal elements to solve these problems.
