MONITORING OF HISTORICAL MASONRY STRUCTURES WITH OPERATIONAL MODAL ANALYSIS: TWO CASE STUDIES

Luís Ramos,	University of Minho, Dep. Civil Engineering,	Portugal
Leandro Marques,	University of Minho, Dep. Civil Engineering,	Portugal
Paulo Lourenço,	University of Minho, Dep. Civil Engineering,	Portugal
Guido De Roeck,	K.U. Leuven, Department of Civil Engineering,	Belgium
Alfredo Campos-Costa	Laboratório Nacional de Engenharia Civil,	Portugal
João Roque,	Polytechnic Institute of Bragança,	Portugal

Abstract

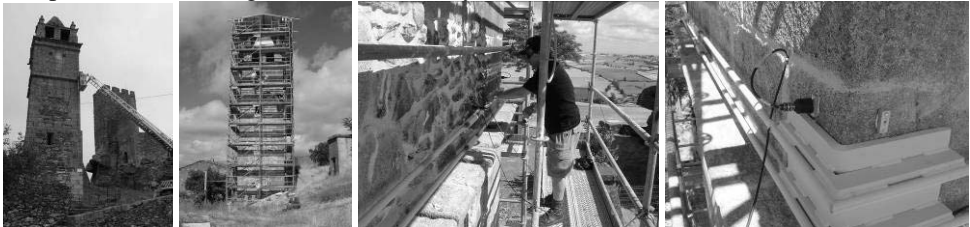
Figure 2: Measurements before and after the rehabilitation showing also some sensor locations

Two dynamic modal identification tests were performed before and after the structural rehabilitation. Operational modal analysis was used to estimate the modal parameters. Figure 2 presents some images of the ambient dynamic tests.

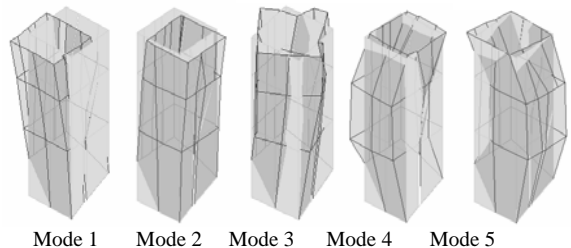
Figure 3: Experimental modes shapes

Table 1 presents the first five estimated natural frequencies, damping ratios and MAC values and Figure 3 shows the corresponding mode shapes after rehabilitation.

From the comparison between the modal parameters before and after the rehabilitation is possible to observe an increase of 40%, on average, for the frequency values and a decrease of 50%, on

average, for the damping values. The MAC values are less than 0.86, indicating that the repair operations clearly altered the stiffness distribution and so the mode shapes.

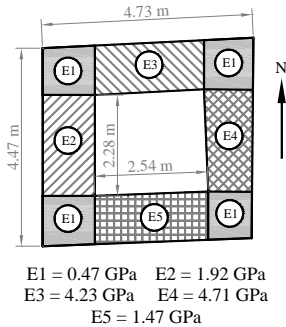
Figure 4: Updating Parameters

The selection of the optimization parameters was done taking into account the geometrical survey of the tower and the possible differences between the material properties. Five modulus of elasticity according to the distribution of Figure 4 were tuned. The updated values are presented in Figure 4. Figure 5 shows the results in terms of mode shapes. The frequency errors were lower than 3.2% and the MAC values better than 0.98. Another updating analysis is being performed for the damage condition to evaluate the level of damage and the effectiveness of the rehabilitation works.

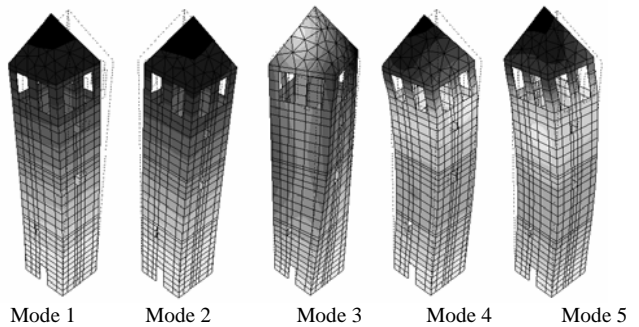
Figure 5: Numerical updated modes shapes

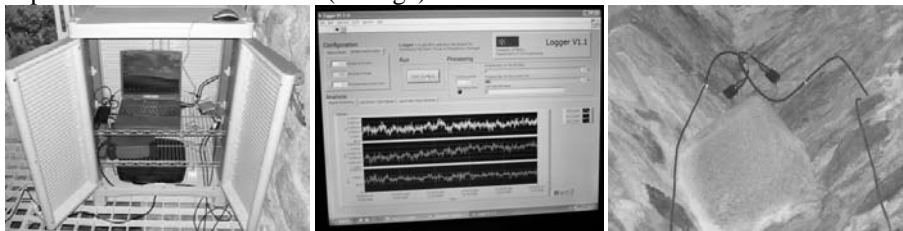
Figure 6: Dynamic monitoring system: datalogger, acquisition software and accelerometers

Three piezoelectric accelerometers connected to an USB data acquisition card with 24 bits resolution are recording each hour 10 min of ambient vibrations. In parallel a combined sensor is recording the ambient temperature and relative air humidity. The monitoring task is performed in several campaigns (test series) during the year. During each campaign 600 records of 10 min at every hour are stored in a laptop. No triggering was applied. Until this moment 6 series were completed in the period from April 2006 till January 2007.

From the beginning of April 2006, so after the rehabilitation, a dynamic monitoring system was installed in the tower, see Figure 6. The aim is to evaluate the environmental effects of temperature and relative air humidity on the dynamic behaviour of the tower, and to detect any possible non stabilized phenomena in the structure (damage).

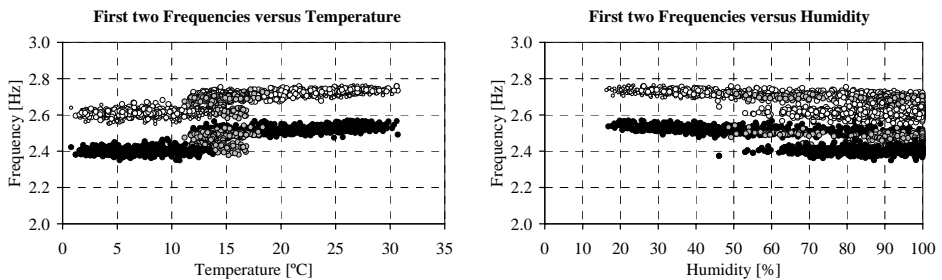
Figure 7: Environmental effects: temperature and relative air humidity

The preliminary results for the first two modes are presented in Figure 7, in terms of frequency variation according to temperature and relative air humidity. One conclusion emerged from the results is the structure sensibility to the relative air humidity (or the water absorption by the masonry material due to the raining season). As no damage was observed in the structure, the humidity influence can be observed by a shift of 4% in the linear relation between frequency and temperature by a transitory series (gray dots in the left part of Figure 7). This series was recorded between November and October, 2006 which was the first raining period at the site.

Since the structure seems to be sensitive to the humidity, it is necessary to have a complete cycle of one year to model the environmental effects. Especially, the new heating season, where the drying phenomena in the material are expected to reestablish the initial frequency values, should be included.

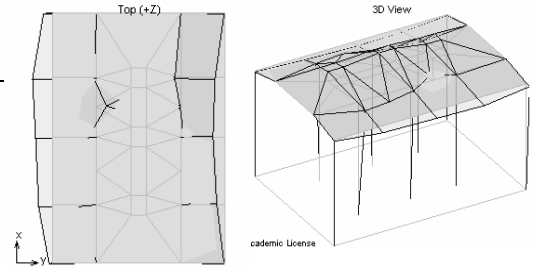
Figure 10: First experimental mode shape

Figure 10 shows the shape of the first mode. The dynamic response of the main nave is influenced by the slenderness of the columns. The mode are essentially composed by components in y (north-south) and z (vertical) directions.

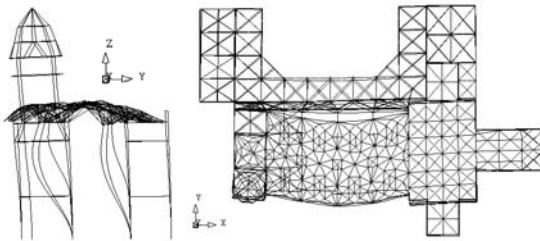
Figure 11: First numerical mode shape

Due to the high level of complexity of the structure a beam FE model was manually tuned to the dynamic experimental results. The updating parameters were the modulus of elasticity of the columns and the main nave and the boundary conditions of the columns. The dynamic response is most governed by the slender columns, as many local modes appear in the results. The first mode shape of the numerical model is presented in Figure 11. Table 3 shows the first eight frequencies after tuning for the first frequency. The results obtained for the modulus of elasticity were 30 GPa for the columns and 12 GPa for the masonry. The high value for the columns can be explained by the higher compression stresses that are present due to the reduced cross section.

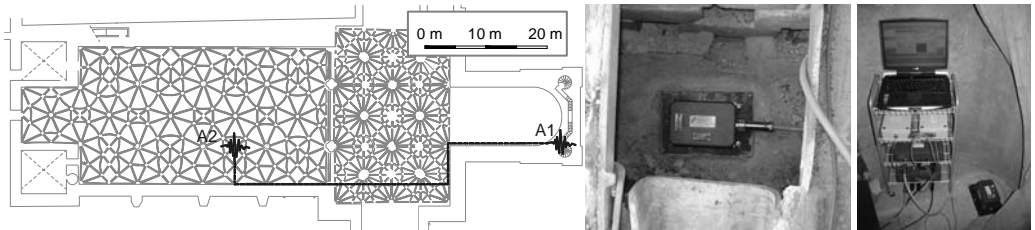
The system is composed by two strong motions recorders with 18 bits AD converters connected to two triaxial force balance accelerometers. One accelerometer (A1) was installed on the base of the structure near the chancel and the other (A2) on the top of the main nave (extrados), between two consecutive columns and in the locations with higher signal levels in the dynamic modal identification analysis.

Figure 12: Dynamic monitoring system: location of the sensors; accelerometer on the main nave, and battery of recorders together with the base accelerometer

The two recorders are connected by an enhanced interconnection network, which allows a common trigger and time programmed records. The recorder connected to sensor A1 is the master recorder: it enables the synchronization and updates the internal clock of the slave recorder connected to sensor A2.

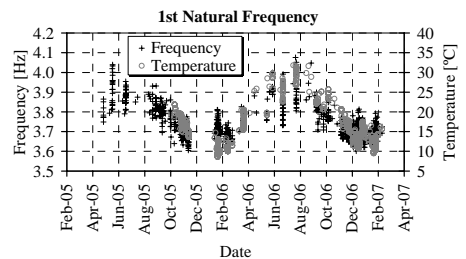
Figure 13: Environmental effects

With the same procedure for parameters estimation as presented in Section 4.3, more than 1000 records were analyzed. The results for the first frequency are summarized in Figure 13 and Figure 14. In the last one, it is possible to observe an apparent quadratic relation between frequency and temperature. For this dependency the 98% confidence intervals were established, which can be used, for future results, as borders defining the domain of significant frequency shifts (so indicating possible damage).

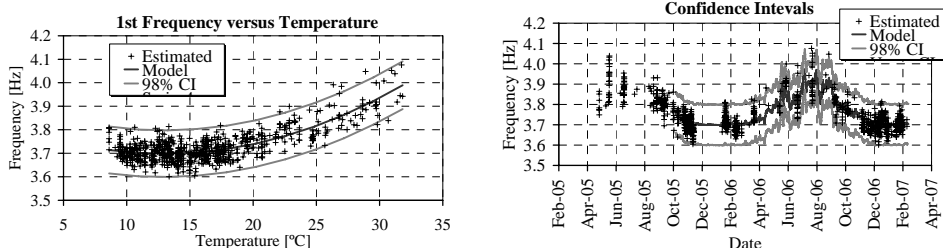
Figure 14: Quadratic regression and confidence intervals
