Damage Identification in Masonry Structures with Vibration Measurements

L.F. Ramos & P.B. Lourenço

ABSTRACT: The paper aims at exploring damage assessment in masonry structures at an early stage by vibration measurements. For this purpose, one approach is proposed combining global and local ND methods. To further evaluate the approach, one masonry tower in Portugal was studied together with one wall model in the laboratory. The model was built as reference, undamaged, state. Afterwards, progressive damage was induced and sequential modal identification analysis was performed at each damage stage, aiming to find adequate correspondence between dynamic behavior and internal crack growth. The paper presents all the analyses carried out with the aim to detect and locate the damage by means of vibrations measurements.

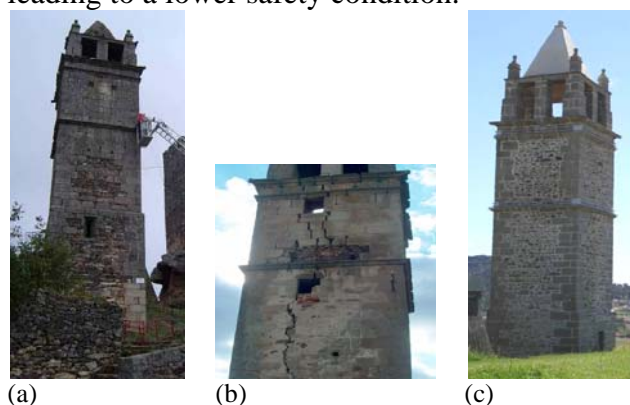
Due to lack of maintenance, severe damage was observed in the tower in 2004. The damage was characterized by cracks, material degradation, out-of-plane displacements, loss of material in some parts, and biological growth, see Figure 1a. The most severe damage was a pair of cracks in the East and West façade, see Figure 1b, that divided the box

Figure 1 – Mogadouro Clock Tower: (a) and (b) general view of the tower with severe damage; and (c) the tower after the strengthening works

To re-establish the tower safety, consolidation works were carried out in 2005. The remedial treatment included: injections for the walls consolidation, replacement of deteriorated materials and the installation of tie-rods at two levels with very light prestressing stress. Figure 1c presents the final appearance of the tower after strengthening.

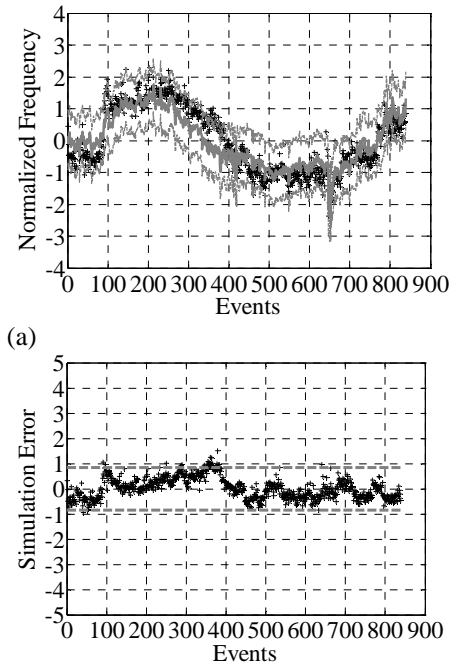
Figure 6 shows for the first natural frequency the fitting model through the normalized frequency and simulated errors with the 95% confidence intervals ci . In general, the model represents the frequency variation, but it doesn't account the water absorption phenomenon, because the relative humidity variation does not totally represent that change. Furthermore, the damage is detected by frequency shifts that significantly go outside the confident intervals ci .

Figure 6 – Numerical simulation: (a) ARX model; and (b) the residuals distribution

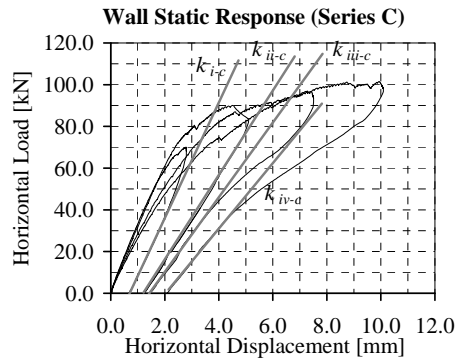
To achieve several controlled cracks, three series of static tests were carried out. Figure 8 presents for the last series (Series C) the test apparatus, the static response of the wall and the final crack pattern. From the static response is possible to observe the stiffness decrease, where the horizontal displacement indicated corresponds to the maximum or top value (LVDT 1).

Figure 8 – Wall static tests: (a) test apparatus; (b) static response of the last series of tests; and (c) final crack pattern from the front and back sides of the wall

The final crack pattern includes three cracks. One bending crack is at left bottom part, and another bending crack is at right top part of the wall, namely crack c_1 and c_2 , respectively. The third crack (c_3) is a shear crack in the diagonal direction of the wall.

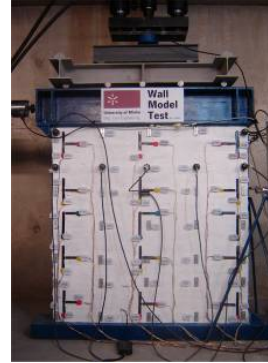
A regular grid of five vertical lines and seven horizontal lines was chosen for the accelerometers. In the case of the strains gauges, it was decided to

use an array of three vertical lines and five horizontal lines. Figure 9 shows the location of the measuring points where the reference points are given in a grey box.

Figure 9 – Wall dynamic tests: (a) and (b) accelerometers and strain gauges locations, respectively; and (c) and (d) details of the ambient dynamic tests

Two different excitation types were used during the identification tests: (a) natural and ambient noise present in the laboratory; and (b) random impact excitation in space and in time with a hammer. The second excitation type was used because it was impossible to estimate accurately modal curvatures with ambient excitation. The impact forces were about 2% of the specimen mass.

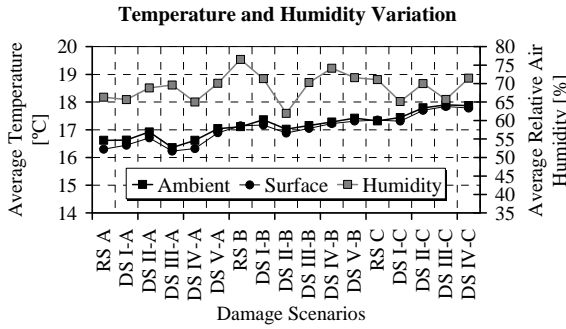
The long-term changes of the environmental effects inside the laboratory where also studied. Figure 10 presents the average values for ambient and surface temperature and relative air humidity measured for each DS. The average temperature values were about 17°C with a low increasing trend. The average humidity is about 69% with $\pm 7\%$ of maximum amplitude. Compared with the values obtained in the Mogadouro Clock Tower, it is expected for values of that order that the dynamic response of the wall does not change significantly and therefore it is assumed that the environmental effects inside the laboratory can be neglected in the subsequent damage identification analysis.

Figure 10 – Environmental effects inside the laboratory
