# **Simplified indexes for the seismic assessment of masonry buildings: International database and validation**

Seismic assessment; earthquake damage; masonry churches; simplified indexes; fragility curves

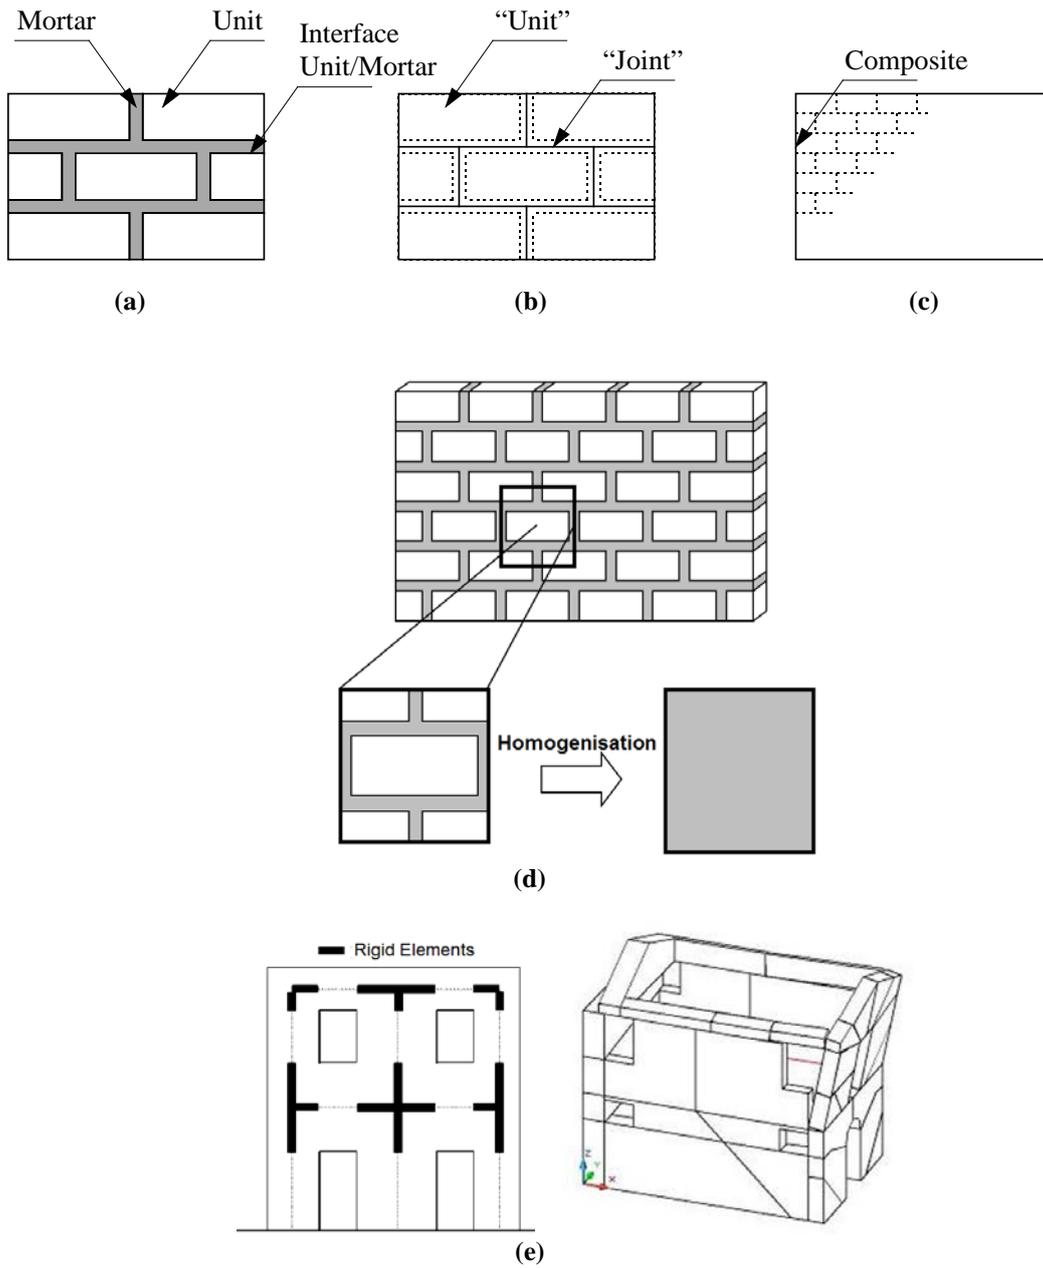
**Figure 2 - Modeling approaches for masonry: (a) representation of regular staggered or running bond masonry; (b) micro-modeling; (c) macro-modeling; (d) homogenization; (e) illustrative structural component models, with beam elements or macro-blocks.**

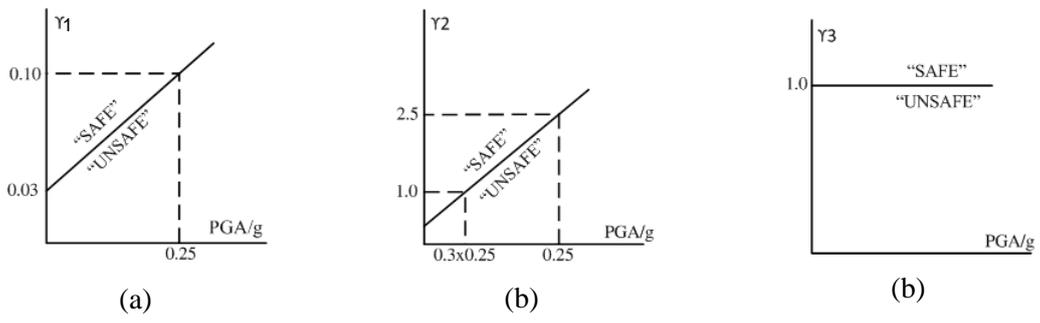
**Figure 3 – Assumed thresholds for indexes 1, 2 and 3 as a function of PGA/g, (a) index 1, (b) index 2, (c) index 3**

For application of the simplified analysis methods, it was assumed that all the masonry materials were similar, the volumetric weight of masonry was  $20 \text{ KN/m}^3$  and the weight of the roofs was equal to  $2.0 \text{ KN/m}^3$ . The results are graphically represented as a function of the local parameter  $\text{PGA/g}$  in Figure 4, along with the threshold above mentioned for each of the indexes, namely  $\gamma_{1,i} \leq 10\%$ ,  $\gamma_{2,i} \leq 2.5 \text{ m}^2/\text{MN}$  and  $\gamma_{3,i} \leq 1.0$  for a  $\text{PGA/g}$  of 0.25.

Figure 16 presents the scatter plots of each index and the recorded horizontal PGA of the 22 February 2011 event for clay brick churches, as well as the proposed thresholds from Figure 3. Direction X and Y correspond, respectively, to the transversal and longitudinal directions regarding the main nave. The threshold for the first index is excellent, with all the *green* tagged churches above or near the line and only one yellow and one red church incorrectly identified. The *yellow* tagged church had only minor cracking with the exception of a large shear crack on one longitudinal wall of the main nave, see Figure 17. There were also

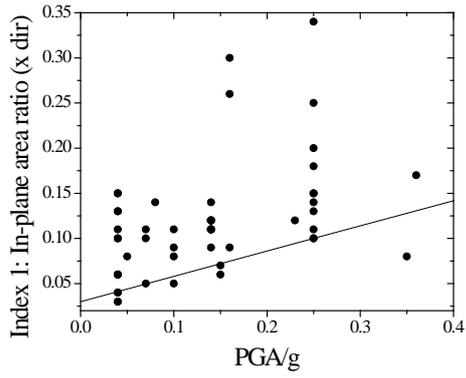
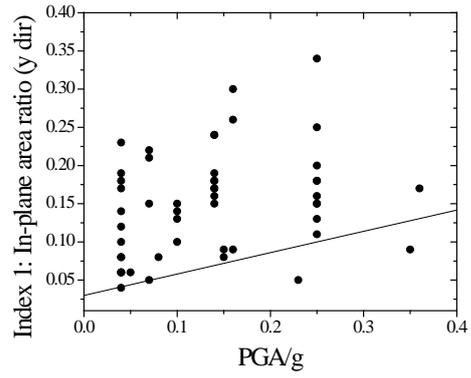
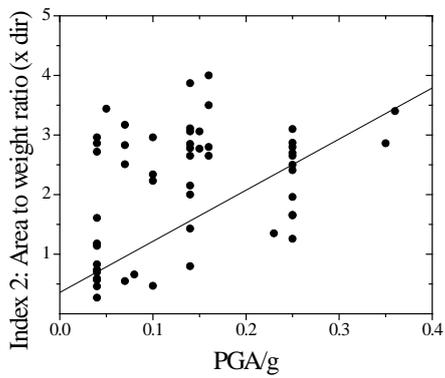
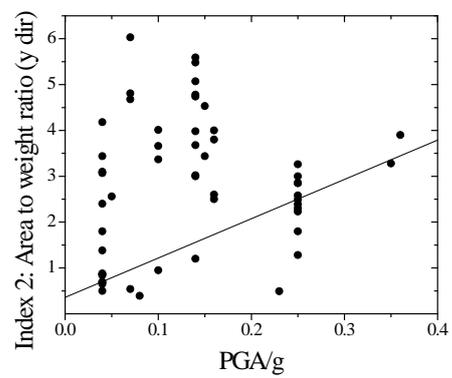
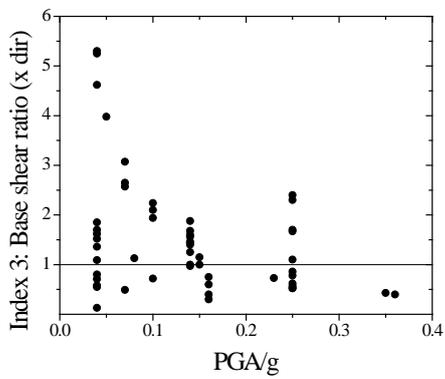
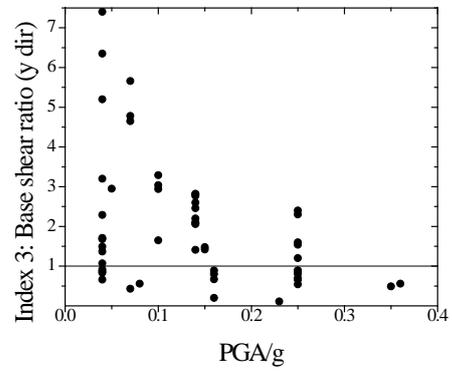
Figure 4 – Relationship between in-plane indexes and PGA/g, for the entire sample: direction x, (a) index 1, (b) index 2, (c) index 3; direction y, (c) index 1, (d) index 2, (e) index 3.

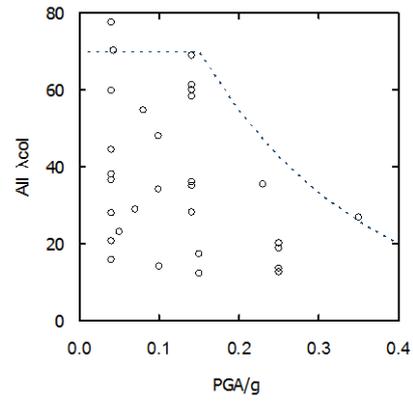
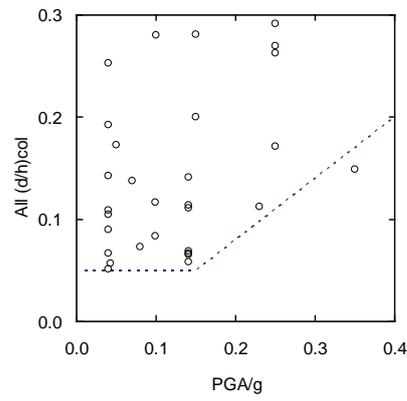
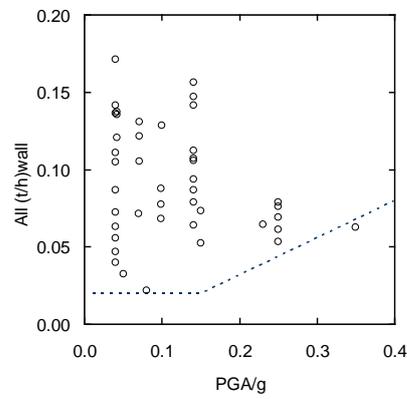
Figure 5 - Relationship between out-of-plane indexes and  $PGA/g$ , for the entire sample: (a) index 4; (b) index 5; (c) index 6.

The values obtained for the three out-of-plane indexes, are graphically represented in Figure 5, for the entire sample, as a function of the local seismicity. Similarly to the in-plane indexes, the out-of-plane indexes do not show any clear relationship with seismicity. However, for a PGA greater than 0.15g, a possible trend may be established. It can be observed that index 4 (column's slenderness) tends to decrease with increasing seismicity and that both index 5 and index 6 seem to increase continuously with seismicity. These trends are depicted in Figure 5 by dashed lines and can be seen as possible first threshold proposals.

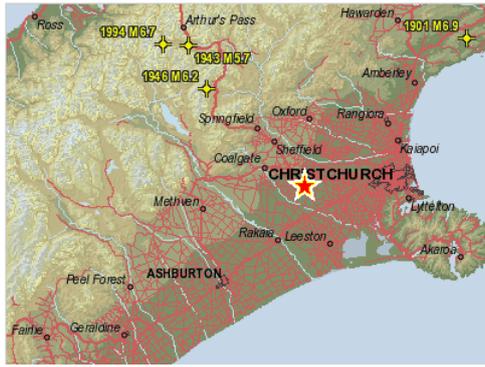
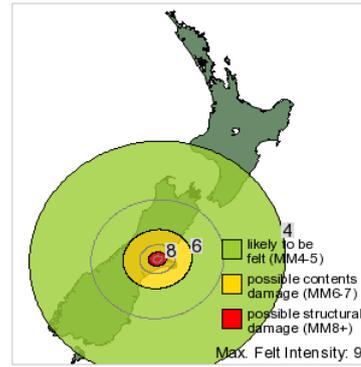
Figure 6 - Details of the 4 September 2010 earthquake [GeoNet, 2011b]: (a) earthquake location map; (b) isoseismal map.

The Canterbury region of New Zealand has been subjected to an intense seismic activity that started on 4 September 2010 at 4:35 pm, when a magnitude  $M_w$  7.1 earthquake struck the region. The epicenter was located near Greendale, 40 km west of CHC (see Figure 6), at a depth of about 10 km. The earthquake produced a ground-surface fault rupture with a length of nearly 30 km and during the ground motion the measured Peak Ground Acceleration (PGA) reached 0.82g for the horizontal component and 1.26g for the vertical component [Allen et al., 2010].

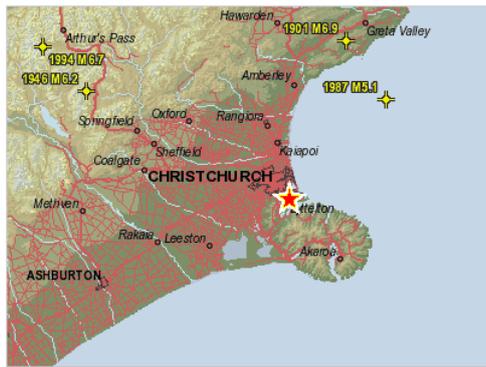
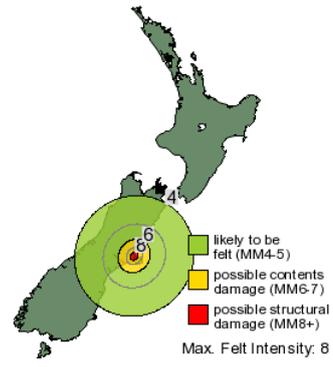
Figure 7 - Details of the 22 February 2011 earthquake [GeoNet, 2011b]: (a) earthquake location map; (b) isoseismal map.

Almost 1500 aftershocks, with a magnitude of  $M_w$  5.0 or higher, were recorded [GeoNet, 2011a] from that day until 22 February 2011, when another major seismic event struck the region. At 12:51 pm an aftershock with a magnitude  $M_w$  6.3 and an epicenter located only 10 km south-east of the CHC and at a depth of 5 km, was felt throughout the entire Canterbury region (see Figure 7). More than 180 people lost their lives and a similar number were severely injured, and the PGA reached 1.7g for the horizontal component and 2.2g for the vertical component. High magnitude aftershocks did not stop in the February event and on 13 June 2011 another two large events occurred with magnitudes  $M_w$  of 5.7 and 6.3.

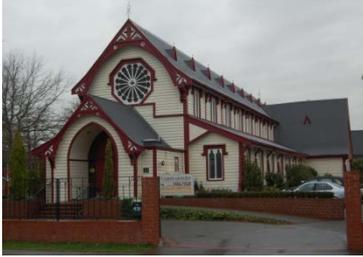
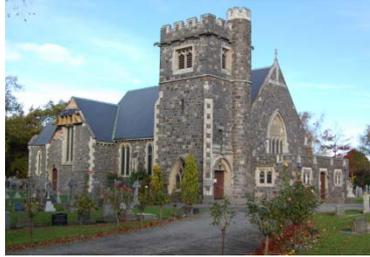
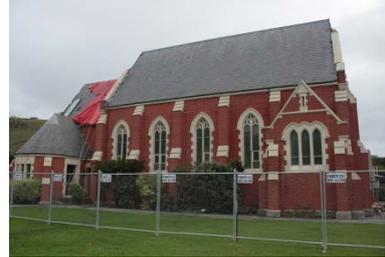
**Figure 8 - Church typologies found in the Canterbury region: (a) timber church of St Andrews, Merivale, 1857; (b) stone church of St Peters, Upper Riccarton, 1876; (c) clay brick church of Our Lady Star of the Sea, Sumner, 1912.**

After becoming a colony of the British Empire in 1840, the demand for residential and community buildings increased due to the larger number of immigrant population [Russell and Ingham, 2010]. The wide availability of wood, and faster construction times, made timber the main construction material during this period. The subsequent prosperity led to the use of stone and clay brick in the construction of important public buildings such as churches. Therefore, these are the three most common materials used for the construction of NZ churches from the first quarter of the 20<sup>th</sup> century (see Figure 8). Almost all churches of the Canterbury region built before 1938 were assessed [Hamilton and Hamilton, 2008], leading to a total number of 112 church buildings contained within the database (see Figure 9). The exceptions were churches that were already demolished and churches that were damaged to such an extent that it was unsafe to perform the assessment.

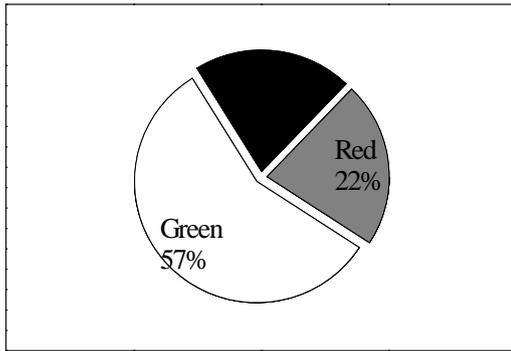
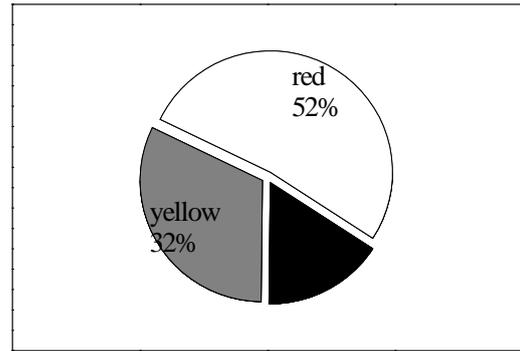
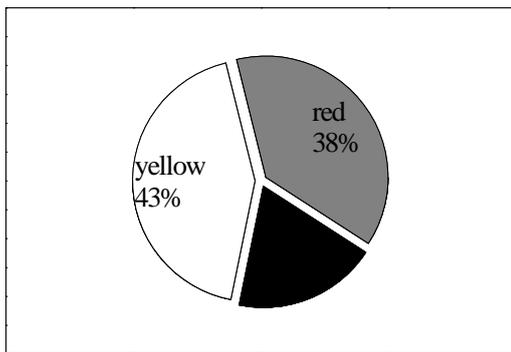
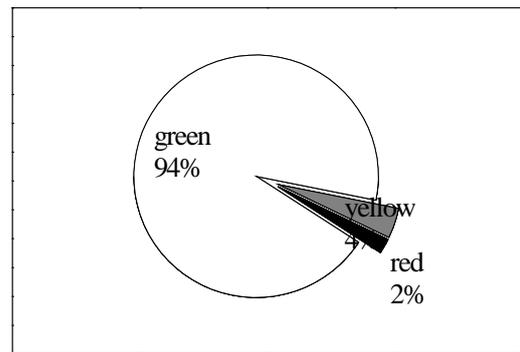
**Figure 10 – (a) placard classification for all the assessed churches; (b) placard classification for the stone churches; (c) placard classification for the clay brick churches; (d) placard classification for the timber churches.**

A comprehensive statistical analysis of the churches including the in situ damage observed, the structural assessment classification assigned by the local authorities and a comparison with the structural classification used in Italy, where a specific survey form for churches is used, is given in [Leite et al., 2013]. More than half of the churches (57%) received a green placard from the structural inspectors (see Figure 10 a), but given the different dynamic characteristics of the three principal church typologies found in the Canterbury region as referred to above, the obtained data had to be analyzed for each individual typology. For the stone churches, more than half of the churches (52%) were assigned a red placard and only 16% of the churches had a green placard assigned (see Figure 10 b). Identically, Figure 10 c) shows that a red placard was assigned to 38% of the clay brick churches, while a yellow placard was assigned to 42% of those churches. The percentage of red placards assigned for the typology was smaller than the percentage assigned for the stone churches, but the sum of the red and yellow placards was similar for both masonry typologies and exceeded 80%. Figure 10 d) shows

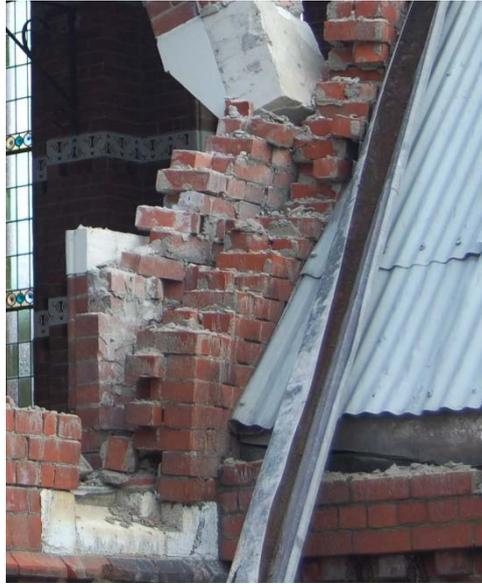
**Figure 11 - Detail of the three dimensional bond of the clay brick walls (Church of the Good Shepherd, Phillipstown).**

The masonry used to build the brick churches is of low quality, given the poor quality of the mortar used [Dizhur et al., 2011]. Still, there is a three dimensional bond of the wall leaves that provides a reasonable interlocking and partly prevents material disintegration, see Figure 11. Contrarily to the clay brick churches, which were all built with the same technique and similar materials, the stone churches vary considerably in composition. There are stone churches built with a stone leaf on the outside, a brick leaf inside and poor quality concrete between the leafs, see Figure 12, and there are stone churches built entirely with rubble masonry, see Figure 13, that are rather prone to material disintegration and out-of-plane expulsion . Now it remains to be discussed how the observed damage compares with the proposed in-plane thresholds.

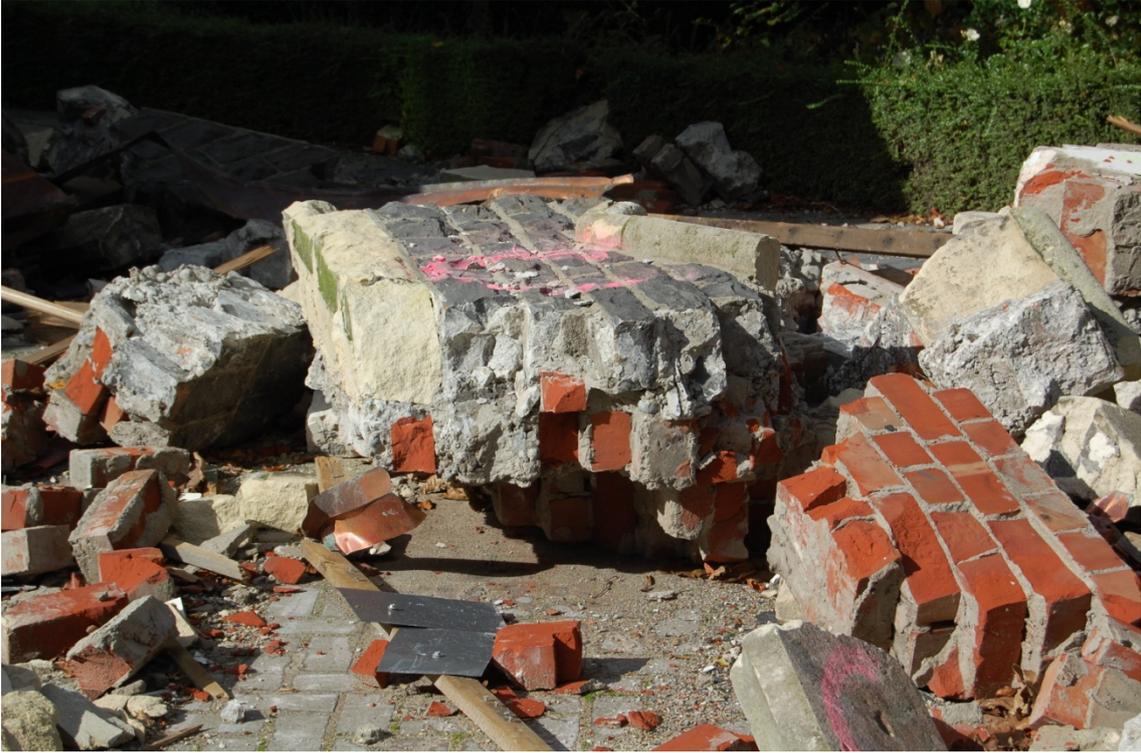
**Figure 12 – Different masonry leaves in stone churches (Rose Historic Chapel, Christchurch CBD), with stone outside and brick inside.**

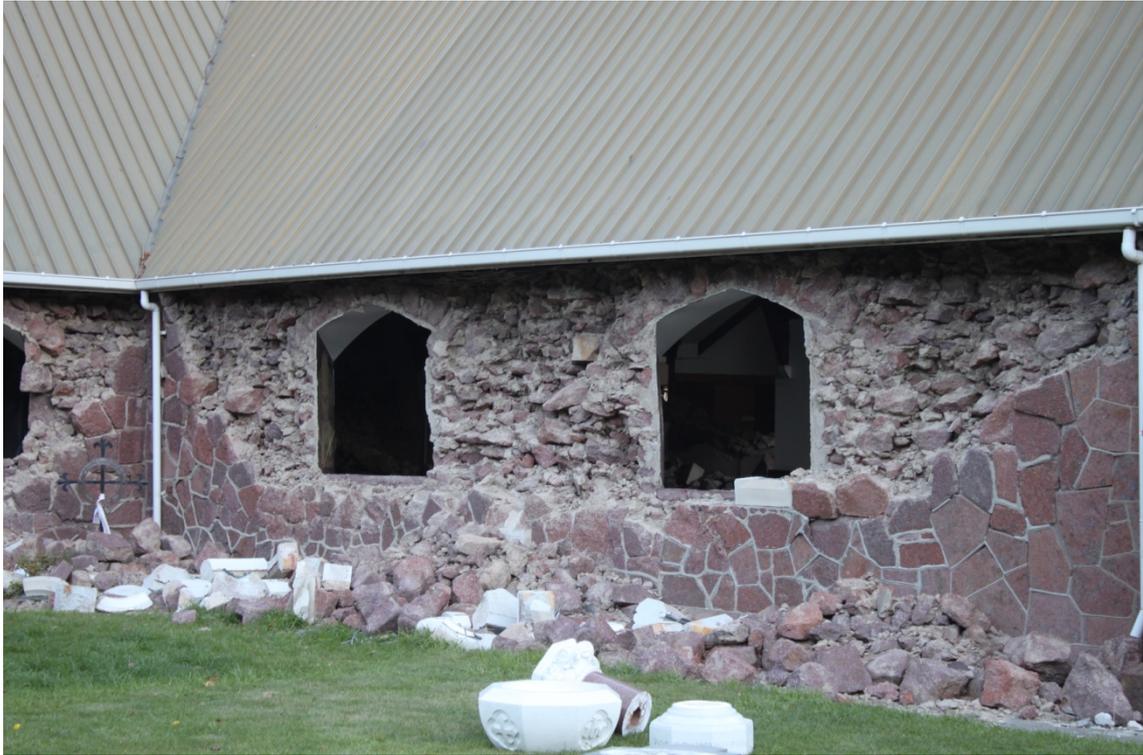
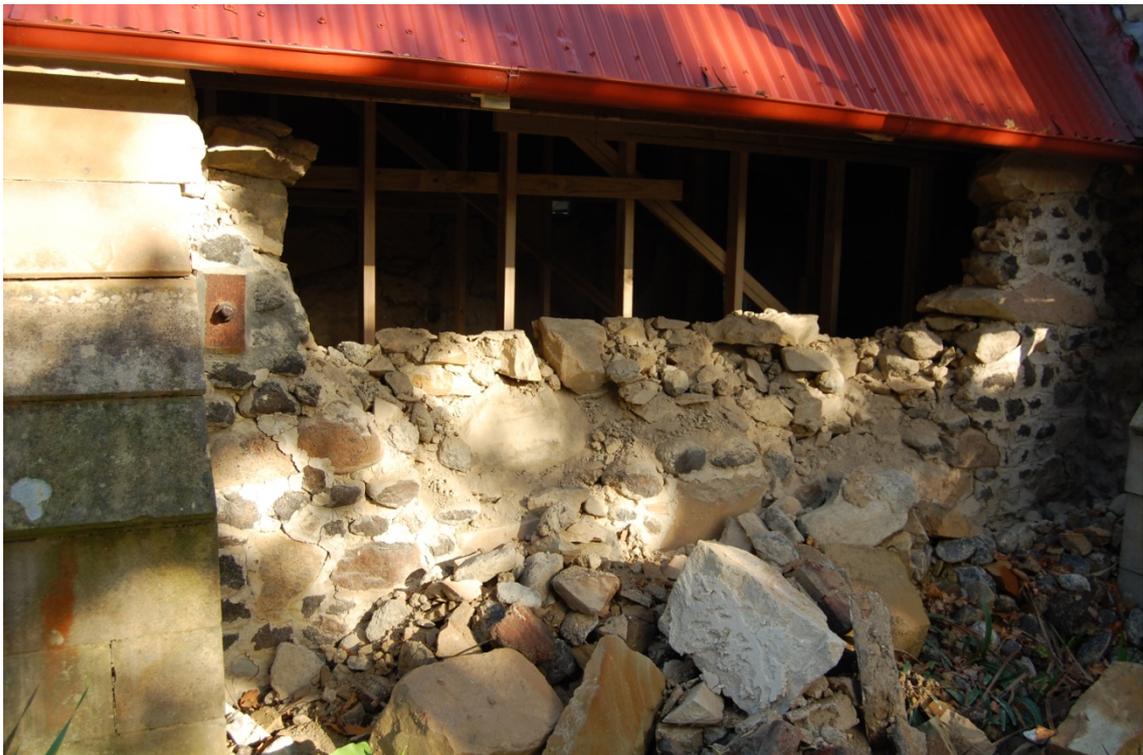
**Figure 13 – Stone church with rubble masonry walls: (a) Holy Trinity, Lyttelton; (b) St. Cuthberts, Governors Bay.**

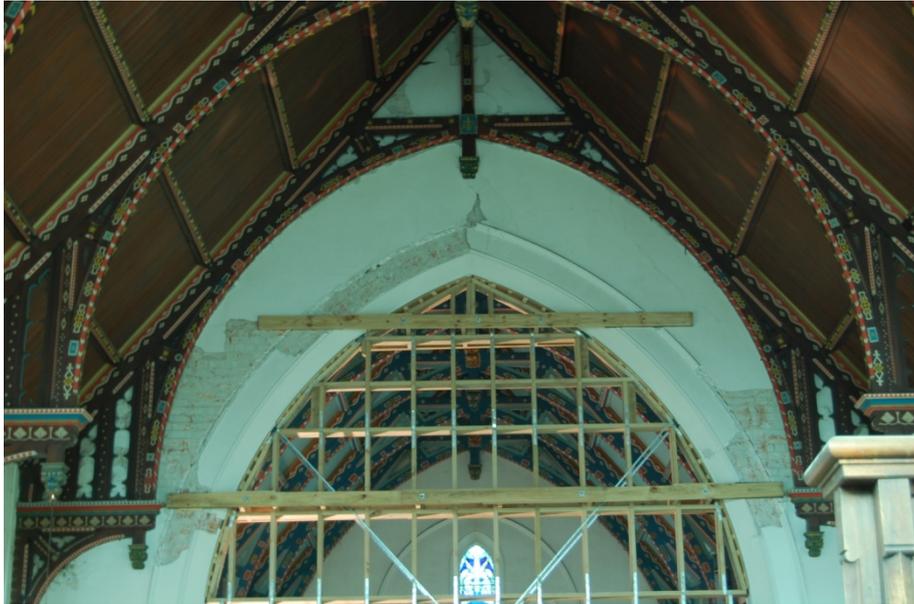
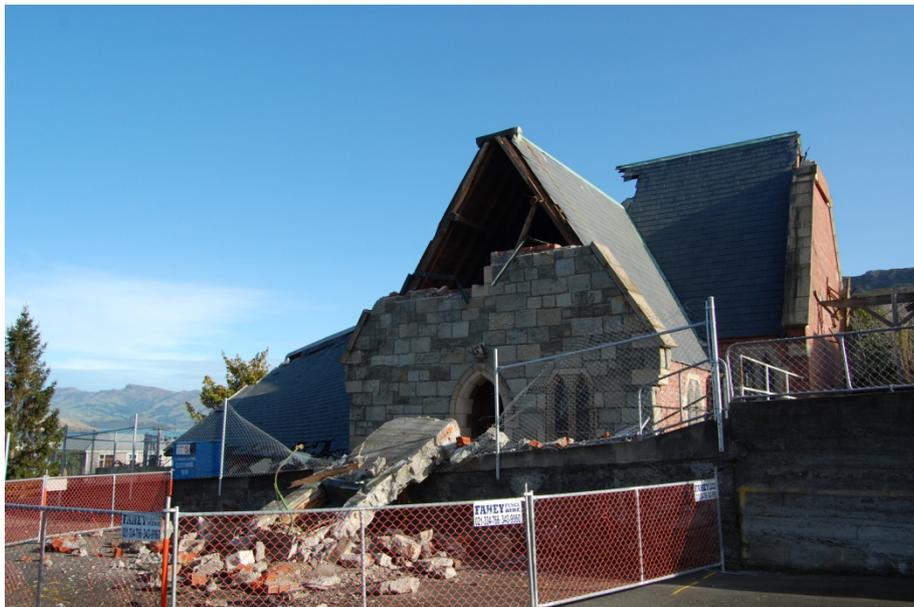
**Figure 14 – Visual inspections of churches: (a) interior inspection (St. James, stone, Riccarton); (b) exterior inspection only due to safety reasons (St. Josephs, stone, Lyttlelton).**

The assessment carried out after the CHC earthquake included the recording of the placard assigned to each church by the NZ National Authorities, a visual inspection (exterior and interior when possible and safe) with photographic documentation of the damage, see Figure 14, completion of the Italian survey form for damage in cultural heritage – churches [Civil Protection Department, 2006] and the geometrical measurement, in plan and height, using a distance meter laser. The thickness of the walls was obtained rather easily in the clay brick churches because the same type of brick and construction techniques were used. As for the stone churches, the heavily damaged churches with large cracks or local collapses allowed an easy measurement, while in the less damaged churches the measurement was done at the openings (windows and doors).

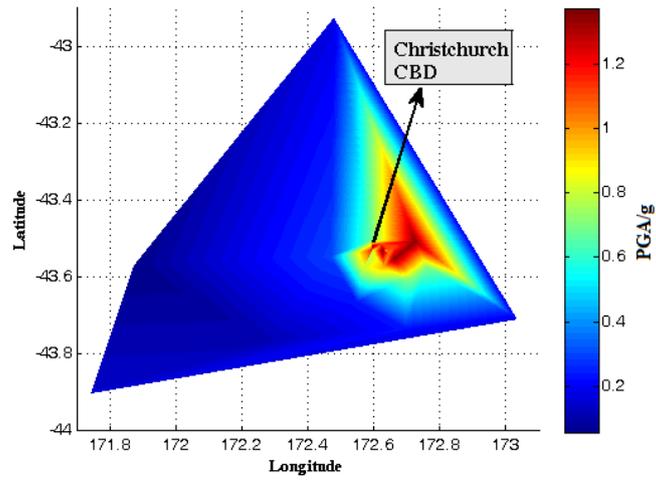
Figure 15 - PGA distribution of the assessed churches.

The indexes related to the above mentioned simplified method of analysis were computed for all the stone and clay brick churches. The timber church typology was excluded since the performance was excellent and the proposed method is not applicable. The objective was to validate the proposed thresholds for each of the three in-plane indexes (in-plane area ratio, area to weight ratio, base shear ratio) by means of the PGA imposed to each church during the 22 February 2011 seismic event, acquired by the National Strong Ground Motion Network's equipment. Given the high number of instruments installed in structures and buildings [Canterbury Regional Strong-Motion Network, 2003], it was possible to associate the PGA recorded at a given location to a nearby church building. In most cases the distance between the church building and the accelerographs was less than 2 km, which ensures the quality of the produced data. Considering the latitude and longitude coordinates of each church and the horizontal PGA associated to it, it is possible to plot a contour map, see Figure 15, which shows that the measured PGAs almost reach 1.4 g for the churches located near the CBD of CHC, and then decrease non-uniformly as the churches are located further away.

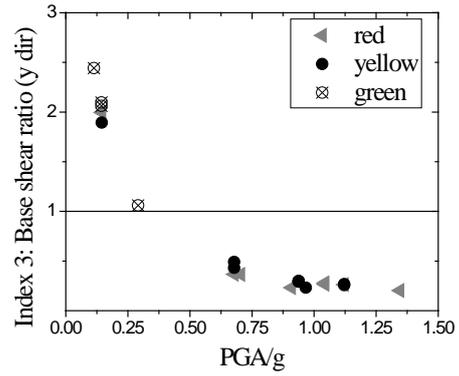
Figure 16 – Clay brick churches: (a) index 1: In-plane area ratio in the x (transversal) direction; (b) index 1: In-plane area ratio in the y (longitudinal) direction; (c) index 2: Area to weight ratio in the x (transversal) direction; (d) index 2: Area to weight ratio in the y (longitudinal) direction; (e) index 3: Base to shear ratio, taking cohesion into consideration, in the x (transversal) direction; (f) index 3: Base to shear ratio, taking cohesion into consideration, in the y (longitudinal) direction; (g) index 3: Base to shear ratio, considering zero cohesion, in the x (transversal) direction; (h) index 3: Base to shear ratio, considering zero cohesion, in the y (longitudinal) direction.

unstable non structural elements inside that could collapse during a stronger aftershock, which led the structural inspector to classify the church as *yellow*. The *red* tagged church was also a particular case, as it had pinnacles overhanging from the transversal walls, see Figure 18 (a), and therefore was unstable even for a low PGA. These elements were severely damaged or partially collapsed, see Figure 18 (b), compromising the connection between the transversal and longitudinal walls. The thresholds for index 2 and 3 also have acceptable results. The X (or transverse) direction provides better results in all three indexes, and this is the critical direction. The indexes are consistent even if they are not directly correlated. Index 3 exhibits the worse performance if cohesion is taken into consideration, with better results obtained for a zero cohesion, see Figure 16 (e) (f) (g) (h).

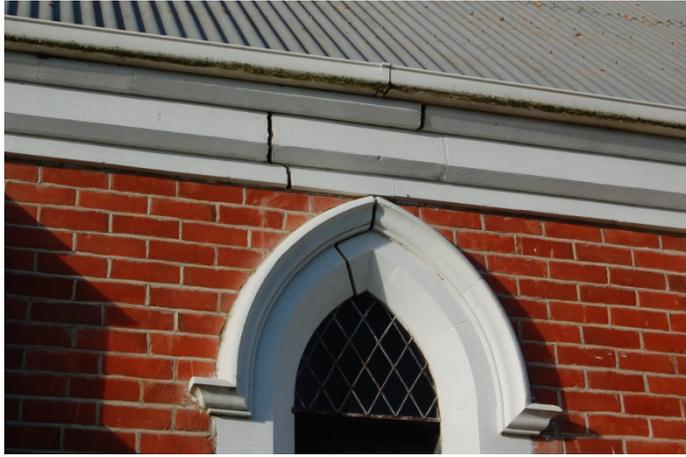
**Figure 17 – Large shear crack in the lateral wall of St. Luke’s Presbyterian church (clay brick, Sefton).**

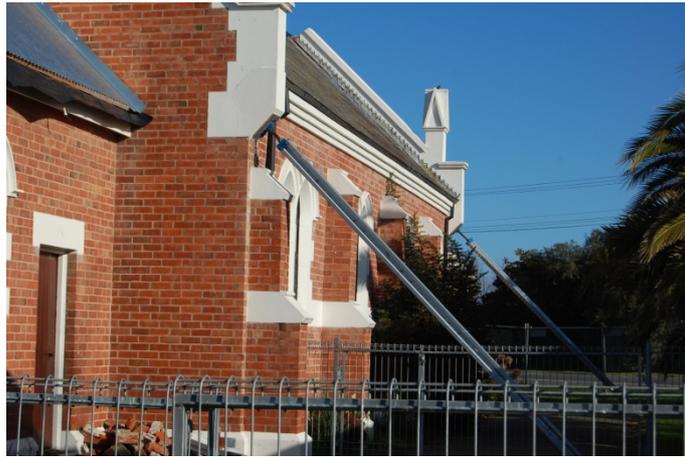
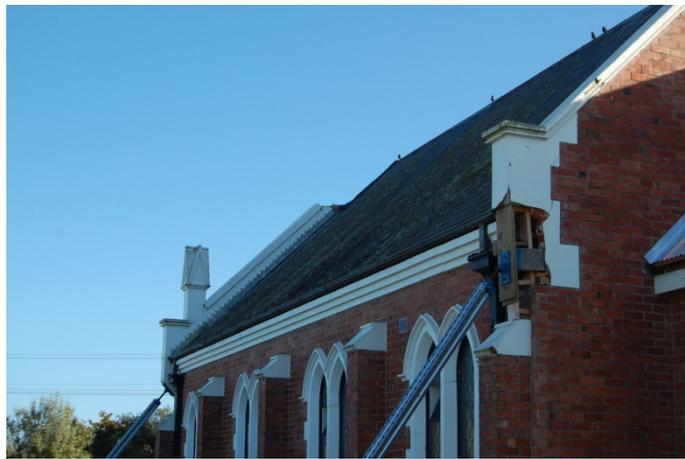
**Figure 18 – Damage in Woodend Methodist church (clay brick, Woodend): (a) pinnacles in each edge of the transversal walls of the main nave; (b) detail of a partially collapsed pinnacle with provisional reinforcement.**

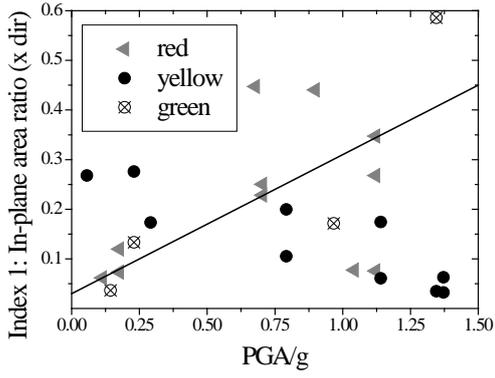
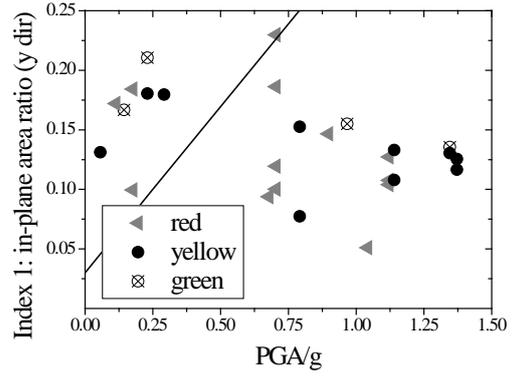
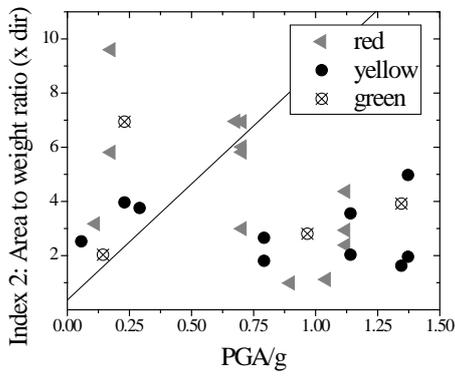
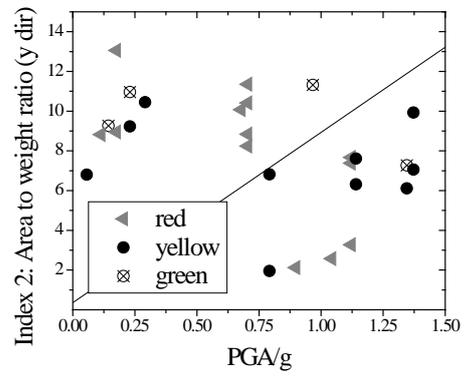
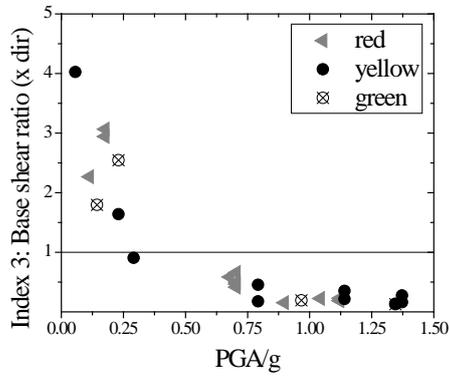
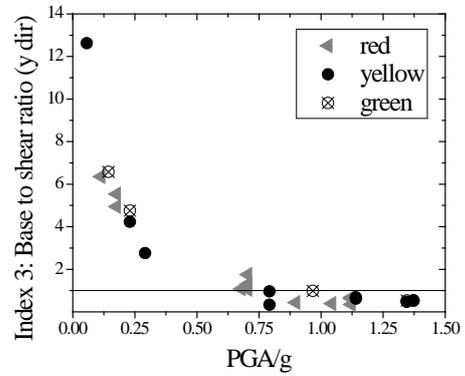
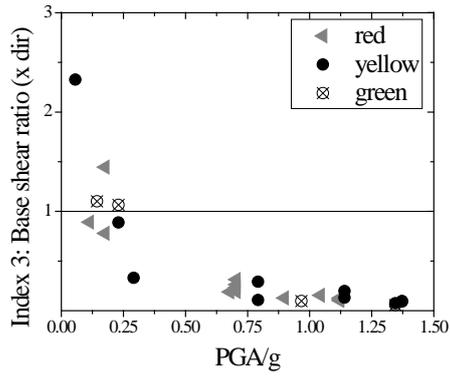
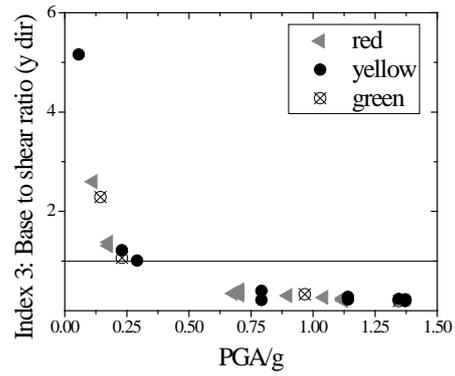
Figure 19 –Stone: (a) index 1: In-plane area ratio in the x (transversal) direction; (b) index 1: In-plane area ratio in the y (longitudinal) direction; (c) index 2: Area to weight ratio in the x (transversal) direction; (d) index 2: Area to weight ratio in the y (longitudinal) direction; (e) index 3: Base to shear ratio, taking cohesion into consideration, in the x (transversal) direction; (f) index 3: Base to shear ratio, taking cohesion into consideration, in the y (longitudinal) direction; (g) index 3: Base to shear ratio, considering zero cohesion, in the x (transversal) direction; (h) index 3: Base to shear ratio, considering zero cohesion, in the y (longitudinal) direction.

The thresholds for the stone churches are not as good as those for the clay brick churches, see Figure 19. For all indexes, and in both directions, there are *green* tagged churches subjected to a PGA equal or higher to 1g under the threshold, and *red* tagged churches subjected to a PGA lower than 0.125g above the threshold. The lack of homogeneity of the stone churches justifies the lack of agreement with the thresholds, as the seismic behavior of these churches is rather different. Monumental good quality stone churches can present a seismic behavior similar to clay brick churches, while rubble weak stone masonry lacks interlocking and disaggregates, even for low PGA values. Redefining the thresholds is not a solution and the stone church typology would possibly have to be divided in sub-categories, according to more specific construction details. As it will be shown next with the fragility curves, the response of the stone churches is rather peculiar. As for the clay brick churches, there is a better agreement with the threshold of index 3 if cohesion is not taken into consideration.

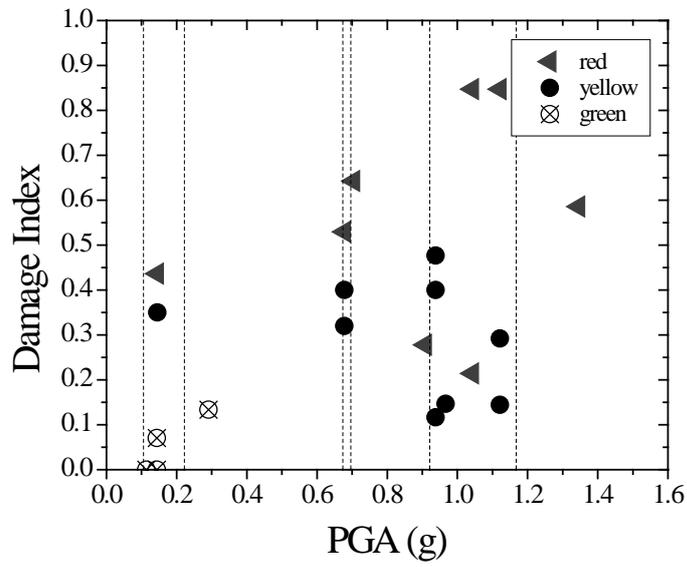
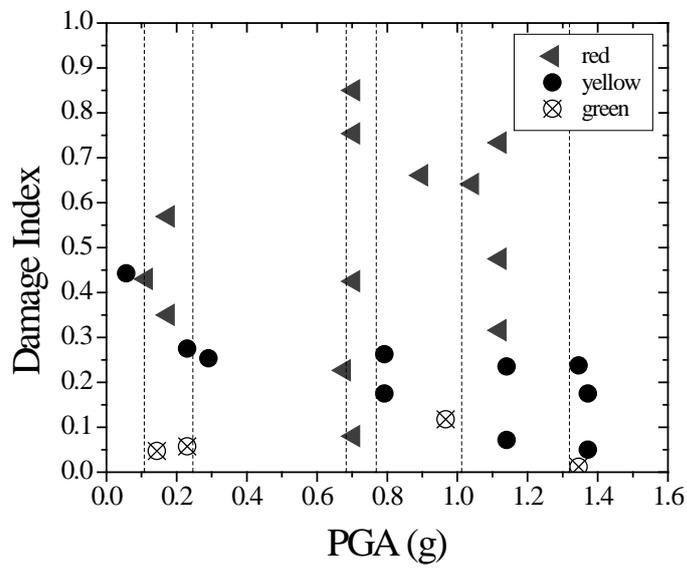
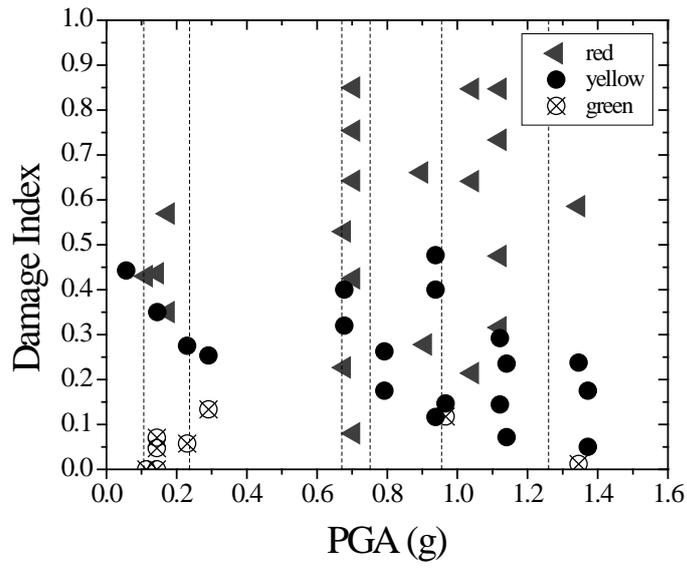
(a) Clay brick churches

(b) Stone churches

(c) All churches

Figure 20 - Relation between damage index and PGA, with data clustering for the fragility curves.

After the above computations, the assessed buildings were sorted following the damage index  $i_d$  assigned to each one [Leite et al., 2013] and the PGA that the buildings were subjected to on the 22 February event, Figure 20. The damage Index  $i_d$ , is based on the concept of *macroelements* [Doglioni et al., 1994]. These *macroelements* are subdivisions of the church based on architectural elements (such as facade, lateral walls, chapel, bell tower) which have an almost independent seismic behaviour at collapse, therefore simplifying the complex structure of most churches into several smaller and simpler elements. The concept is based on experience acquired from past earthquakes, and was later revised and applied to the inspection forms [Angeletti et al., 1997; Lagomarsino and Podestà, 2004] used by the Italian Civil Protection [Civil Protection Department, 2006].

Each data plot of Figure 20 was divided into three shaded areas obtained using the average PGA of the group and one standard deviation, iteratively defined to include 70% of the data. This clustering provides two empirical fragility curves, being one referred to as *slight-moderate*, obtained considering the percentage of *green* tagged churches within the respective shaded areas, while the second one, referred to as *extensive-complete*, considered the percentage of *green* and *yellow* tagged churches in the same groups. Figure 21 shows the empirical fragility curves for stone and clay brick churches, individually and merged in a single group. The higher vulnerability of stone churches is clear, with almost 50% of the churches having important damage and over 75% of the churches having some damage for a PGA value of 0.25g. For brick similar values of damage occur for about 0.6g.

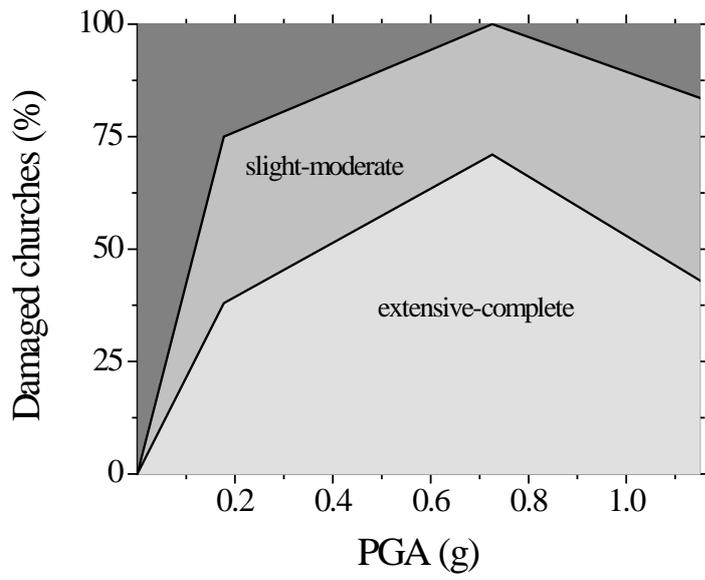
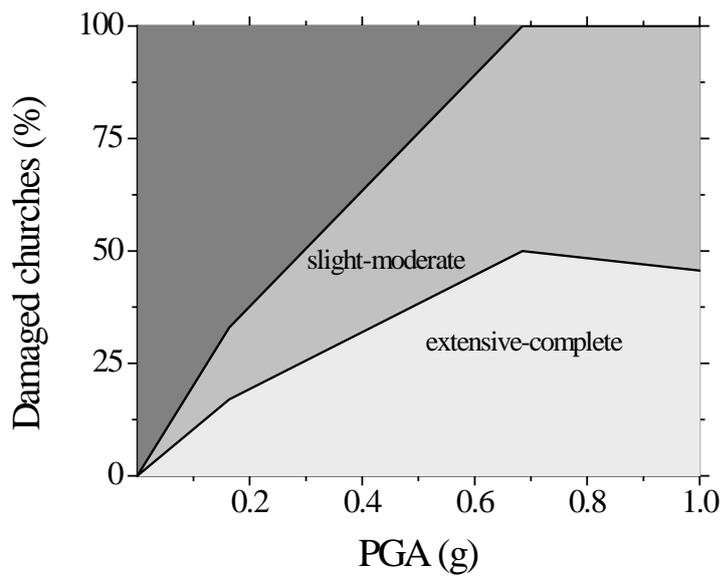
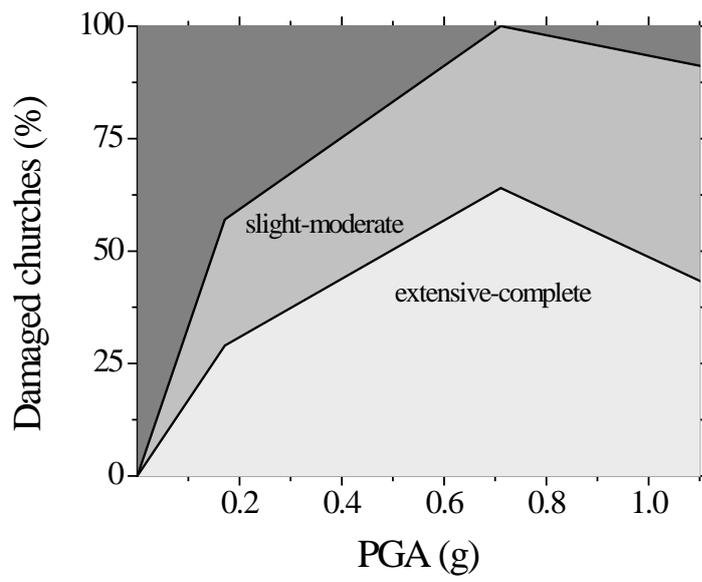
Figure 21 – Empirical fragility curves: (a) stone churches; (b) clay brick churches; (c) all churches.

lognormal distribution was fitted to the data points; (b) the lognormal cumulative distribution function was set to pass in the average quantile; (c) the standard deviation (measured by  $\beta$ ) was obtained by the least square method for the slight-moderate sample, being the same  $\beta$  used for the extensive-complete damage. The fitted fragility curves are plotted in Figure 22, where a  $\beta$  equal to 1.3, 0.8 and 1.1, was found respectively for stone masonry, clay brick masonry and the entire sample. The higher vulnerability of stone churches is again demonstrated by the fitted fragility curves.

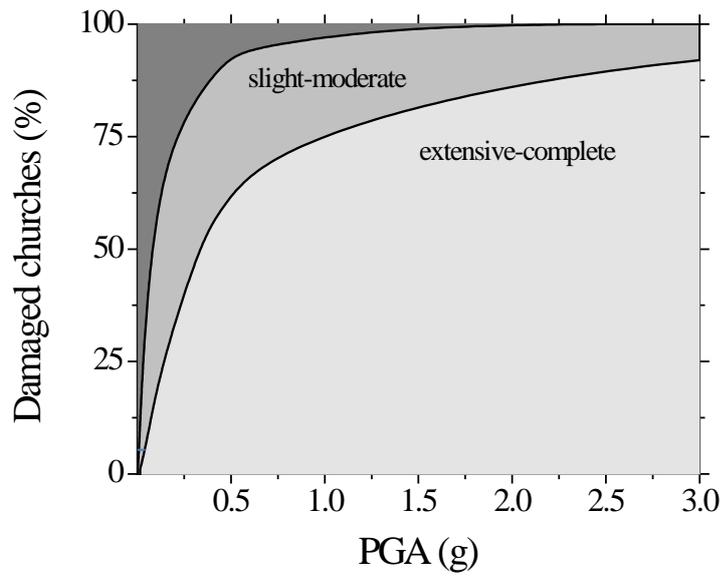
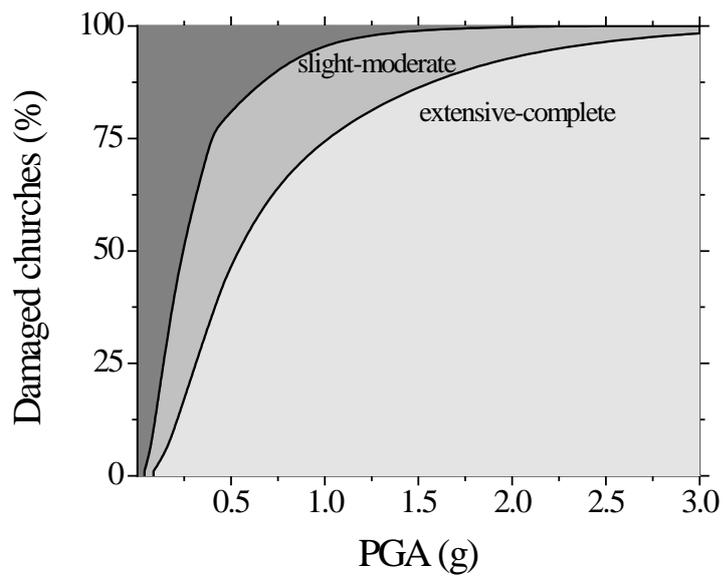
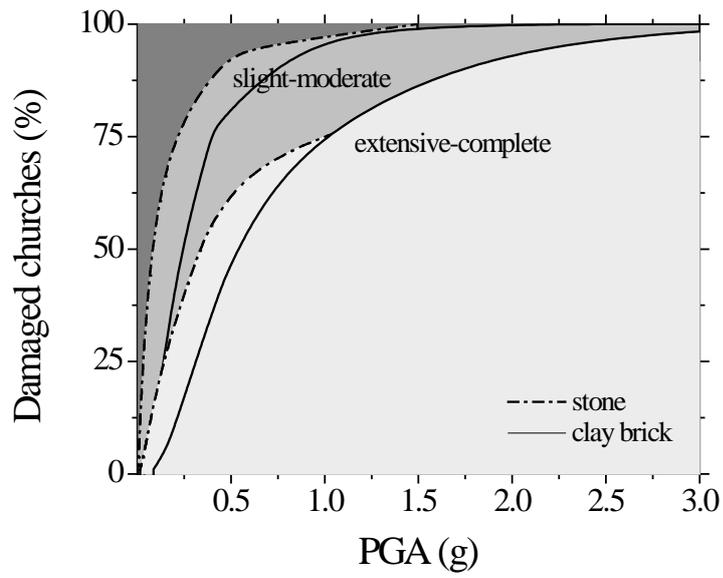
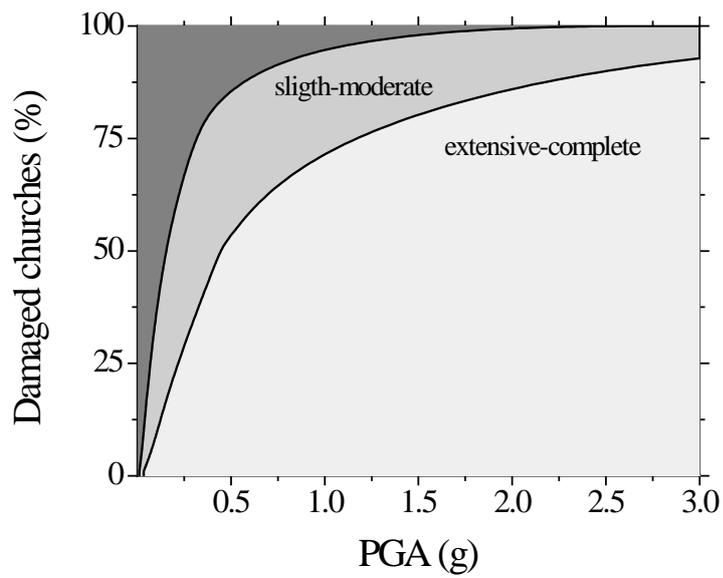
Figure 22 – Fragility curves: (a) stone churches; (b) clay brick churches; (c) stone and brick; (d) all churches.
