Experimental Investigation on the Long-term Durability of Bond Between FRP and Masonry Substrates

B. Ghiassi¹, D.V. Oliveira², P.B. Lourenço³

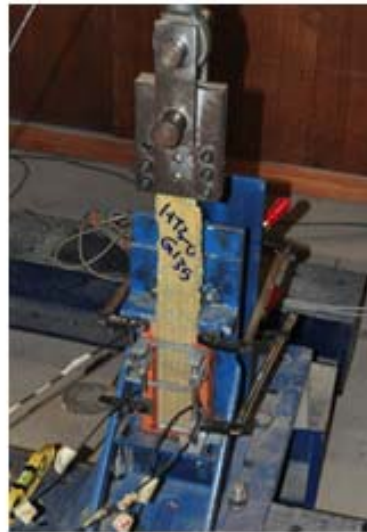
Figure 6: Single-lap shear bond test setup.

Single-lap shear bond tests were performed using a mechanical testing machine with maximum load capacity of 50 kN. A steel frame was used to support the specimens appropriately and avoid misalignments in load application. The specimens were placed on the steel frame and firmly clamped to it as shown in Figure 6. Tests were driven under displacement control conditions with reference to the LVDT sensor placed at the loaded end of the FRP composite. The specimens were pulled monotonically with a speed rate of 5µm/sec. The resulting load was measured by means of a load cell. The relative slip between the GFRP and the masonry substrate was measured with the LVDTs glued along the bonded length.
