# Typology based Method for Choosing Old Masonry Walls Inspection Procedures

**ABSTRACT:** The diagnosis of historic masonry walls is an intricate and complex field and has been an object of research for many years. This paper aims to propose practical methodologies for the diagnosis of historic masonry walls, specifically based on their typological characteristics. In order to develop such procedures, information relating to historic masonry typologies in Portugal, classified as rural, urban and military was gathered and techniques for the assessment of historic masonry were studied. All information was integrated to develop a pattern typology oriented methodology. Developed methodology was tested and validated in a small diagnosis campaign carried out in the Guimarães Castle. Methodology was proven to be advantageous and although the study is limited and focused on the Portuguese architectural specificities, it still holds global classifications, and therefore can be useful for any diagnosis procedure of a historic masonry wall.

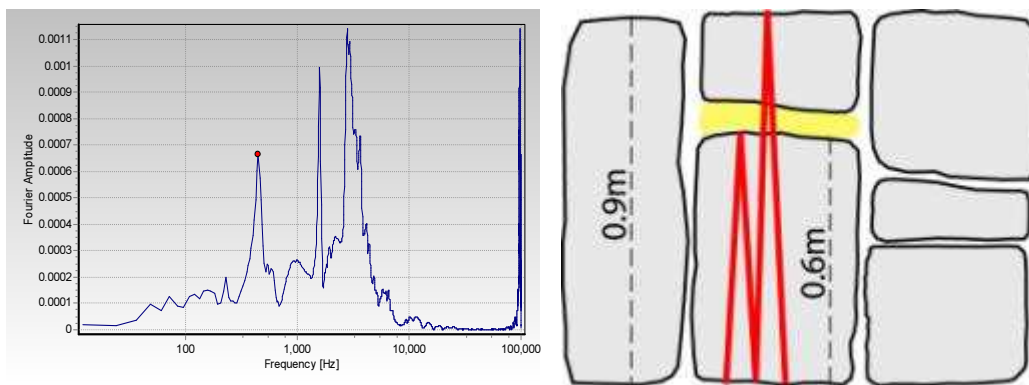
Figure 6 - Plot of (a) frequency signal showing multiple peaks, and (b) horizontal plan of masonry section illustrating interior interfaces with large, detectable joints.

Results of two measured points showed results representative of wall morphology. One of the points showed two peaks in the distances of 0.51m and 0.87m. The actual wall width, measured on site was 0.93m, which is very close to the estimated result. The closer peak can indicate existence of an inner joint or layer. Similar results were noted in the other points. All measurements showed a very low coefficient of variation (less than 1%). Figure 6b illustrates this diagnose.
