Application of acoustic emission technique for bond characterization in FRP-masonry systems

Keywords: Acoustic emission; FRP; strengthening; masonry; debonding.

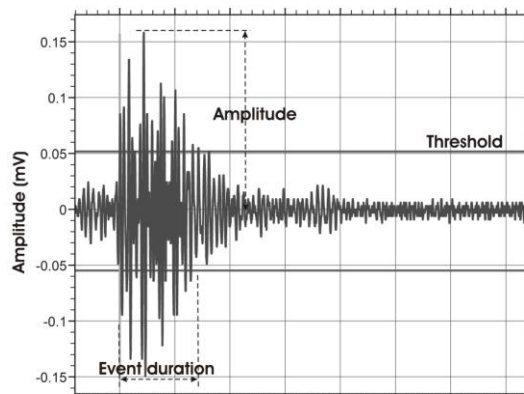
Fig. 2 Typical AE transient event with indication of wave characteristics.

A typical AE transient is presented in Fig. 2. Background noise is eliminated through setting a minimum amplitude threshold. An AE hit with a predefined duration is recorded when the threshold is exceeded. For each AE hit, a number of parameters (e.g. arrival time, amplitude, count, duration and energy) and the waveform itself are recorded. The amount of detected AE hits and energy is influenced by the hardware used and software settings, thus software defined parameters (e.g. threshold and sampling frequency) should be kept constant for subsequent tests. The detection of acoustic emissions is also sensitive to a number of setup-specific boundary conditions, such as quality of the coupling between sensor and test specimen, attenuation and speed of wave propagation, source-sensor distance, specimen size and homogeneity.

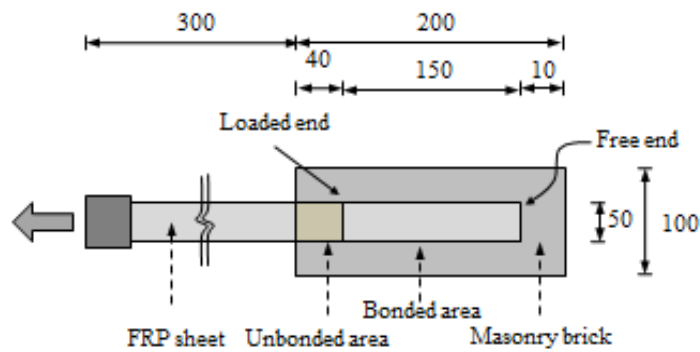
Fig. 3 Geometrical details of the specimens.

Test specimens consisted of bricks strengthened with GFRP and SRG composites. Solid clay bricks with dimensions of 200x100x50 mm³ were used as the substrate. The composite materials were cut with 50 mm width and applied to the bricks' surface along 150 mm length of the brick with a 40 mm unbounded part near the loaded end in order to minimize edge effects [1], see Fig. 3.

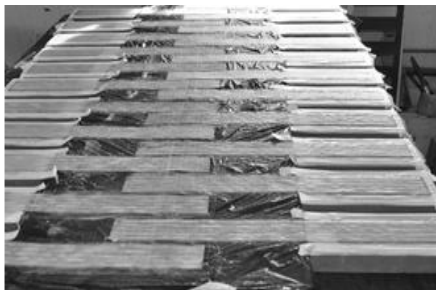
Fig. 4 (a) GFRP-brick specimens; (b) SRG-brick specimens.

In the GFRP-strengthened brick specimens, GFRP strips were applied to the brick surface along its centerline following the wet lay-up procedure, see Fig. 4(a). The bricks were dried in the oven before application of the GFRP sheets. Then, a two-part epoxy primer was applied to the bricks' surfaces for preparation of the substrate surface. Finally, a two-part epoxy resin was used as the matrix for the composite material and adhesion to the masonry substrate.

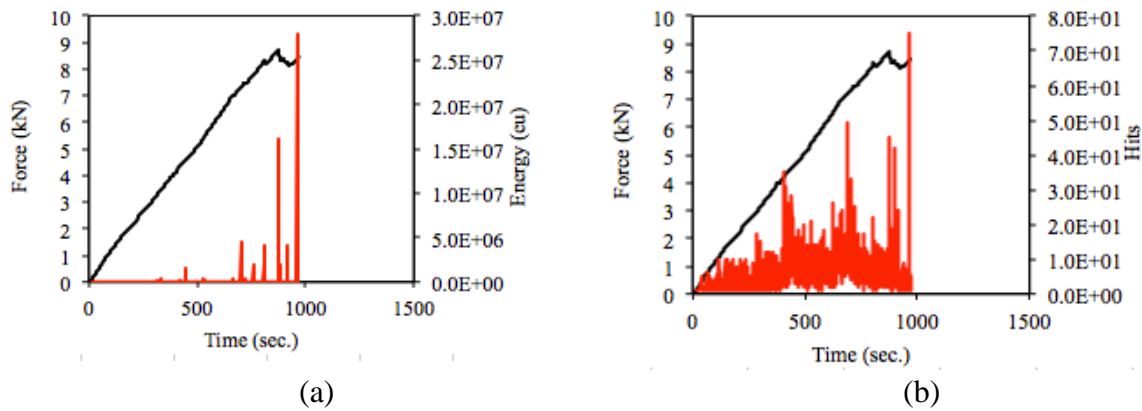
Fig. 6 AE output from debonding tests on a GFRP-brick specimen: (a) AE energy; (b) AE hits.

Typical AE results obtained from the debonding tests are shown in Figs 6 for a GFRP-brick specimen. It can be seen that as the debonding progresses, the amount of emitted AE energies increase. The final peak in the AE energy curve, Fig. 6(a), is corresponding to the delamination moment which has occurred with releasing of a high amount of energy.

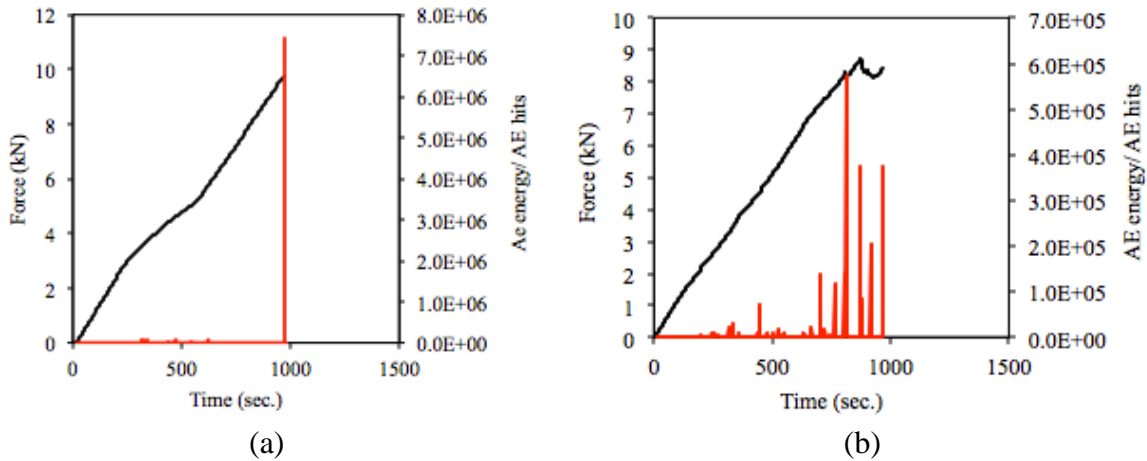
Fig. 8 E/h ratio in GFRP-strengthened bricks for different failure modes: (a) cohesive debonding; (b) adhesive debonding.

A comparison is made next between the AE outputs in specimens with different failure modes. The aim was to investigate the existence of any correlation between the fracture process and the AE outputs. In GFRP-brick specimens, the comparison is made between cohesive and adhesive failure modes, see Figs. 7, 8. It can be observed that in the specimen with cohesive debonding the AE energy remains relatively low throughout the test, accompanied by a sudden and large amount of AE energy release when the debonding occurs at the end of the test, Fig. 7. The observed behavior confirms the brittle and sudden nature of the cohesive debonding. On the contrary, in the specimen with cohesive/adhesive failure a progressive release of energy is observed during the test. The high rate of energy detection shows the high number of active cracks and progressive failure during the tests. Progressive detection of AE energies is observed until the complete debonding. However, the magnitude of the detected energies is much lower than the ones detected in the specimens with cohesive failure mode. This large difference is due to the different nature and fracture properties of brick and FRP/brick interface. The specimen with adhesive failure combined with formation of a brick bulb at the free end shows a similar AE energy emission to the specimen with pure adhesive failure. However, a large amount of energy is released in this specimen before debonding due to the brick bulb fracture at the free end. Fig. 8 presents the energy/hit (E/h) ratio during the tests. The cohesive failure shows a peak at the end of the tests showing that a strong energy has been emitted at the moment of debonding. However, several peaks can be observed in the specimens with adhesive debonding showing the progressive nature of failure in this mode.

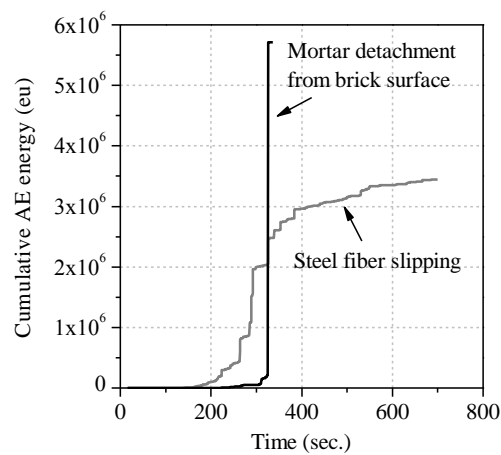
Fig. 9 Comparison of different failure modes in SRG-strengthened bricks.

Fig. 9 presents a comparison between two failure modes in SRG-brick specimens. A brittle behavior is observed in the specimen with brick/mortar detachment failure. The detected energy in this specimen is very low during the test followed by a sudden release of energy at the moment of debonding. On the other hand, the fibers slipping failure mode produces a progressive release of energy during the test until diminishing the adhesive bond, followed by a reduction of the AE energy rate in the stage governed by frictional resistance. This E/h curve, Fig. 10, confirms this hypothesis. Again, in the specimens with mortar detachment failure a large peak is observed at the moment of debonding, while the specimen with fiber slipping failure shows several peak during the test.
