Window-Wall Interface Details to Evaluate the Risk of Condensation on Box Windows

W. Maref, M. Armstrong, M.A. Lacasse, H. Elmahdy, R. Glazer

National Research Council Canada, Institute for Research in Construction, Ottawa, ON, Canada

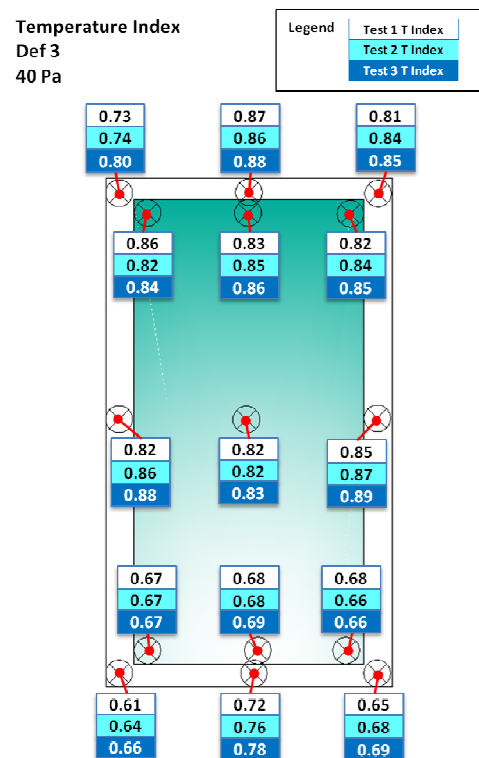
Figure 4. Temperature indexes at 40Pa with deficiencies for the different test sets.

While there is no effect on the outside surface temperatures due to pressure difference, a pressure difference has a small effect on the window frame temperatures on the inside. Figure 4 shows the temperature indexes for the case where deficiencies are present and a pressure difference of 40Pa is applied. The results show, from top to bottom, the test without insulation between window frame and wall, with mineral fibre insulation and SPF respectively. Without insulation, there was an additional temperature drop of 1.5°C on the interior side of the window frame compared to the same test without deficiencies. With the glass fibre insulation the additional effect of the deficiencies was negligible. While the presence and type of insulation had no effect on the temperature drop due to a pressure difference without deficiencies, it had a clear effect when the deficiencies are in fact present. This supports the theory that the overall temperature drop described above was caused by air leakage in the window frame itself, and not by air leakage in the cavity.

Figure 4 shows the temperature indexes on the inside of the window, which shows that glass fibre insulation has a positive effect. The low value at the top left corner of the window frame might be attributable to minor deficiencies in the caulking, measurement accuracy or rounding. The effect on the temperature index at the interior surface is a little over 0.01, consistent with the 0.5°C increase due to the insulation (recorded in the case without pressure differences and without deficiencies). The lowest temperature index achieved at a pressure difference of 40Pa was 0.64, only slightly higher than the situation without insulation. Due to the thermal stratification of the gas in the IGU, the lowest temperature indexes can be found at the sill; hence, it is evident that the insulation will not have a major effect on results at this location.
