Repair of Aerospace Composite Structures Using Liquid Thermoplastic Resin

Khan , Tayyab; Hafeez, Farrukh; Umer, Rehan

Khan , T, Hafeez, F & Umer, R 2023, 'Repair of Aerospace Composite Structures Using Liquid Thermoplastic Resin', *Polymers*, vol. 15, no. 6, 1377. <https://doi.org/10.3390/polym15061377>

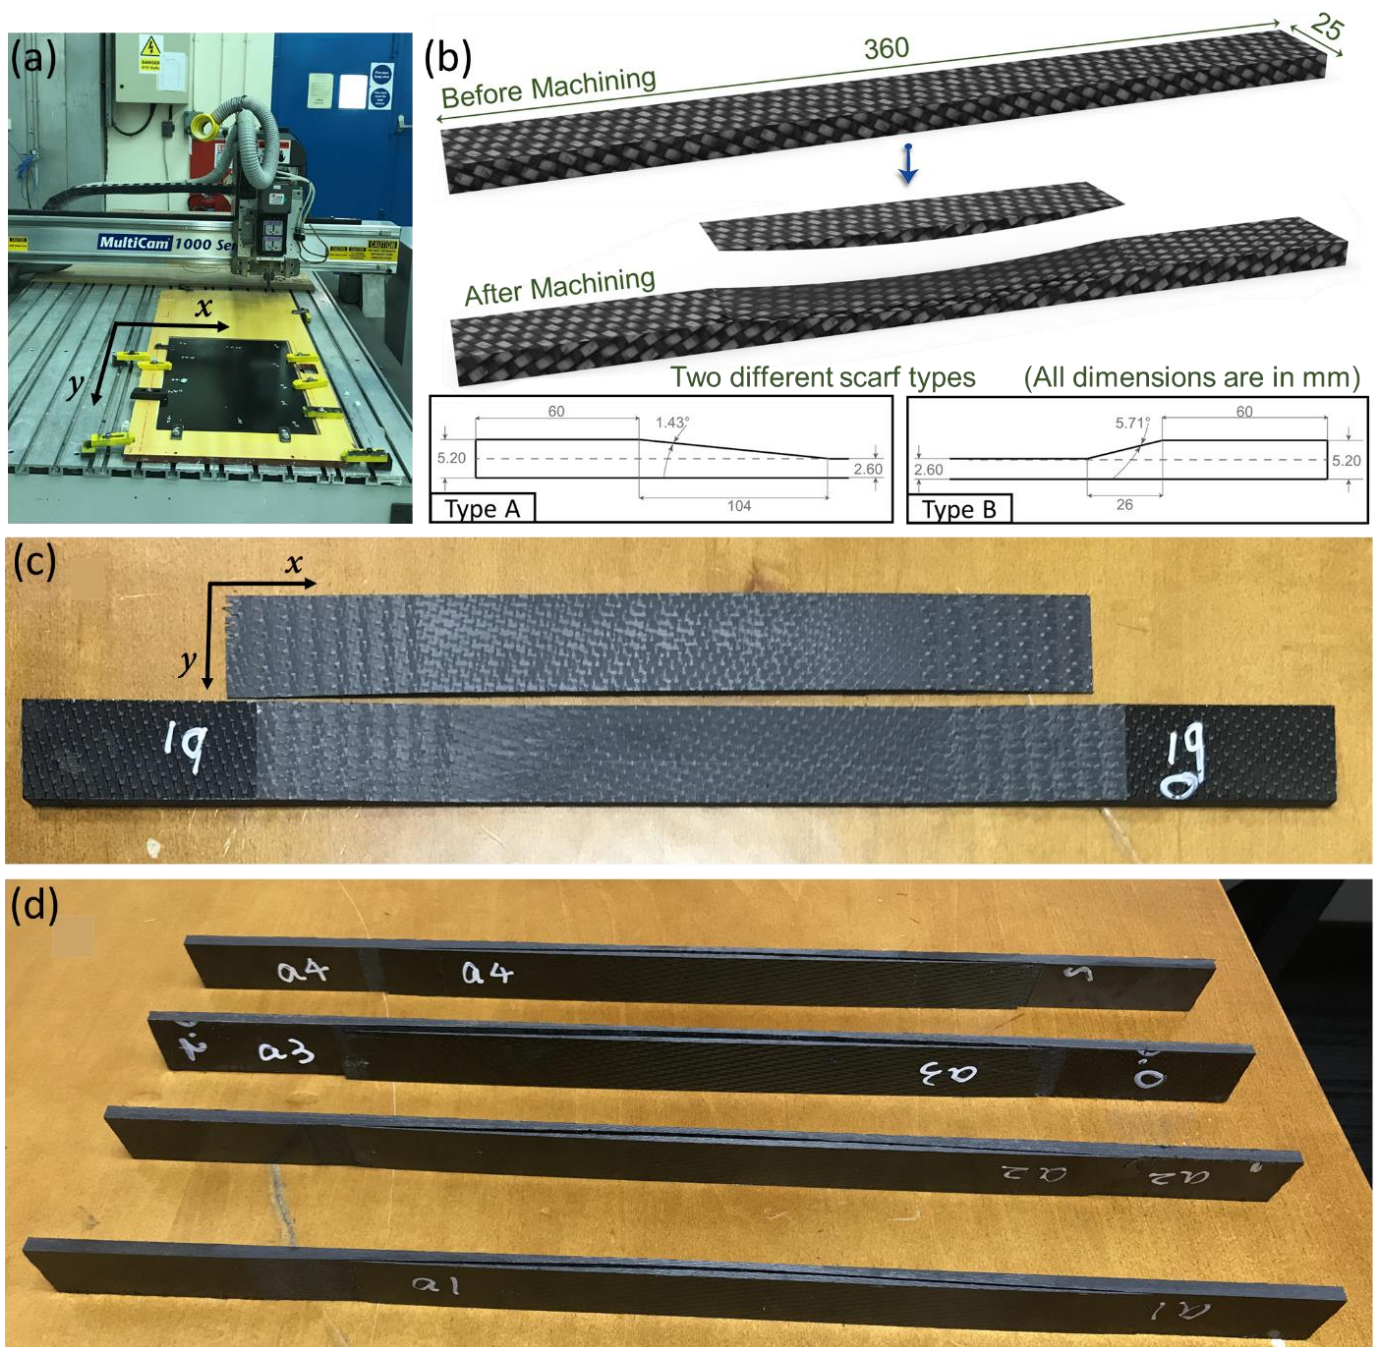
Figure 1. (a) CNC router used for the machining of the scarf joints and (b) the dimensions of two different scarf geometries. (c) A sample specimen with machined surfaces, (d) a set of machined samples ready for joining.

The scarf geometries were created by conducting the edge trimming technique using a 3-axis CNC router (i.e., MultiCam 1000 series), Texas, TX, USA. (Figure 1a). Initially, a $600 \times 400 \text{ mm}^2$ CFRP laminate with a thickness of 5.2 mm was clamped on the router. A customized wooden fixture was created for clamping the CFRP laminate by making a recess in a wooden block. The recess in the fixture was of the same size as the laminate for safe operation and quality specimens. The laminate was dropped in this recess such that the top surface was almost parallel to the border of the fixture. Clamps were installed with self-tapping bolts on the border around the recess and were tightened to hold the laminate. The flatness of the fixture was ensured while machining the recess for the profile consistency. The laminate was aligned along the axis of the router bed such that the weft was along the router gantry (the x -axis of the router) and the warp was aligned along the depth axis perpendicular to the gantry (the y -axis of the router). The profiles for the scarf surfaces were then machined for the total width required for all specimens, with margins for cutting the final width of each specimen. Four different profiles were machined, two for each type of scarf geometry. Specimens were produced by cutting them out from the laminate along the weft direction. The depth of the final cut was slightly greater than the thickness of the laminate to ensure the consistency and quality of the specimens, particularly around the edges. This resulted in grooves in the wooden fixture; however, the fixture eliminated any possibility of damage to the cutting tool or the machine bed.

The edge of the laminate was trimmed in a climb milling configuration using a 10 mm diamond solid-carbide-coated segmented straight flute tool. The scarf surfaces were created by trimming at a cutting speed of 4000 rpm and a feed rate of 800/min, as recommended by the cutting tool manufacturer. Two different types of scarf geometry were cut using two different scarf angles, i.e., 1.43° (Type A) and 5.71° (Type B) (Figure 1b). The maximum depth of the scarf geometries was kept constant in both types of specimens at 2.6 mm. The dimensions and scarf geometries of both types of specimens are shown in Figure 1b. The experimental setup and the details of the cutting tools as well as the machining of the CFRP panels can be found elsewhere [32].

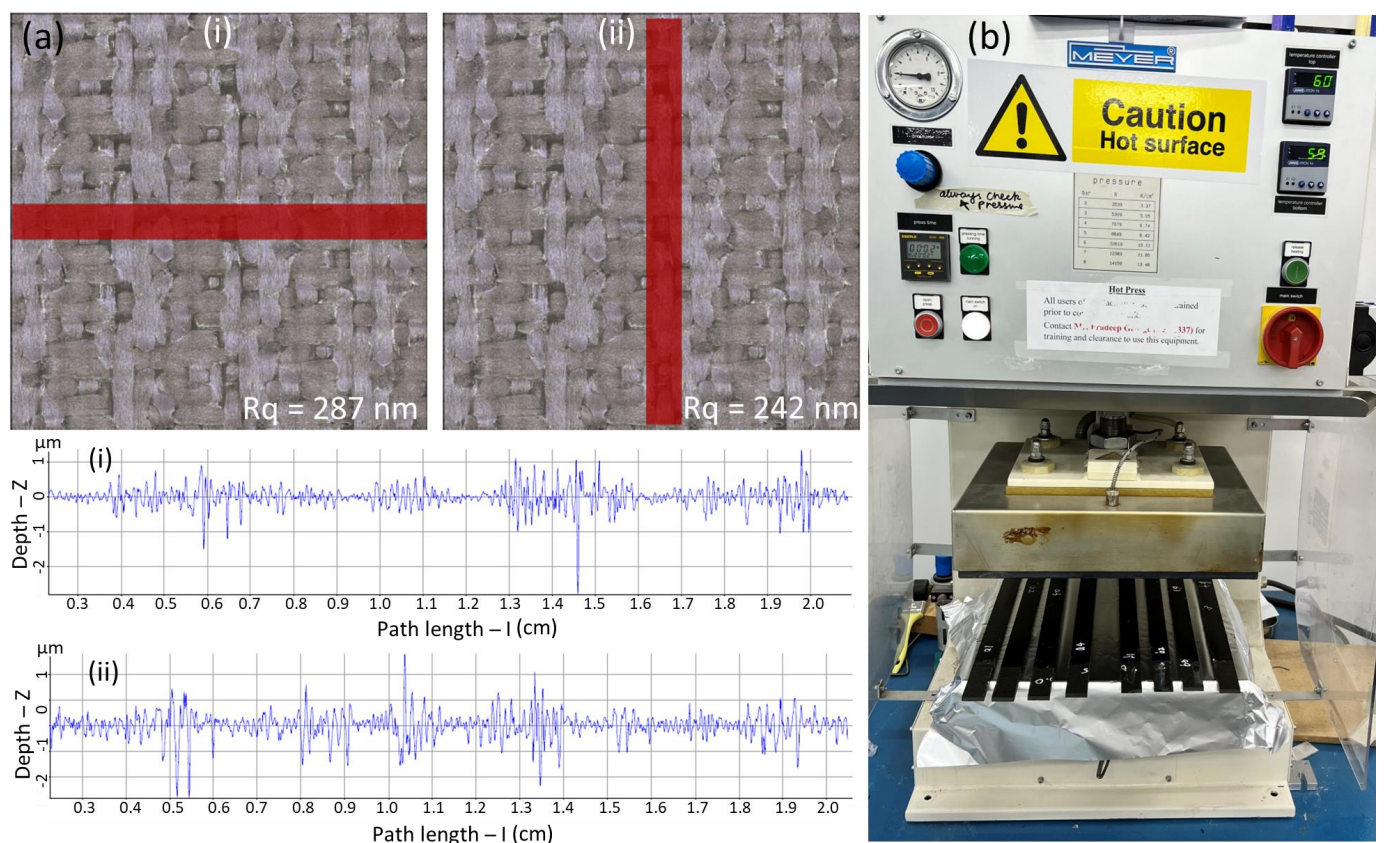
Figure 2. (a) Surface roughness profile of the specimens and (b) hydraulic press used for the repair of the scarf joints. Note: (i) shows roughness in the x direction and (ii) shows roughness in the y direction.

The surface roughness of the scarf surfaces was investigated using an Alicona Infinite-Focus optical 3D measuring instrument, Alicona, Graz, Austria, with a vertical resolution as high as 10 nm. A comprehensive roughness analysis was conducted by observing the roughness profile in both the x and y directions. The root mean square (RMS) value is commonly used to calculate the average surface roughness using data variance [33]. The R_q (RMS) in the x direction was found to be 287 nm and was recorded as 242 nm in the y direction, as shown in Figure 2a. Both types of specimens exhibited a similar roughness profile.

The composite laminates were repaired using a liquid thermoplastic resin. The specimens were repaired at both ambient temperature as well as at 210 °C using a Meyer[®] hot platen press (model: APV 3530), Roetz, Germany, equipped with dual-contact heating platens presenting a total platen area of 350 × 300 mm² (Figure 2b). It is important to note that the specimens repaired at both ambient temperature and at 210 °C were repaired at a constant pressure of 4 bar. The specimens repaired at room temperature were left to cure for 24 h, whereas the specimens repaired at 210 °C were left to cure for 90 min. The repair temperature and the repair time were selected based on the design of the experiments and

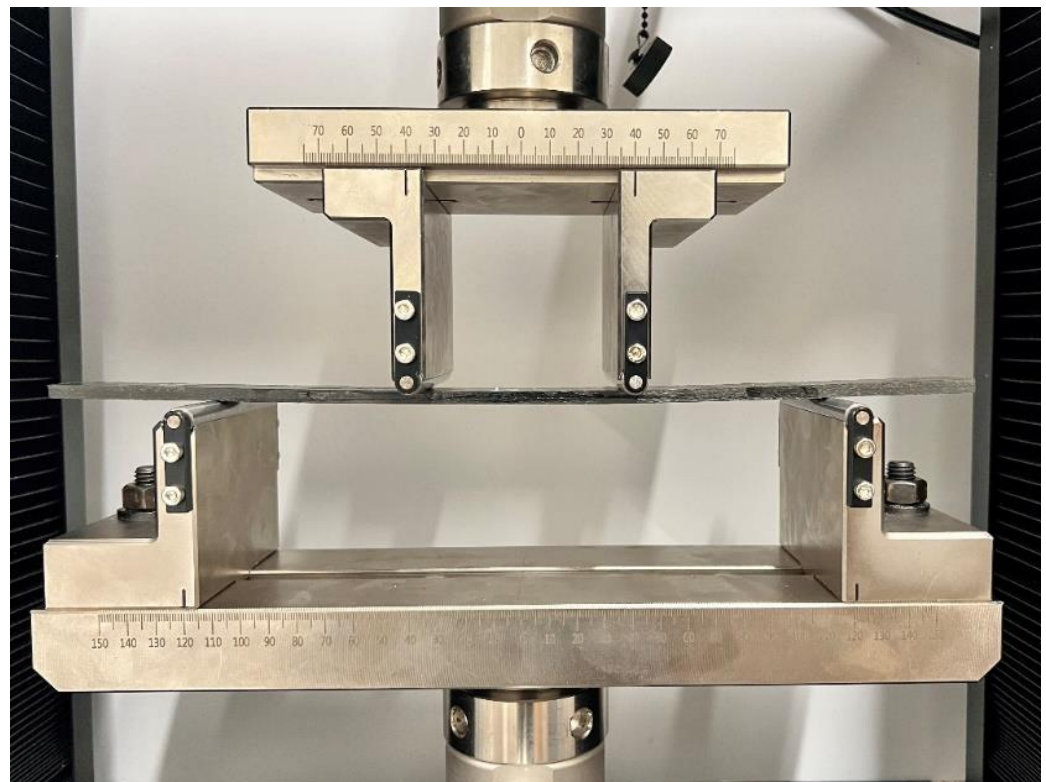
Figure 3. Repaired specimen under four-point bending test.

The flexural properties of the repaired composite samples were investigated using 4-point bending tests. The tests were performed on a SATL ST-1004 Universal Testing Machine (UTM), Incheon, Republic of Korea, equipped with a load cell of 2 kN. The tests were performed in accordance with the ASTM D6272 test standard [35]. The loading span and the support span were kept constant at 80 mm and 240 mm, respectively. The loading rate was kept constant at 2 mm/min, and the span-to-thickness ratio was 40:1. At least four specimens were tested for each configuration, and the variation in the results was determined through the 95% confidence interval (CI) formula, i.e., $\pm 1.96 \times SD / \sqrt{n}$, where SD is the standard deviation and n is the number of specimens [36]. The performance of the repaired samples was determined in terms of residual flexural strength compared to the pristine composites without any repairs. The scarf joints were placed on the bottom side (i.e., tension area of the sample) during all the tests to observe complete delamination. A repaired specimen under the 4-point bending test is shown in Figure 3.

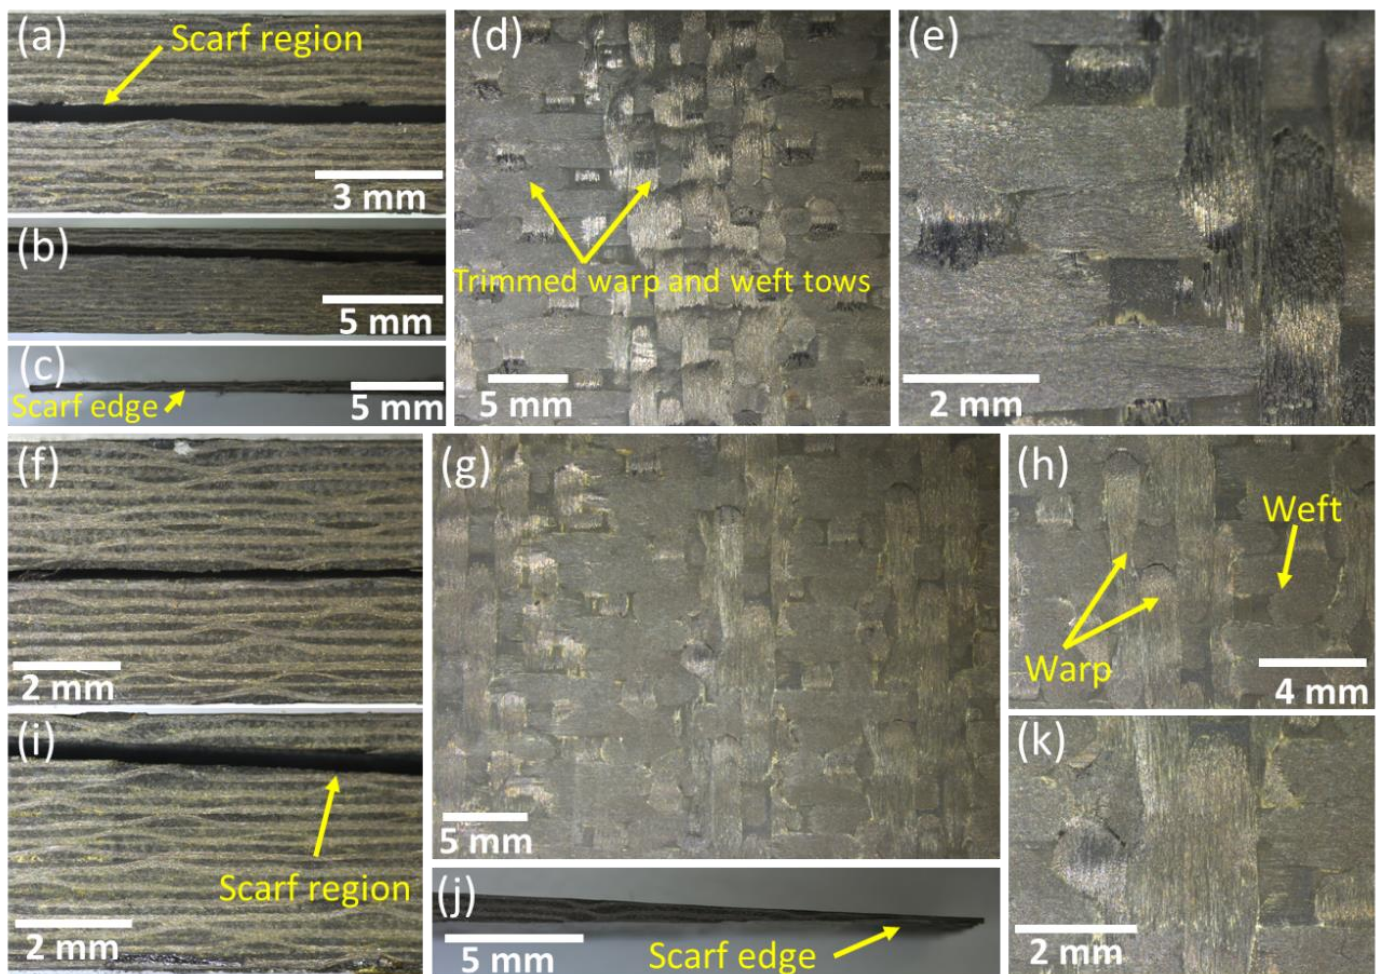
Figure 4. Optical micrographs of the scarf geometries (a–e) Type A and (f–k) Type B.

The surfaces of the scarf geometries and their cross-sections were examined using optical microscopy after machining. Similarly, the repair quality of the samples at both ambient temperature and 210 °C was also investigated through optical microscopy. The optical micrographs of the Type A composite laminate after machining are shown in Figure 4a–e, whereas those of the Type B samples are shown in Figure 4f–k. The micrographs showed no signs of micro/macro defects as a result of the machining process in both types of specimens. The edges of the scarf regions for both Type A (Figure 4c) and Type B (Figure 4j) were also machined precisely and had no visible damage. Apart from this, the micrographs of the laminates before the repair process also showed that there were no visible process-induced defects associated with the manufacturing of composites.

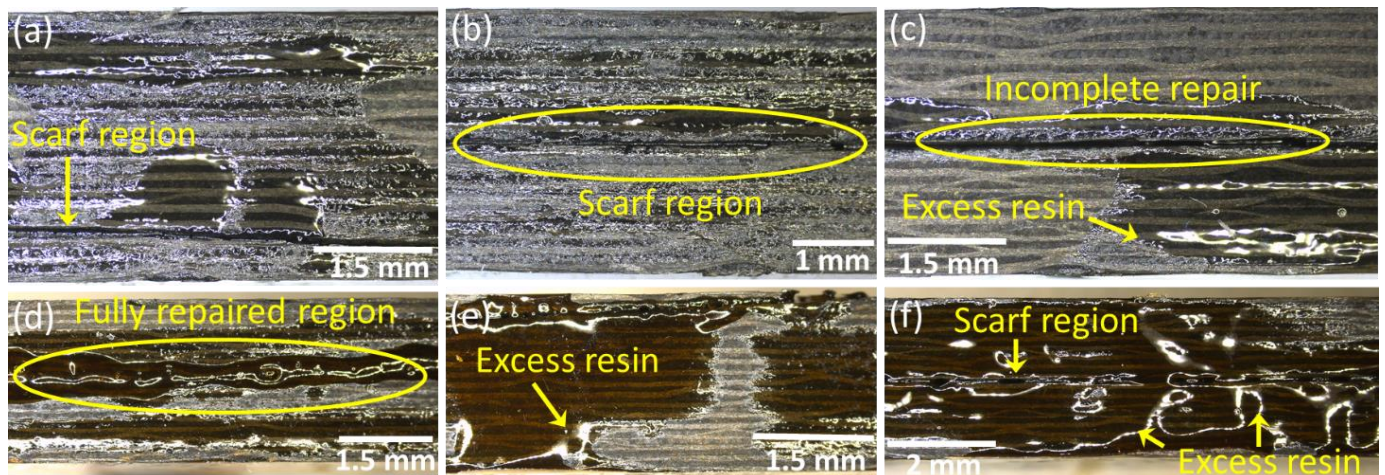
Figure 5. Optical micrographs of the specimens (a–c) repaired at room temperature and (d–f) repaired at 210 °C.

Both Type A and Type B specimens with different scarf geometries were initially repaired at room temperature using liquid thermoplastic resin. The thermoplastic resin was evenly applied on both surfaces of the scarf geometries, and the laminates were carefully joined. The specimens were then placed in the Meyer[®] press under a constant pressure of 4 bar and left to cure at room temperature for 24 h. The optical images of the Type A specimens repaired at room temperature using liquid thermoplastic resin are shown in Figure 5a–c. It can be observed that the samples were not fully repaired, and the scarf regions remained open in some areas. The excess resin applied on the surfaces of the laminates was squeezed out through the cracks. Even though a constant pressure of 4 bar was applied on the specimens, the laminates exhibited a random repair pattern comprising fully repaired as well as incomplete repair regions. These incomplete repairs had a major influence on the mechanical performance of the repaired laminates, as discussed in detail in Section 3.4.

Once the repair temperature was increased to 210 °C, the cross-sectional micrographs showed better bonding by the liquid thermoplastic resin, and the laminates were observed to be fully repaired (Figure 5d–f). Again, the excess resin was squeezed out of the cracks due to the applied pressure. It is important to note that even at a high temperature such as 210 °C, there was no visible deformation or flow in the thermosetting resin used for manufacturing the composite laminates in the form of prepregs. Therefore, no physical or chemical changes were made to the parent structure during the repair of the scarf joints using liquid thermoplastic resin. Based on the high quality of the repairs, both types of composite laminate repaired at 210 °C exhibited significant improvements in their mechanical performance, as discussed in detail in Section 3.4.

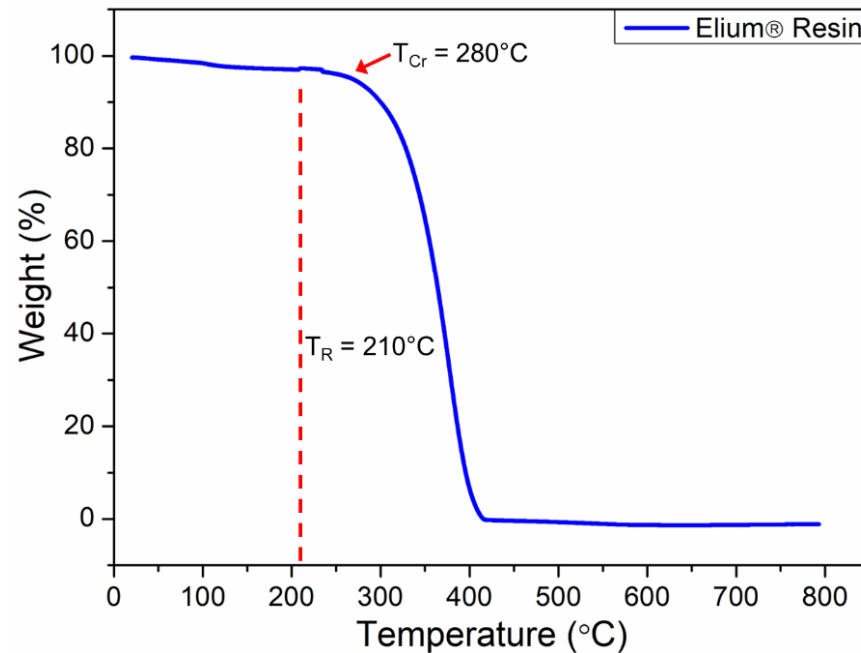
Figure 6. Thermal degradation of the liquid thermoplastic resin.

A TGA analysis of the liquid thermoplastic resin was completed to identify the critical degradation temperature (T_{cr}) of the liquid thermoplastic resin. Multiple TGA scans of the pure liquid thermoplastic resin were performed by keeping the overall BPO content constant at 3 wt.%. As shown in Figure 6, the liquid thermoplastic resin presented a rapid degradation beyond 280 °C. Therefore, the repair temperature (T_R) for the composite laminates was kept below T_{cr} . Furthermore, the optimum repair temperature was identified as 210 °C based on a comprehensive analysis of variance (ANOVA) from a previous study on the self-healing of liquid thermoplastic composite laminates [1]. Another study has also shown that the best mechanical performance of self-healed liquid thermoplastic composites was achieved at 210 °C [30]. It is important to note that the initial drop in the weight of the resin from 100 to around 95% before reaching 280 °C was due to the dehydration process.

The actual degradation of the resin started beyond this point and was reflected by the sharp drop in weight. The degradation of the resin was completed at around 420 °C, where the weight dropped to zero.

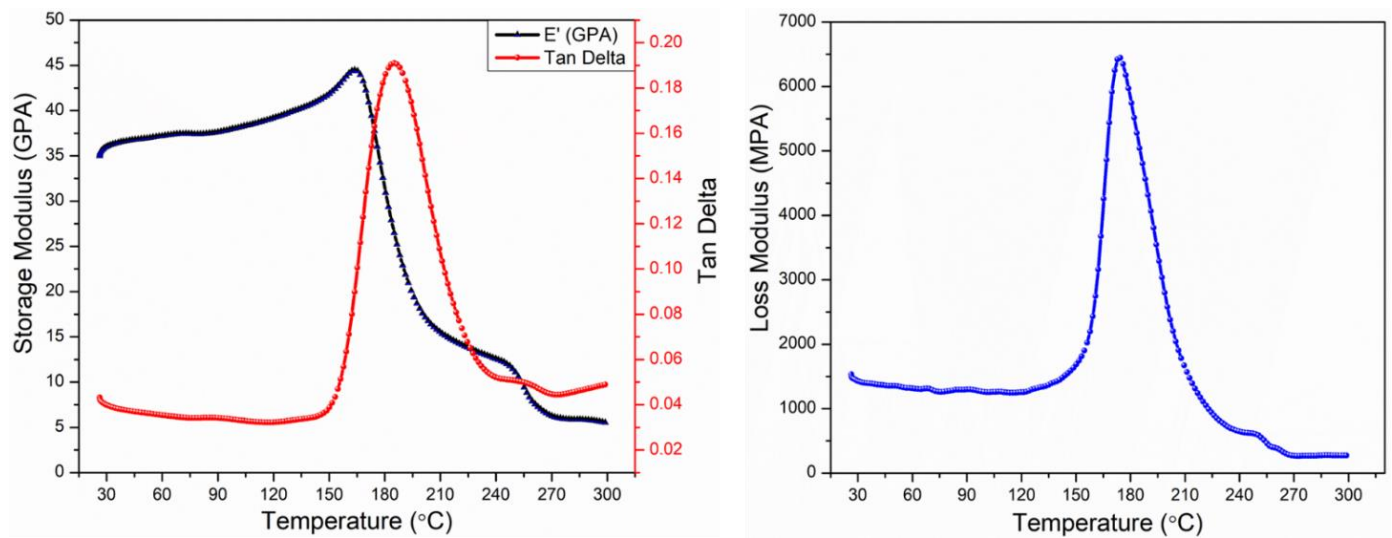
Figure 7. Thermomechanical properties of the pristine specimens: (a) storage modulus and tan delta, (b) loss modulus.

The thermomechanical properties of pristine composite laminates were investigated by conducting a number of DMA tests. Within the scope of these tests, the storage modulus, loss modulus, tan delta, and glass transition temperature of the composites were calculated. The average thermomechanical properties of the pristine samples are listed in Table 2. The storage modulus and tan delta over the temperature range of 30–300 °C are graphically presented in Figure 7a, whereas the loss modulus is shown in Figure 7b. The storage modulus of the specimens gradually increased as the temperature was increased before the onset of the glass transition temperature (T_g). This initial increase in the stiffness was attributed to the thickness of the specimens. A further increase in the temperature above T_g led to a sudden decrease in the storage modulus due to the transition from glass to the rubbery state. The highest value of the storage modulus was recorded as 44.5 GPa in the glassy state, where the polymer chains were densely packed and experienced strong intermolecular forces. The T_g was calculated from the peak of the tan delta as 186.6 °C, which was comparable with the T_g of the epoxy resin provided in the datasheet (i.e., 190 °C).

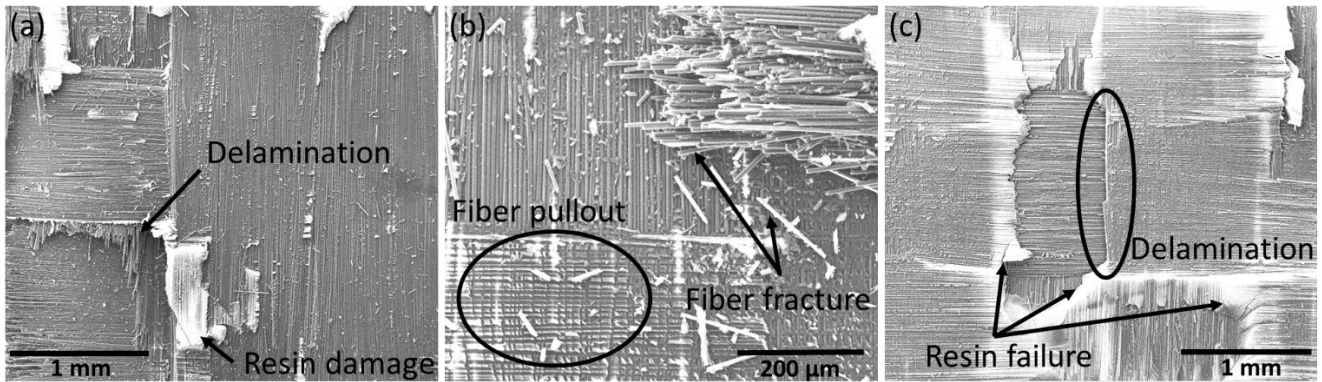
Figure 10. SEM micrographs showing different failure modes in the samples repaired at room temperature after flexural testing (a) delamination, (b) fiber pullout and fracture and (c) resin failure and delamination.

The results in Section 3.4 demonstrated that even though the strength of the repaired samples was recovered to up to 97% that of the pristine samples, all the repaired specimens exhibited a similar delamination failure mode. The failure of the scarf-repaired specimens at both room temperature and 210 °C after flexural testing was thoroughly investigated through SEM micrographs. Both Type A and Type B specimens exhibited similar failure modes; therefore, only the fractographic analysis for the Type A specimens is considered here. The SEM images of the Type A specimens repaired at ambient temperature are shown in Figure 10. As expected, the failure at the microscopic level was mainly comprised of delamination at the tow level. Apart from the delamination failure mode, rigorous fiber fracture was also observed throughout the delaminated surfaces (Figure 10b). Upon failure, multiple fibers were also pulled out of the specimens. Along with this, excessive liquid thermoplastic resin failure was observed across the edges of individual fiber tows, promoting the delamination failure. The SEM micrographs also revealed a fiber–matrix interface failure mode, especially in the fiber fracture regions. Nonetheless, macroscopic delamination was the most dominant failure mode in both Type A and Type B specimens repaired at room temperature, due to the incomplete scarf repair.

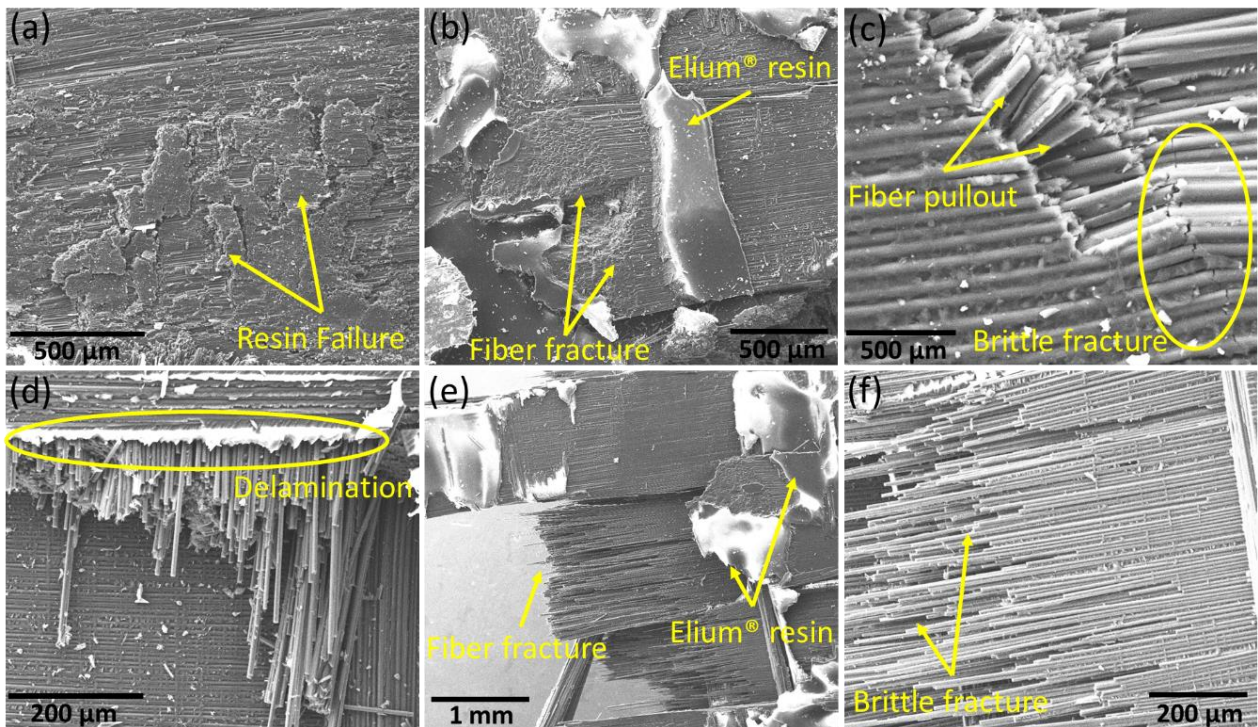
Figure 11. SEM micrographs showing different failure modes in the samples repaired at 210 °C after flexural testing (a–c) Type A and (d–f) Type B specimens.

As mentioned before, increasing the repair temperature to 210 °C significantly influenced the flexural properties of the repaired specimens and hence their microstructures upon failure. The SEM micrographs of the Type A and Type B specimens repaired at 210 °C upon failure after flexural testing are shown in Figure 11a–c and Figure 11d–f, respectively. The failure comprised a dominant delamination mode along with resin damage and fiber fracture. The micrographs showed a stronger bond between the liquid thermoplastic resin and the composite laminates. The failure was mainly comprised of bulk liquid thermoplastic resin failure in the form of patches on both the top and bottom sides of the repaired laminates. Along with this, the fibers were also pulled out and fractured upon the complete failure of the scarf joints, as the scarf geometry was pulled out due to complete delamination. The carbon fibers exhibited the commonly observed brittle fracture mode, especially along the edges of the scarf joints [42].

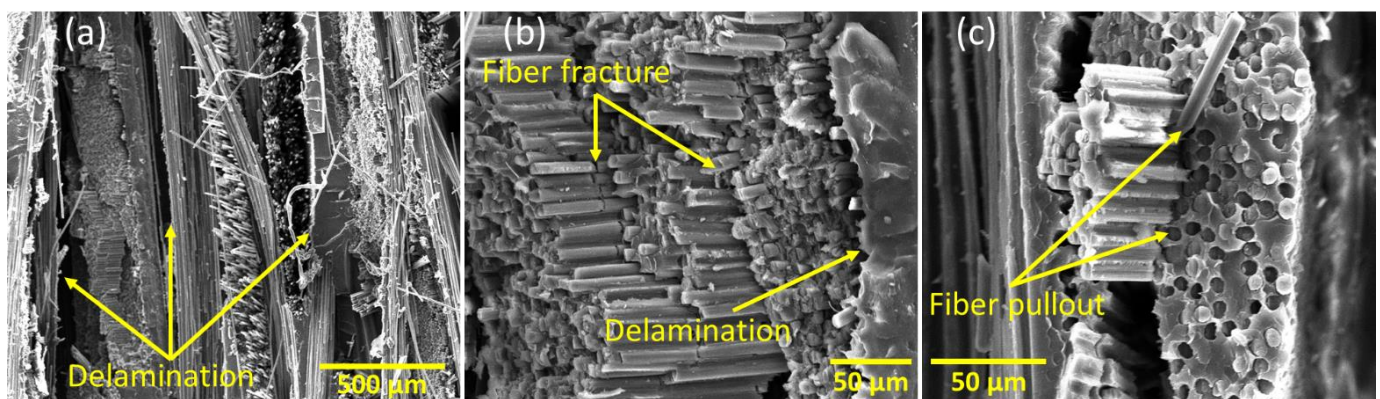
Figure 12. SEM micrographs showing different failure modes in the pristine specimens (a) delamination, (b) fiber fracture and (c) fiber pullout.

The failure of the pristine specimens without any scarf joints was also investigated at a microscopic level after subjecting them to flexural tests. The SEM micrographs in Figure 12 showed that the pristine CFRP specimens exhibited a dominant brittle fiber fracture failure mode commonly observed in carbon-fiber-based composite laminates [3]. Apart from that, the microscopic failure comprised delamination, fiber pull out, fiber cracking, and resin damage. Numerous studies in the literature have observed similar failure modes in CFRP composite specimens [42–45]. The results also showed a strong interface between the fibers and the thermosetting matrix, which was primarily due to the high surface roughness of the carbon fibers. As a result of this surface roughness, the surface area per unit volume of the fibers increased, and a stronger bond was established due to mechanical interlocking [3]. Based on this strong bonding, most of the fractured regions showed the collective brittle failure of carbon fibers and the matrix.
